GEOTECHNICAL RISK MANAGEMENT POLICY FOR PITTWATER
FORM NO. 1 – To be submitted with Development Application

Address of site 25 – 27 Kevin Avenue, Avalon Beach, NSW

**REPORT ON GEOTECHNICAL INVESTIGATION
AND RISK ASSESSMENT**

This report details the results of a Geotechnical Investigation (GI) and Risk Assessment carried out to provide advice and recommendations for the Development Application (DA) submission for a proposed new senior living development building at 25-27 Kevin Avenue, Avalon Beach, NSW. The investigation was undertaken by Crozier Geotechnical Consultants (CGC) at the request of Gartner Trovato Architects, on behalf of the client, Gregory Natrass.

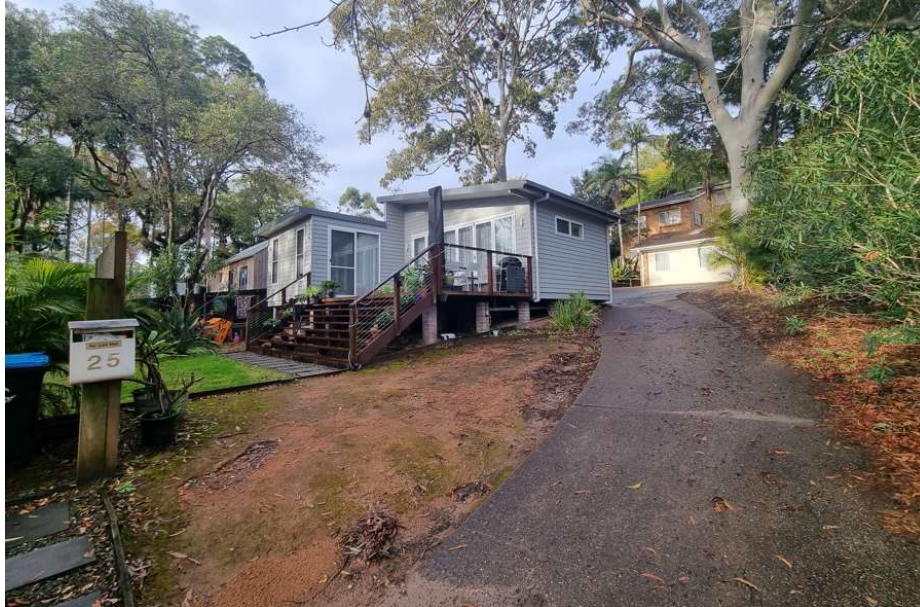
Photograph-2: View of front of 25 Kevin Avenue. View looking south-west from the roadway.

- 25 Kevin Avenue: contains a two-storey brick building with two detached granny flats (within the front site area), a swimming pool and a pavilion. The buildings/structures appeared in fair to good condition. The remaining area of the block was occupied by timber decking, concrete driveway, footpath, timber retaining walls, trees and lawn.
- 27 Kevin Avenue: comprises a two-storey brick dwelling with attached garage and a detached storage area located within the rear area of the block. The main house and storage area appeared in fair to good condition. The remaining area is occupied by asphalt-paved driveway, footpath, trees and lawn.

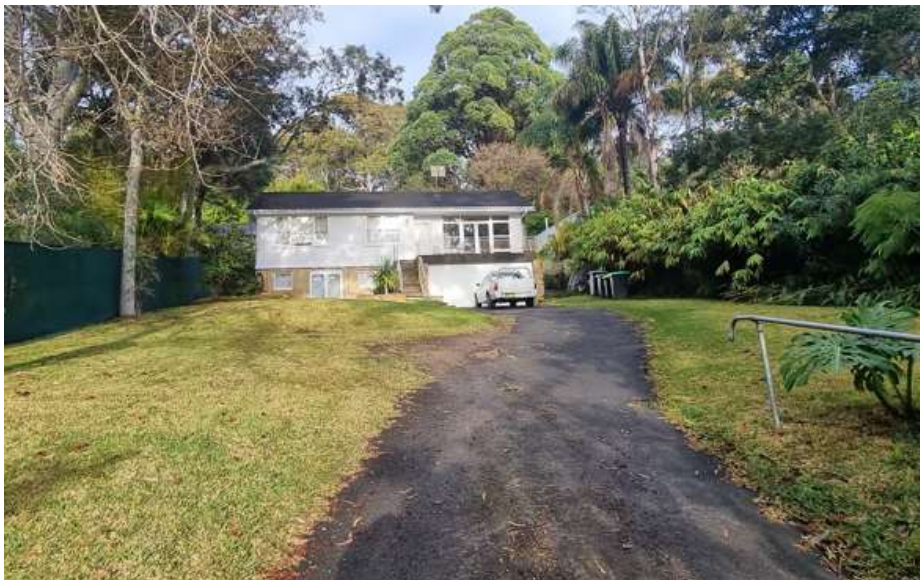
Photograph-3: View of front area of 27 Kevin Avenue. View looking south-west from the roadway.

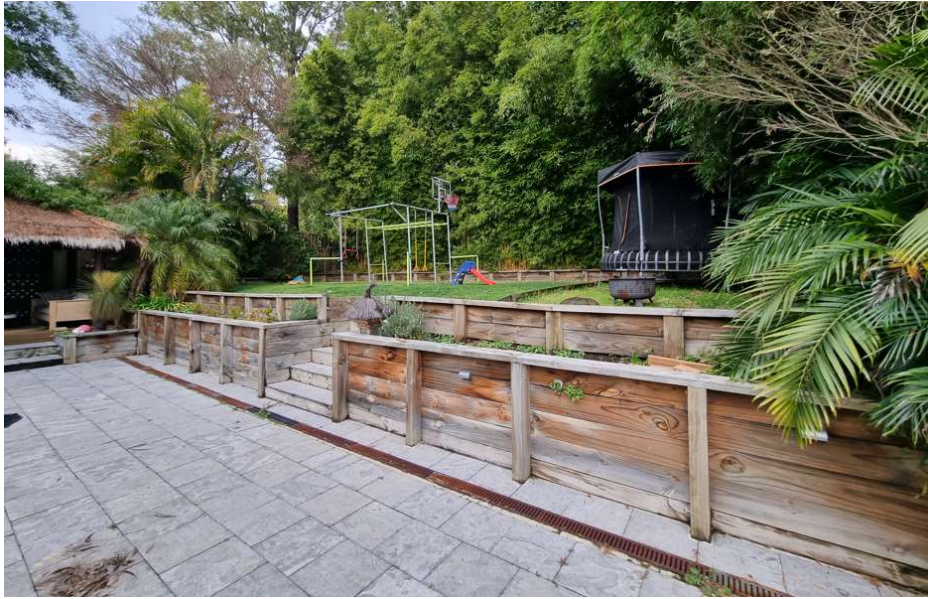
Photograph-4: View of rear area of 25 Kevin Avenue. View looking south from the rear yard.

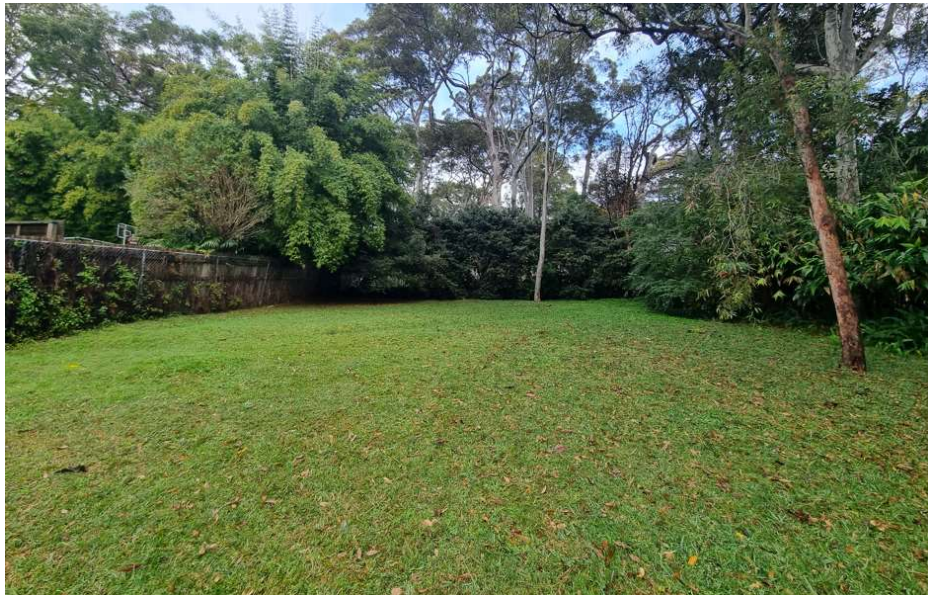
Photograph-5: View of rear area of 27 Kevin Avenue. View looking south-west from the rear yard.

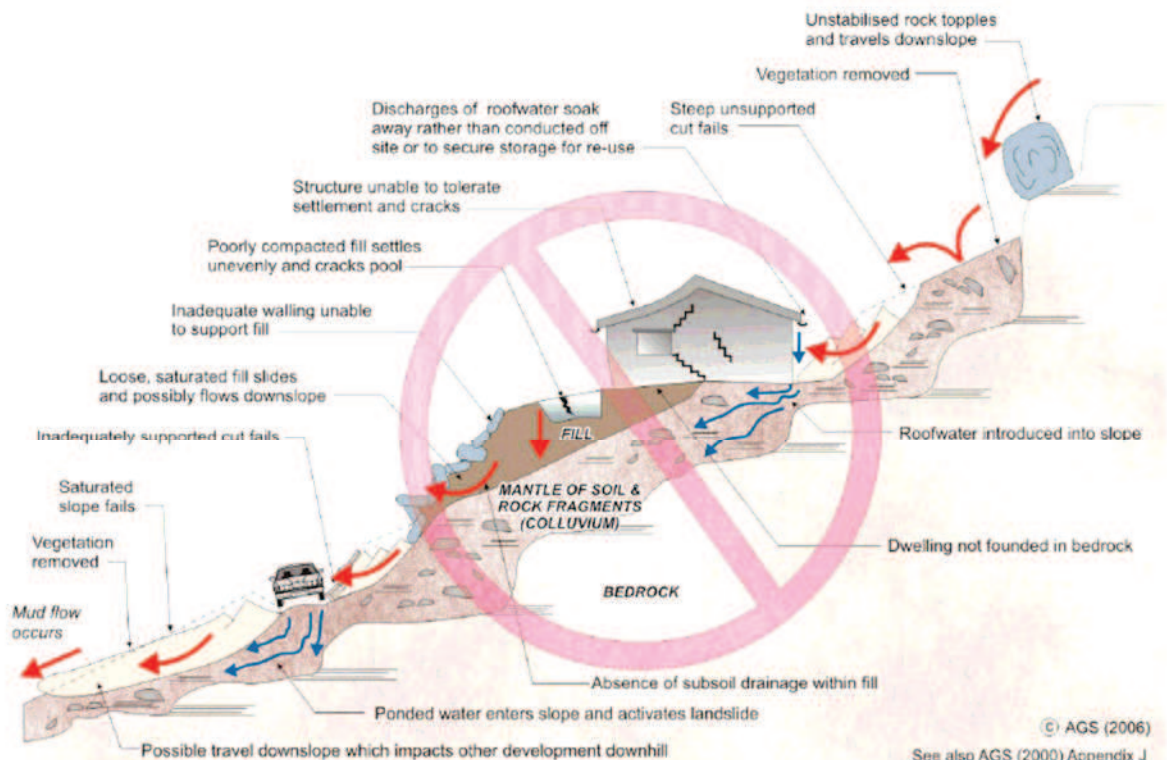
EXAMPLES OF **POOR** HILLSIDE PRACTICE
