# PRELIMINARY ACID SULPHATE SOIL ASSESSMENT

## PRELIMINARY ACID SULPHATE REPORT

Proposed Residential Sub-Division  
45/49 Warriewood Road, Warriewood, NSW

**28 February 2020**

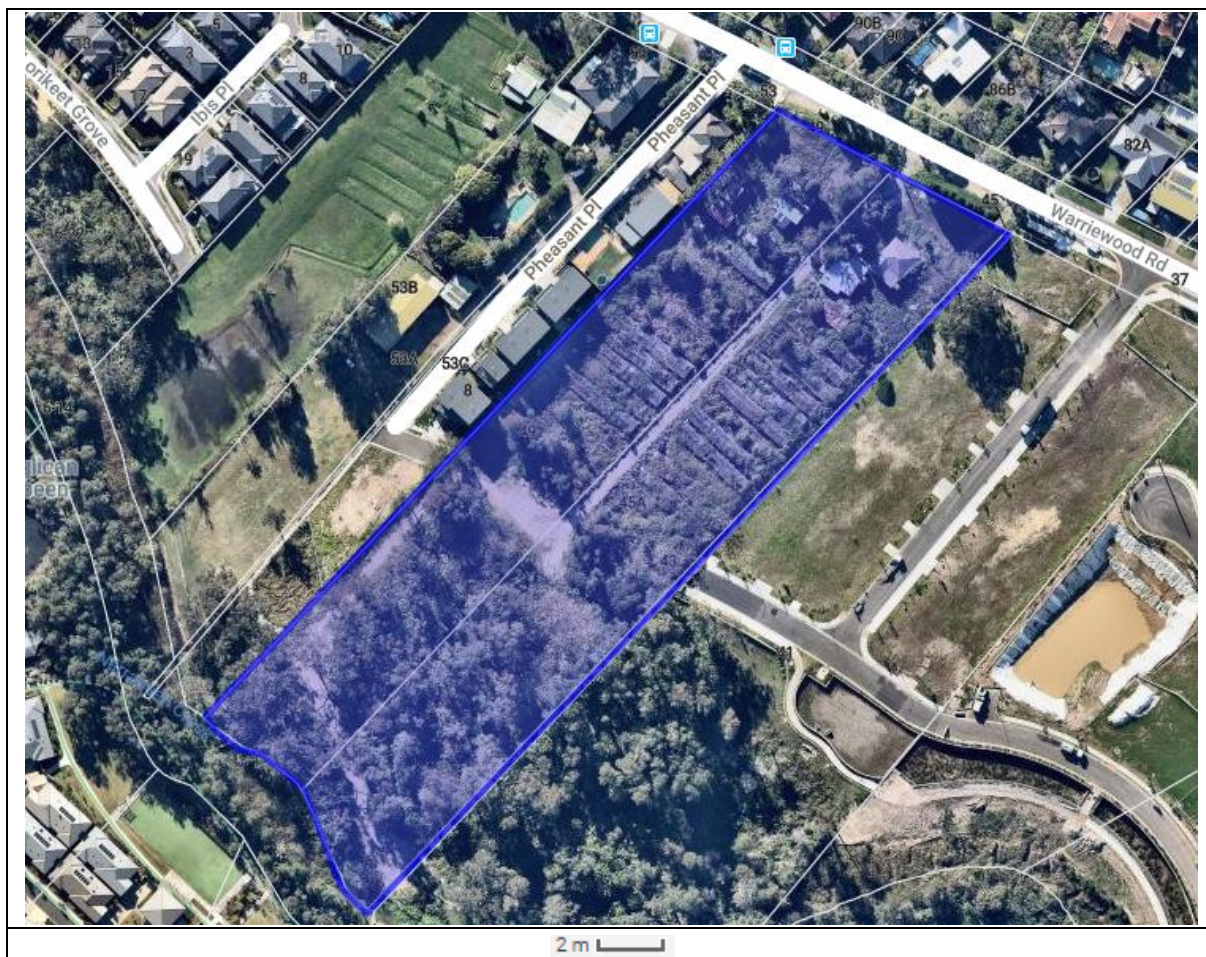
**Figure 1.1 – Aerial View of the Proposed Development Site**

The site area is shown shaded in blue in both diagrams.

The proposed development site is bounded by Warriewood Road to the north; by prospective or existing residential developments to the east and west, and by Narrabeen Creek to the south and south-west.

Recent satellite views and street maps showing the location of the proposed development are provided in Figures 1.1 and 1.2 respectively on the following page.

The direction of north is towards the top of both diagrams.

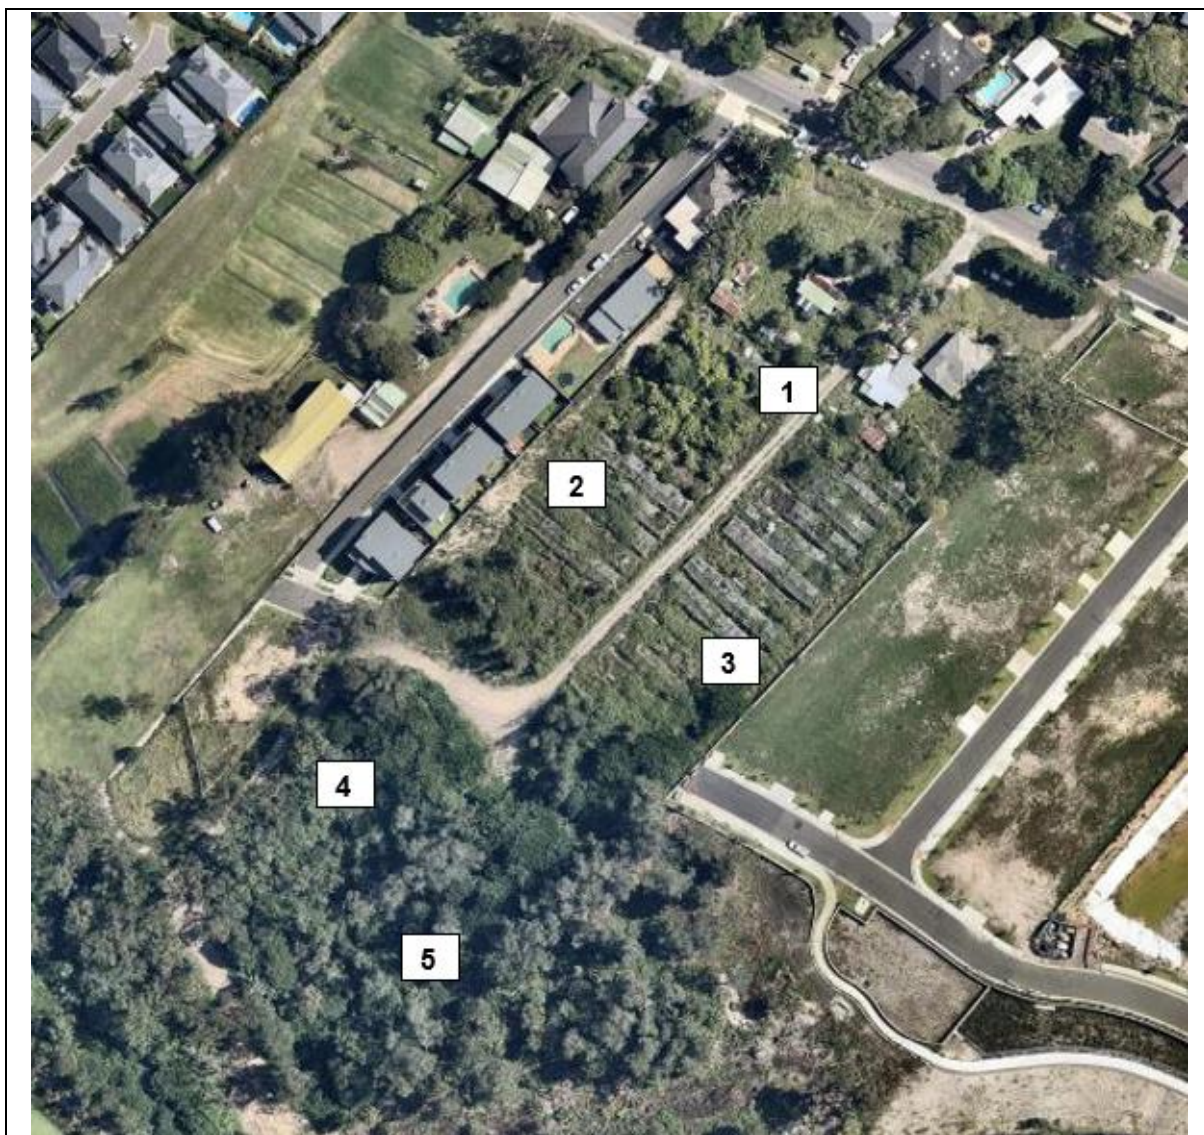
**Figure 5.3 – Soil Sampling Locations**

Locations of the five soil bores associated with the Preliminary Site Investigation are shown in Figure 5.3, on the following page.
