GEOTECHNICAL INVESTIGATION:

New House at **32 Bellara Avenue, North Narrabeen**

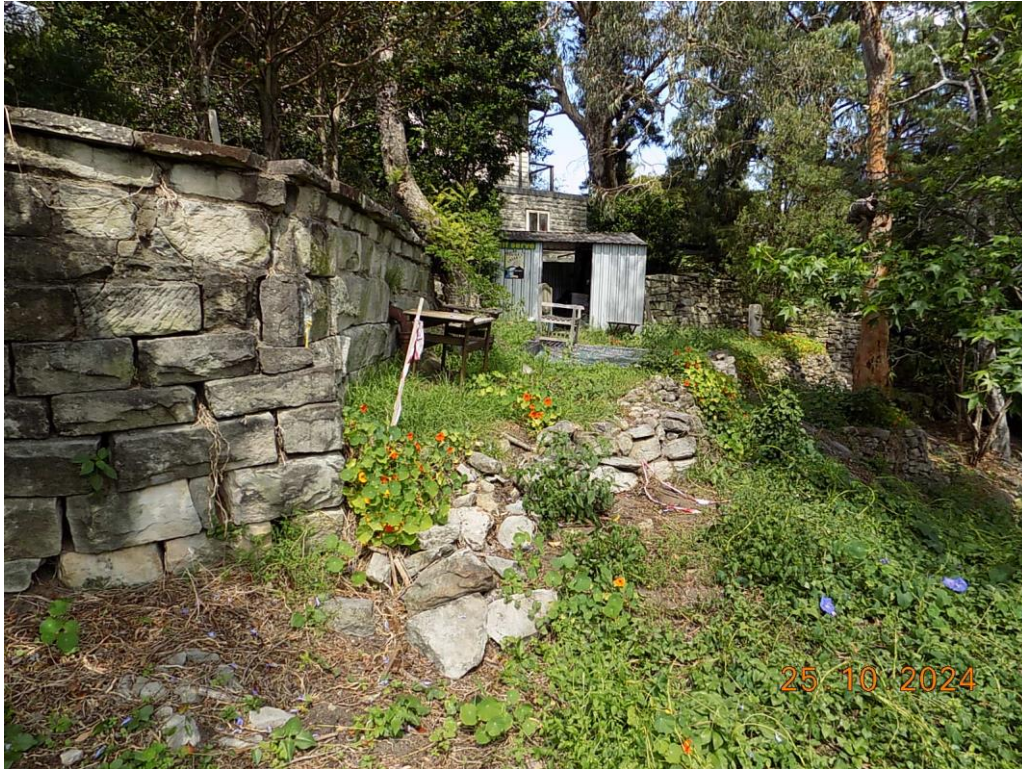
Photo 3

- 2.3** At the road frontage, a stable sandstone clad concrete block retaining wall reaching ~3.1m high supports a cut for the turning circle. Vehicle access to the property is mid-way up the block (Photo 1). The proposed new house is to be constructed uphill of the road access and retaining wall. Loose sandstone boulders are scattered across the moderately graded slope and are either resting or embedded in stable positions (Photo 2). A stable 1.5m high stack rock retaining wall extends along

the uphill boundary (Photo 3). Stable sandstone bedrock was observed to be outcropping above the subject property (Photo 4).

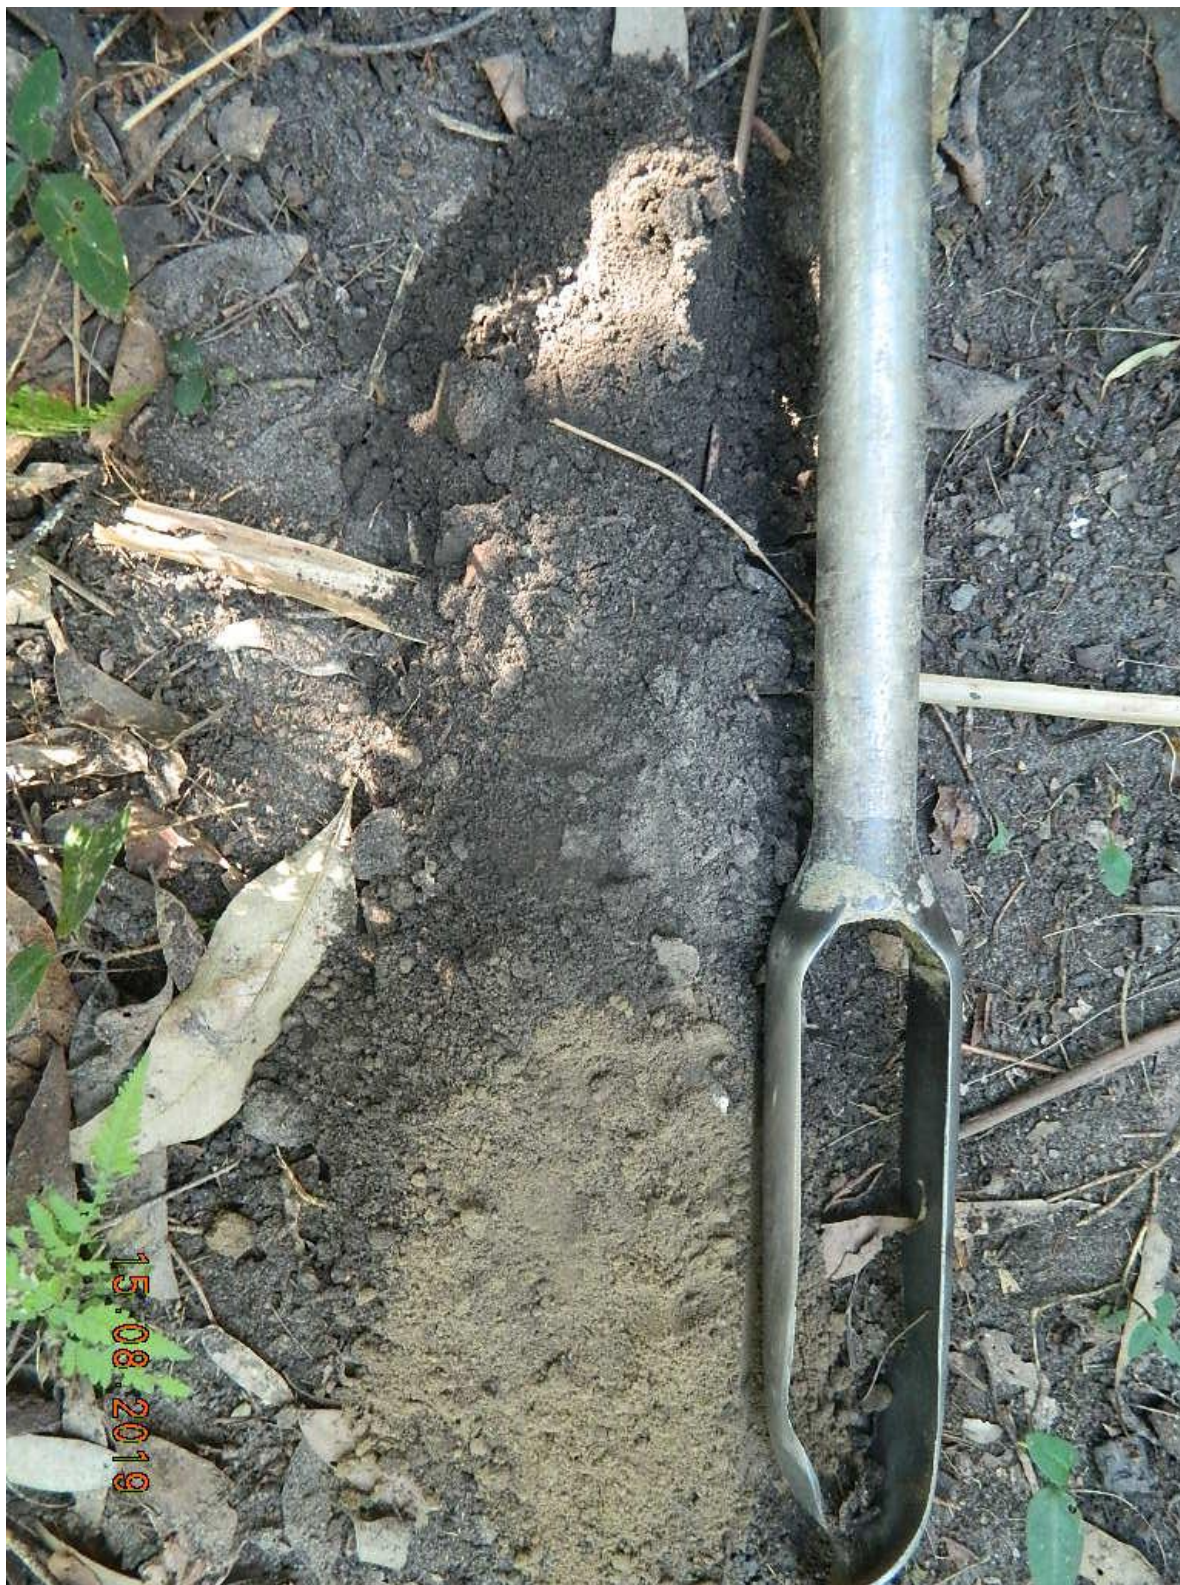
Photo 5 – downhole is top to bottom

AUGER HOLE 1 (~RL33.5) – AH1 (Photo 5)

Depth (m)	Material Encountered
0.0 to 0.1	TOPSOIL , Sandy soil, fine grain, dark brown
0.1 to 0.2	SILTY SAND , fine grain, light brown.

End of hole @ 0.2m. No water table encountered.

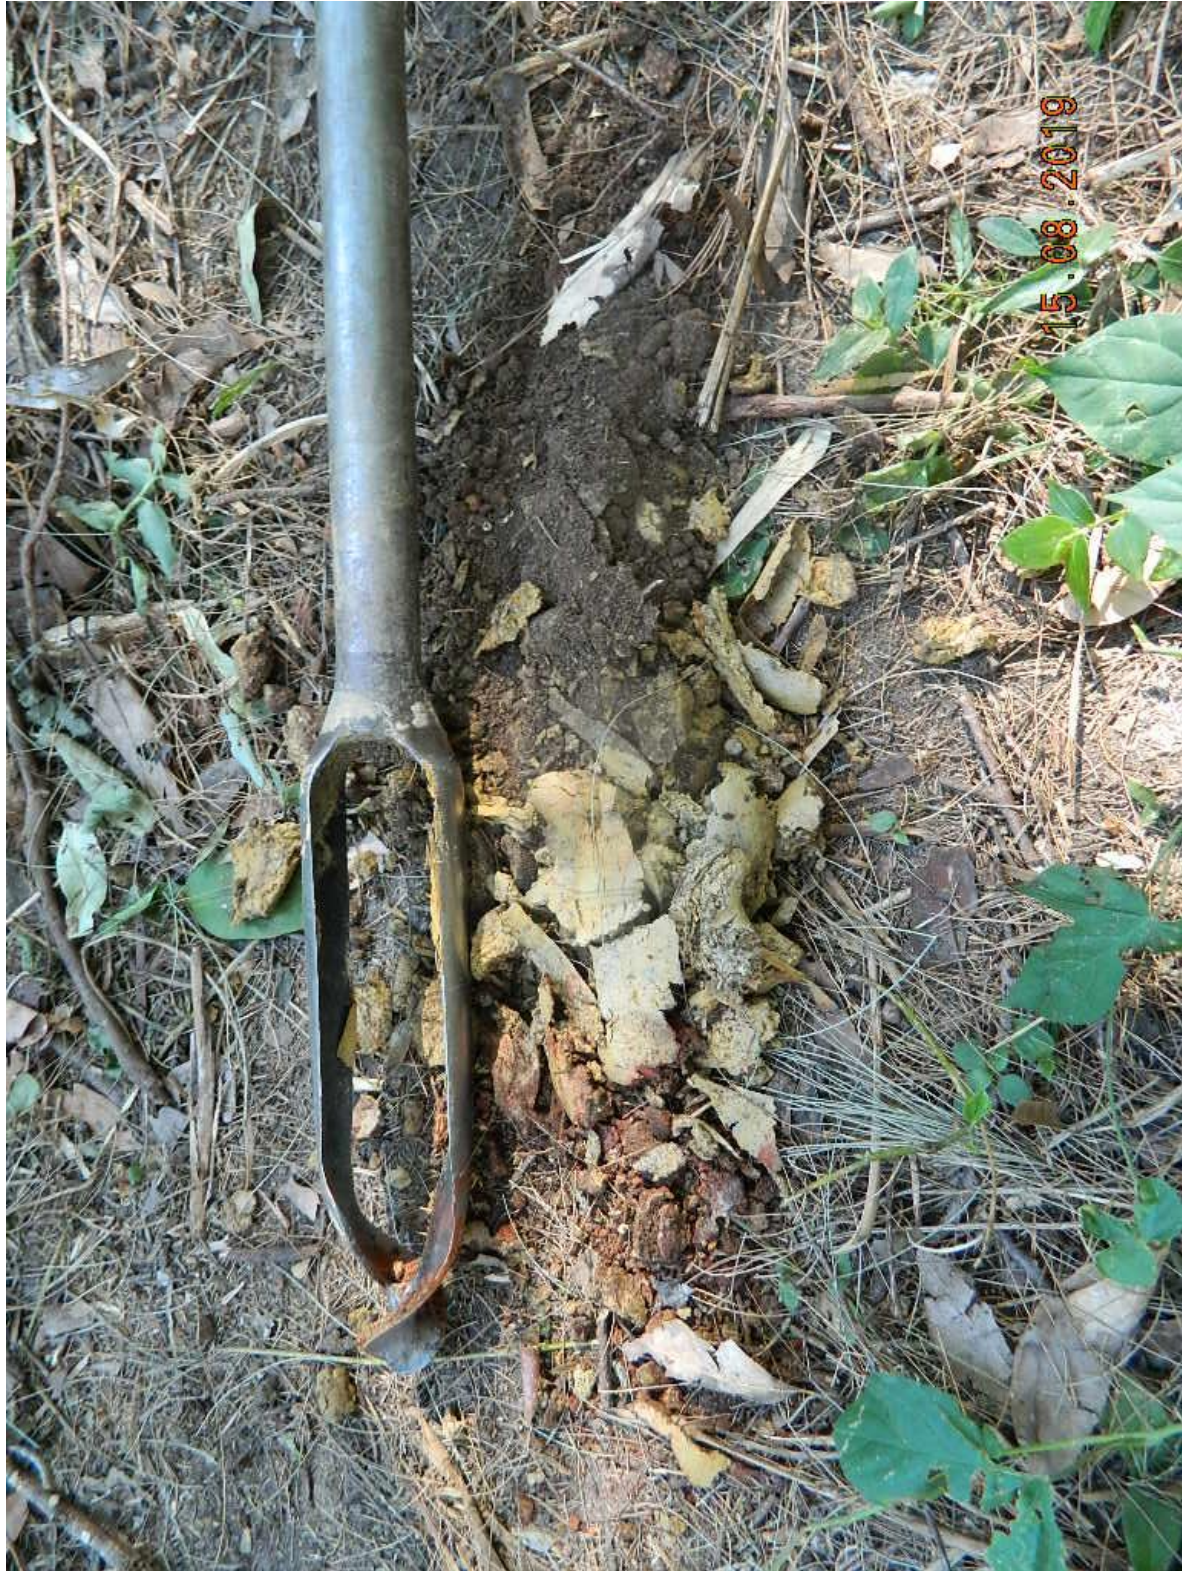
Photo 6 - downhole is top to bottom

AUGER HOLE 2 (~RL31.5) – AH2 (Photo 6)

Depth (m)	Material Encountered
0.0 to 0.1	TOPSOIL , Sandy soil, fine grain, dark brown
0.1 to 0.2	CLAY , stiff clay, light brown with maroon shale fragments.

End of hole @ 0.2m hitting shale. No watertable encountered.
