GEOTECHNICAL INVESTIGATION:

Subdivision and Two New Houses at 50 Condoover Street, North Balgowlah

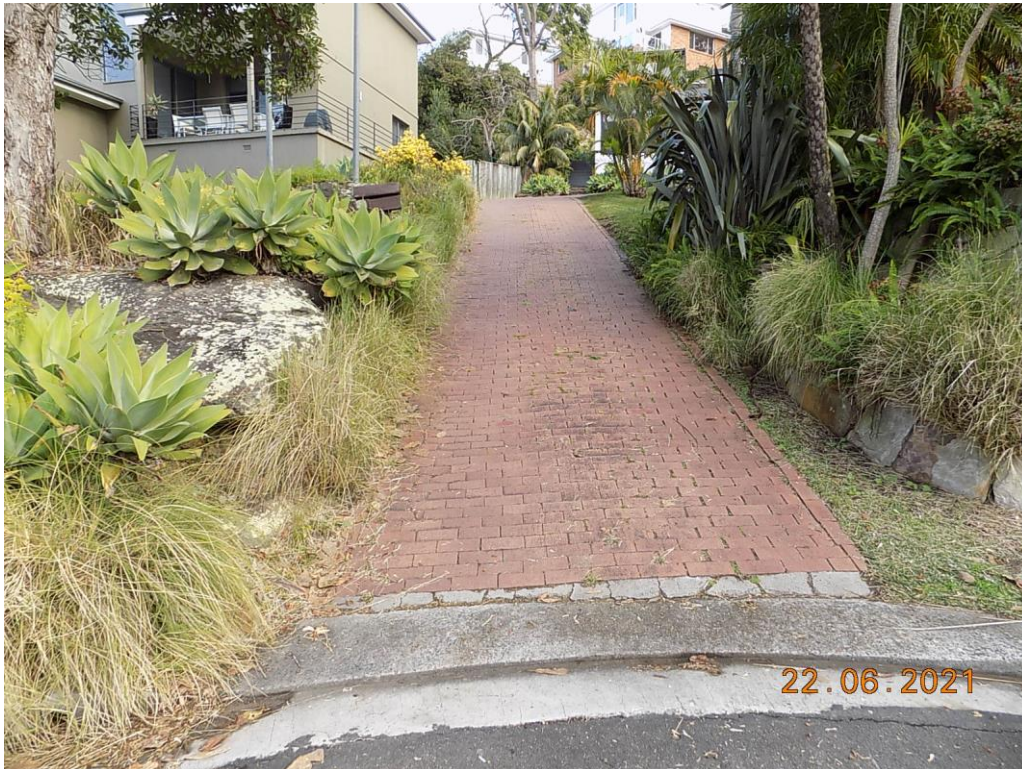
Photo 1

- 2.3** At the road frontage, a brick-paved driveway runs up the slope to a carport on the downhill side of the property (Photo 1). The driveway and carport will both be demolished as part of the proposed works. Competent Medium Strength Sandstone outcrops at the road frontage and on the downhill side of the carport (Photo 2). The single-storey brick house was observed to be supported directly off outcropping sandstone and will also be demolished as part of the proposed works (Photo 3). The cut for the uphill side of the house is supported by a stable stack rock retaining wall ~1.0m high (Photo 4). Medium Strength Sandstone bedrock outcrops and steps up the

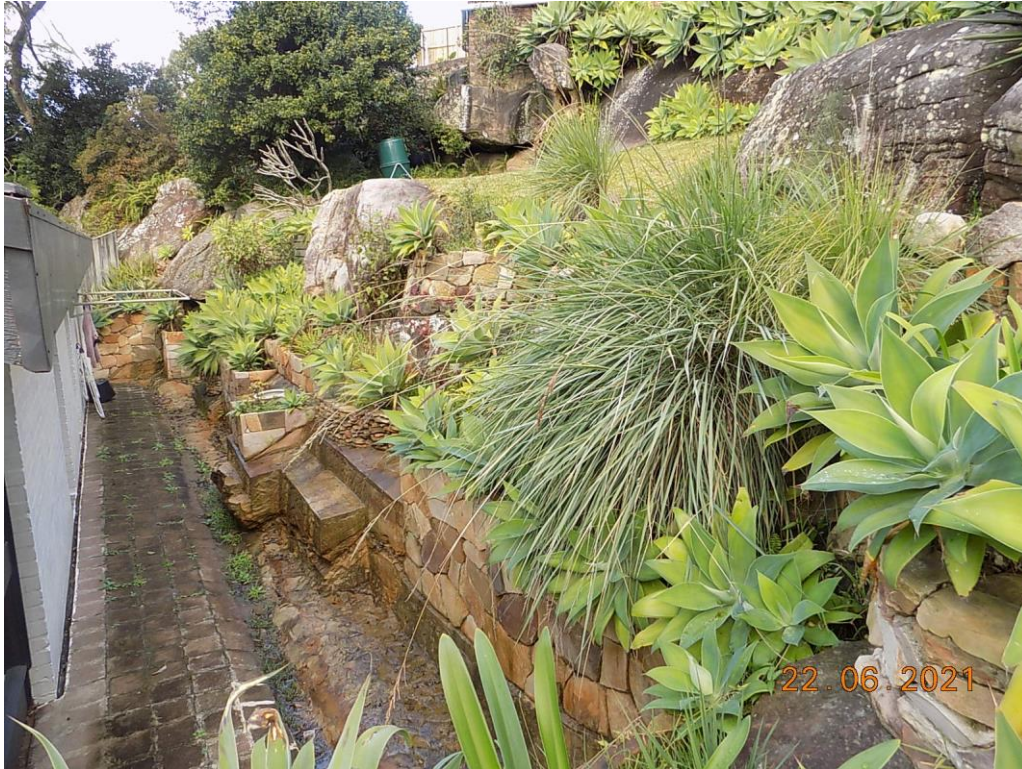
Photo 5

slope above the cut (Photo 5). The outcropping rock is slightly undercut but has been underpinned in the past by the owner using concrete block and brick blade walls and piers mortared with non-shrink grout (Photo 6). A gentle to moderately sloping lawn rises above the outcrop to the road frontage with Kimo Street (Photo 7). Medium Strength Sandstone outcrops and steps up the slope through this lawn (Photo 8). No significant geological defects were observed in the outcrop and it is considered stable.
