RESIDENTIAL DEVELOPMENT
4 DELMAR PARADE & 812 PITTWATER ROAD,
DEE WHY NSW

Reference: P3018_01 rev3

2 May 2024

1 PROJECT BACKGROUND

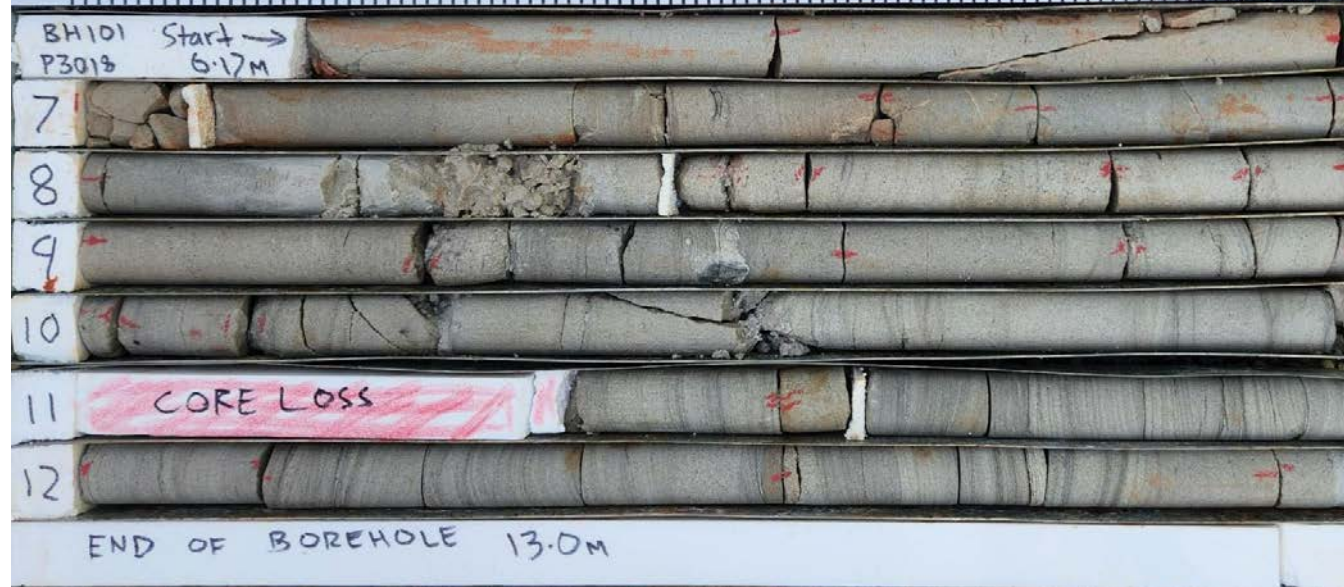
BOREHOLE ID: BH101
DEPTH: 6.17M to 13.0m
CORE TRAY NO: Box 1+2 of 2
DATE: 30.08.23

RQD = 26% TCR = 100%						SW			SST	rock SANDSTONE: slightly weathered, medium strength, grey, fine to medium grained, (massive, subvertical joints).				6.24, J, defect bounds 6.20m to 6.28m, 80°, , STP, CL, C 6.35, J, defect bounds 6.34m to 6.37m, 80°, , STP, CL, C 6.8, J, defect bounds 6.65m to 6.93m, 80°, RO, STP, CL, OP 7-7.1, , IR, CL, OP 7.34, P, clay coating, 6°, RO, CV, CT, OP 7.38, P, clay coating, , PL, CT, OP 7.46, P, clay coating, 6°, RO, PL, CT, OP 7.64, J, defect bounds 7.59m to 7.68m, 70°, , IR, CL, C 7.87, P, 5°, RO, PL, CL, OP 8-19-8.39, XWS, infill clay and extremely weathered sandstone 3°, , IR, CT, 9.33, P, clay coating, 4°, , PL, CT, OP 9.42, P, 5°, , STP, CL, OP 9.5-9.51, IS, infilled clay, 3°, RO, UN, CL, 9.66, P, 4°, RO, PL, CL, C 9.76, P, 3°, , PL, CL, C 9.89, P, 4°, , IR, CL, C 9.92, P, 3°, , PL, CL, C 9.99, P, 3°, RO, PL, CL, C

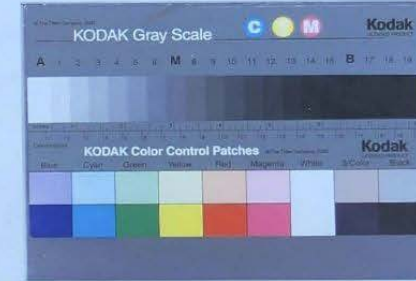
BOREHOLE ID: BH102
DEPTH: 2.21m to 7.0m
CORE TRAY NO.: Box 1 of 3
DATE: 30.08.23

CLIENT NAME: LANDMARK GROUP
PROJECT: Dee Why
LOCATION: 4 Delmar Parade
JOB NUMBER: P3018
LOGGED BY: MP

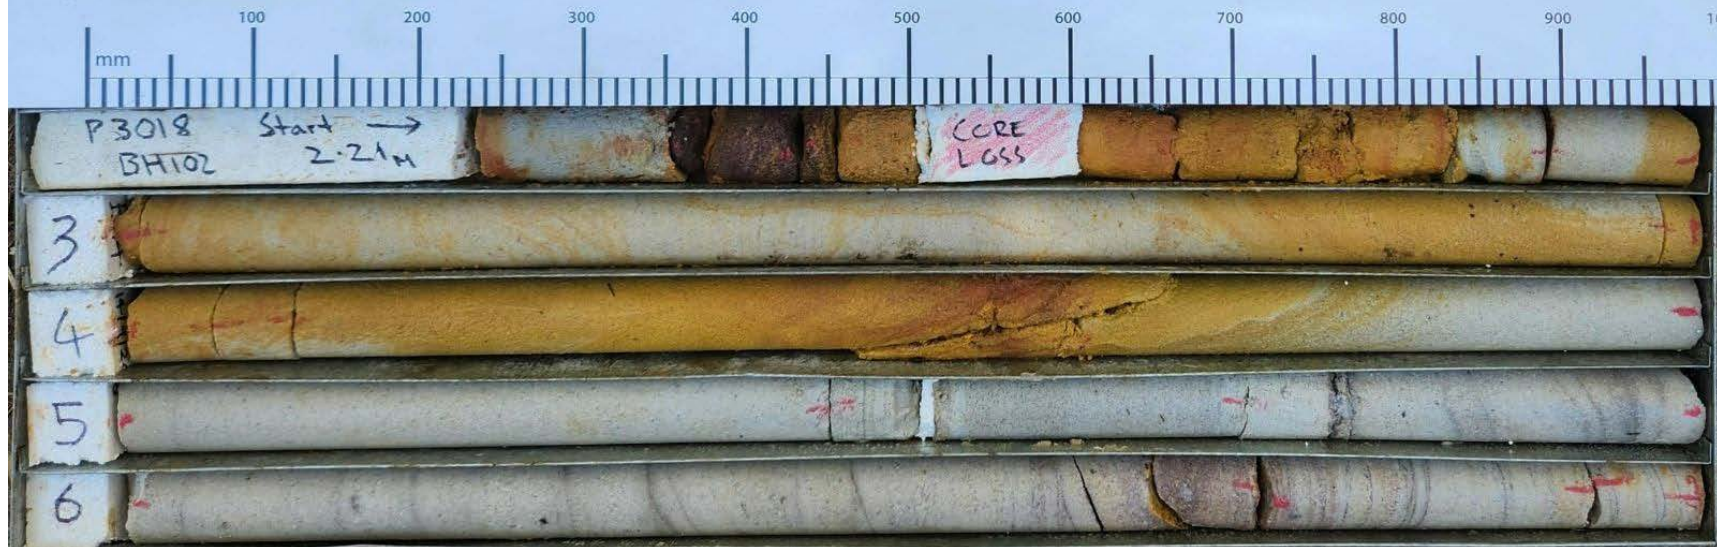
Drilling Method	Water	Well Diagram	Testing		Estimated Strength	Weathering	Depth (m)	Elevation (m)	Graphic Log	Classification Code	Material Description	Defect Spacing (mm)	Defect Depth	Defect Description
			RQD% and TCR%	Is(50)										
NMLC Coring			RQD = 81% TCR = 96%	d: 0.48, a: 0.60	SW		27.1		SST	rock SANDSTONE: slightly weathered, medium strength, grey, fine grained, (massive, infilled sandy clay seams).				
			RQD = 68% TCR = 86%	d: 1.34, a: 1.12			26.1							5.53. IS, clay infilled, 3°, RO, UN, CL, C

6.6		SST	As above, but highly, grey red orange, (generally massive, iron stained with sub horizontal laminations and subvertical joints).				5.72-5.78. IS, sandy clay infilled, 3°, RO, PL, CT.
						HW	7	25.1						6.61. P, iron stained, 10°, RO, PL, STN, OP

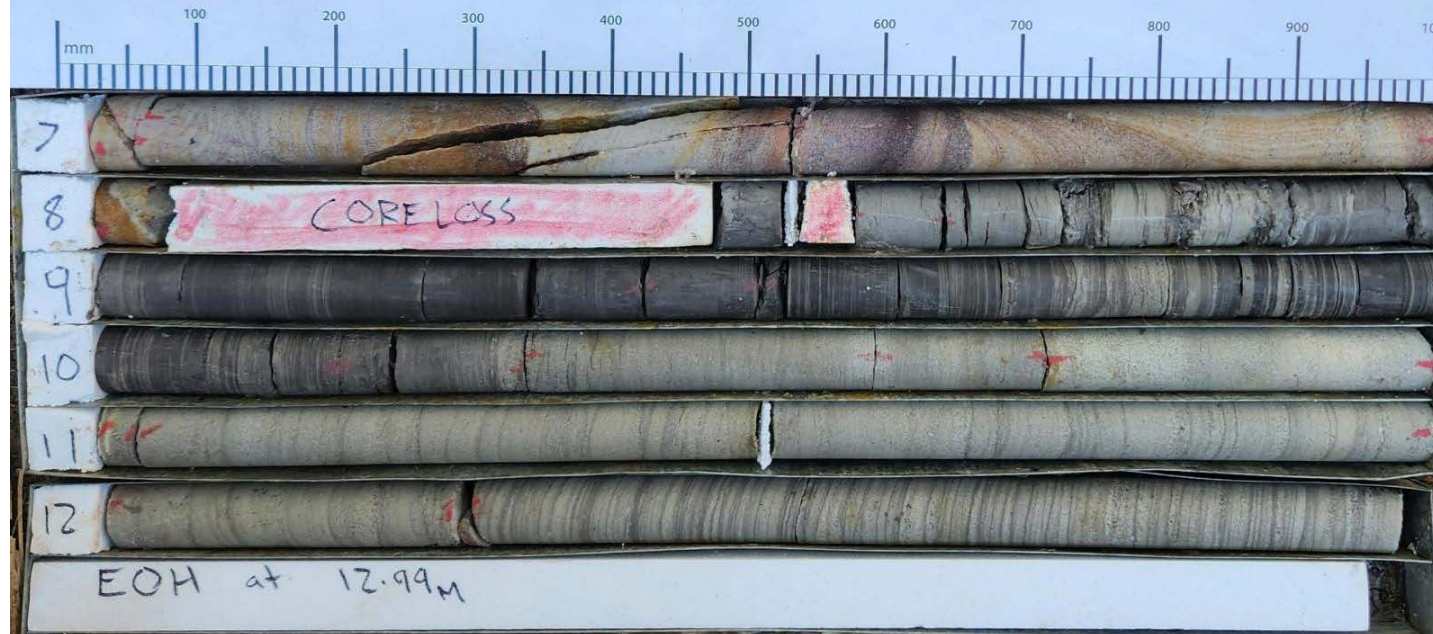
BOREHOLE ID: BH102
DEPTH: 7.0m to 12.99m
CORE TRAY NO.: Box 2+3 of 3
DATE: 30-08-23

Drilling Method	Water	Well Diagram	Testing		Estimated Strength	Weathering	Depth (m)	Elevation (m)	Graphic Log	Classification Code	Material Description	Defect Spacing (mm)	Defect Depth	Defect Description			
			RQD% and TCR%	Is(50)													
NMLC Coring			RQD = 52% TCR = 97%		MLS LS MS HS VHS EHS	MW-S	10	22.1		SHA	rock SHALE: moderately to slightly weathered, low to medium strength, grey, fine grained, (minor sandstone bands).	30 100 300 1000 3000		10. P, 2°, SO, PL, CL, OP 10.08, P, 2°, RO, PL, CL, OP 10.21-10.22, IS, infilled extremely weathered shale, 3°, RO, PL, CL			
				d: 0.72, a: 1.07			F				SST	rock SANDSTONE: fresh weathered, medium to high strength, light grey, fine grained, (generally massive, minor carbonaceous laminations).					
				d: 0.72, a: 0.91					11	21.1							
				d: 0.62, a: 1.36					12	20.1							
			RQD = 99% TCR = 100%				13	19.1			BH102 Terminated at 12.99 m (Target Depth Reached)			12.52, P, 8°, RO, CL, OP

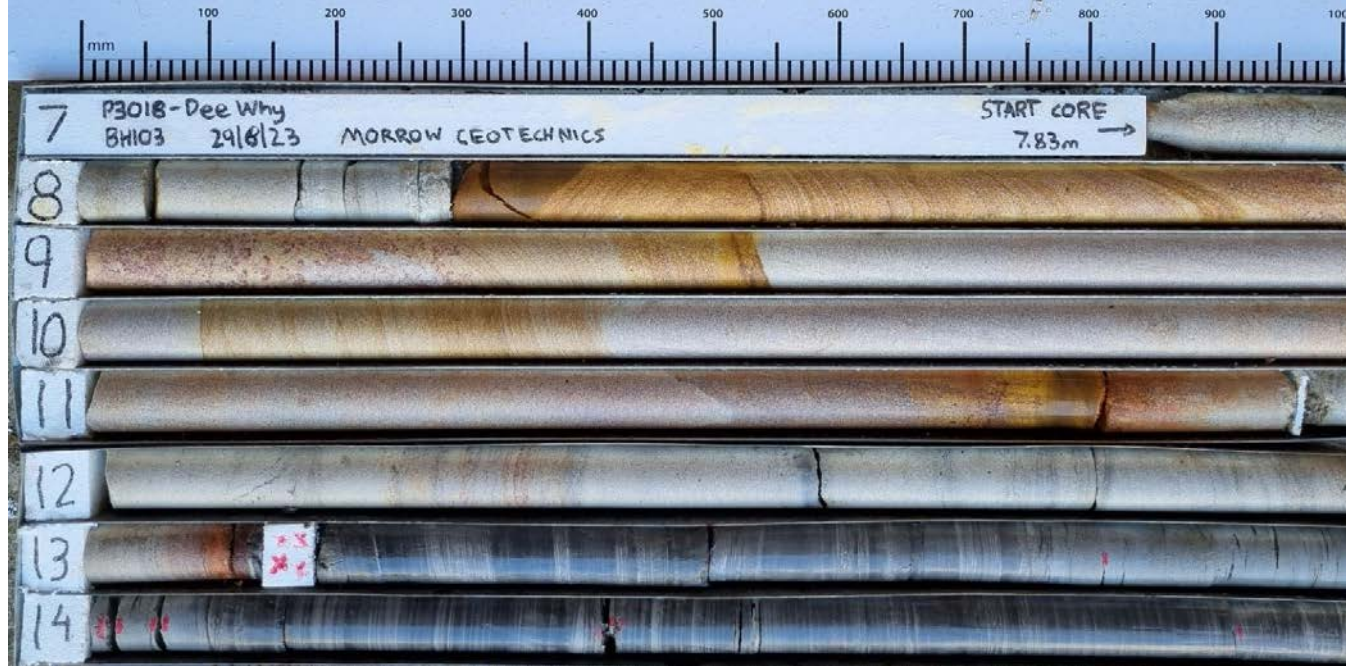
BOREHOLE ID: BH103
DEPTH: 7.83 → 15.00m
CORE TRAY NO.: 1+2 of 2
DATE: 29/8/23

Drilling Method	Water	Well Diagram	RQD% and TCR%	Testing						Weathering	Depth (m)	Elevation (m)	Graphic Log	Classification Code	Material Description	Defect Spacing (mm)	Defect Depth	Defect Description <small>type, inclination, planarity, roughness, coating, thickness</small>
				Is(50)	MLS	LS	MS	HS	VHS									
NMLC Coring			RQD = 100% TCR = 100%							10.0	21.5		SST	rock SANDSTONE: slightly weathered, medium to high strength, very light grey pink, medium grained, (generally massive).

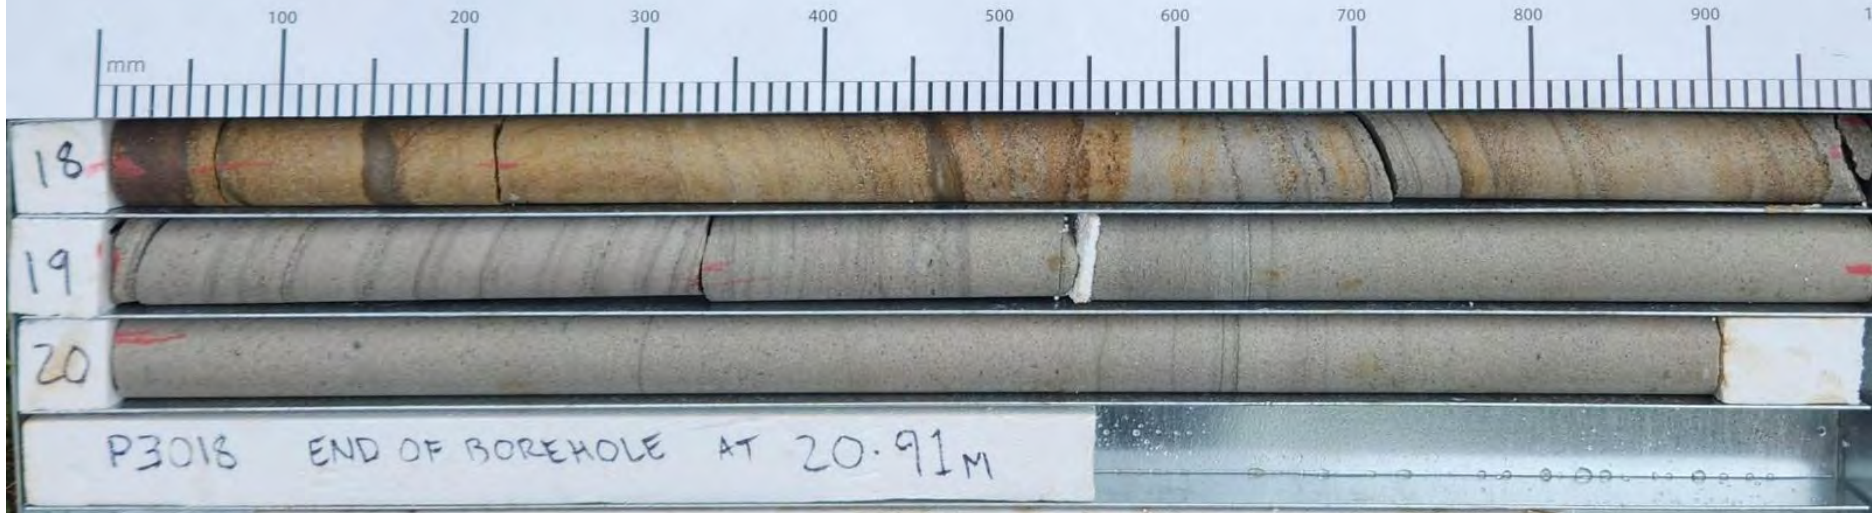
CLIENT NAME: LANDMARK GROUP PTY LTD BOREHOLE ID: BH104
PROJECT: DEE WHY DEPTH: 18.0m to 20.91m
LOCATION: 4 DELMAR PARADE CORN: Box 4 of 4
JOB NUMBER: P3018 DATE: 03.11.23
LOGGED BY: MP

Drilling Method	Water	Well Diagram	RQD% and TCR%	Testing				Weathering	Depth (m)	Graphic Log	Classification Code	Material Description	Elevation (m)	Defect Spacing (mm)	Defect Depth	Defect Description <small>type, inclination, planarity, roughness, coating, thickness</small>
				Is(50)	Estimated Strength	MS	LS									
NMLC Coring	0% Water Loss	<p>5mm Graded Sand 50mm PVC Slotted</p>	ROD = 100% TCR = 100%							SST	Rock SANDSTONE: fresh weathered, high strength, light grey, fine to medium grained, massive.	11.8				
								21			BH104 Terminated at 20.91m (Target Depth Reached)	10.8		21		
								22				9.8		22		
								23				8.8		23		
								24				7.8		24

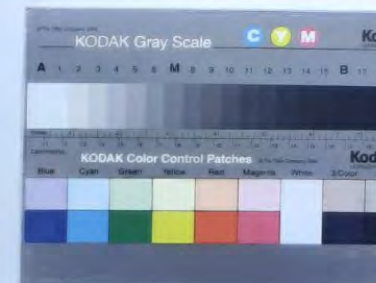
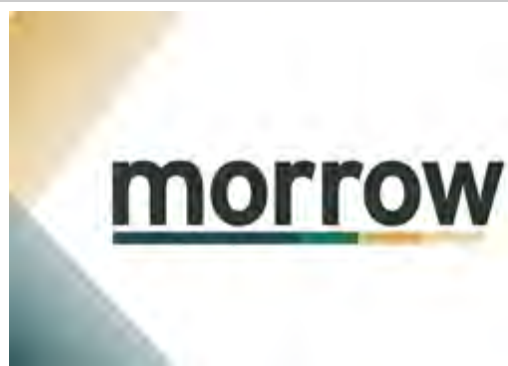
BOREHOLE ID: BH105
DEPTH: 8.72 to 13
CORE TRAY NO: Tray 1 of 3
DATE: 8, 11, 23

CLIENT NAME: Landmark Group Construction Australia
PROJECT: Dee Why
LOCATION: 4 Delmar Parade
JOB NUMBER: P3018
LOGGED BY: MJ

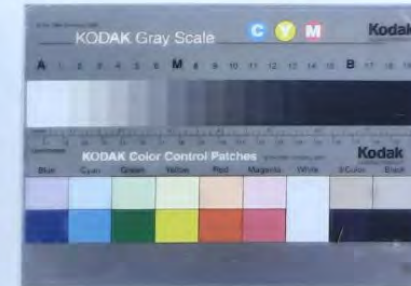
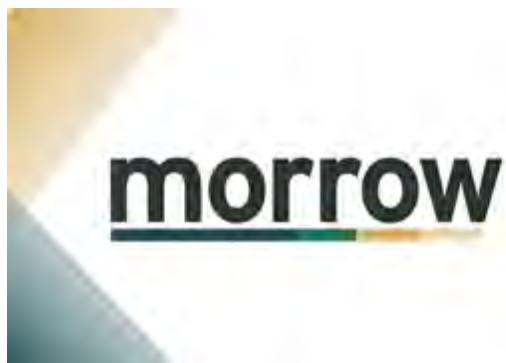
BOREHOLE #: BH105
DEPTH: 13 to 18
CORE TRAY NO: 2 of 3
DATE: 8/11/23

CLIENT NAME: Landmark Group Construction Australia
PROJECT: Dee Why
LOCATION: 4 Delmar Parade
JOB NUMBER: P3018
LOGGED BY: MJ

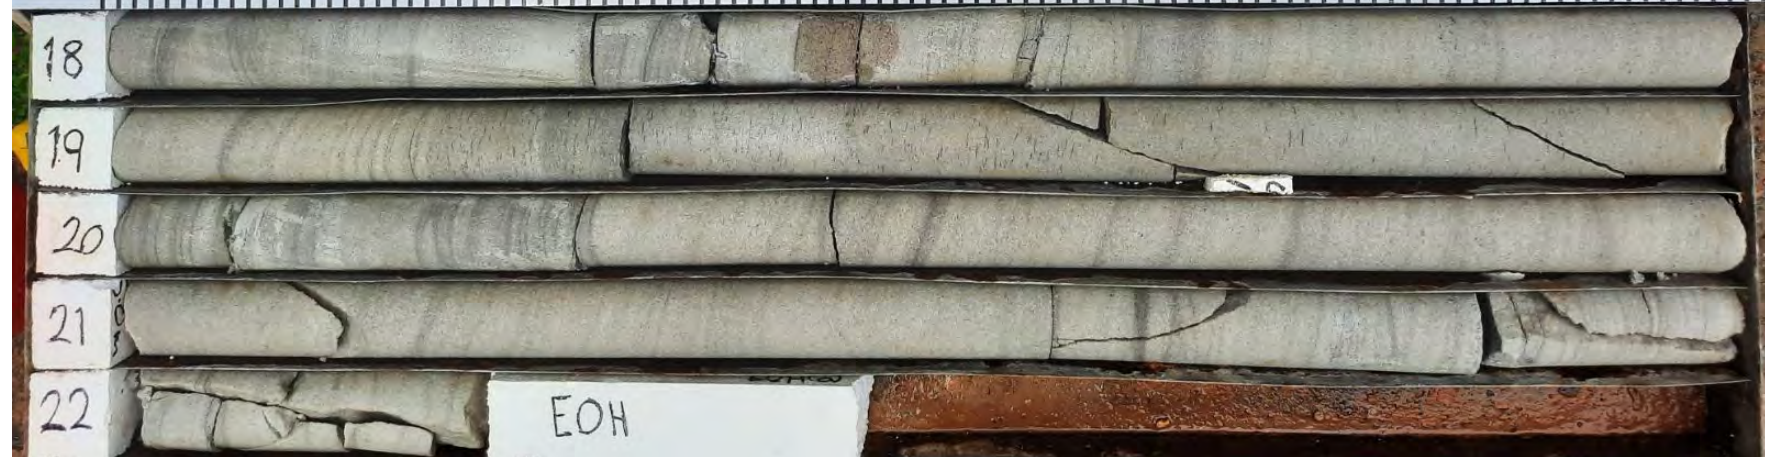
BOREHOLE ID: BH105
 DEPTH: 18 to 22.22
 CORE TRAY NO: 3 of 3
 DATE: 8/11/23

Drilling Method	Water	RQD% and TCR%	Testing		Estimated Strength	Weathering	Depth (m)	Graphic Log	Classification Code	Material Description	Elevation (m)	100% Defect Spacing (mm)	Defect Depth	Defect Description <small>type, inclination, planarity, roughness, coating, thickness</small>		
			Is(50)	Is(100)												
NMLC Coring	70% Water Loss	RQD = 88% TCR = 100%			[Shaded Bar]	T	[Dotted Pattern]	SST	Rock SANDSTONE: fresh weathered, medium to high strength, light grey, fine grained, generally massive, 10° laminations at 1-5mm spacing.	13.5	[Line Graph]	[Line Graph]	15.34, J, 75°, RO, PL, CL, OP	15.37, P, 10°, RO, PL, CL, OP		
		d: 1.58, a: 1.52	16	16.3, P, 5°, SO, PL, CL, OP												
		d: 0.87, a: 0.90	17	16.59, P, 5°, SO, PL, CL, OP									16.73, J, 60°, RO, PL, CL, OP	16.77, P, RO, PL, CL, OP		
		RQD = 91% TCR = 100%	18	17.09, P, RO, PL, CL, OP												
		d: 0.89, a: 1.08	19	17.6, P, 5°, SO, PL, CL, OP									17.7, P, 5°, RO, PL, CL, OP
