SITE ADDRESS: 23 – 25 & 33 Bassett Street, Mona Vale, New South Wales, 2106.

PROJECT - Addendum to Arboricultural Impact Assessment (AIA) in relation to alterations and additions.

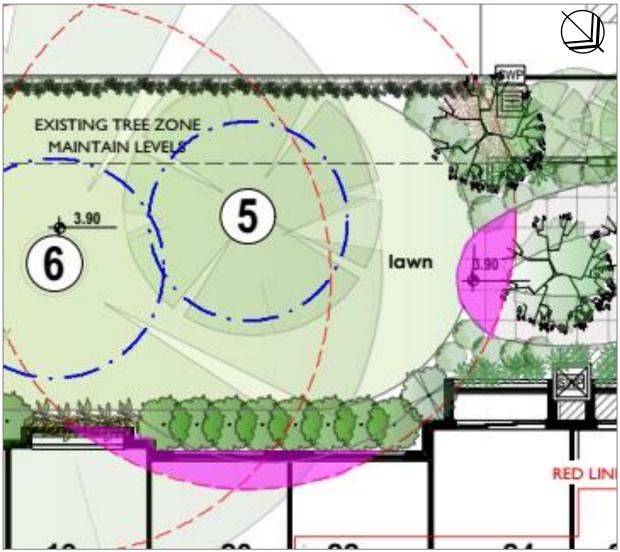
• An encroachment of 5.6% (see Figure 1 next page) has been estimated for the proposed pathway and built form with basement. This level of encroachment is considered *minor* under AS4970 and impacts on tree health/condition are likely to be negligible.

<u>Figure 1 - Tree 5 encroachment calculation</u> – Excerpt of Landscape Plan, Project 2403, dwg no. DA2-L01, 28/3/24 authored by Trish Dobson Landscape Architecture. Red hashed circle indicates TPZ, blue hashed circle denotes the SRZ. Pink shading indicates encroachment. NOT TO SCALE. Marked up by C Hughes.

- Protect Tree 5 by placing temporary fencing 7.8m from tree stem within the subject site and outside active work zones.
- Works within the calculated TPZ are to be supervised by the Project Arborist.
- Care when planting within the TPZ is required. Hand tools only are to be used and planting positions are to be flexible should the unlikely event roots are uncovered.

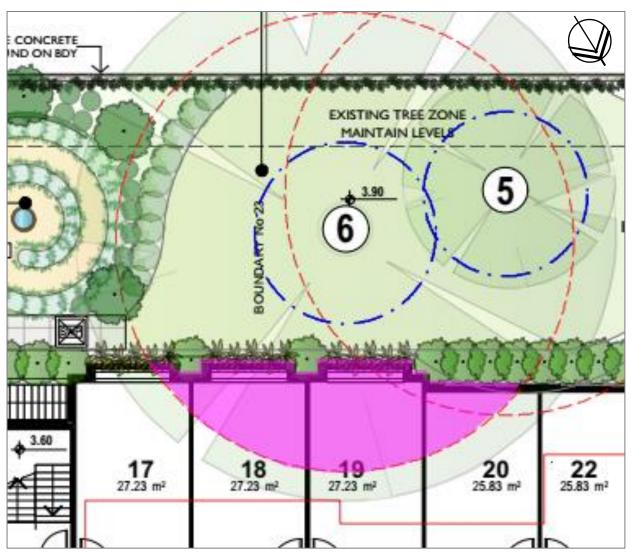
- An encroachment of 16.5% (see Figure 2 next page) has been estimated for the proposed built form with basement placing it within *major* encroachment under AS4970 and triggering referral to Clause 3.3.4 of AS4970-2009.
- The primary considerations most relevant for this tree under Clause 3.3.4 of AS4970-2009 in relation to tree retentions are (c) Tree species and tolerance to root disturbance, (d) Age, vigour and size of the tree and (e) Lean and stability of the tree.
- The tree is a species tolerant of root disturbance, whilst it is mature it has plenty of active growth into the future, thus vigour is of such to overcome surrounding site disturbances.

- The tree form is one of fairly straight stem/trunk and a balanced canopy. Tree form is consistent with tolerating the proposed surrounding works.
- It is likely the tree may be impacted somewhat in the short-term but is expected to make a full recovery and thrive into the long term.

<u>Figure 2 - Tree 6 encroachment calculation</u> – Excerpt of Landscape Plan, Project 2403, dwg no. DA2-L01, 28/3/24 authored by Trish Dobson Landscape Architecture. Red hashed circle indicates TPZ, blue hashed circle denotes the SRZ. Pink shading indicates encroachment. NOT TO SCALE. Marked up by C Hughes.

Pruning is likely to be required as the canopy sweeps down low to the ground in the location of the proposed built form. Pruning could be carried out in accordance with AS4373 – Pruning of Amenity Trees.

- Protect Tree 6 by placing temporary fencing 8.1m from tree stem within the subject site and outside active work zones.
- Works within the calculated TPZ are to be supervised by the Project Arborist.
- All pruning works are to comply with AS4373 Pruning of Amenity Trees and are to be carried out
 by experience minimum AQF 3 Level Arborists. A maximum 20% of total live canopy is to be
 removed and limited to a maximum 100mm branch diameter. Project Arborist to determine limit
 of canopy pruning prior to works commencing.
- Care when planting within the TPZ is required. Hand tools only are to be used and planting positions are to be flexible should the unlikely event roots are uncovered.

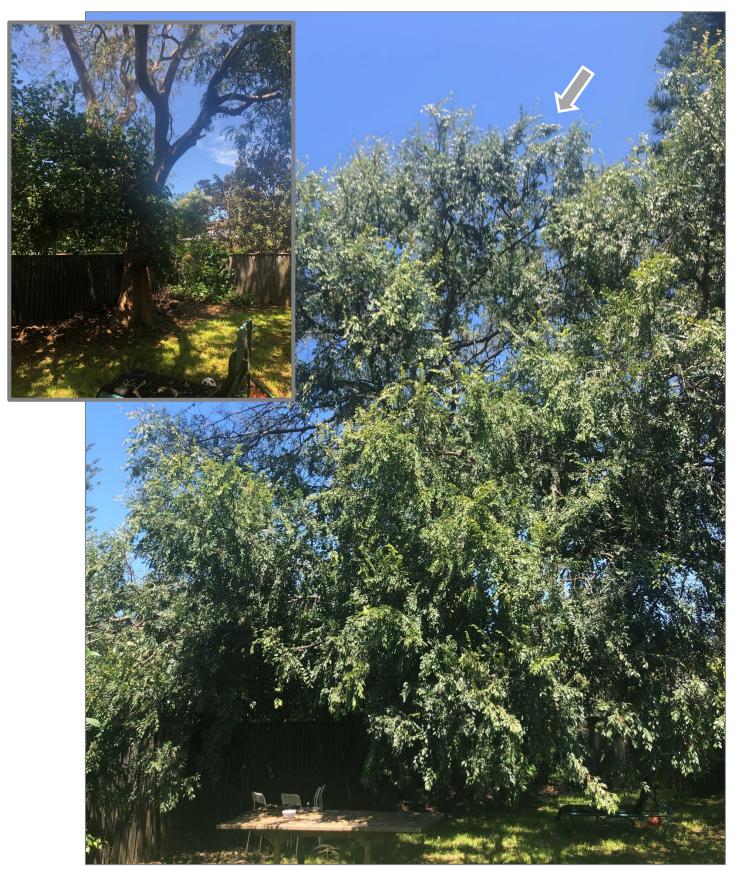
Plate 1 – Arrow notes Tree 6. INSET – Base/lower stem of Tree 6.

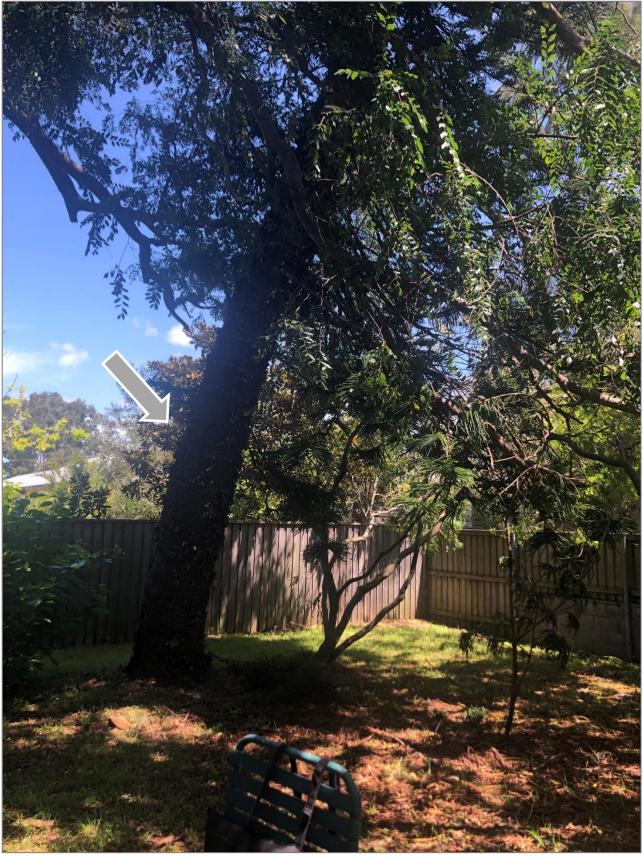
Plate 2— Tree 12 - Arrows note stem of Tree 5.

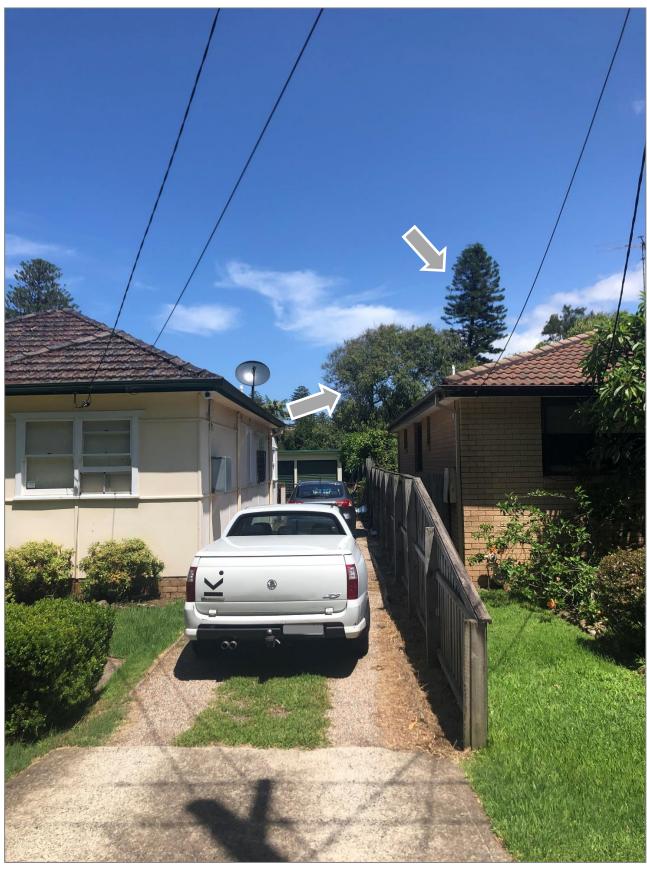
Plate 3— Tree 5 and 6 – Arrow notes subject trees. Both can be seen from street/surrounding area however as Tree 6 is an exempt species the RV is only Medium to Tree 5 High RV.

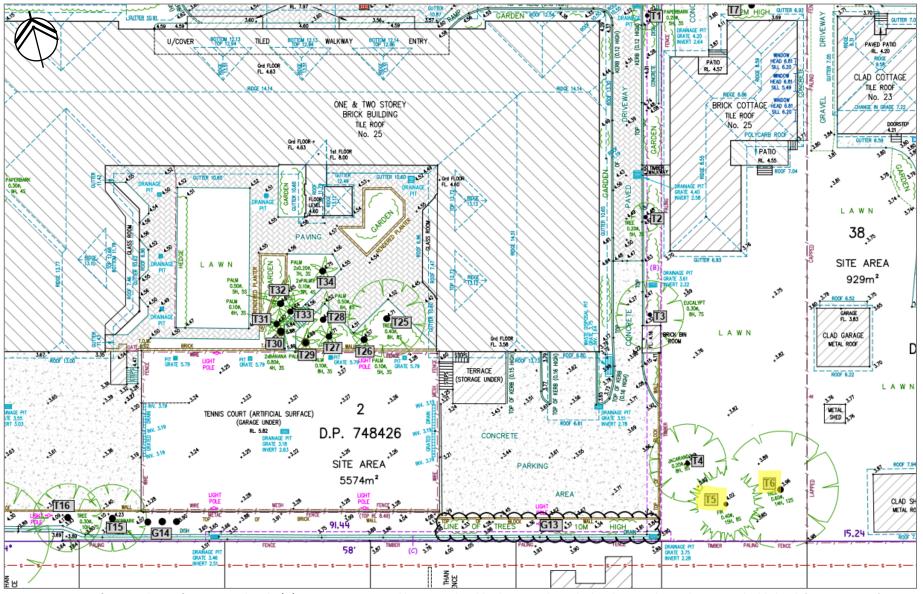
Figure 1 – Excerpt of Survey Plan, Ref no. 15006, dated 4/3/2016, Rev 1, prepared by Bee and Lethbridge Pty Ltd. Marked up by C Hughes, subject trees highlighted. (NOT TO SCALE).
