**GEOTECHNICAL RISK MANAGEMENT POLICY FOR PITTWATER
FORM NO. 1 – To be submitted with Development Application**

Address of site 54 Bardo Road, Newport

GEOTECHNICAL INVESTIGATION:

New Seniors Housing Complex at 54 Bardo Road, Newport

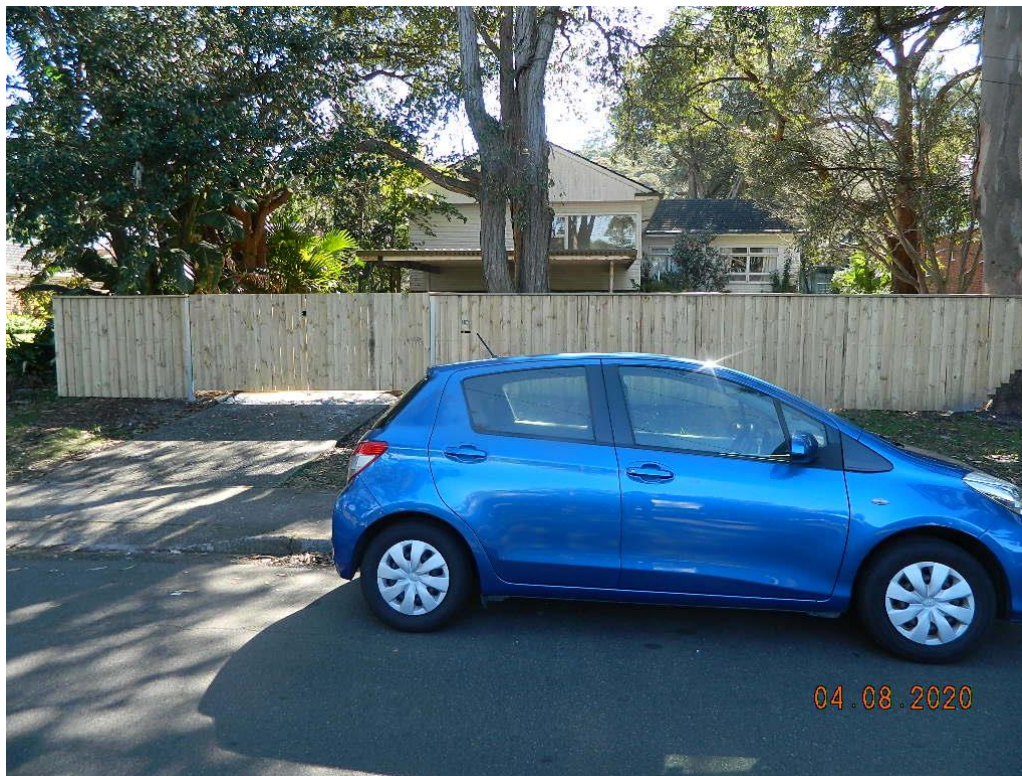
Photo 1

- 2.3** At the road frontage, a concrete driveway runs to a carport on the downhill side of the house (Photos 1 & 2). A gently sloping lawn is located E of the driveway, carport and house (Photo 3). The one storey brick and timber clad house is supported by brick walls and brick piers (Photo 3). The supporting walls and piers stand vertical and show no significant signs of movement (Photo 4). A gently sloping lawn extends from the uphill side of the house to the uphill property boundary (Photo 5). A fibro shed is located near the NW corner of the property. The house and shed will be demolished and the site will be cleared as part of the proposed works. The adjoining

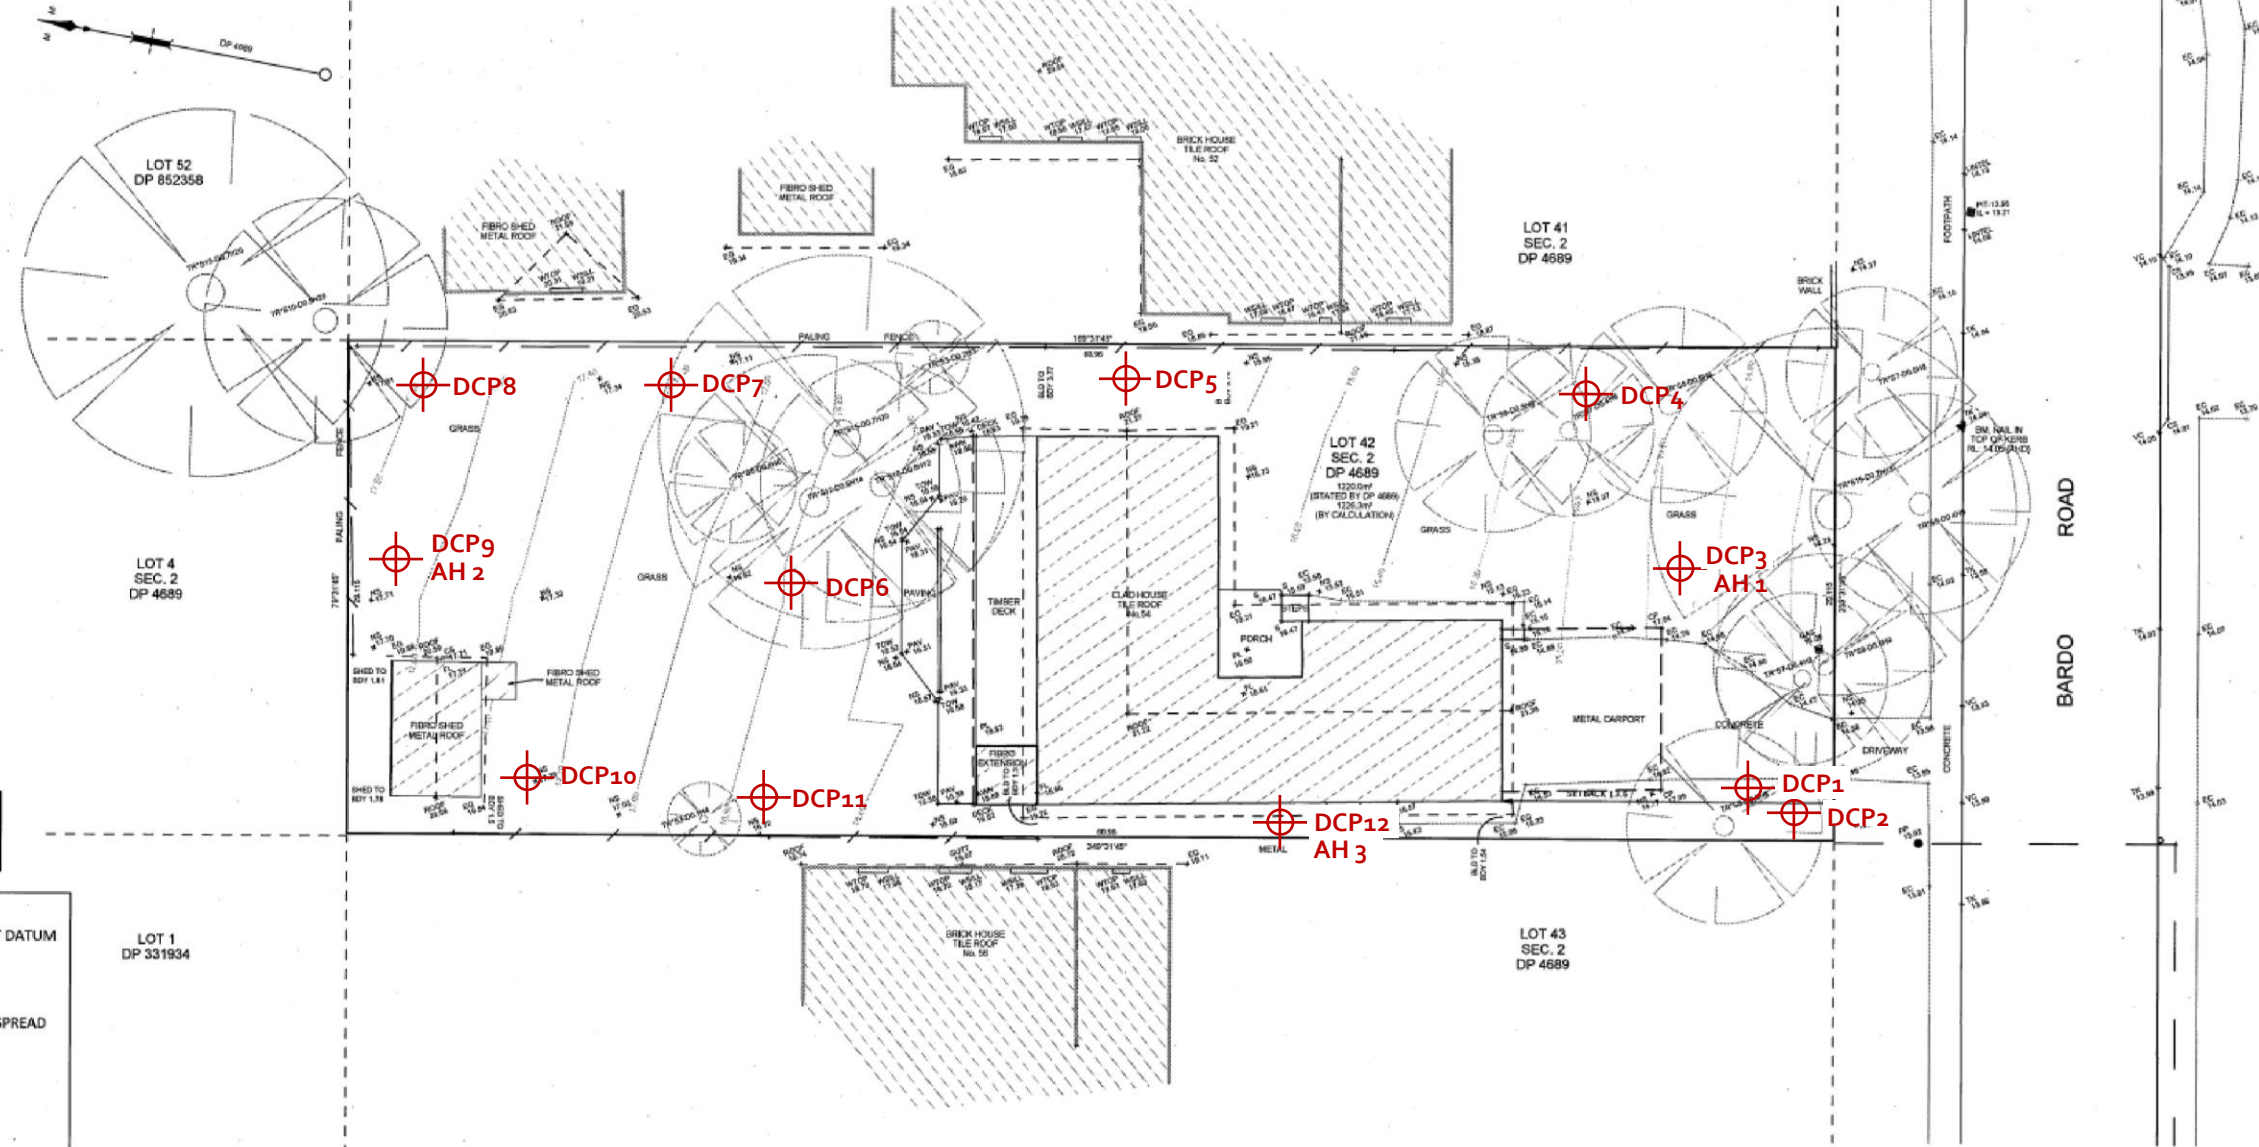
SITE PLAN – showing test locations

Three auger holes were put down to identify the soil materials. Twelve Dynamic Cone Penetrometer (DCP) tests were put down to determine the relative density of the overlying soil and the depth to weathered rock. The locations of the tests are shown on the site plan. It should be noted that a level of caution should be applied when interpreting DCP test results. The test will not pass through hard buried objects so in some instances it can be difficult to determine whether refusal has occurred on an obstruction in the profile or on the natural rock surface. This is expected to have occurred for DCP1 to DCP3, DCP6 and DCP10. Due to the possibility that the actual ground conditions vary from our interpretation there should be allowances in the excavation and foundation budget to account for this. We refer to the appended "Important Information about Your Report" to further clarify. The results are as follows:
