# Acid Sulfate Soils Investigation

Lot 40, No 136 Narrabeen Park Parade  
Mona Vale NSW 2103

**Site Number**  
130018

**Date**  
1/11/2019

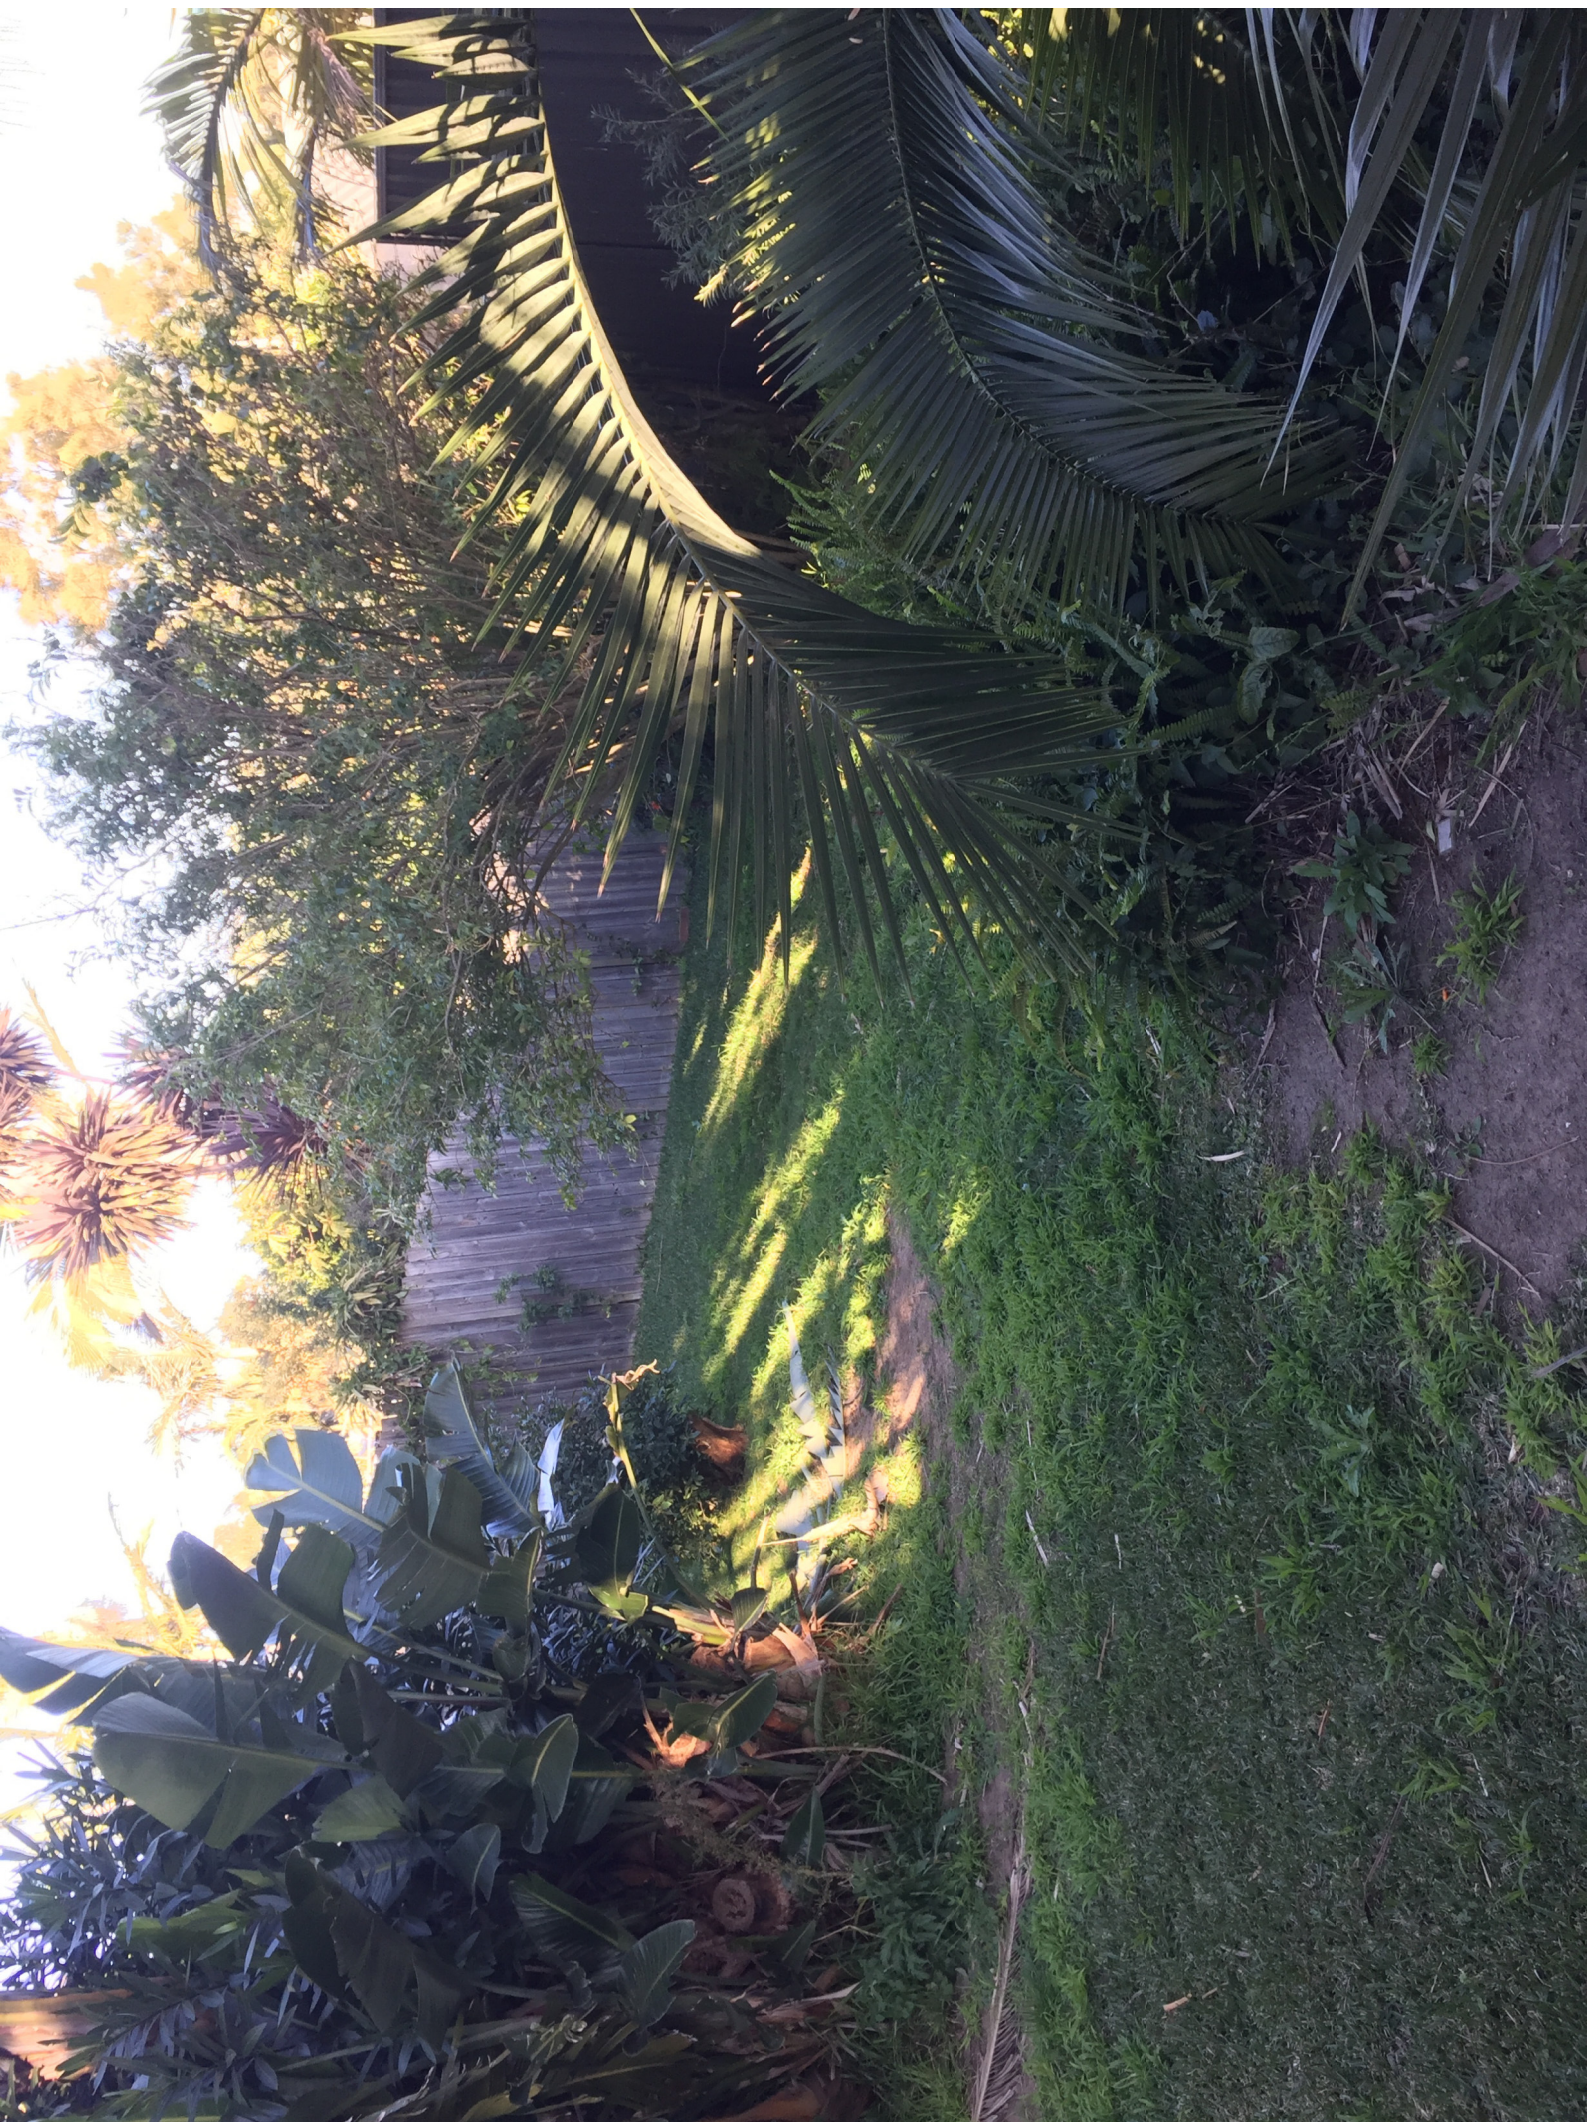
### Site Photography

The site is located to the west of Narrabeen Park Parade and occupies an area of about 594.4m<sup>2</sup>. The site area slopes down to the south east at 9° to 10°. Site is occupied with a residential dwelling. Some medium size trees were observed at the rear of existing house. Site is bounded by

Site conditions on the date of inspection are visible in the attached photography in Appendix B with the site features indicated in the site plan, refer Appendix A.
