2 April 2024

ABORIGINAL DUE DILIGENCE ASSESSMENT REPORT

WARRINGAH GOLF CLUB

AUGUST 2023

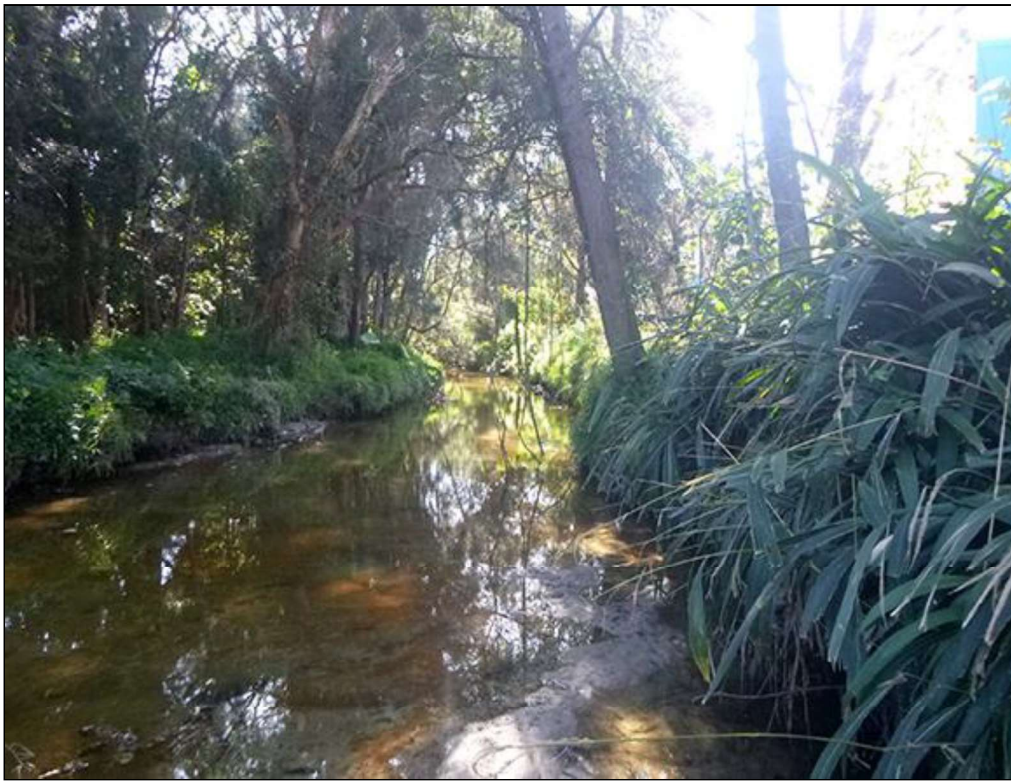
View north along Brookvale Creek adjacent to the study area.

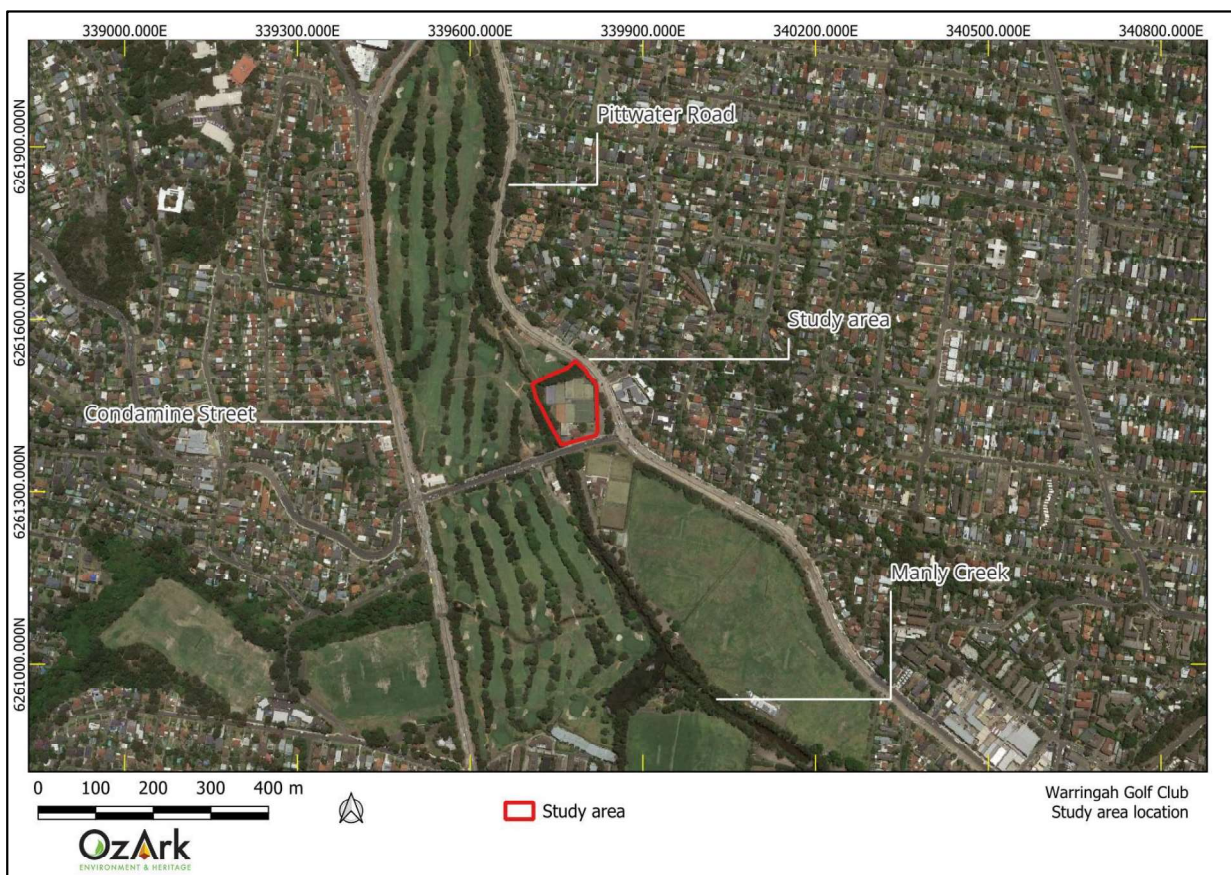
Figure 1-1: Club House and Tennis Courts location.

Warringah Golf Club propose to construct a new club house, to be located on the existing footprint of the current tennis courts at Lot 2742 DP752038 on Kentwell Road in North Manly (**Figure 1-1**).

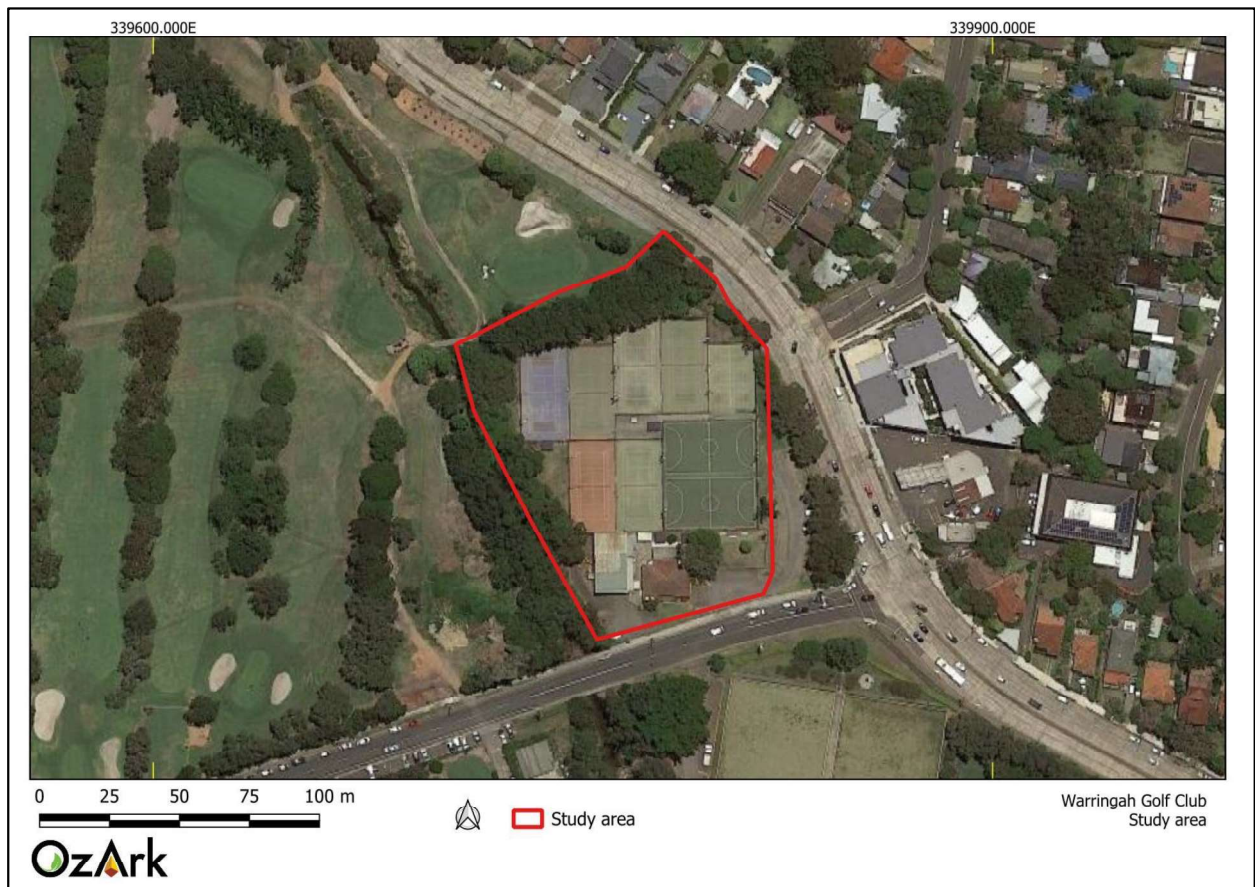
Figure 1-2: Aerial view of study area.

The study area is located at Lot 2742 DP752038 on Kentwell Road in North Manly which encompasses approximately 1.1 hectares (ha) of land, most of which has been developed for tennis courts, buildings, and car parking.

kilometres (km) to the east. The study area is extensively developed in the centre with native vegetation remaining along the northern and western boundaries (**Figure 1-2**).

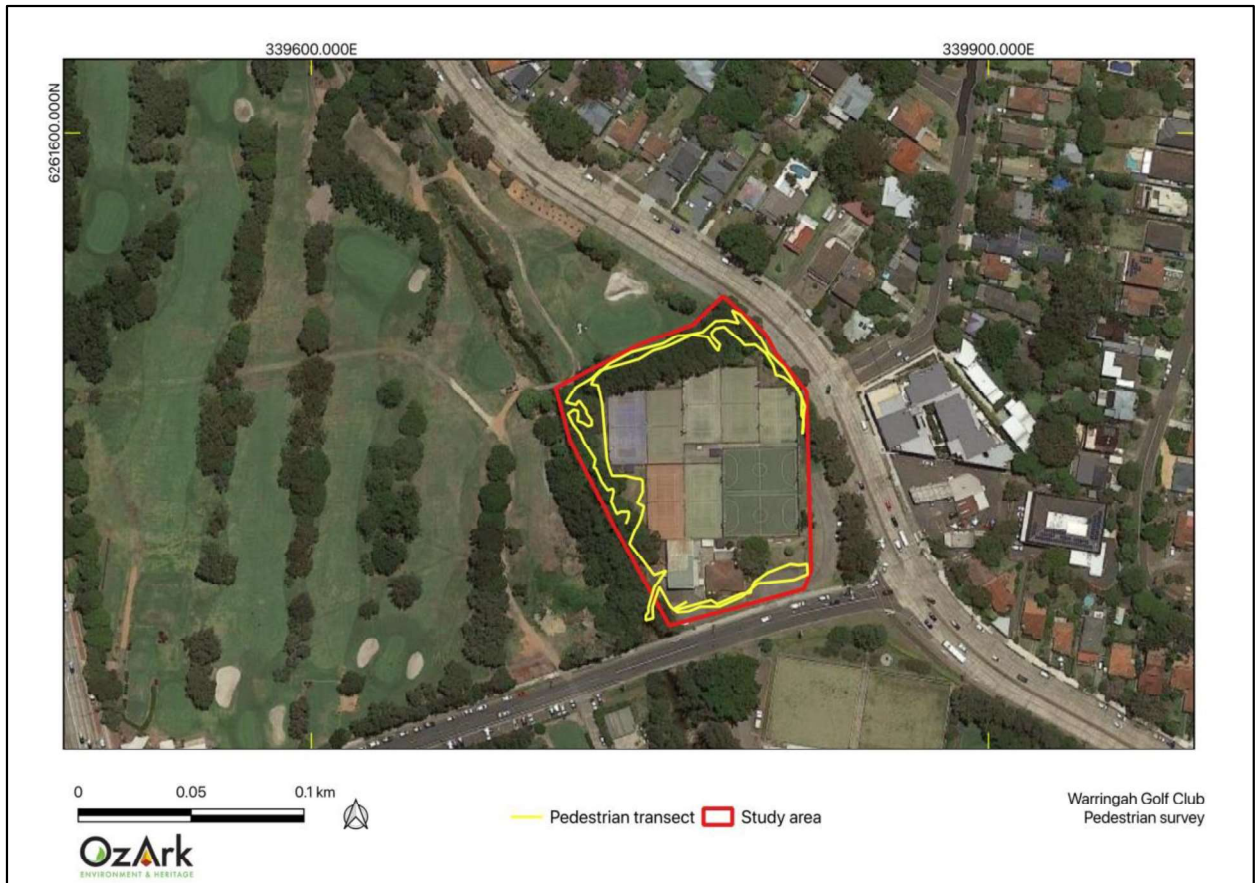
Figure 2-3: Survey coverage within the study area.

The visual inspection of the study area was undertaken on 11 August 2023 by OzArk Archaeologist, Harrison Rochford, and Josh Muir, representing Metropolitan Local Aboriginal Land Council. The inspection focused on the named waterway, Brookvale Creek, which borders the study area on the western side and the drainage channel and wetlands on the north-eastern boundary. Josh Muir noted that the casuarinas provide good habitat for cockatoos and was satisfied that the cleared trees will be replaced on site with the same species for a continuation of habitat.

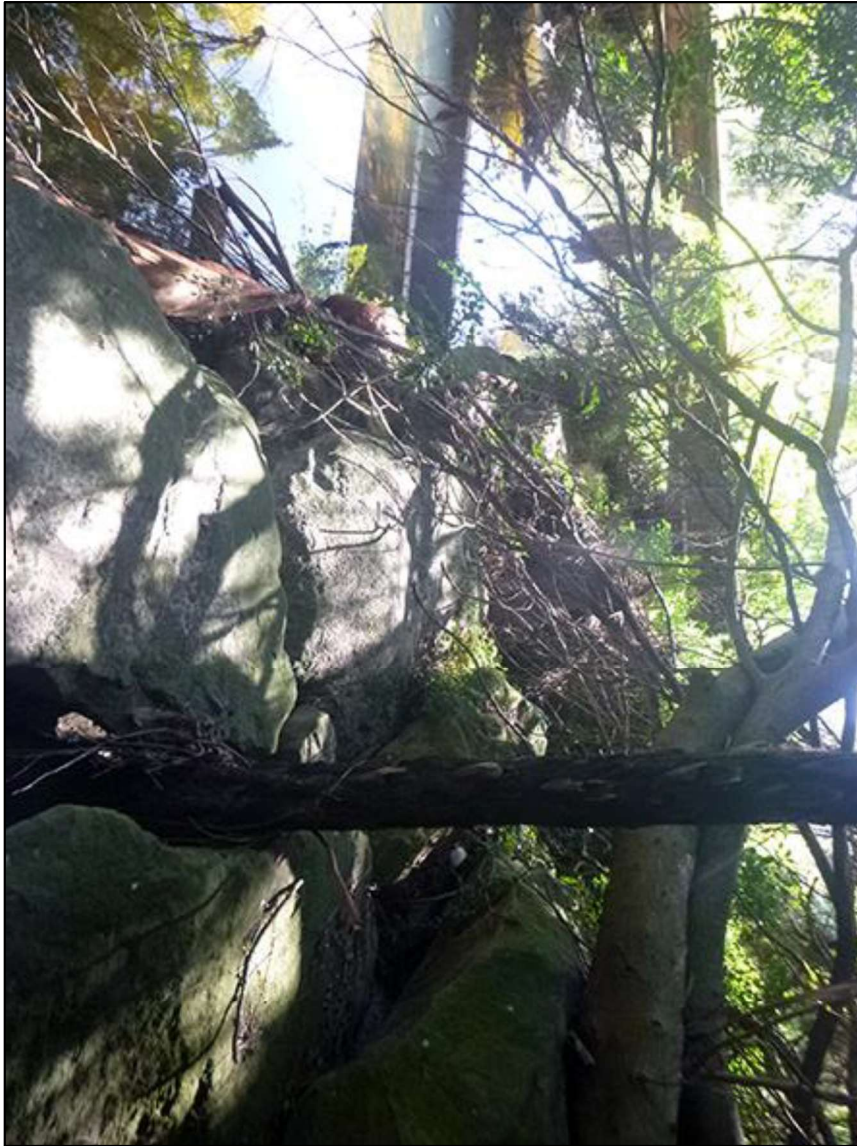
Plate 4: View north along Brookvale Creek showing the modified banks and imported boulders for erosion control.

| Plate 4: View north along Brookvale Creek showing the modified banks and imported boulders for erosion control. | 17 |

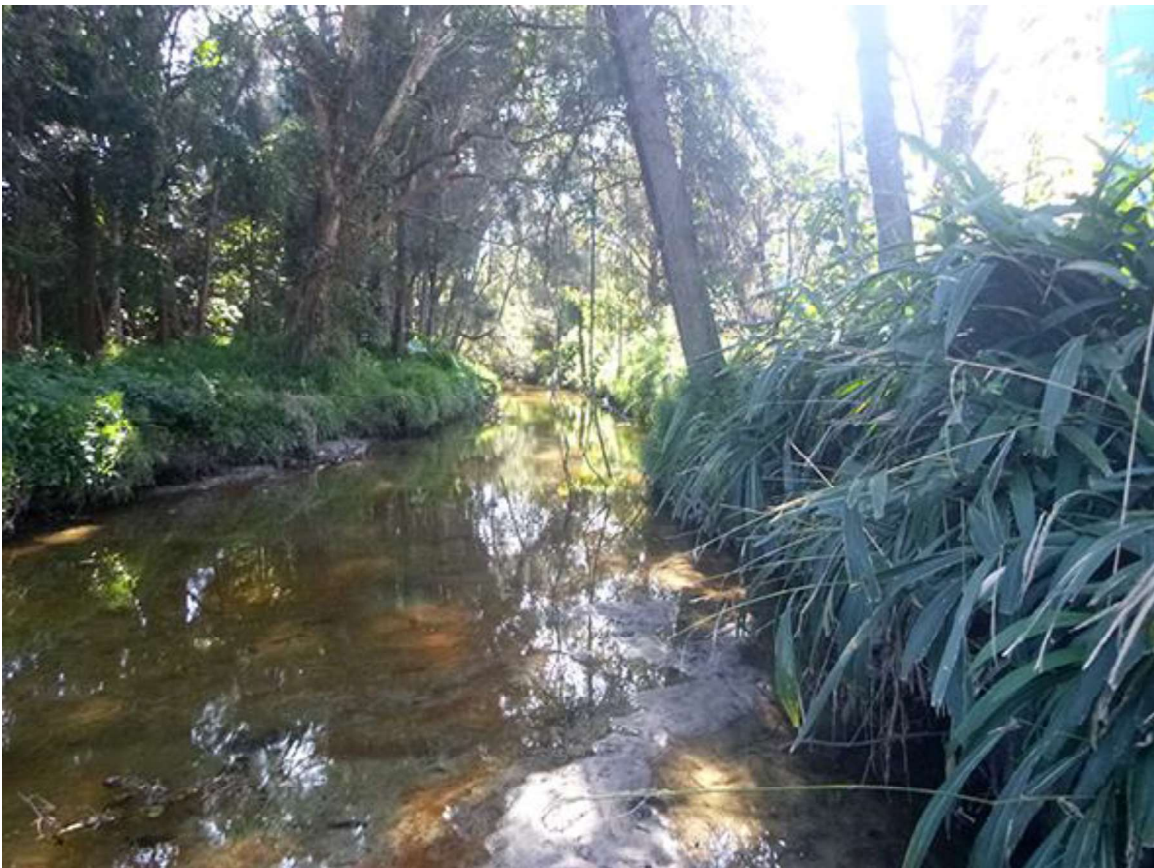
Plate 5: Sandy soil was evident where exposures were present.

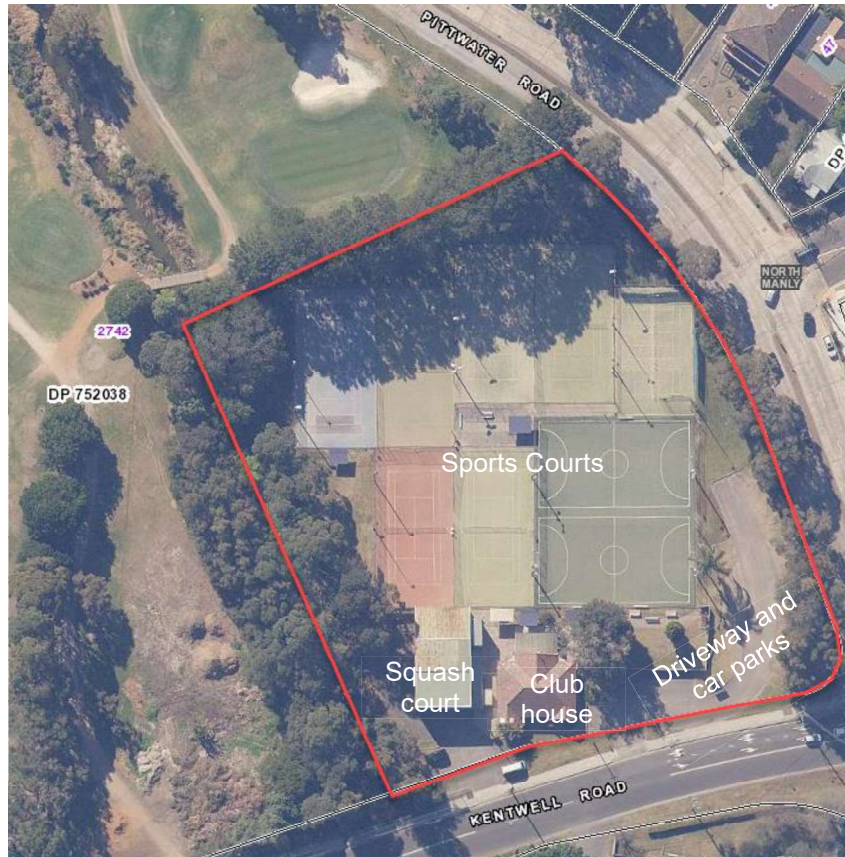
The site, known as Warringah Recreation Area (Lot 2742 DP 752038), is approximately 1.04 ha. The existing development of the site consists of a clubhouse, squash court, sporting courts, driveway, and car parks (the existing site is shown below in Figure 1).

Figure 1 - Site locality and previous development (SIX Maps)

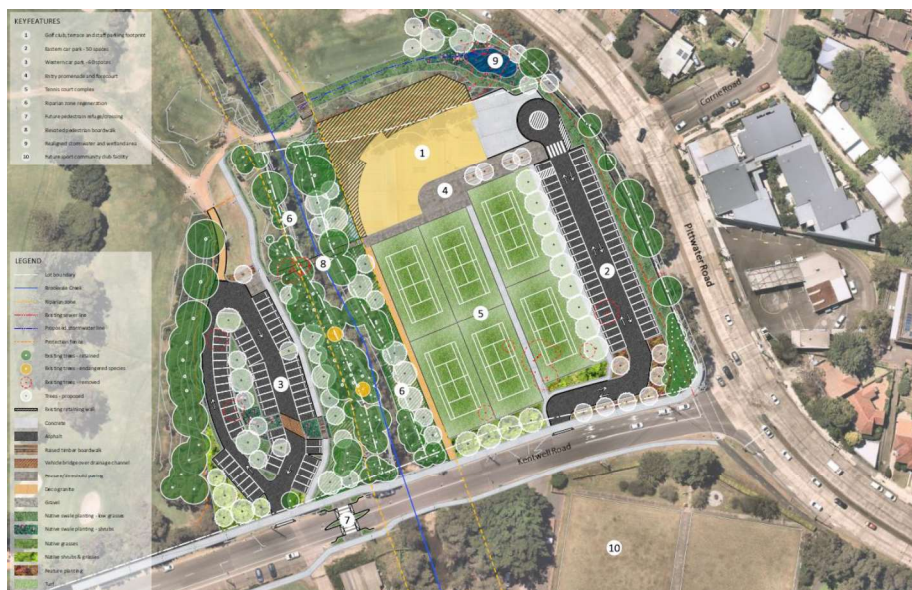
The proposed master plan is shown in Figure 2. It introduces 6 new tennis courts, a club building with a loading area, parking, and car access. The architecture plans listed in Appendix A show the scope of the DA application of the new main building with a loading area of approximately 0.26 ha as part of the master plan. The design drawings also highlight the layout of the tennis courts, car parks, and the access driveway as shown in Figure 3.

Figure 2 - Proposed master plan layout

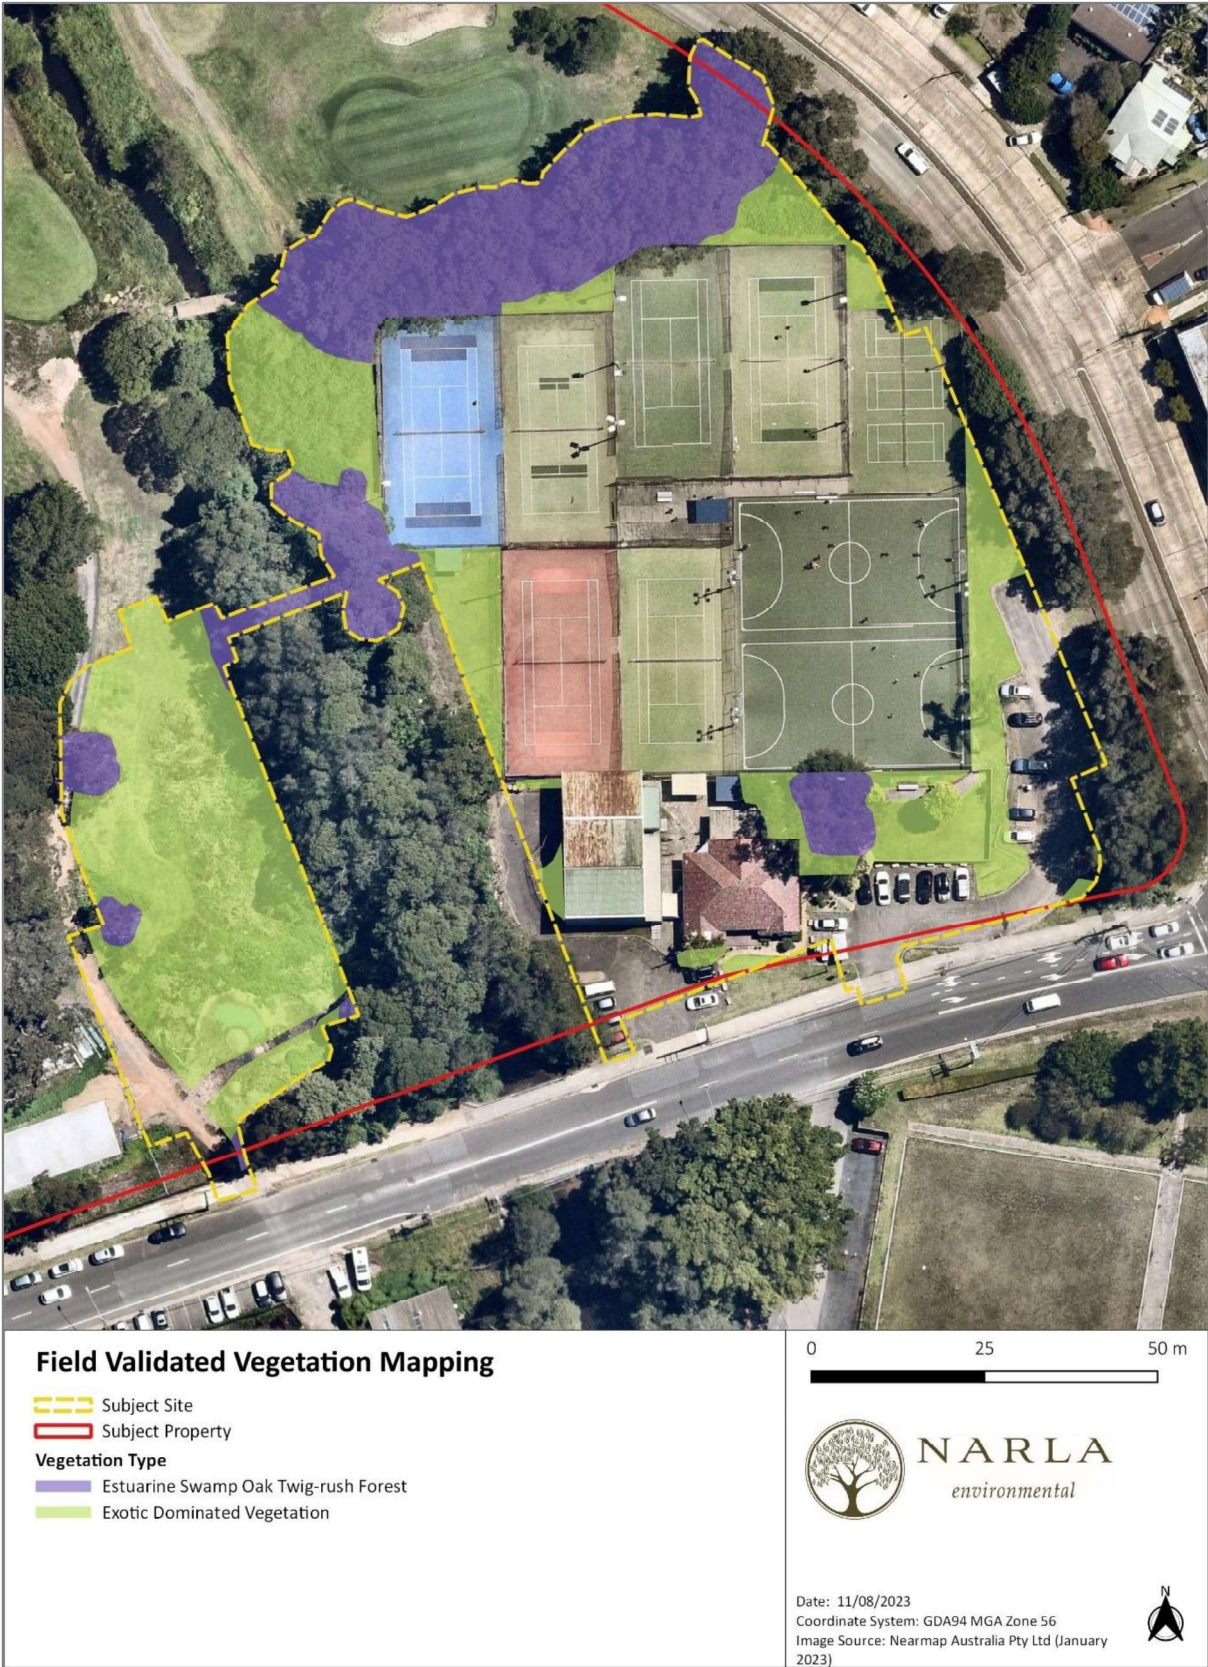
The field survey conducted by Narla identified the vegetation within the Subject Property as best conforming to two (2) vegetation community (**Figure 4**):

- Estuarine Swamp Oak Twig-rush Forest (**Table 7**);
- Exotic Dominated Vegetation (**Table 8**).

Figure 4. Field Validated Vegetation Mapping of the Subject Site.

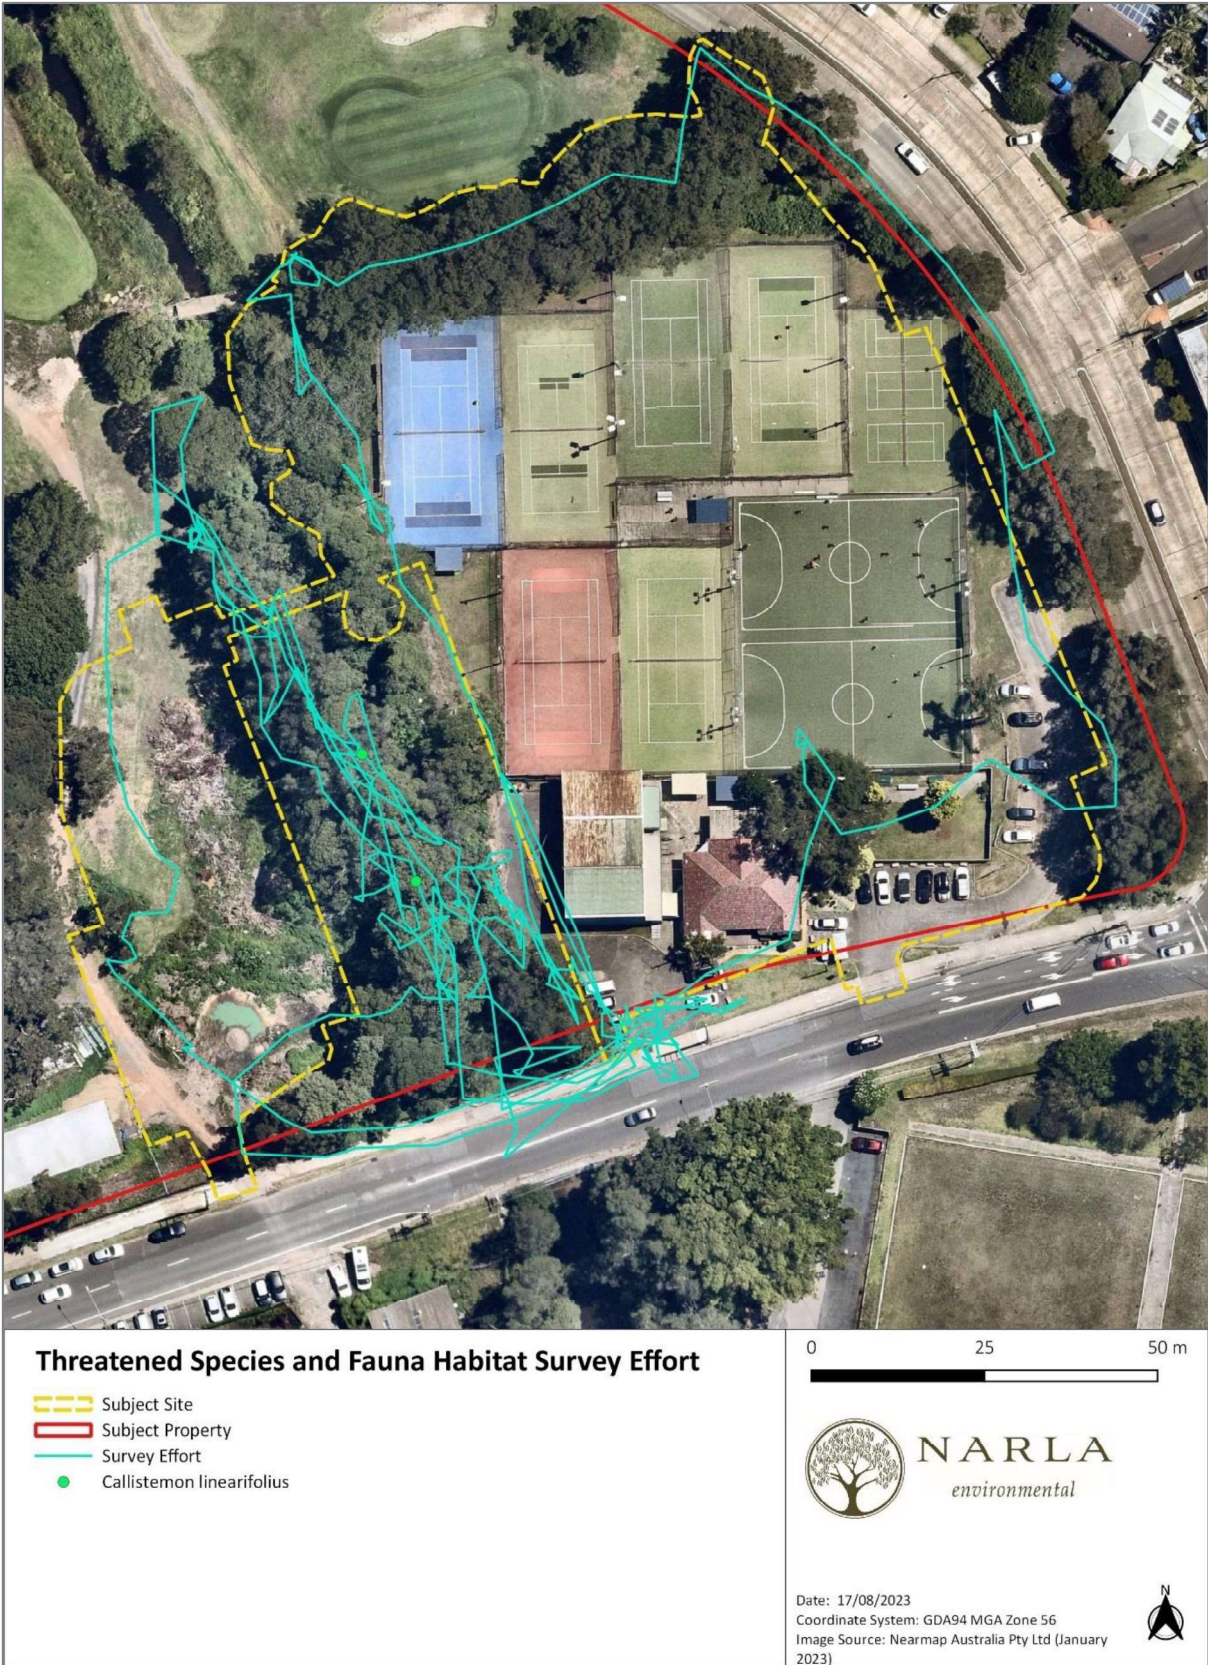
Details of the fauna habitat recorded within the Subject Site are included in **Table 12** and displayed **Figure 5**. The likelihood of occurrence of threatened fauna species within the Subject Site is presented in **Table 13**.

Figure 5. Threatened Species and Fauna Habitat Survey Effort.

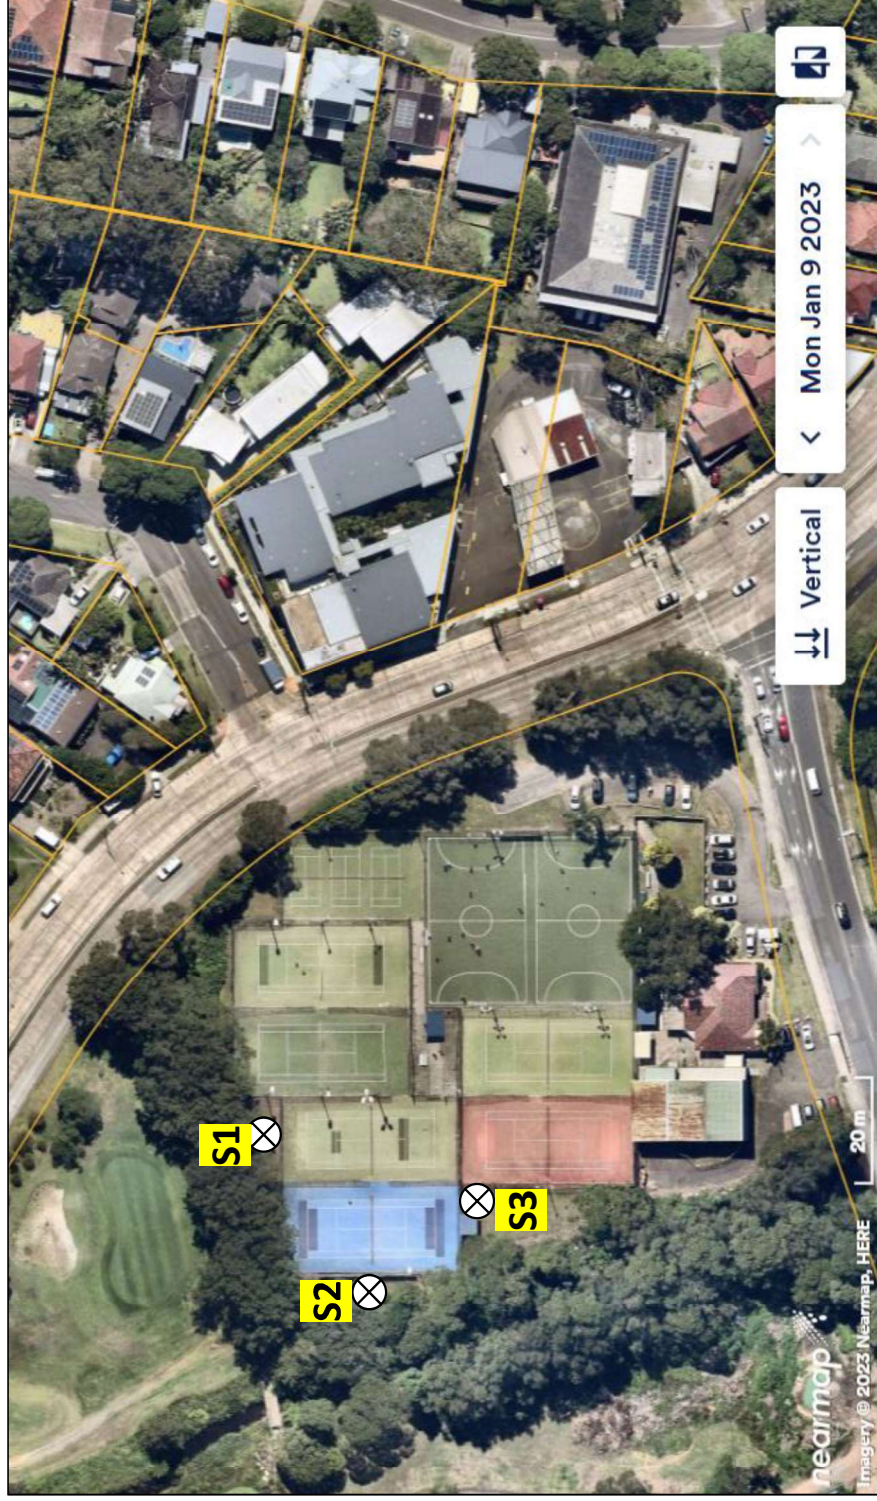
Figure 2
Project

Figure 2. 3 targeted primary soil samples were obtained from the site. Site layout from January 2023, showing the surfaces of the courts have obviously been changed overtime, however the footprints of the courts appear to have remained relatively unchanged.

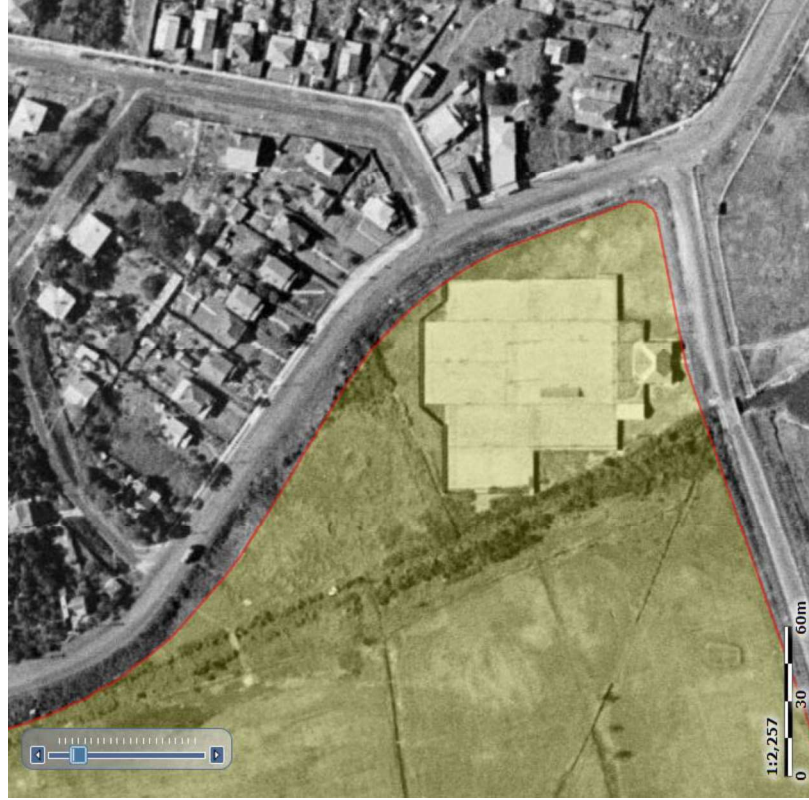
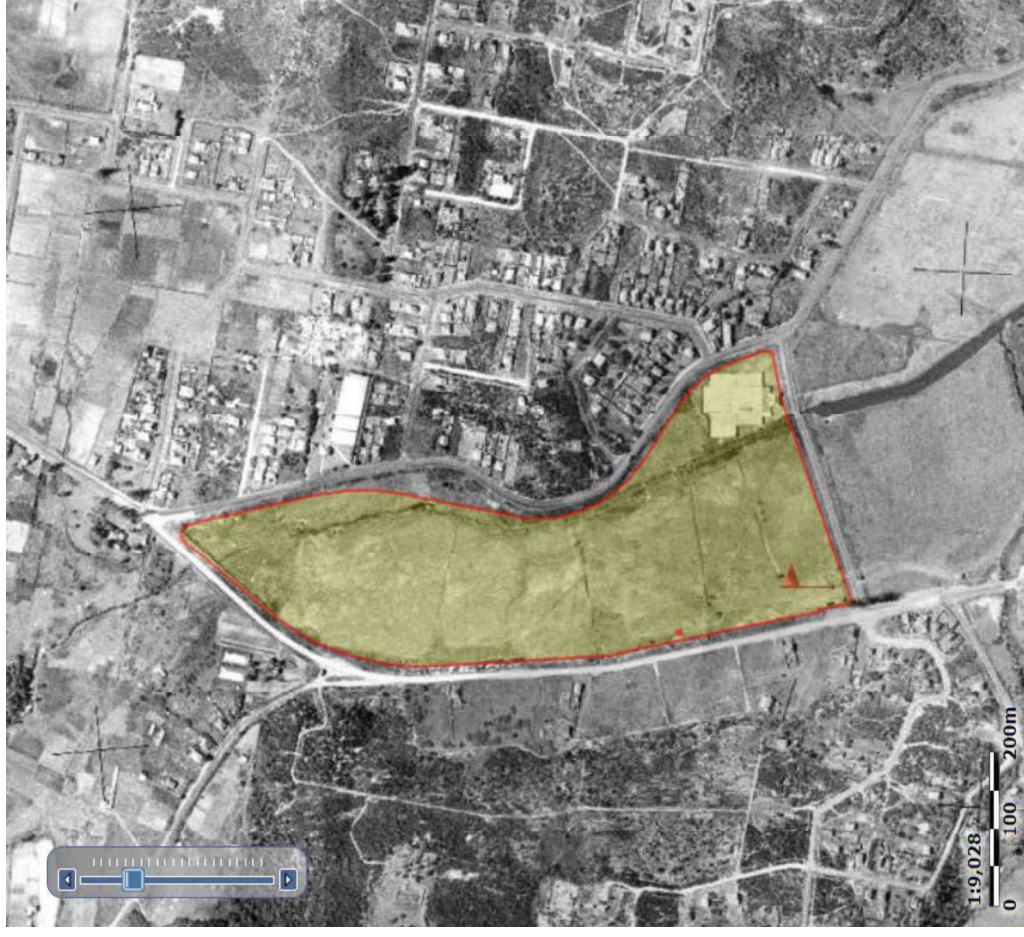
Figure 3
Project

Figure 3. Aerial image of the site and surrounding area 1943. The targeted area shows the same layout of tennis courts as in today's current layout.

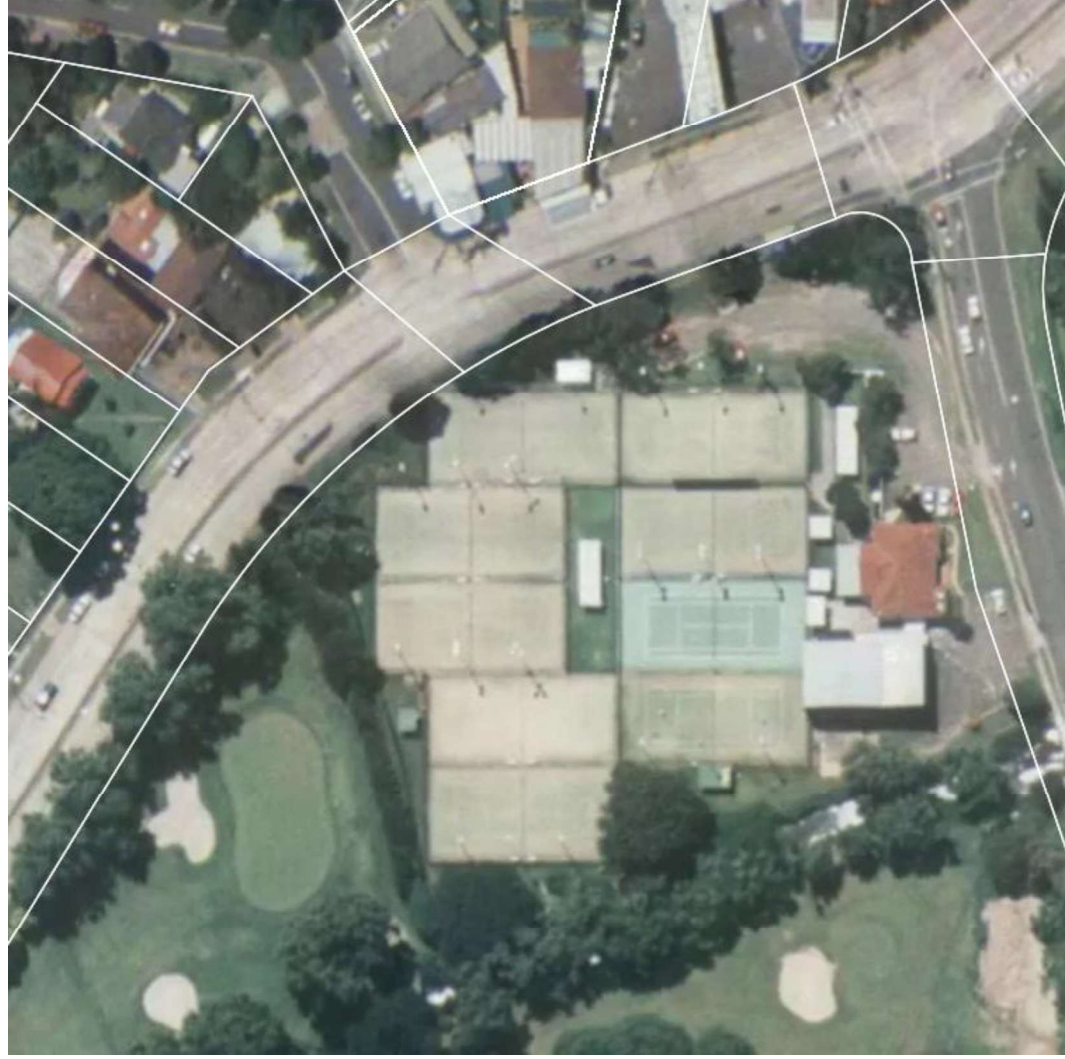
Figure 4

Figure 4. Aerial image of the site from the year 2000 shows a similar layout to today's configuration.

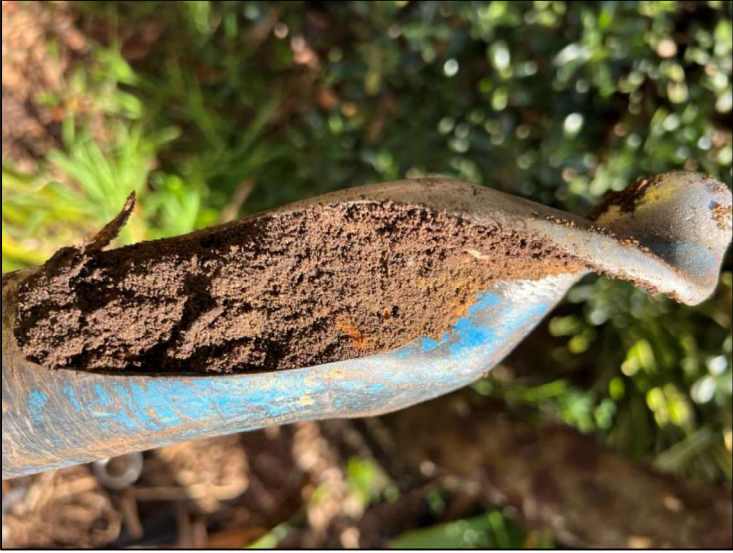
Figure 5. Collection of samples S1, sandy fertile top soil.

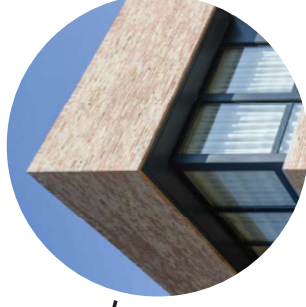
BLACK STEEL HANDRAIL

FACEBRICK
