Geotechnical Investigation Report

Report G10132-1

Proposed Mixed-Use Development

28 Lockwood Ave, Belrose NSW 2085

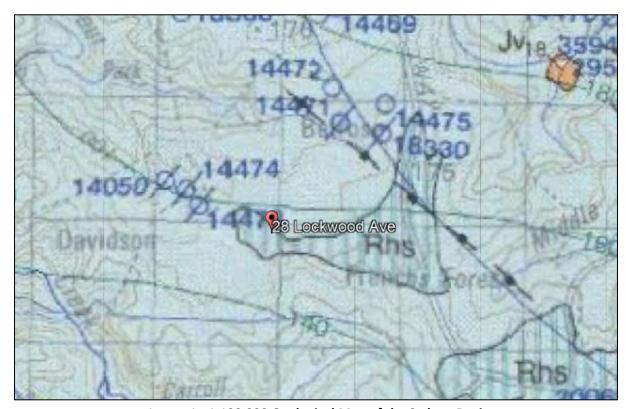
Image 1 - 1:100,000 Geological Map of the Sydney Region

The 1:100,000 scale Geological Series Map of the Sydney region indicates that the subject site is underlain by a Middle Triassic Hawkesbury Sandstone (Rh/Rhs) of the Mesozoic Era, described as 'Medium to coarse-grained quartz sandstone, very minor shale and laminite lenses/Shale, laminite'.

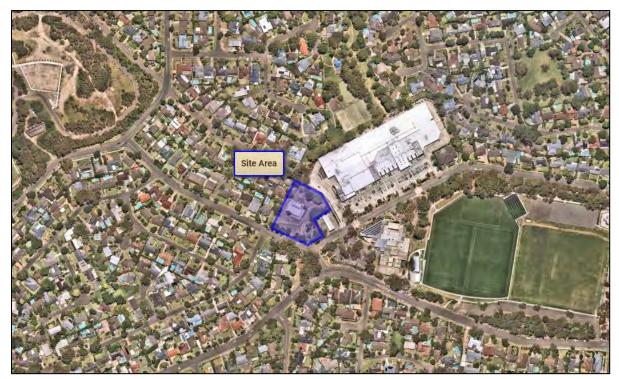
Image 2 - General Site Location

As indicated in Image 2, the site is bounded by:

It is understood that the proposed development comprises the demolition of the existing site structures and the construction of a two (2) multi-leveled structure with underground basement facilities, located within the internal confines of the site boundary (Image 2).

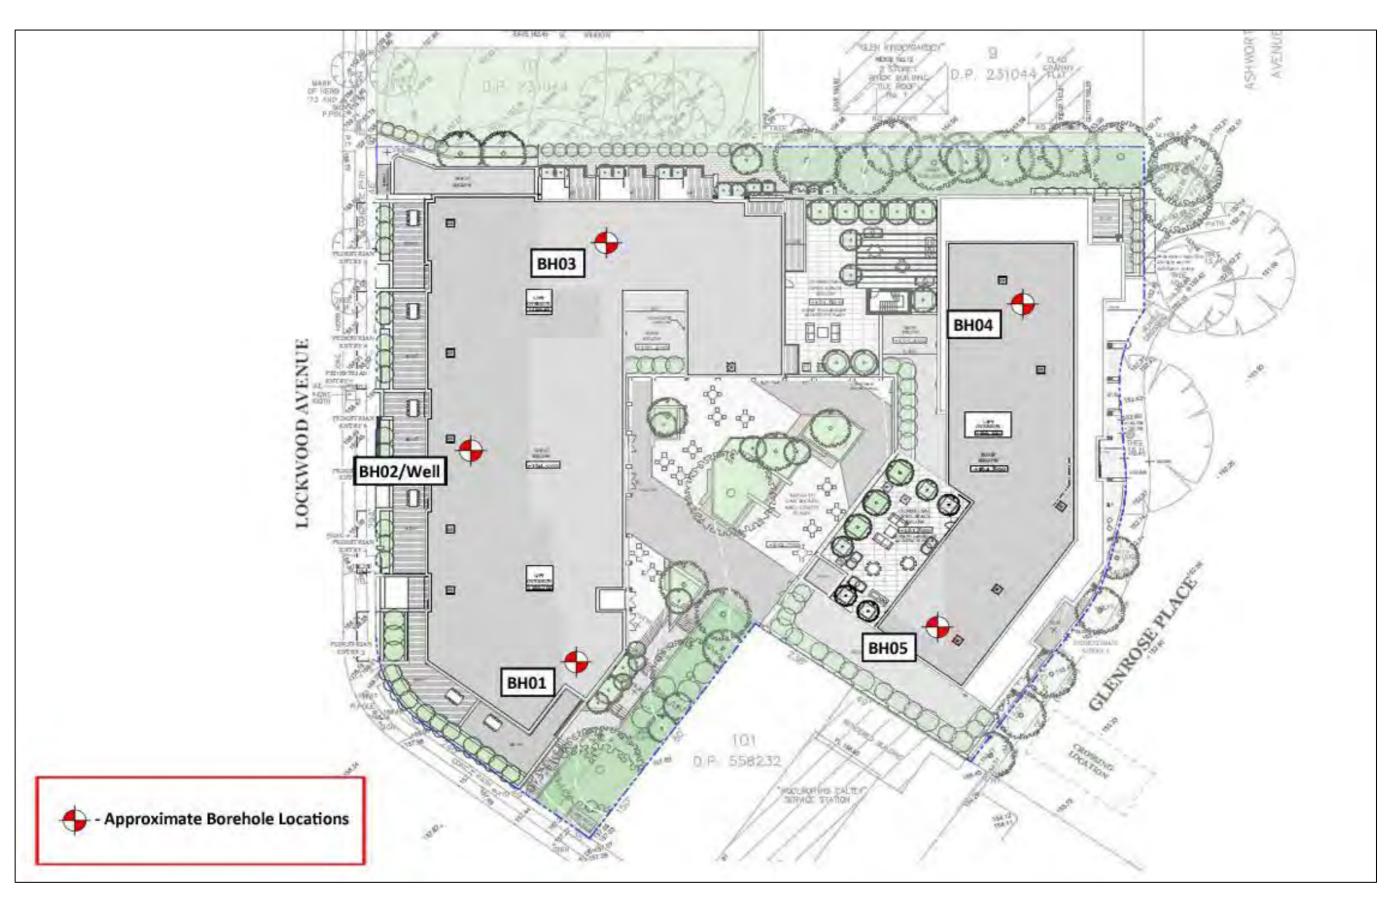
Borehole Location Figure 1 Plan

The location of boreholes is shown on the Borehole Location Plan (Figure 1) enclosed in Appendix A. The approximate borehole locations were determined by measuring from the existing site features.

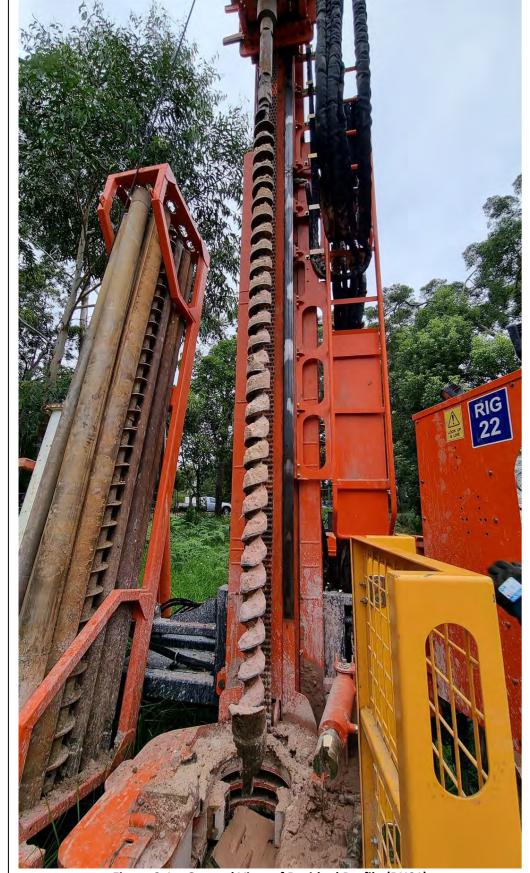
Figure 2.1 – General View of Residual Profile (BH01)

The residual soils comprise low plasticity, firm to stiff sandy clay, loose to very dense clayey sand and silty sand. The depth of the residual soil encountered, extends to an approximate depth of 2.2m to 2.5m across the site.

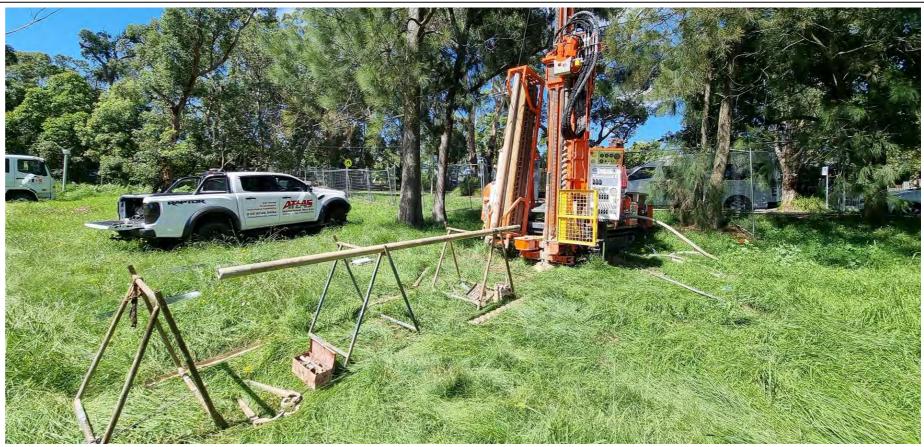
Figure 2.2 – General View of Drilling Operation (BH02)

The boreholes were drilled using a Hanjin D&B 8D drilling rig operated by BG Drilling. The boreholes were advanced by solid flight 100 mm diameter auger with a TC (Tungsten Carbide) drill bit. A combination of augering with a TC drill bit and core drilling with NMLC core barrel was used to advance each borehole and were terminated upon reaching the target depth.

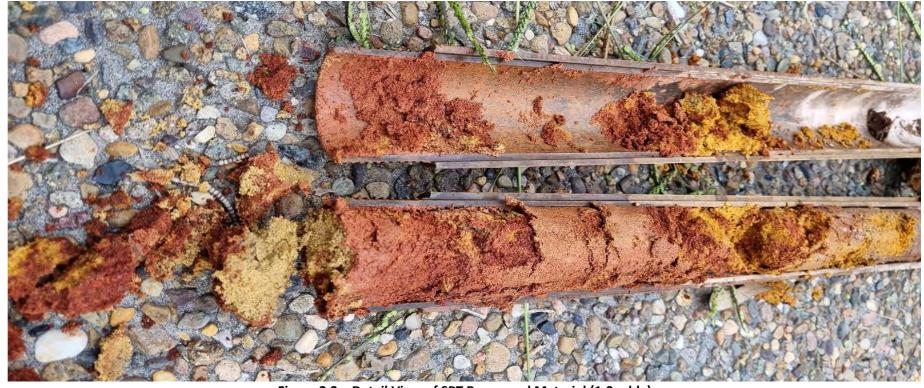
Figure 2.3 – Detail View of SPT Recovered Material (1.0m blg)

During the site investigation, the subsurface strata encountered was logged by an AGS's geotechnical engineer and SPTs were undertaken at selected intervals to assess shallow soil consistency. The borehole logs and the core box photos are enclosed in Appendix B and A respectively.

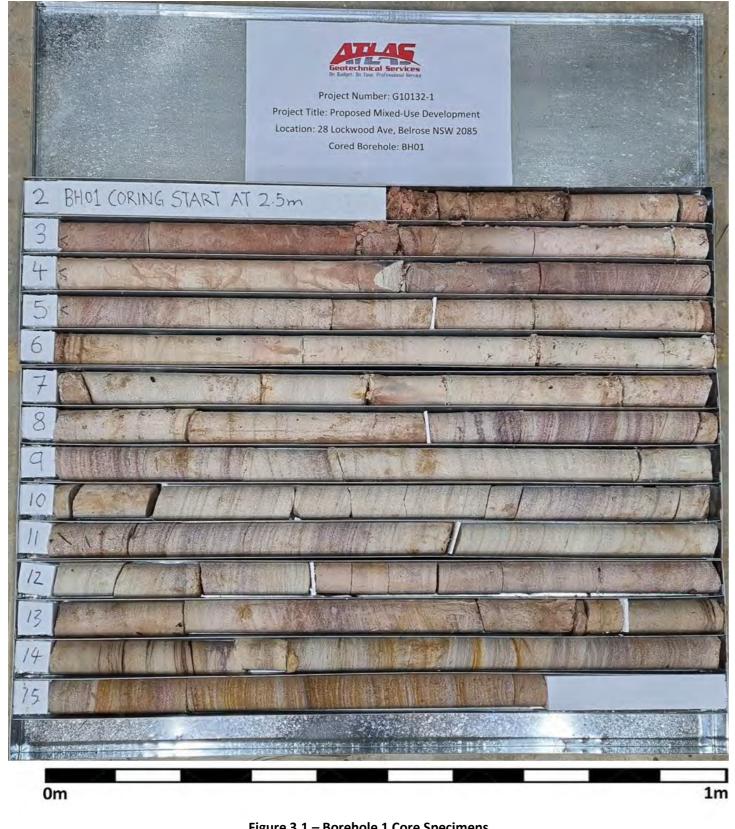
Figure 3.1 – Borehole 1 Core Specimens

The site is underlain by extremely to slightly weathered, extremely low to high strength sandstone bedrock extending to an approximate depth of 15.75m, across the site. Frequent clay seams were observed across all cored boreholes, varying between 4m, 8m, 11m and 14 below ground levels across selected boreholes.

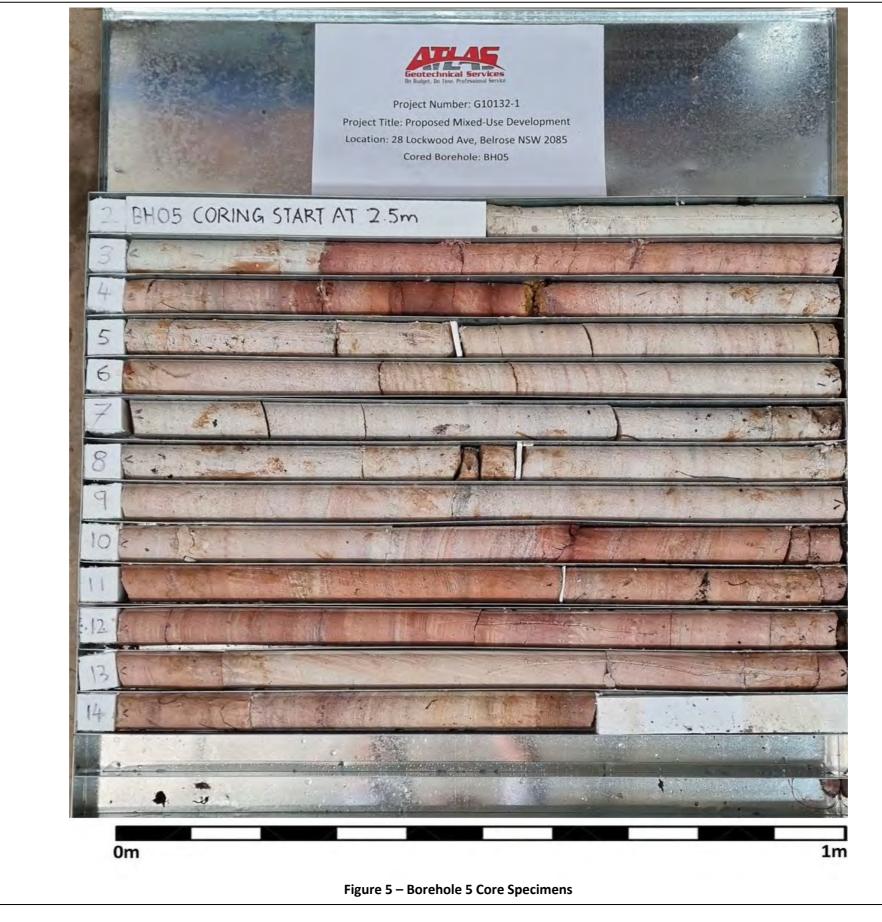
Figure 5

Core Specimens
