1 Narrabeen Park Parade, North Narrabeen

Stage 1 Preliminary Site Investigation - Contamination

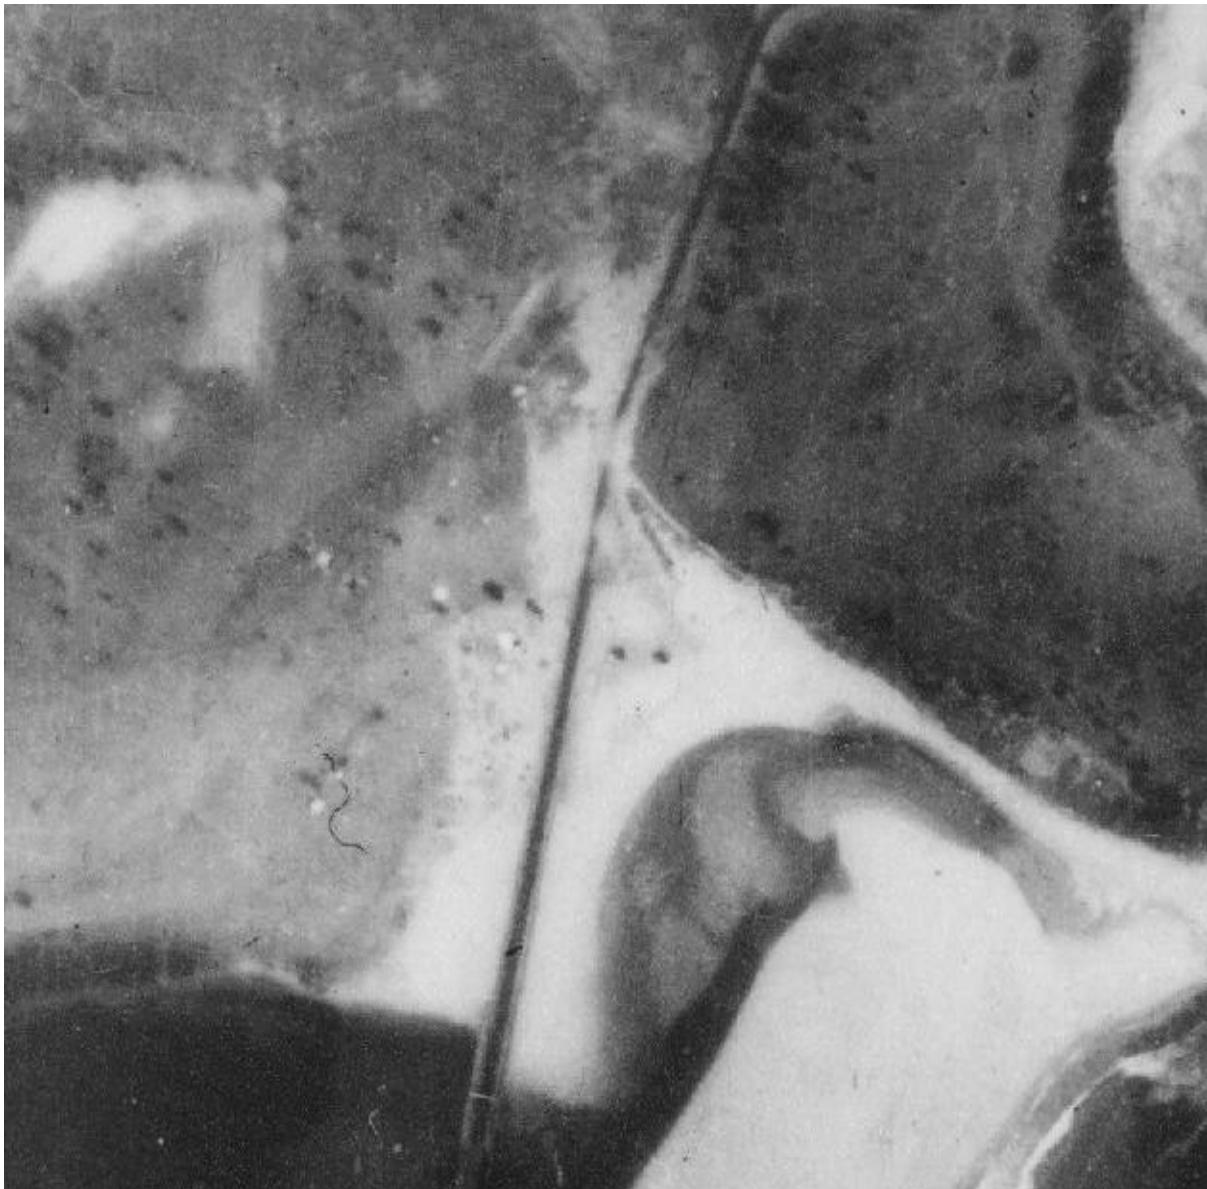
Historical aerial imagery shows the property was developed sometime between 1930 and 1943 (Photos 1 & 2). The current café appears to be the first structure constructed in the area. It was originally constructed to be a general store (Photo 3).

Photo 1 – 1930. No structure present.

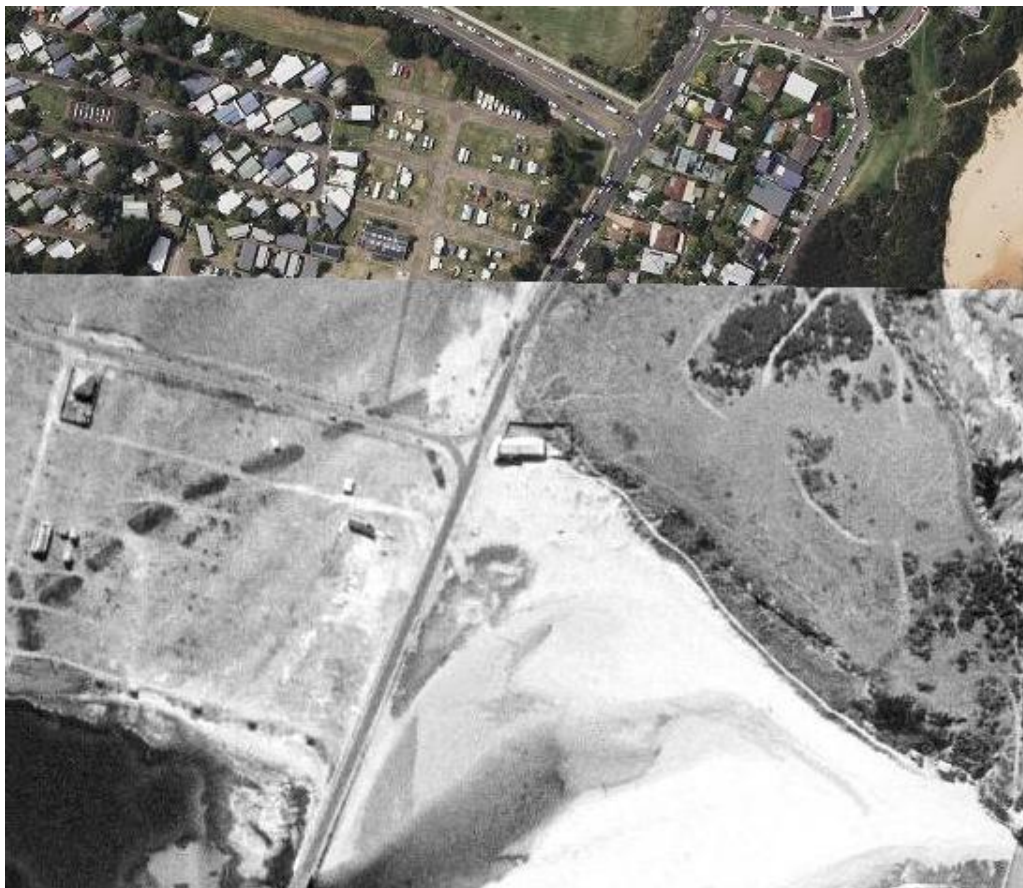
Photo 2 – 1943. Top of historical image cut off.

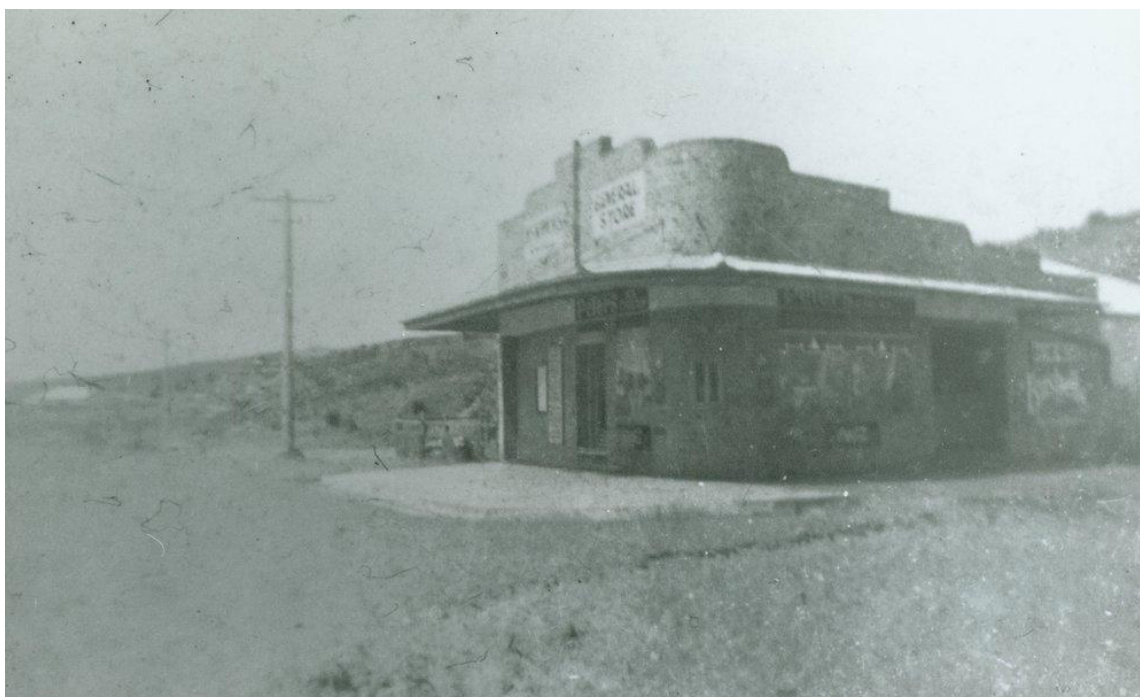
Photo 3 – Original general store ~1941 (Northern Beaches Council History Hub)

Historical photographs confirm the structure on the property is the original building (Photo 3). It originally operated as a general store and, more recently, several restaurants and cafes have operated on the premises. As such, we expect no potentially contaminating activities have occurred on the property.

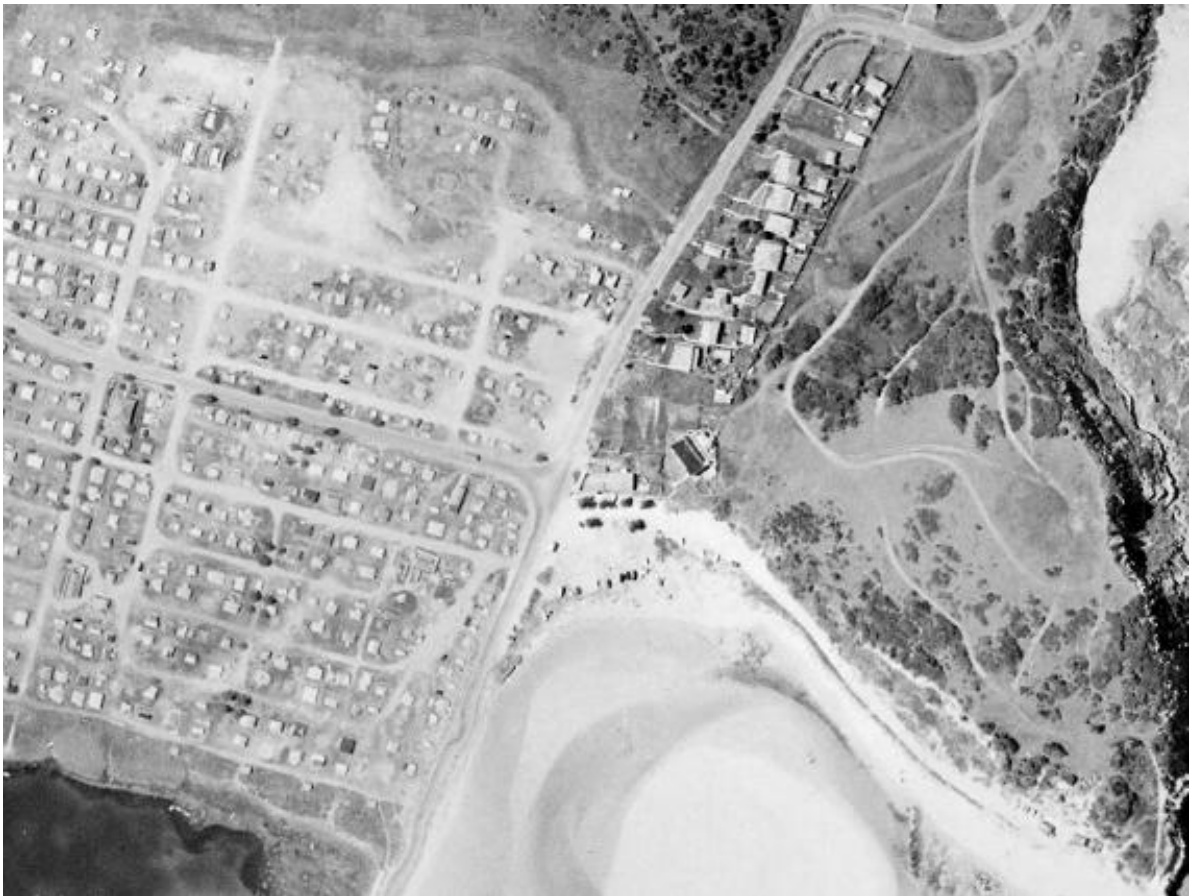
Photo 4 – 1955

1955 – Photo 4 – Narrabeen Park Parade developed to the N of the property. Makeshift carpark adjacent to subject property.

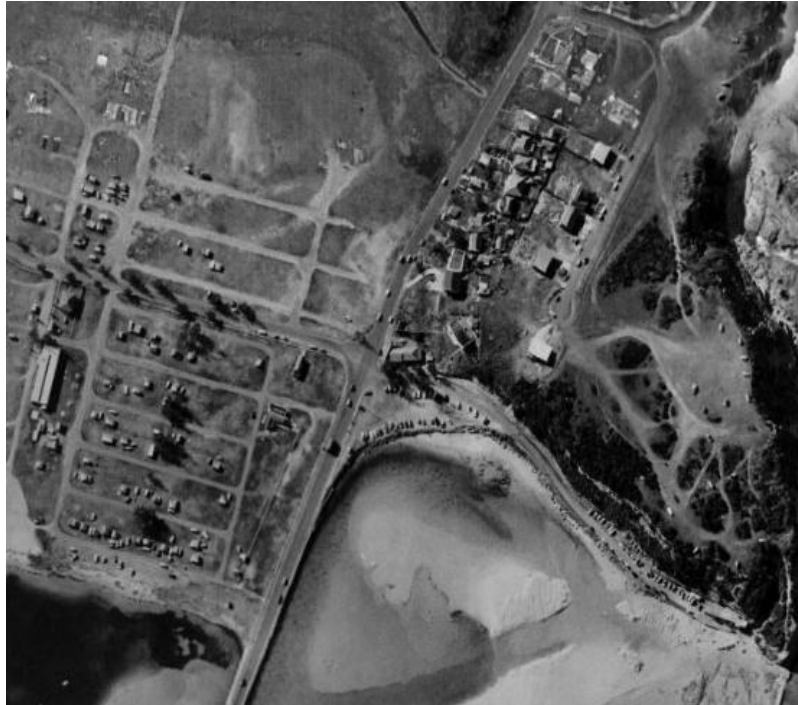
Photo 5 – 1965

1965 – Photo 5 – Additional development along Narrabeen Park Parade. Peel Place constructed and partially developed.

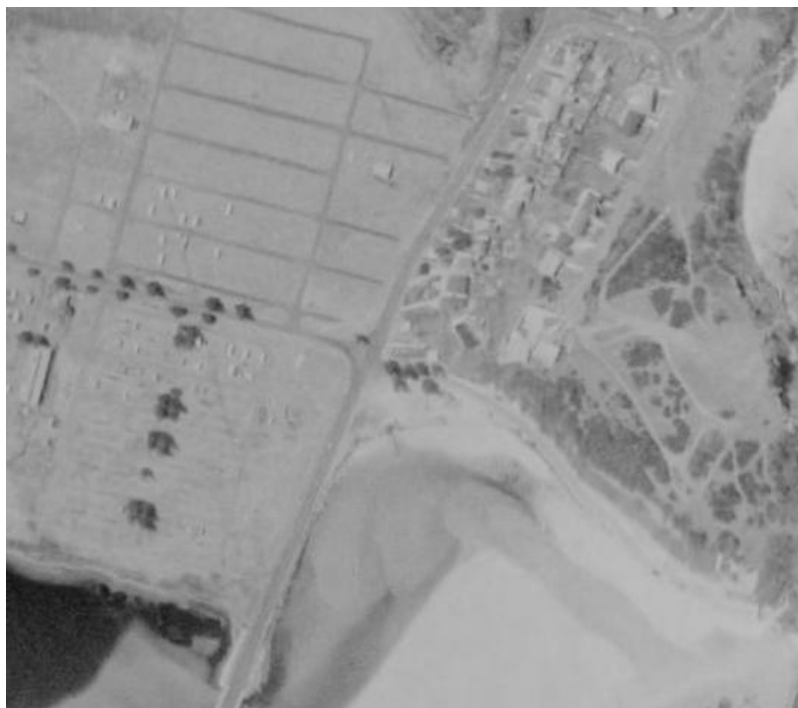
Photo 6 – 1971

1971 – Photo 6 – Additional development along Narrabeen Park Parade and Peal Place.
Expansion of the holiday park to the N.

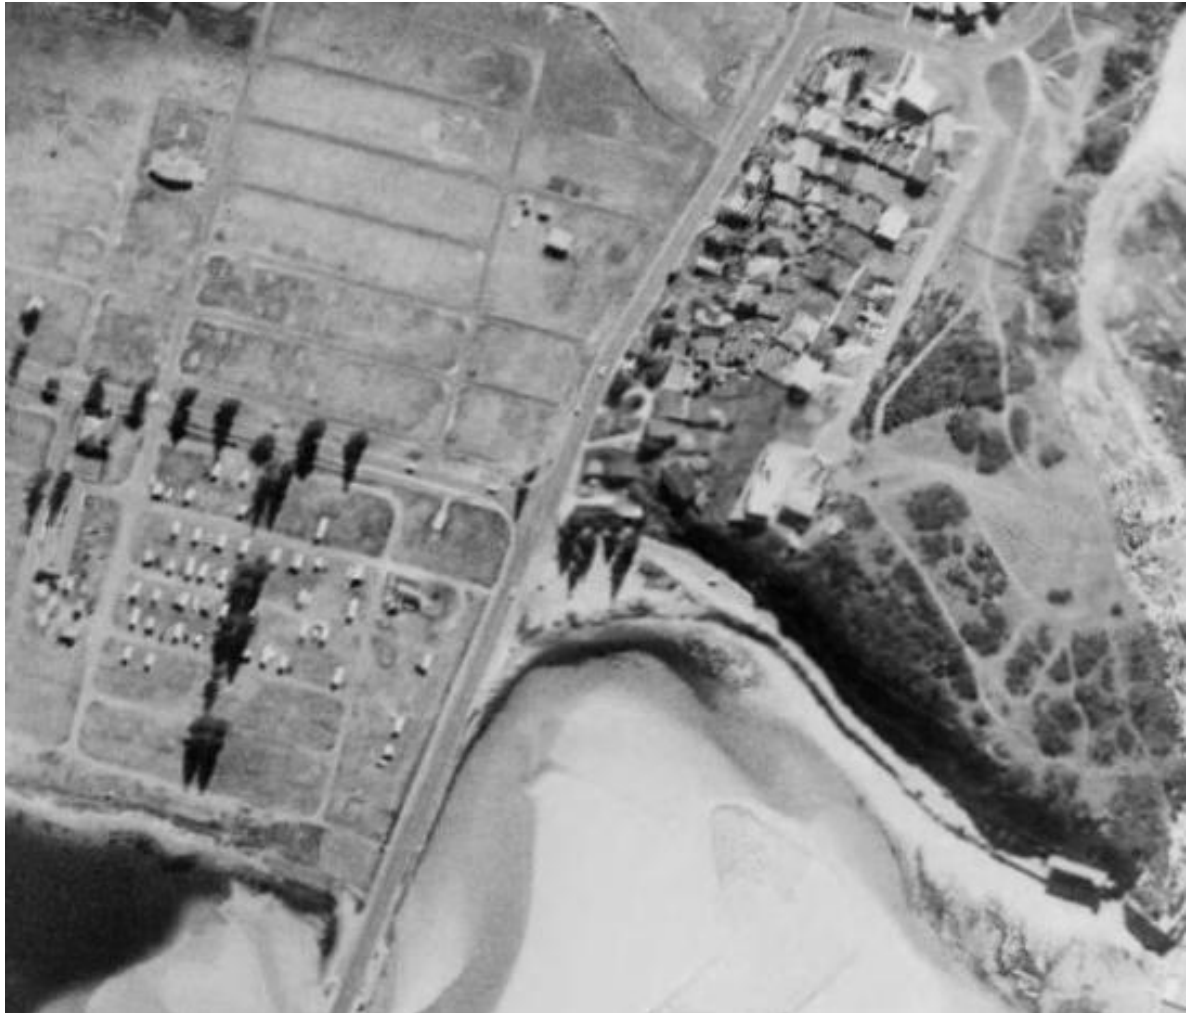
Photo 7 – 1975

1975 – Photo 7 – Additional development along Narrabeen Park Parade and Peal Place.

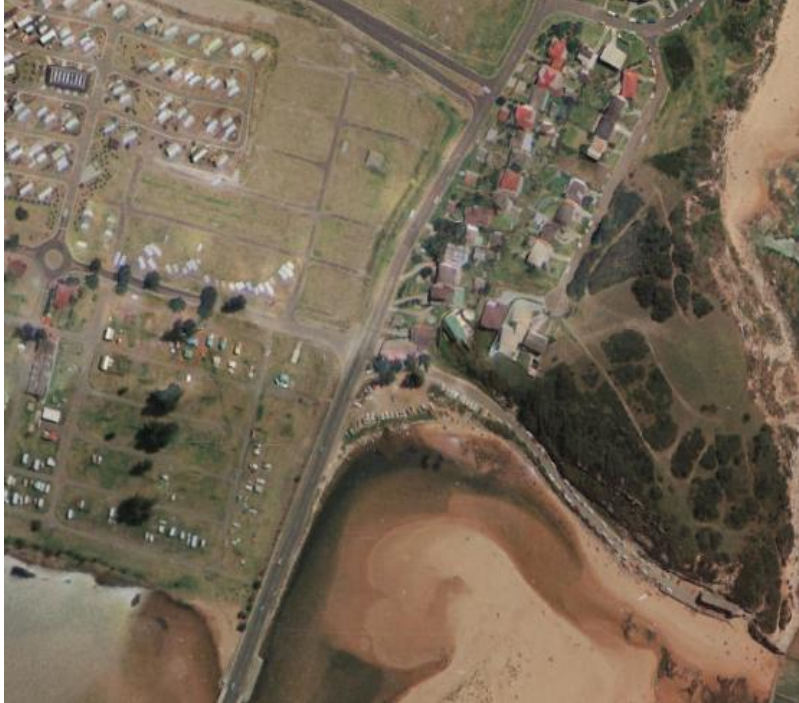
Photo 8 – 1982

1982 – Photo 8 – Construction of the unit block on the N neighbouring property. Additional development along Peal Place. Redevelopment of the NW corner of the holiday park. Construction of Walsh Street.

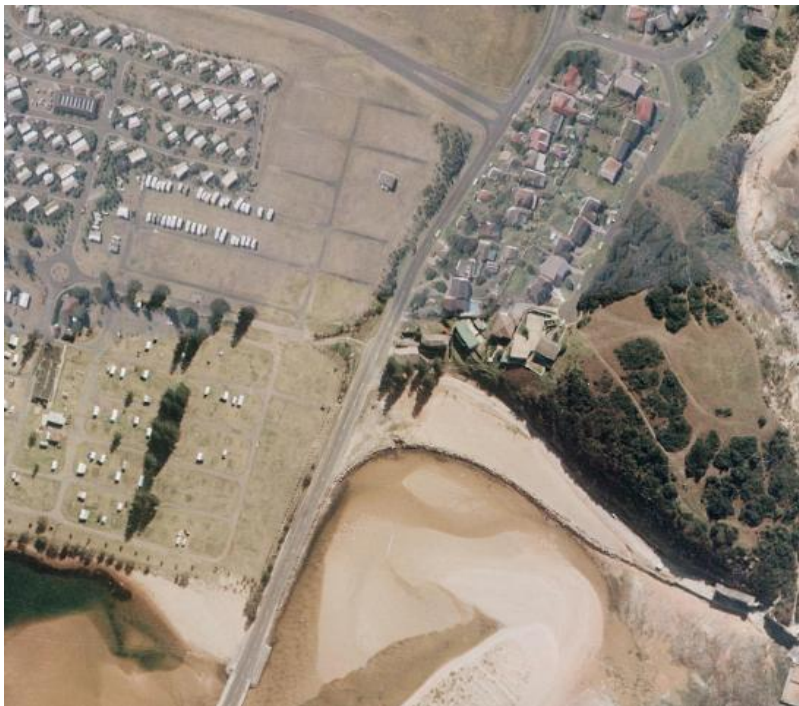
Photo 9 – 1986

1986 – Photo 9 – Seawall constructed. Additional development along Peal Place. Intersection adjacent to subject property removed.

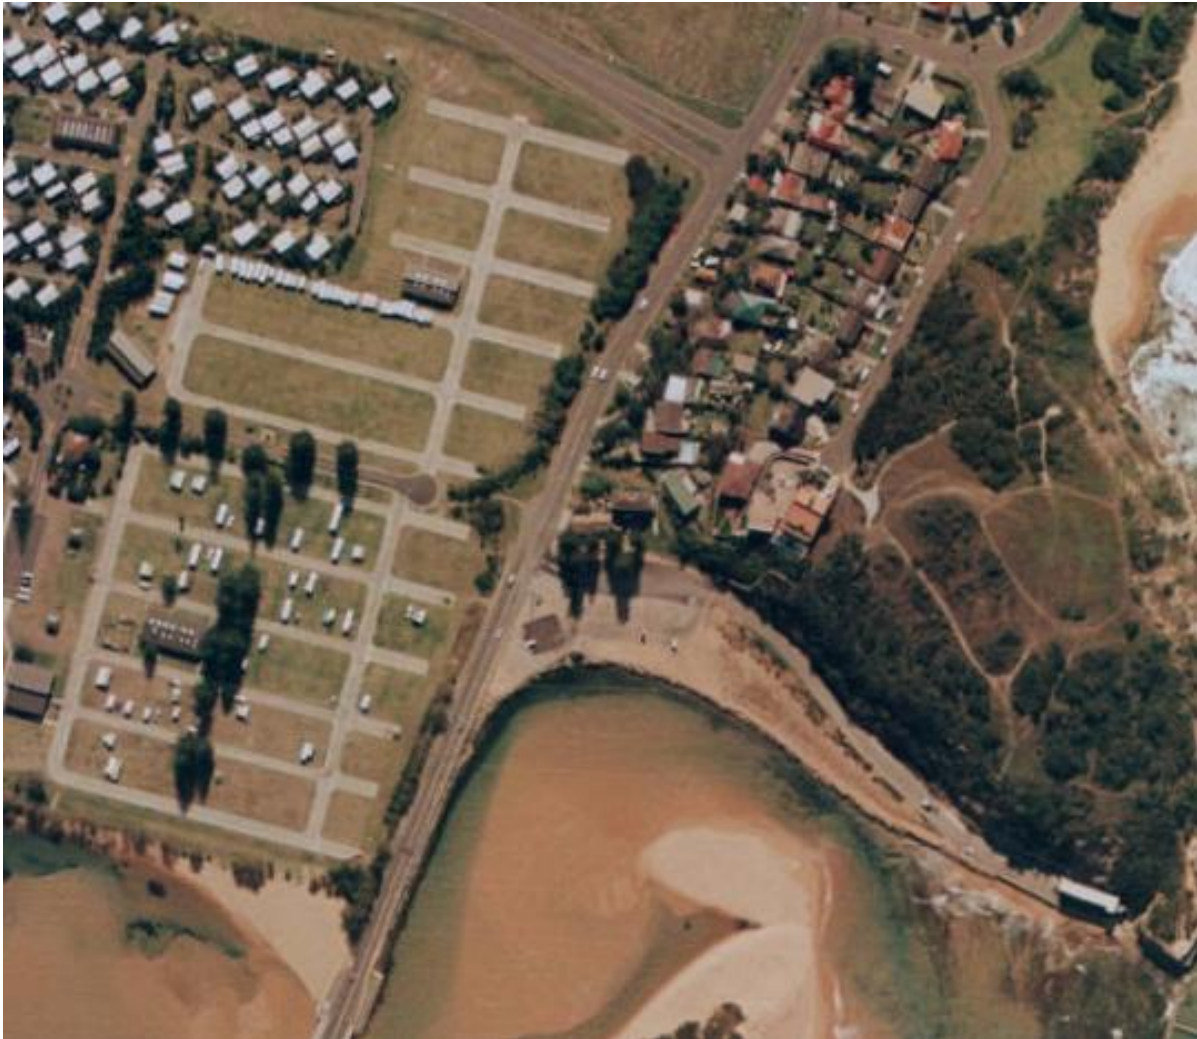
Photo 10 – 1991

1991 – Photo 10 – Carpark adjacent to subject property constructed. Final property developed on Peel Place. Additional roads constructed at holiday park.

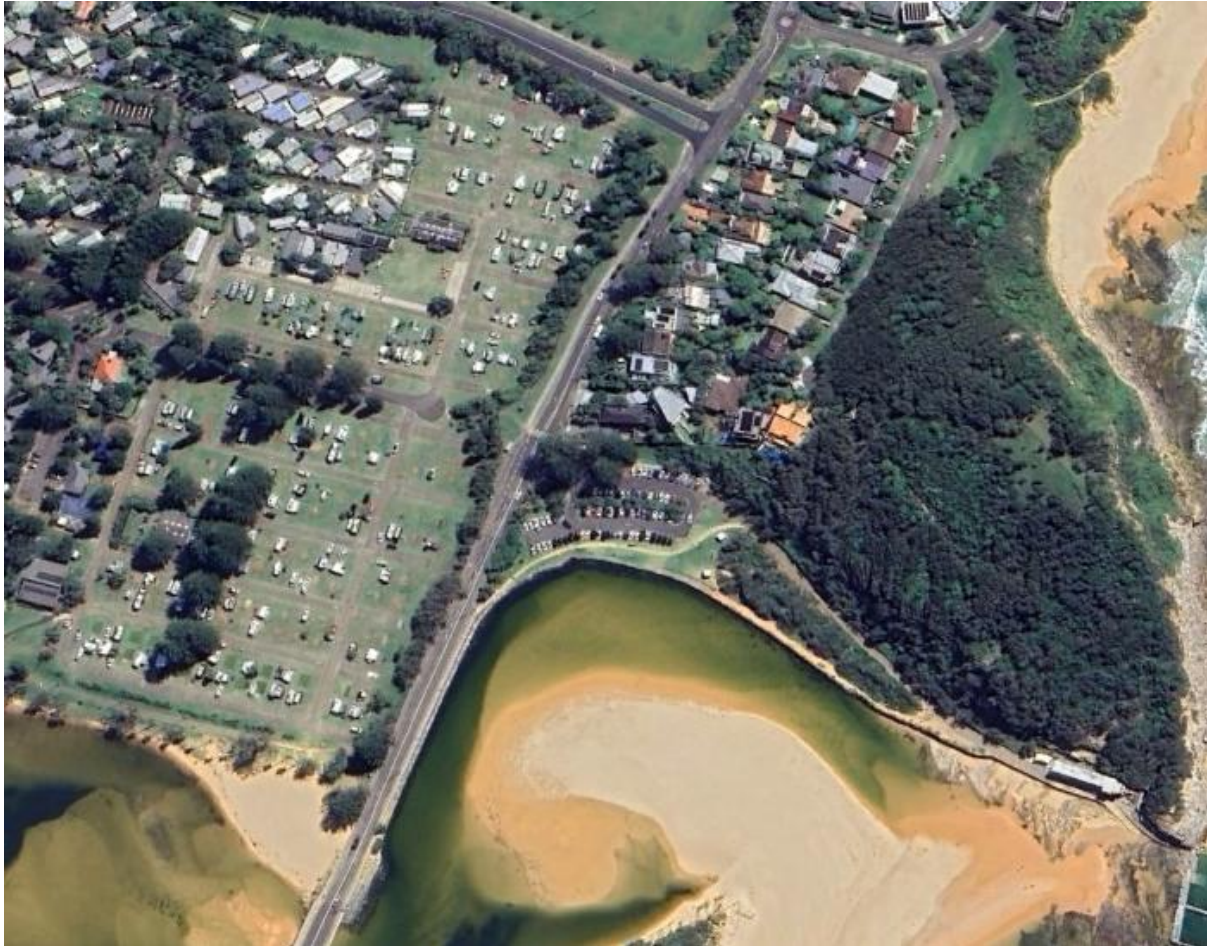
Photo 11 – 2025

2025 – Photo 11 – No significant changes to site or surrounding area.

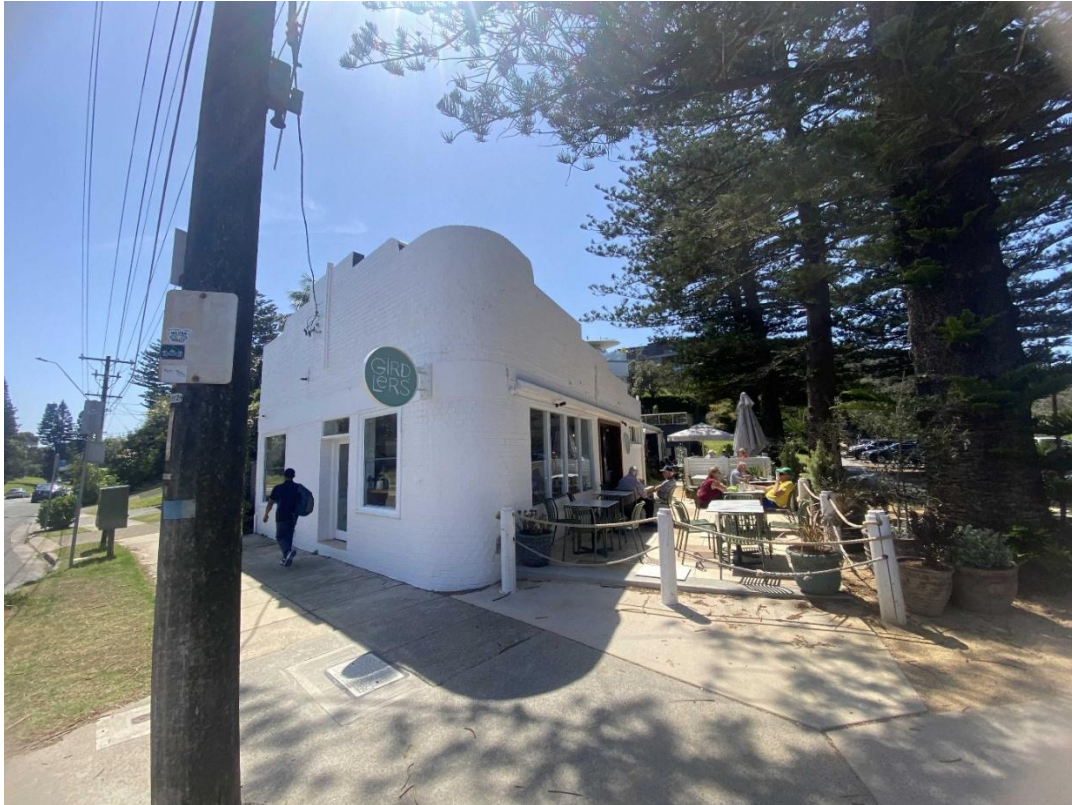
Photo 12

The structure itself is of brick construction and was likely built prior to 1940 (Photo 12). As such, there is a low risk of any asbestos containing materials present in the structure.
