RE: RESPONSE TO REQUEST FOR ADDITIONAL INFORMATION: DA2023/1858 AT NO. 14 BIRKLEY ROAD, MANLY

Council requested a Preliminary Assessment of Site Conditions as the land is located in Landslip Risk Area G2 and G4 under Council's Landslip Risk Map.

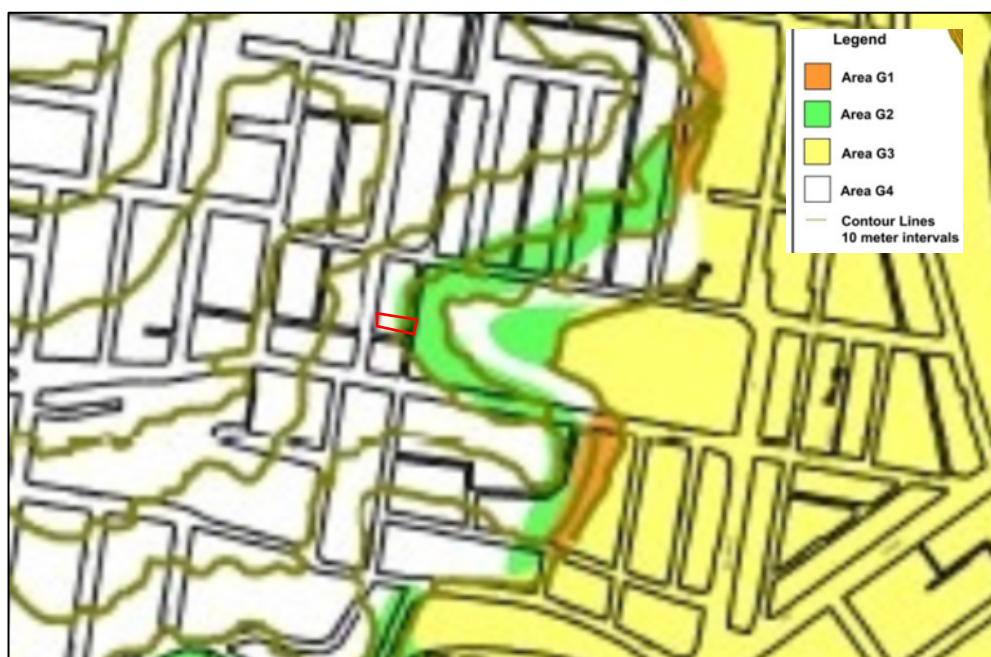
Figure 1: Schedule 1 Map C - Potential Geotechnical Landslip Hazard Areas
Subject site shown outlined in red

In response it is noted that the proposed works are located towards the western part of the site along Birkley Road. Area G2 is confined to the eastern boundary of the site and across Ivanhoe Park. All the proposed works are located outside of the G2 mapped land and is located in the G4 mapped land – refer to **Figure 1** below. Moreover the site is not located within the Manly landslip risk area (refer to **Figure 2**).

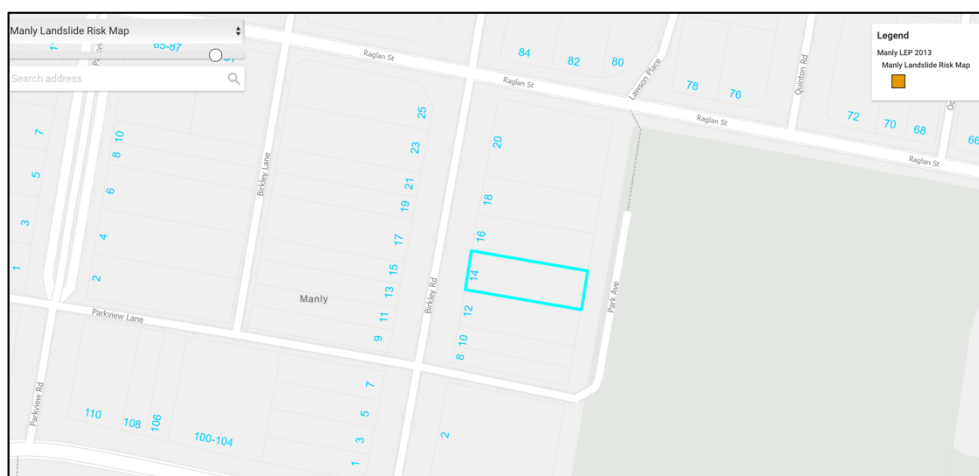
Figure 2: Manly landslide Risk Map
Subject site outlined in blue

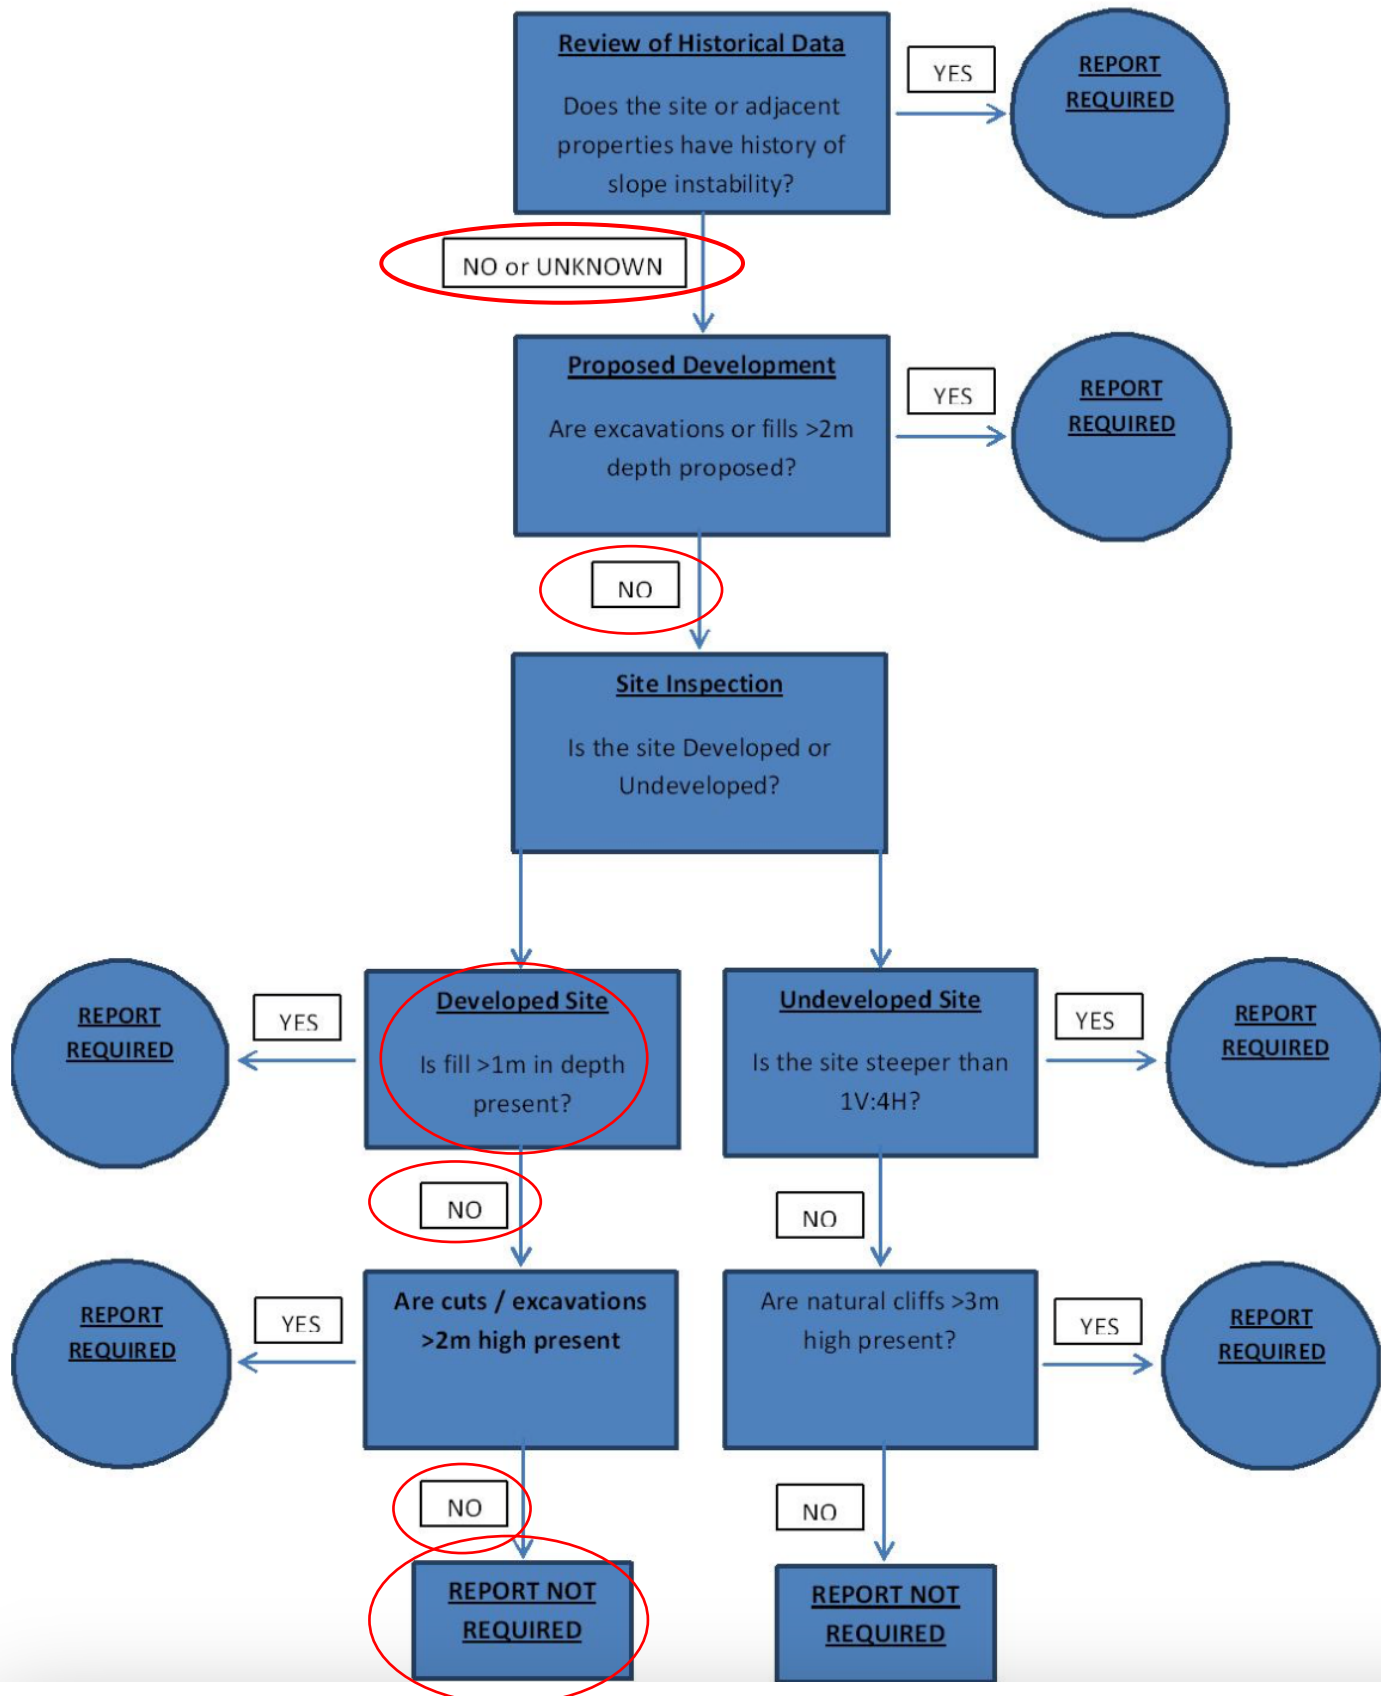
CHECKLIST FOR COUNCIL'S ASSESSMENT OF SITE CONDITIONS AND NEED FOR GEOTECHNICAL REPORT IN GEOTECHNICAL CLASS B AND D

5. Recommendations: based on the above items, and the flowchart below that indicates the principal factor(s) considered in the assessment, it is recommended that:	<p>No geotechnical assessment required</p> <p>The minor excavation will not impact on the site stability.</p> <p>It is considered that the nature of the works does not require a preliminary assessment of site conditions and or site stability report.</p> <p>All new footings will be constructed in accordance with AS2870.</p>

Refer to flow chart below
