MALA GPR Australia
26/10-18 Orchard Road
Brookvale, NSW 2100

Tank Investigation

COMPANY Dad & Dave's Brewing

PROJECT SITE 45 Mitchell Rd Brookvale NSW,
2100.

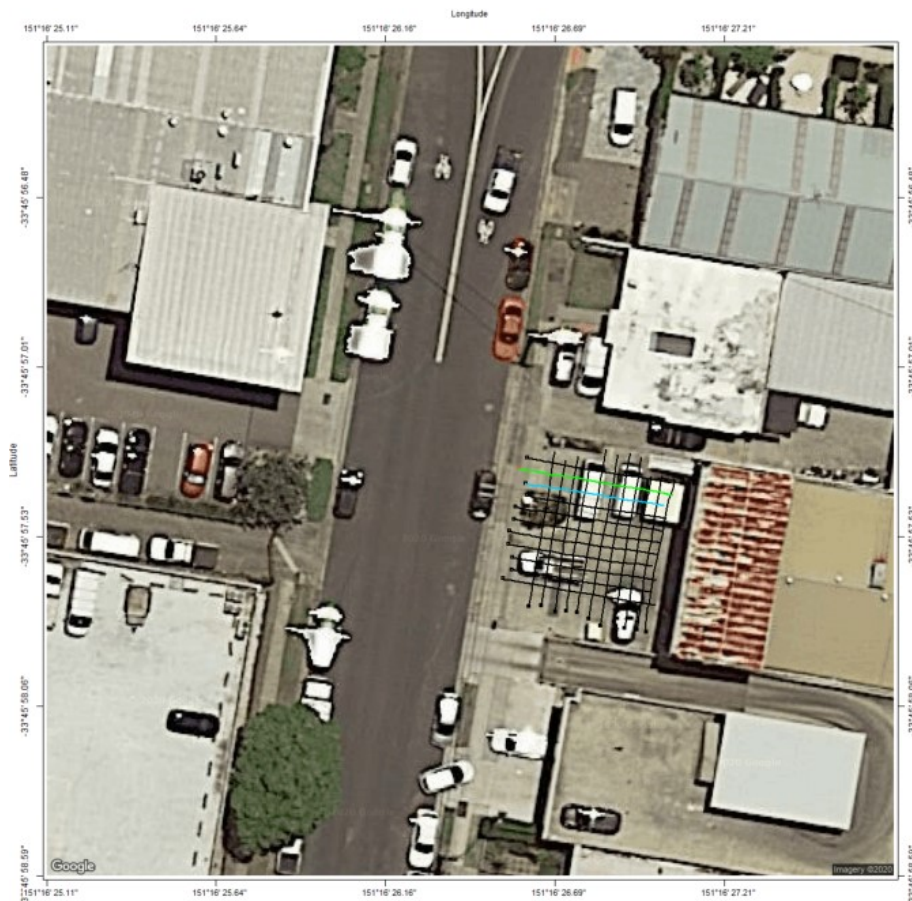
Figure 4 - 2D Survey coverage, x and y axis grid.

Positioning for the GPR survey was tracked by an external Hemisphere RTK GPS rover antenna, mounted above both 2D and 3D instruments. Horizontal accuracy is approximately 100-300mm when a fix is obtained from GLONASS satellites. Horizontal chainage for GPR profiling was measured using an optical distance encoder triggered by the instruments left rear wheel. Figure 4 represents the GPR profiles acquired.

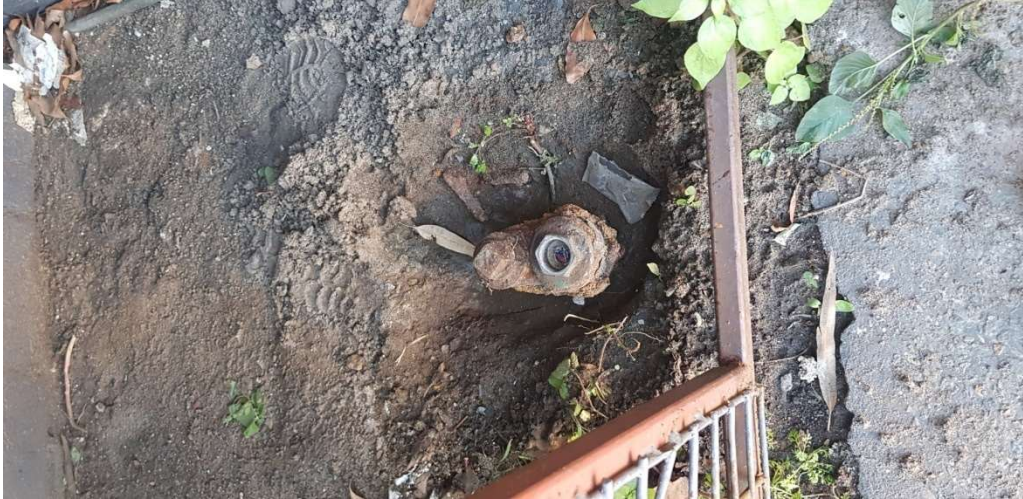
The Council document states the diameter of the tank to be 2.5m and 3.5m in length. Tank capacity is claimed to be 11,900 litres buried at a maximum depth to 3.4m. Taking the total depth and diameter into account the top of the tank should be approximately 1m below the surface. The tank also had an associated bowser at one point in time mounted against the building. A valve/pipe is visible at the surface under the stair case suspected to be relating to the tank/bowser (Figure 5).

Figure 5 - Valve/pipe believed to be associated with the tank/bowser, located under the stairs in the car park.

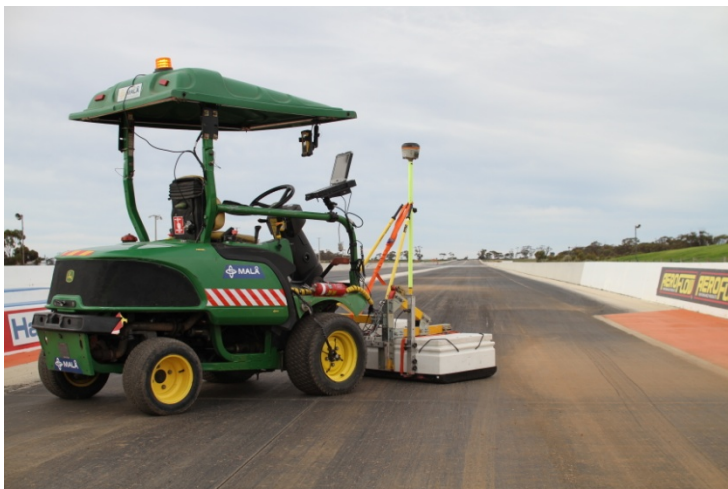
MALA GPR Imaging Radar Array (MIRA) is the most technically advanced GPR system on the market. It is the only system of its kind that integrates acquisition, processing, QA/QC, positioning data, interpretation and export of ground penetrating radar data (Figure 7).

The MIRA instrument has the ability to quickly and easily gather full 3D data in broad paths, called "swats" using 16 channels. This allows for data collection in one pass (i.e. a swat needs to be covered only once, in singular direction) as opposed to single channel systems which require multiple passes in multiple directions. The MIRA system is an efficient and effective solution for large scale ground penetrating radar mapping and subsurface object identification. Results are processed in 3D depth slices and are displayed and interpreted through a dedicated software package (rSlicer) and then exported into suitable GIS or CAD data formats (.dxf) if required.

Figure 7 - MALA MIRA 400Mhz 16 Channel 3D GPR System.

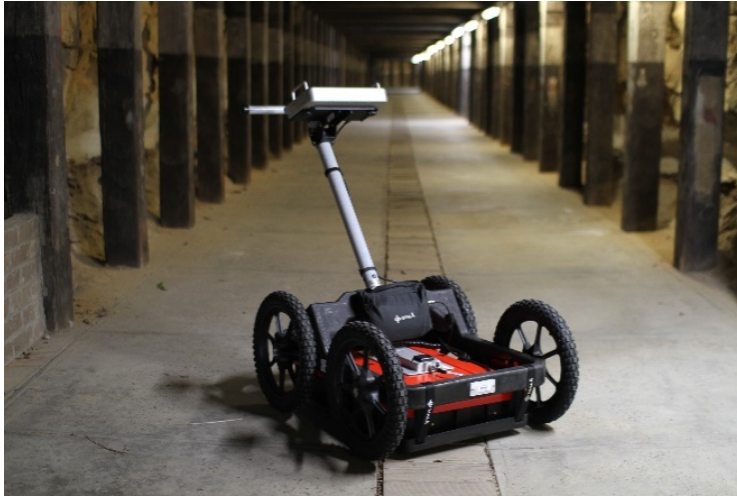
MALA Easy Locator Wide Range HDR GPR; represents one of the highest levels of 2D GPR surveying. This dual frequency system (670Mhz/160Mhz) is portable and easily integrated into a

range of configurations for manoeuvring which will allow for a time efficient and cost-effective solution for large scale ground penetrating radar mapping and subsurface object identification. The GPR system was manoeuvred by hand in a pushcart solution for this investigation.

Figure 8 - MALA Easy Locator Wide Range in Rough Terrain Cart

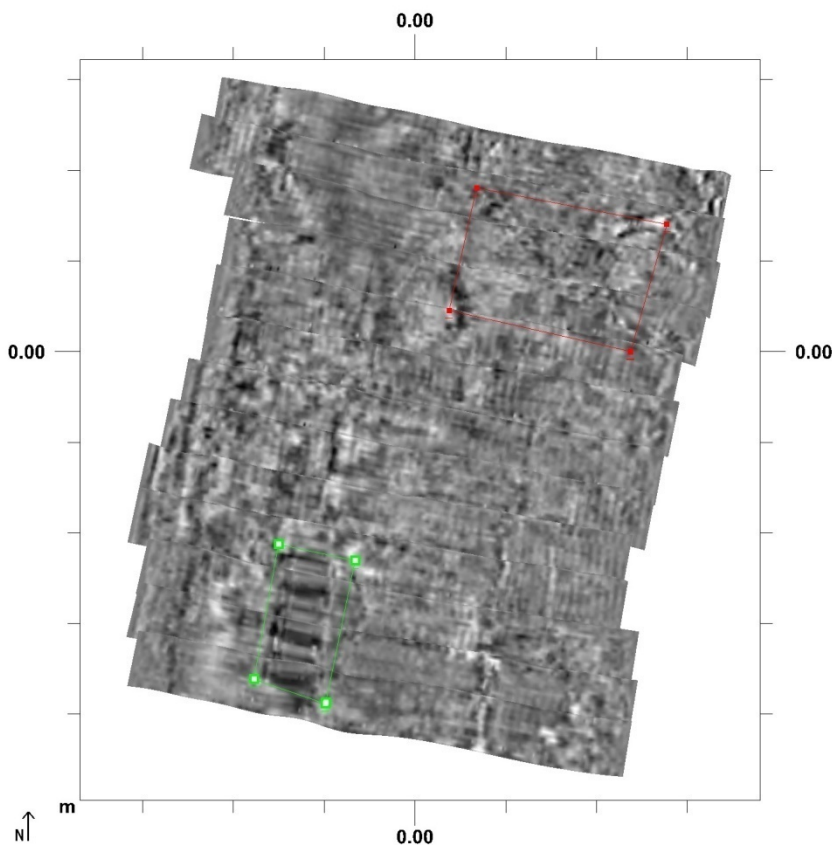
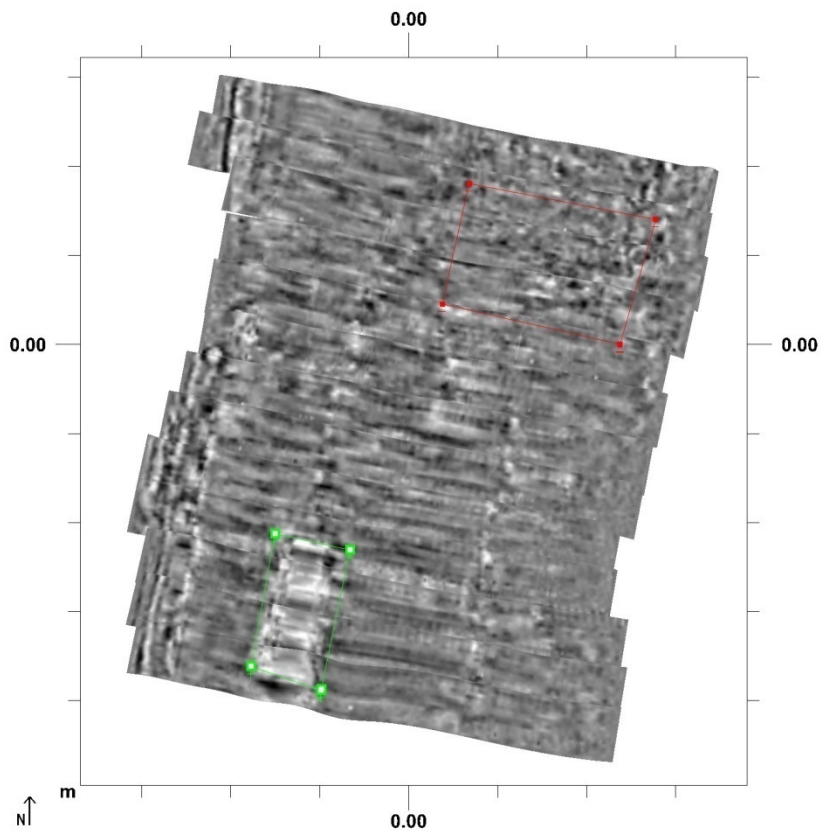
Below are a range of depth slices taken from the 3D data at 500mm intervals to a total depth of 2 meters. The red box has been placed over the area the tank is suggest to have been buried in the council document. The green box outlines the grease trap, a known visible surface anomaly.

No depth slice shows strong evidence to suggest a subsurface tank is present in the data. However, evidence is apparent of disturbed soils profiles.

Figure 9 - MIRA data 0.5m depth slice.

Figure 10 - MIRA data 1m depth slice

Figure 11 - MIRA Data 1.5m depth slice

Figure 12 - MIRA Data 2.0m depth slice
