# GEOTECHNICAL INVESTIGATION REPORT

No.11 Raven Circuit Warriewood NSW

Reference: 8793

Date: 13 April 2025

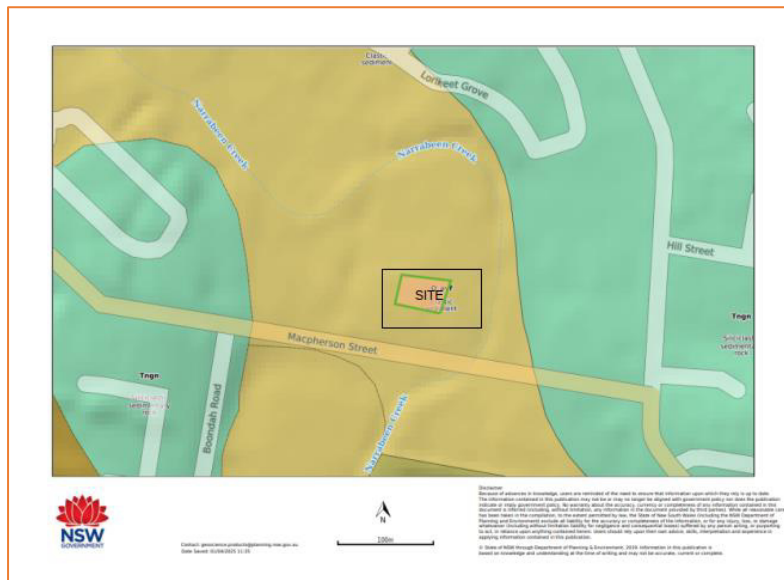
Reference to the Geological Survey of NSW seamless geology extracted from MinView indicates the site is located in an area of Fluvially-deposited quartz-lithic sand, silt, gravel, clay from Quaternary age. The subsurface conditions encountered during the field works is considered to be consistent with the geological map indications presented in Figure 1.

Figure 1: Local Geology (Extracted NSW seamless geology from MinView)

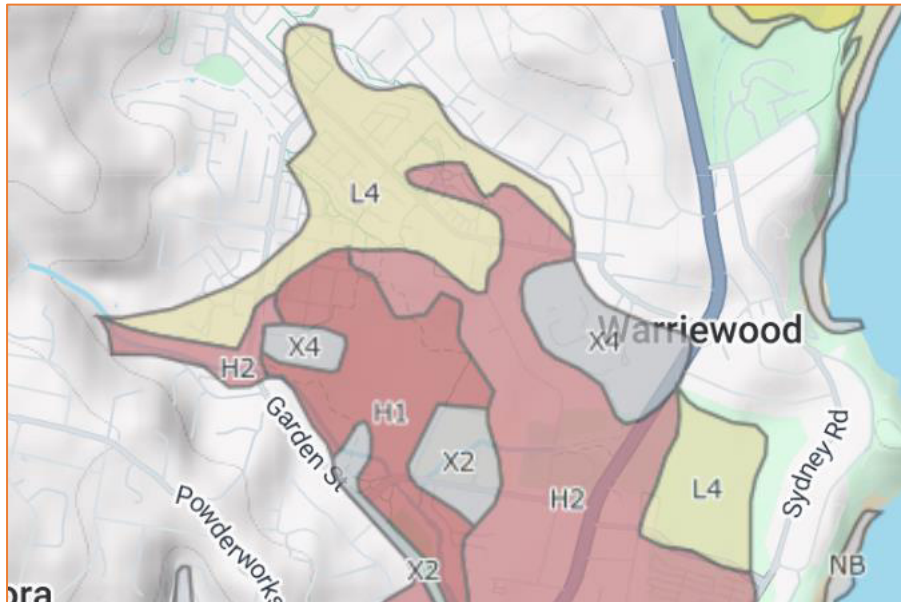
Published acid sulphate soil risk mapping indicates that the area encompassing the proposed residential development is located near mapped as “low probability of occurrence of acid sulfate soil materials between 1 to 3 meter below the ground surface”.

Figure 2: Acid sulphate soil probably map (extract from eSPADE, NSW)

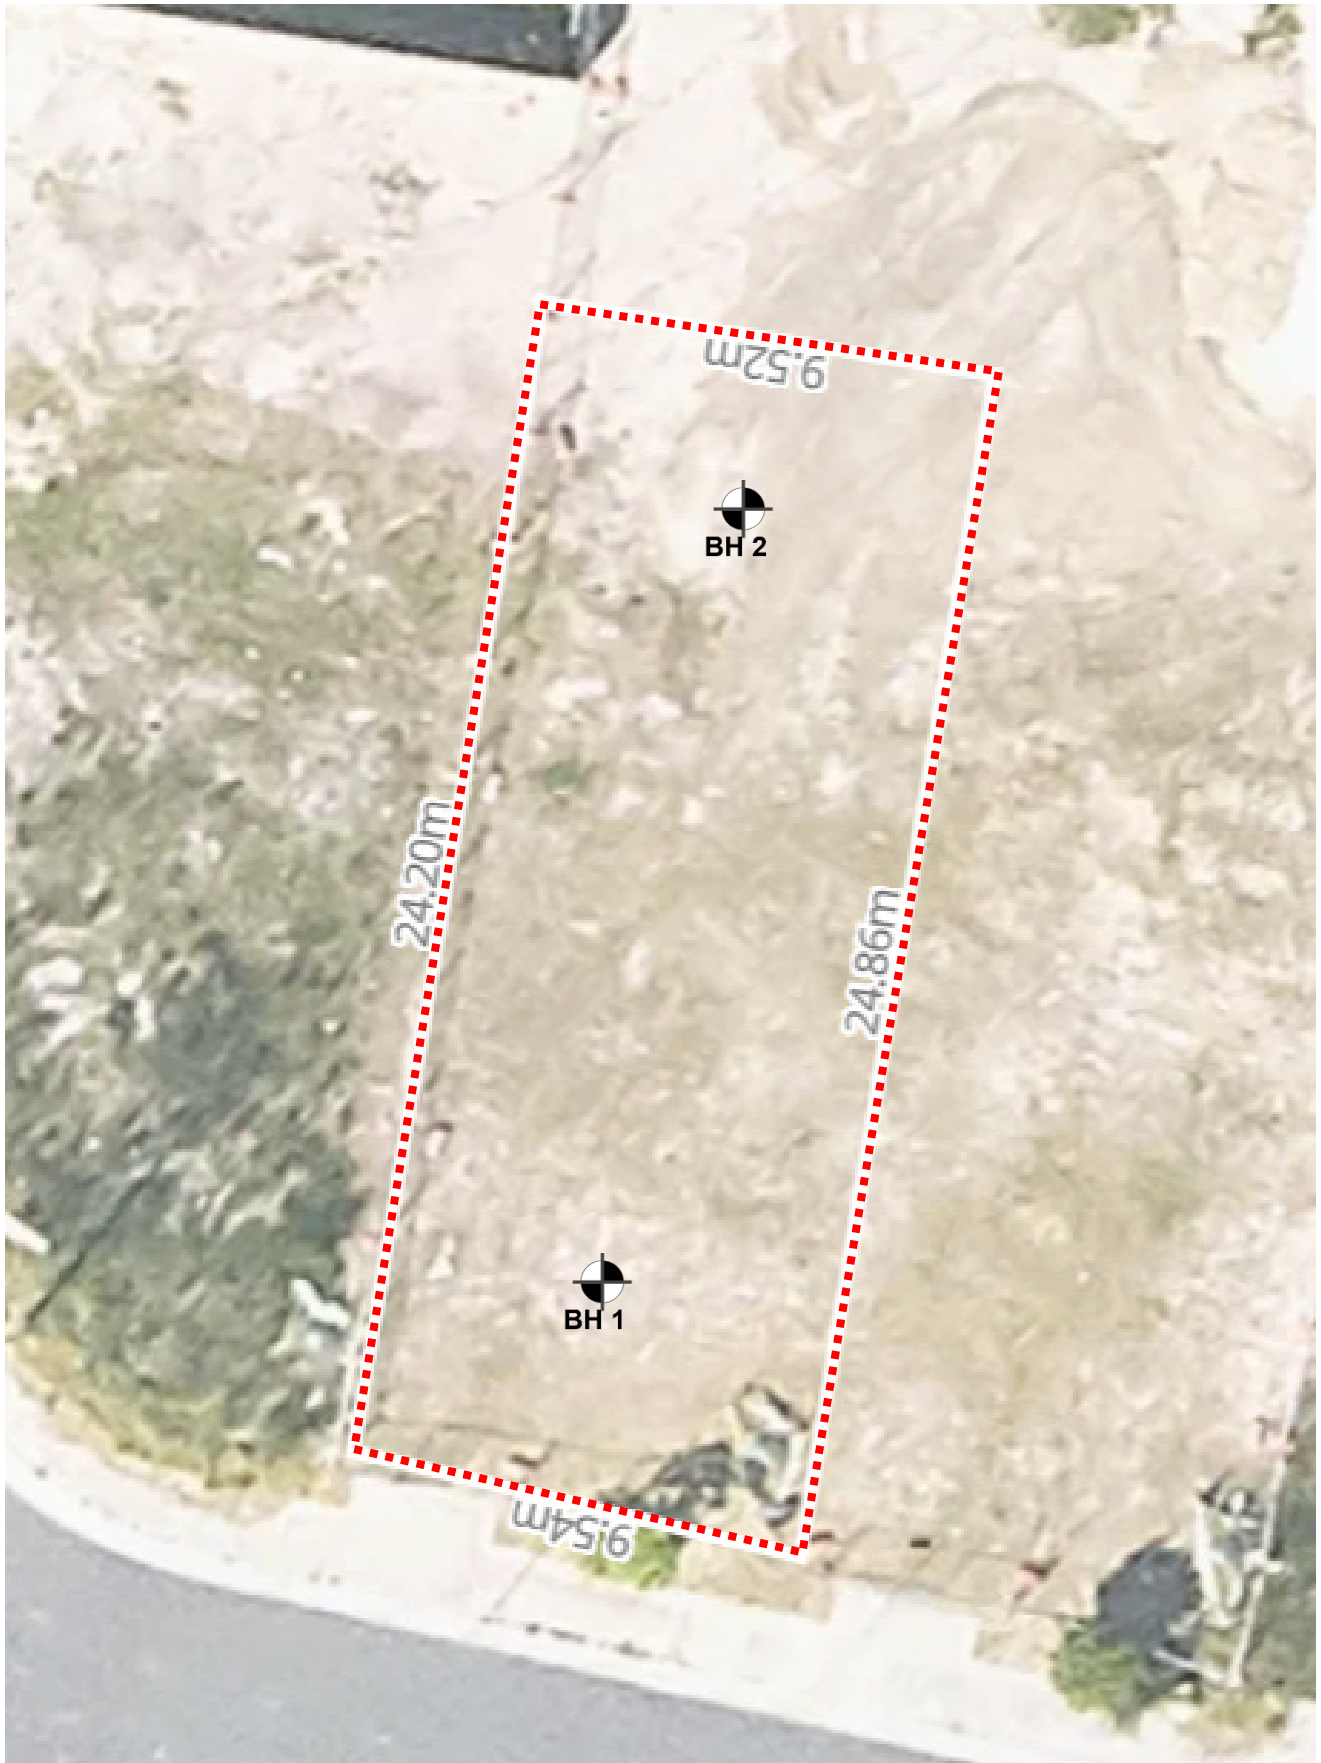
### SITE PLAN AND BOREHOLE LOGS

| Drilling Method | DCP Graph ● | Water | Depth (m) | Soil Origin | Graphic Log | Classification Code | Material Description | Consistency | Moisture | Remarks |
|---|---|---|---|---|---|---|---|---|---|---|
| | | | 2 | Fill | | SM | Fill Gravelly to silty SAND SM: medium dense, red brown grey, fine to coarse grained, fine to medium sized gravel, moist. | MD | M | |
| | | | 4 | Natural | | SM | Natural SAND, SM: Silty, medium dense, grey orange brown, fine to coarse grained, moist. | MD | M | |
| | | | | | | | <b>BH02 Terminate at 4.5m (End of borehole, target depth achieved)</b> | | | |

Details of the borehole logs are given in Appendix A including the AS 1726 classification definitions and relevant descriptive terms. Relatively uniform conditions were encountered underlying the site, with the succession of strata broadly summarized as follows:

The ground conditions encountered in the boreholes drilled at the time of the investigation typically comprised of 3.5 m of fill overlying natural soils originated from residual.
