Northern Beaches Council

John Fisher Park, Curl Curl, NSW

Environmental Management Plan

22 March 2019

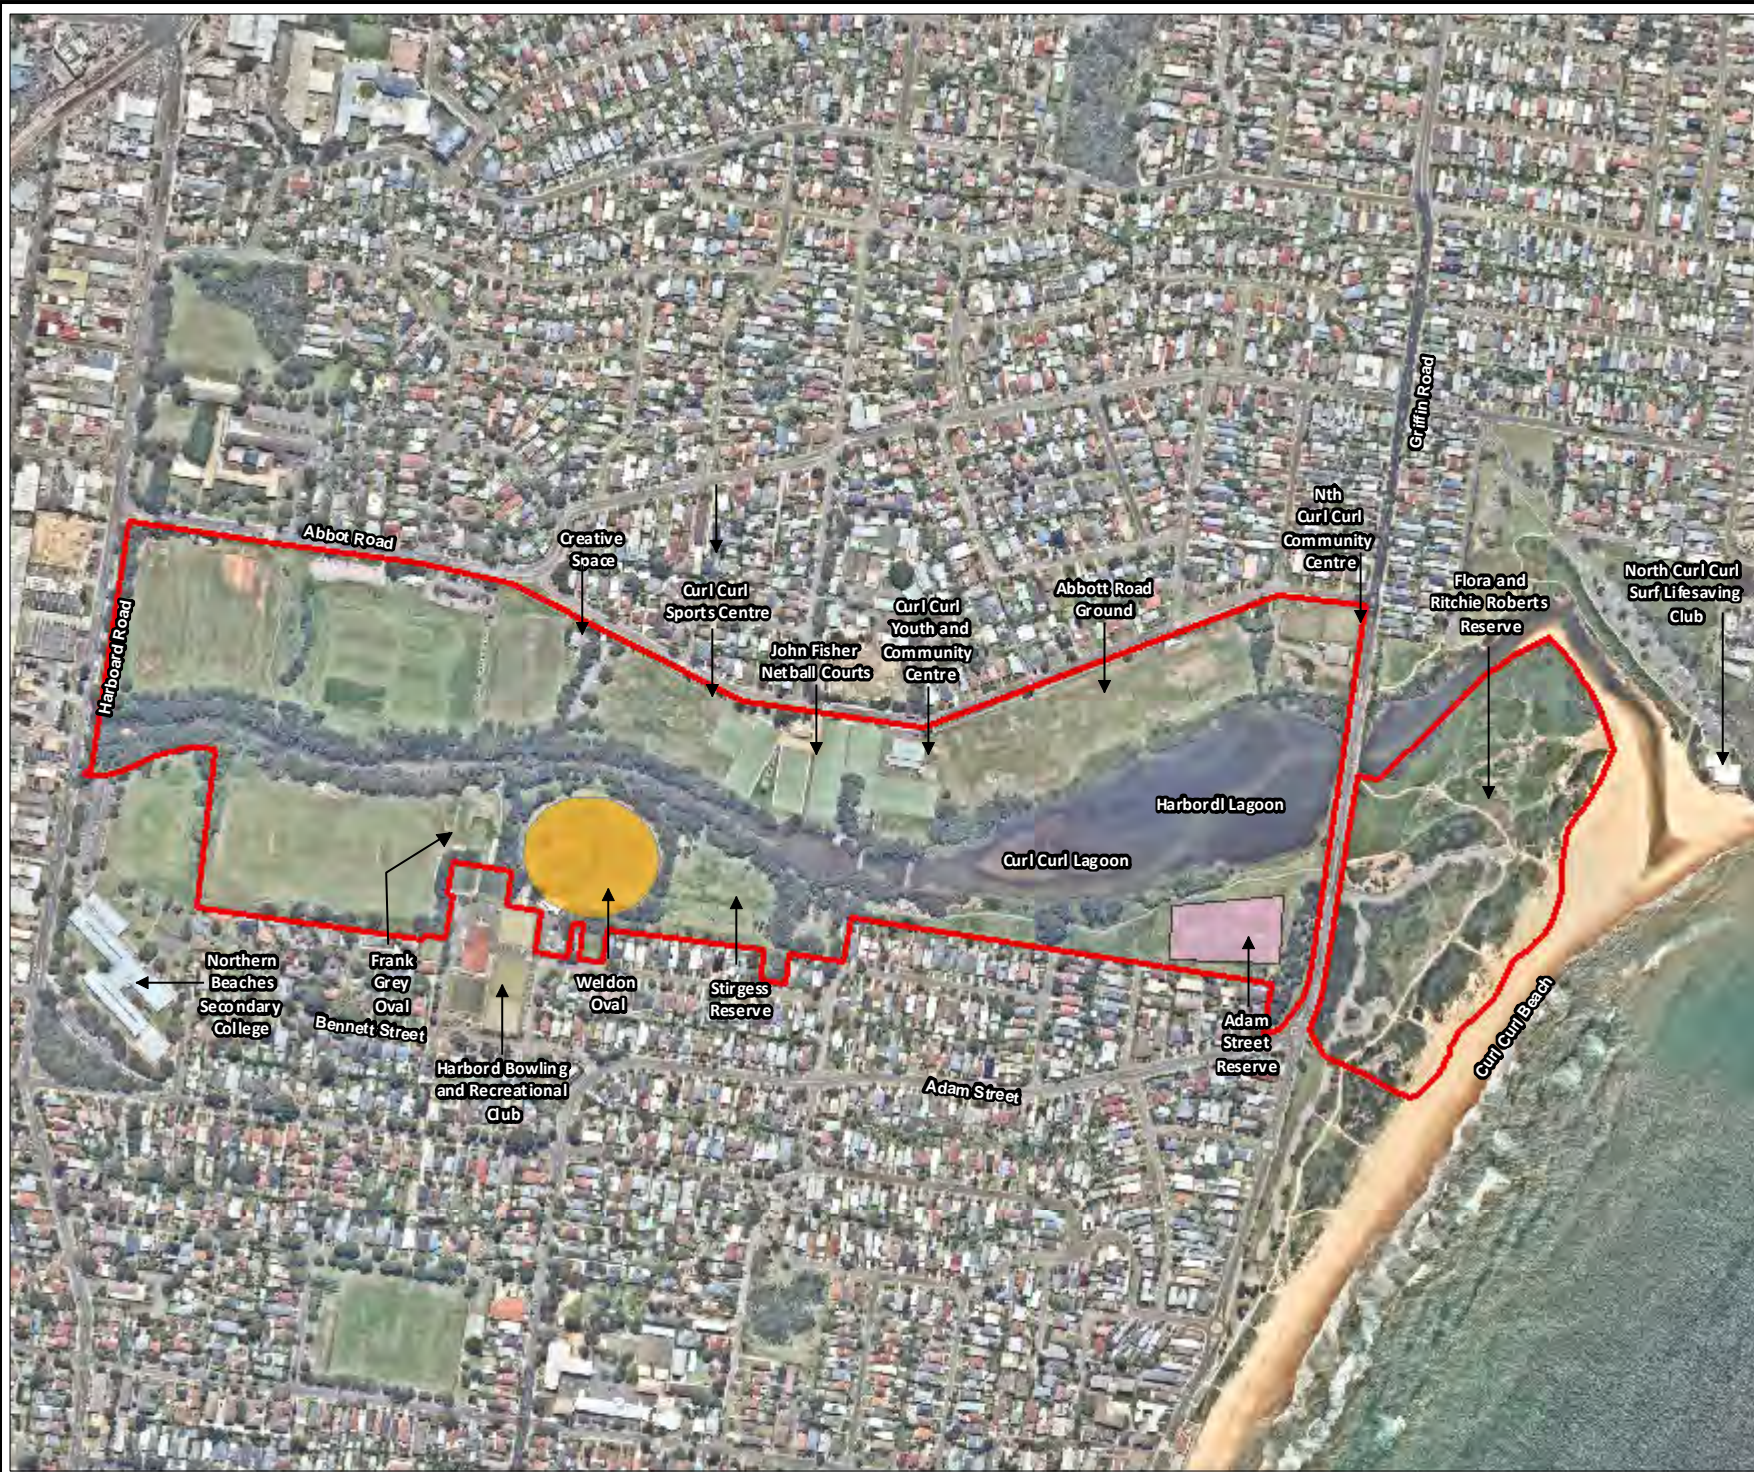
- Legend:**
- Approximate Site Boundary
  - Adam Street Reserve (Managed Under Existing EMP)
  - Weldon Oval (Managed Under Existing EMP)

JBS&G Australia Pty Ltd (JBS&G) has been engaged by Northern Beaches Council (Council, the client) to prepare an Environmental Management Plan (EMP) for John Fisher Park (the site), located across the boundary between the suburbs of Curl Curl and North Curl Curl, NSW. The site comprises an area of approximately 50 hectares (ha). The site location and boundary are shown on **Figure 1, Attachment B**. The current site layout is shown on **Figure 2, Attachment B**.

It is noted that assessment, remediation and validation works have been conducted at Weldon Oval and Adams St Reserve to make them suitable for recreational and sports use, as long as they are managed in accordance with the existing EMPs (WSP, 2012 and SKM, 2012). The works at Weldon Oval and Adams St Reserve have been signed off by EPA-accredited auditors. The controls in the EMPs prepared for these areas apply for these specific areas only (**Figure 2, Attachment B**).

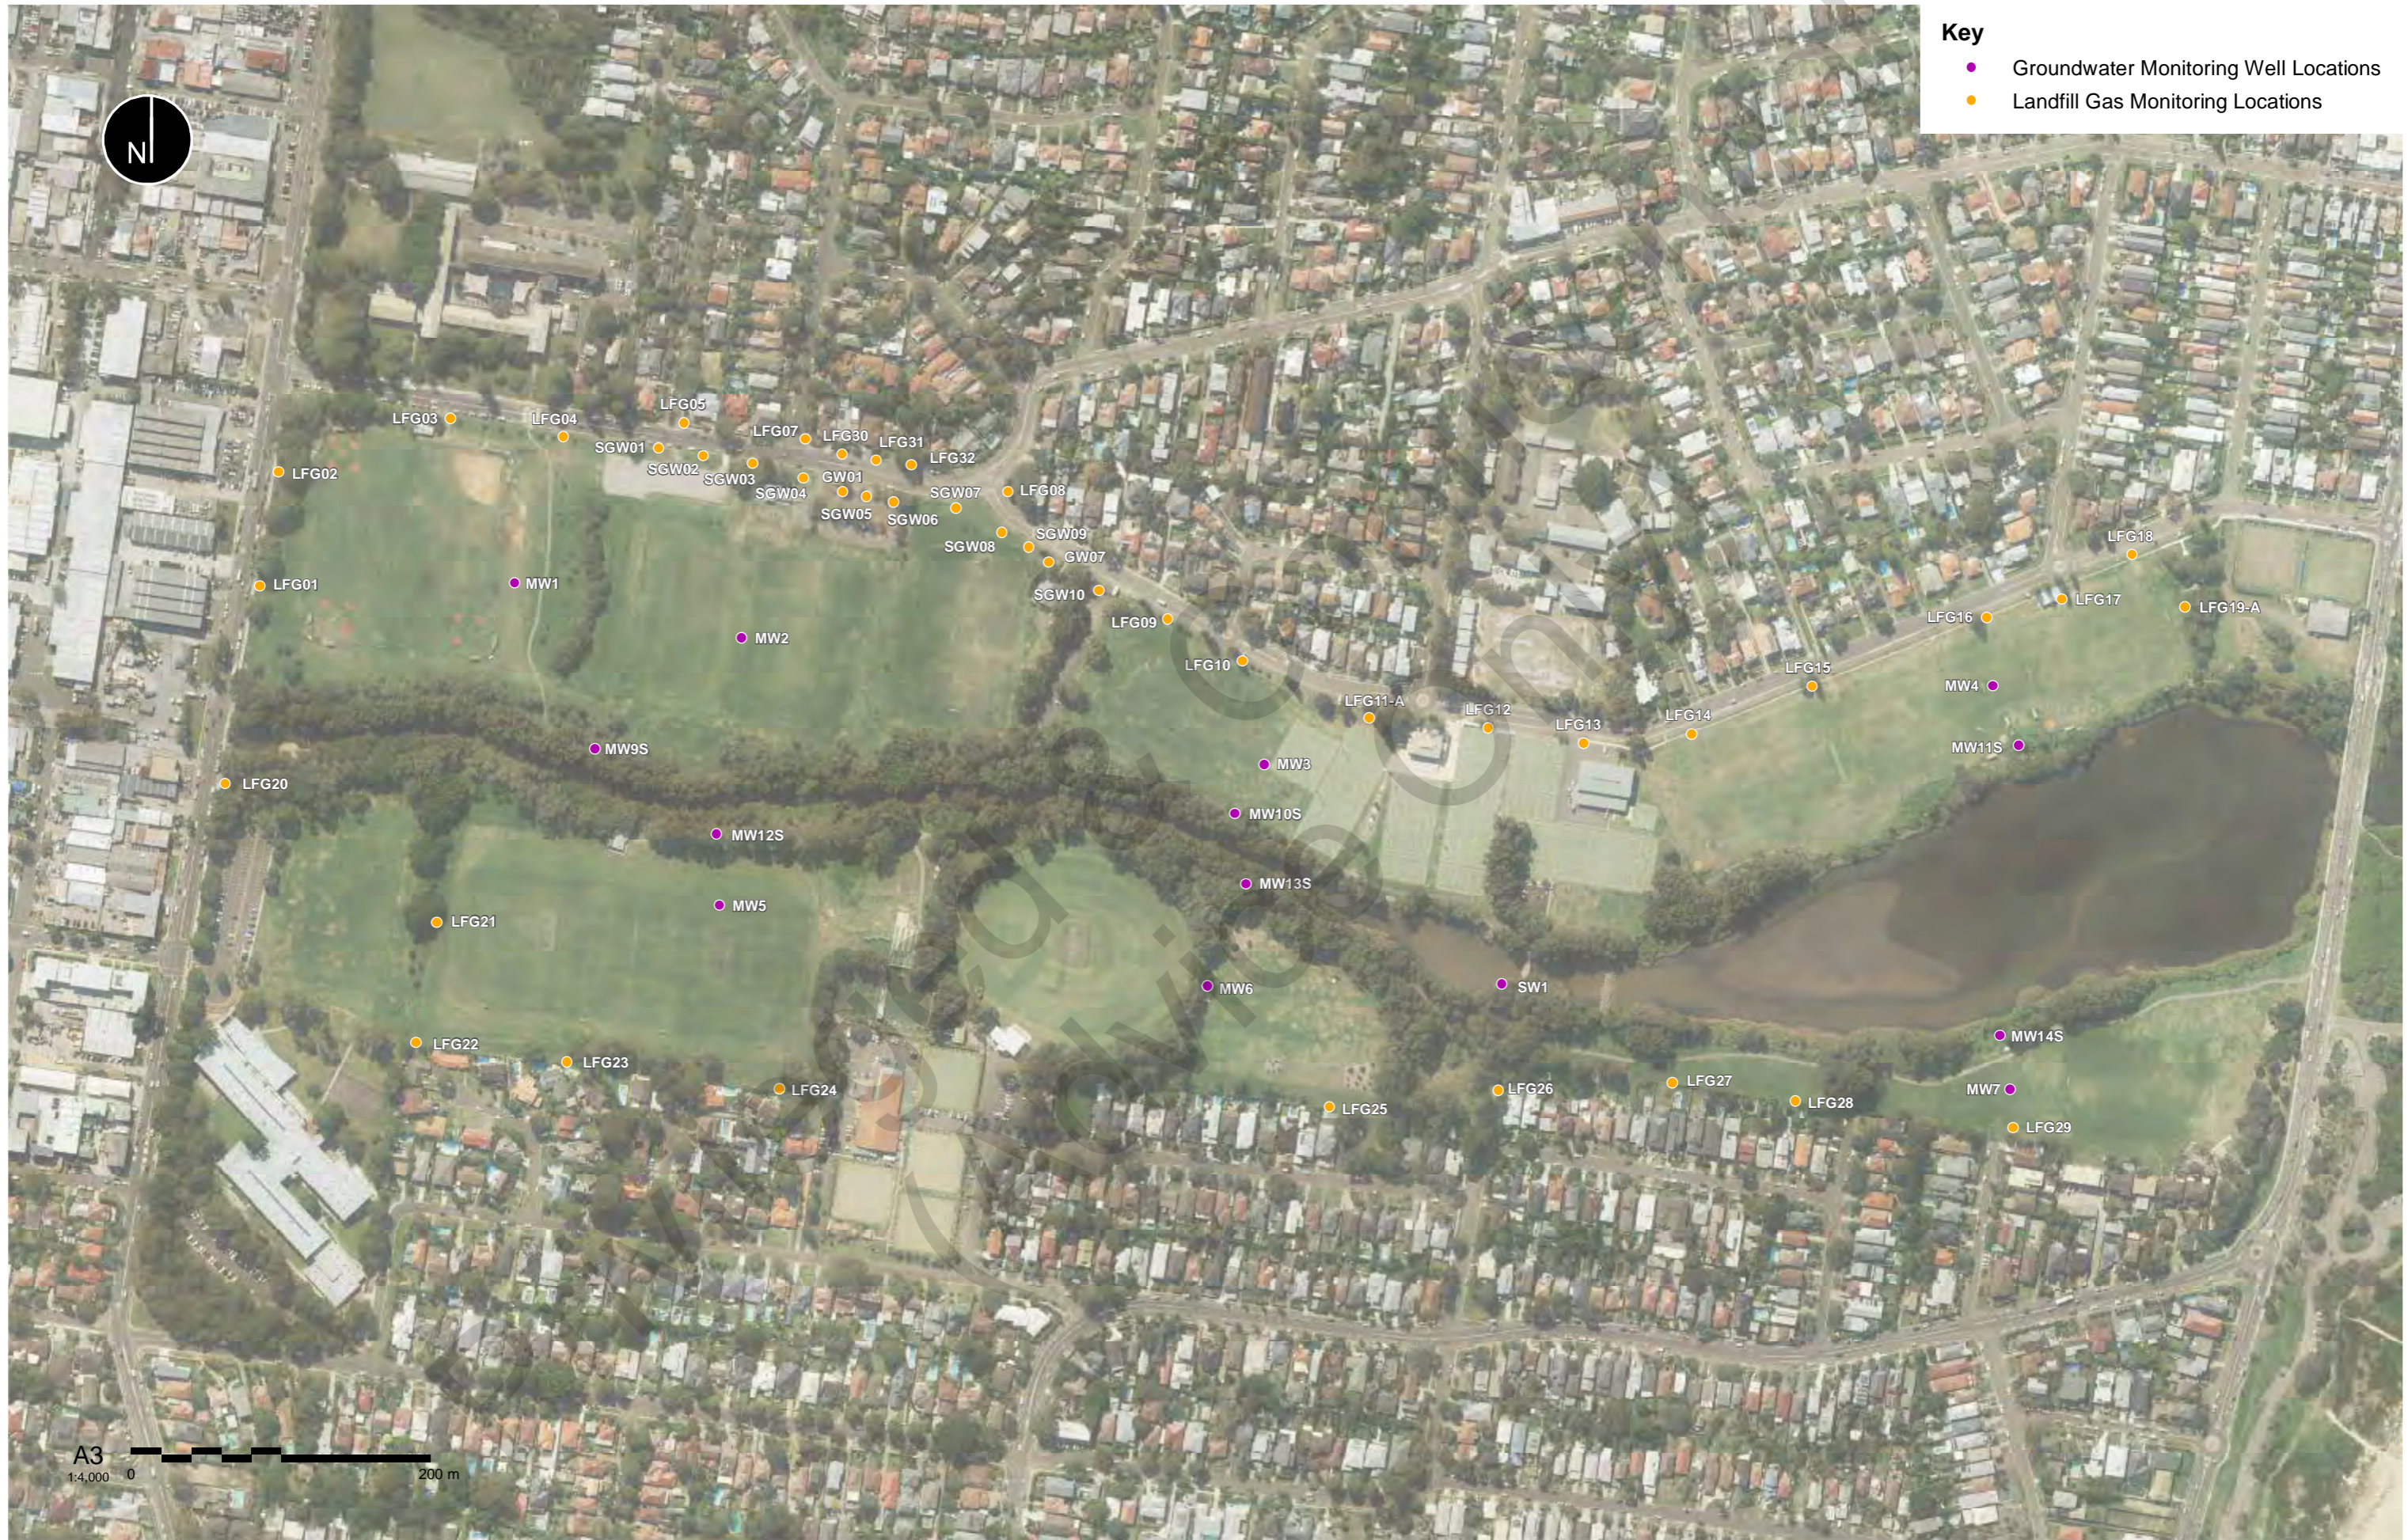
## Attachment F – Gas Monitoring Well Location Plans

- Key**
- Groundwater Monitoring Well Locations
  - Landfill Gas Monitoring Locations
