**PRELIMINARY GEOTECHNICAL INVESTIGATION
AND SLOPE RISK ASSESSMENT
RESIDENTIAL DEVELOPMENT
37-43 HAY STREET COLLAROY NSW**

COLLARROY LIVING PTY LTD

Reference: P2828_01 rev1

13 March 2024

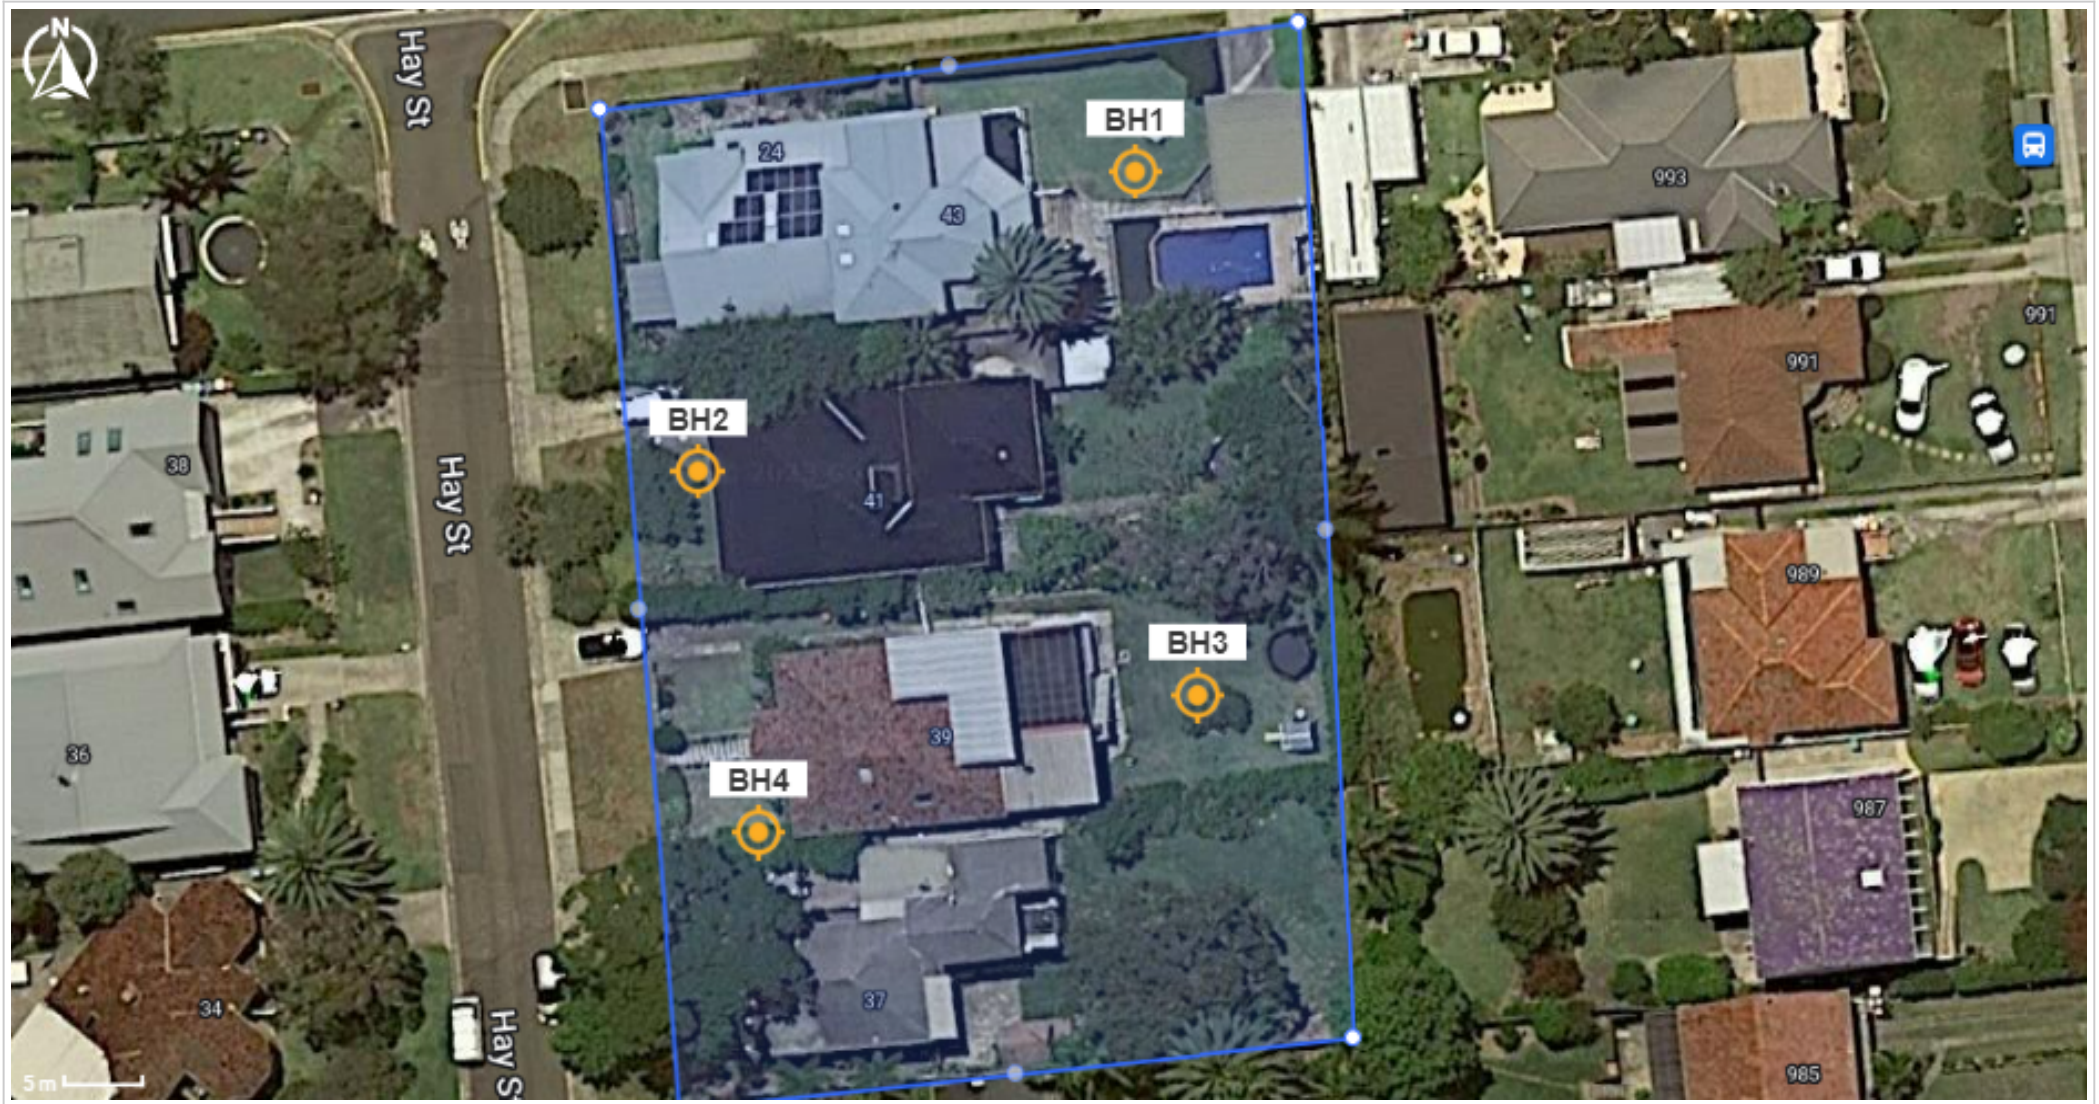
Map description	P2828 -Borehole Location Plan		
Site location	37-43 Hay Street, Collaroy NSW		
Client	Collaroy Living Pty Ltd		
Project name	Collaroy		
Project No	P2828	Scale	Not to scale

Investigation locations are shown on **Figure 1** and the borehole logs are presented in Appendix A.
