H2O Consulting Group Pty Ltd

Marine Habitat Survey: 37 Beaconsfield Street, Newport

January 27, 2018

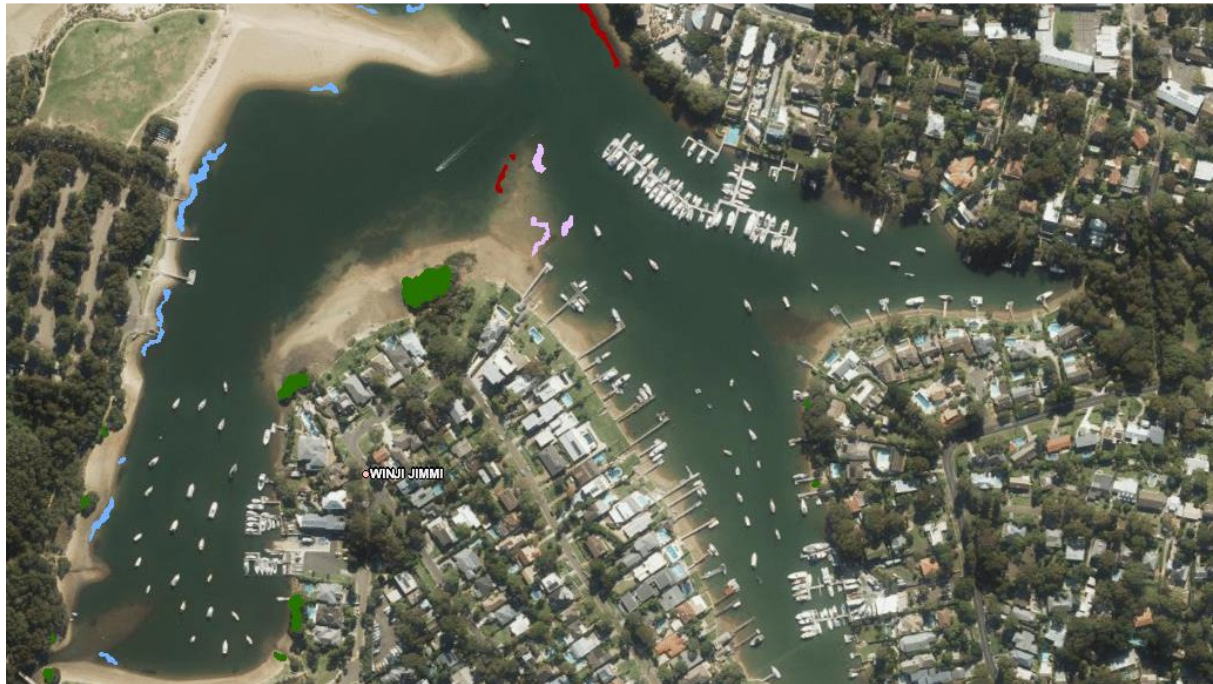
Figure 2: Previous mapping of estuarine macrophytes in the south-eastern corner of Pittwater, showing mangroves (green) and seagrasses, *Posidonia australis* (red / pink), and *Zostera capricorni* (blue / pink). Source NSW DPI 2017.

NSW DPI habitat maps indicate the common occurrence of seagrasses *Posidonia australis*, *Zostera capricorni* and *Halophila ovalis*, mangroves and saltmarsh communities in Pittwater. In six NSW estuaries including Pittwater (Creese *et al.* 2009), *P. australis* has been listed as an endangered population and added to Threatened Species Schedules under the FM Act (NSW DPI 2012), while more recently *P. australis* seagrass meadows of the Manning-Hawkesbury ecoregion ecological community have been listed as endangered under the EPBC Act. Additionally, Coastal Saltmarsh is listed as an endangered ecological community on the NSW North Coast, Sydney Basin and South East Corner Bioregions under the BC Act, which also corresponds with the listing of Subtropical and Temperate Coastal Saltmarsh as a vulnerable ecological community under the EPBC Act. In the upper south-east reaches of Pittwater isolated stands of mangroves and seagrasses (both *P. australis* and *Z. capricorni*) may occur, however none have been previously mapped in the vicinity of the subject site (Figure 2)

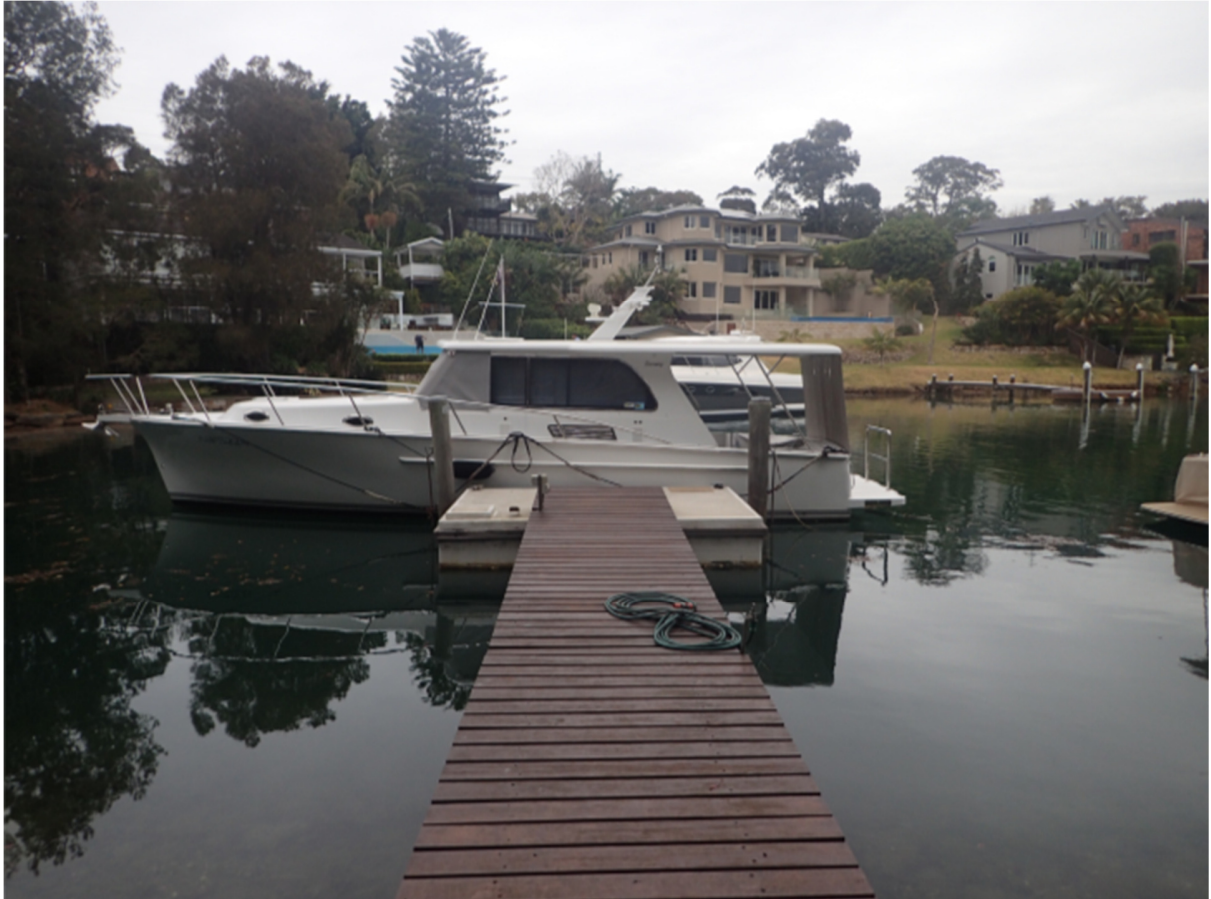
Figure 2: Area proposed for the berthing area.

The proposed works are for construction of a berthing area (9 x 5 m), requiring one additional pylon. The berthing area is proposed seaward of the existing waterfront jetty, ramp, and pontoon (Figure 3 and 4).

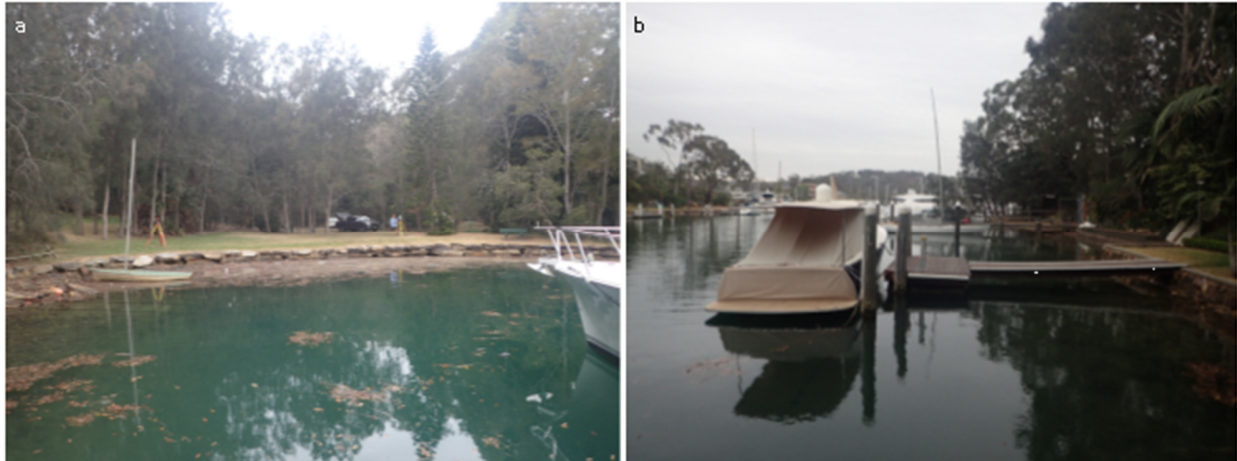
Figure 5: Neighboring waterfront structures to the (a) east, and (b) west of the subject site.

The adjoining shoreline is moderately sloping with a southerly aspect and residential properties. There is a low-lying stone seawall 0.8 m in height near the MHW, which minimises shoreline erosion at the site. The subject site includes an existing jetty, ramp and pontoon, while the property neighbors a bushland park to the east. The neighboring properties to west also include similar waterfront structures to the subject site (Figure 5).

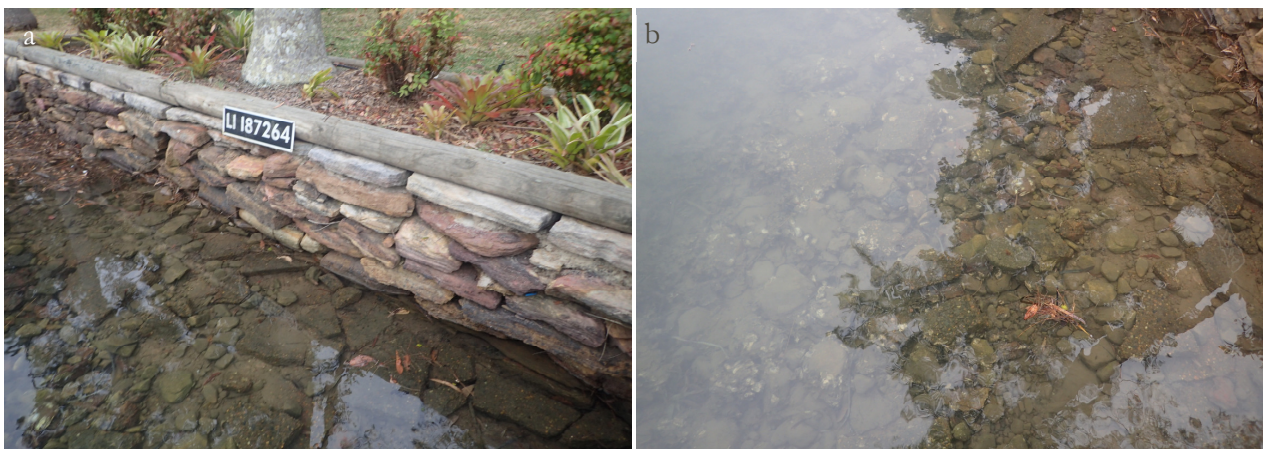
The intertidal habitat along the shoreline was predominantly rubble (Figure 6), with some patches of gravel and the occasional accumulation of silt in lower areas. Artificial substrates provided by the seawall, and footings and pylons associated with the existing structures also provided some additional habitat. The habitat provided by the gravel in lower areas and the existing structures was colonized by Sydney rock oysters (*Saccostrea glomerata*) and the common periwinkle (*Bembicium nannum*). Intertidal vegetation was restricted to turfing algae amongst rubble, no mangroves, saltmarsh plants, or intertidal seagrasses were found.

Figure 6: Intertidal habitat (a) provided by the seawall, and (b) rubble and gravel, in the study area.

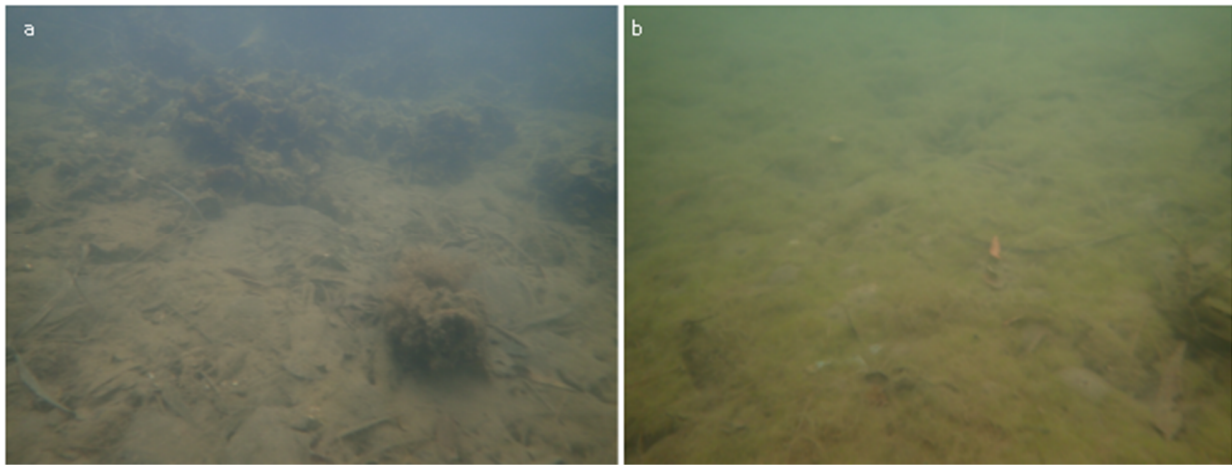
The seabed was moderately sloping either side of a silty drop-off approximately 5 m from the shore. Habitats above the drop-off consisted of silty sediments with scattered occurrences of rubble and brown macroalgae and a lot of debris. Below the drop-off the silty sediments continued but appeared much more uniform in nature. Subtidal vegetation was absent; however, areas of turfing brown and green algae were present in places, growing across the surface of the sediment (Figure 6).

Figure 6: Typical subtidal habitat (a) of rubble and debris above the drop-off, and (b) silty sediments with turfing algae below the drop-off.
