GEOTECHNICAL INVESTIGATION:

New Spa and Storeroom at **32 Nareen Parade, North Narrabeen**

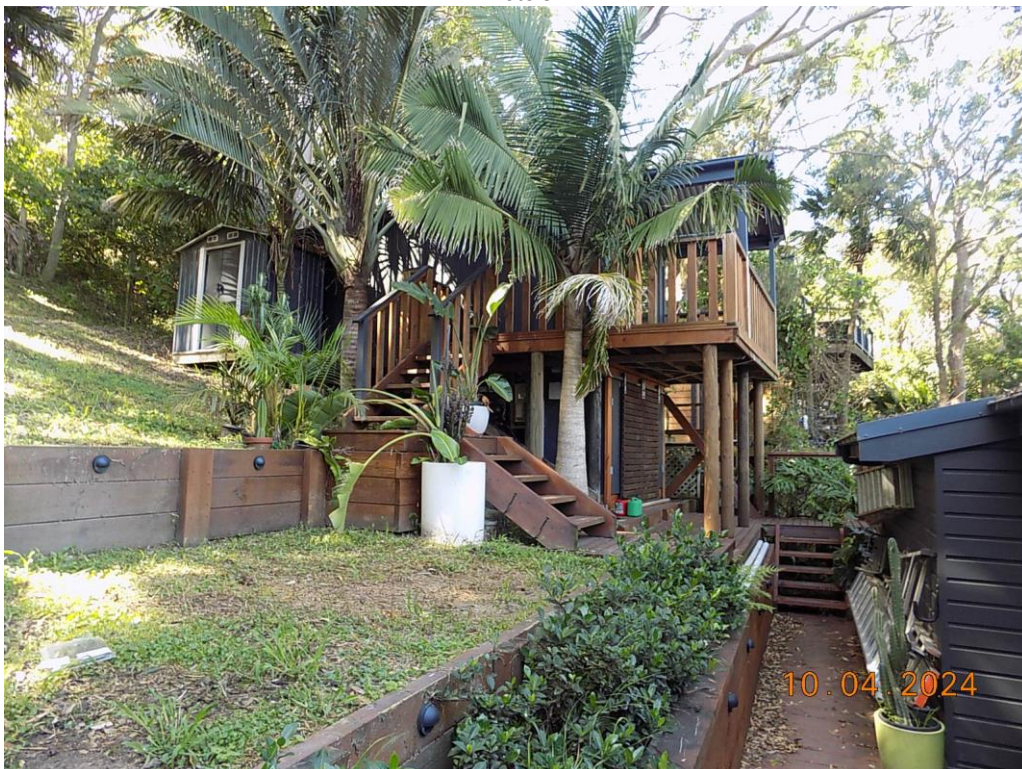
Photo 4

- 2.3** At the road frontage, a concrete ROW runs up the slope to a parking area and garage on the downhill side of the property (Photo 1). The slope below the ROW has partially collapsed and has undercut the ROW. The owner informed us it is currently undergoing remediation works by another geotechnical firm. The cut for the garage is supported by a ~2.5m high retaining wall (Photo 2). This wall is clad and its condition could not be assessed but no significant signs of tilting were visible. A series of stable timber log retaining walls reaching up to ~0.8m high terrace the slope between the garage and the house (Photo 3). A series of stable timber retaining walls between ~0.6m and ~1.0m step up past a suspended timber studio and terrace the steeply

sloping lawn area above the house (Photos 4 -6). The lawn and garden area extend to the upper boundary (Photo 7).

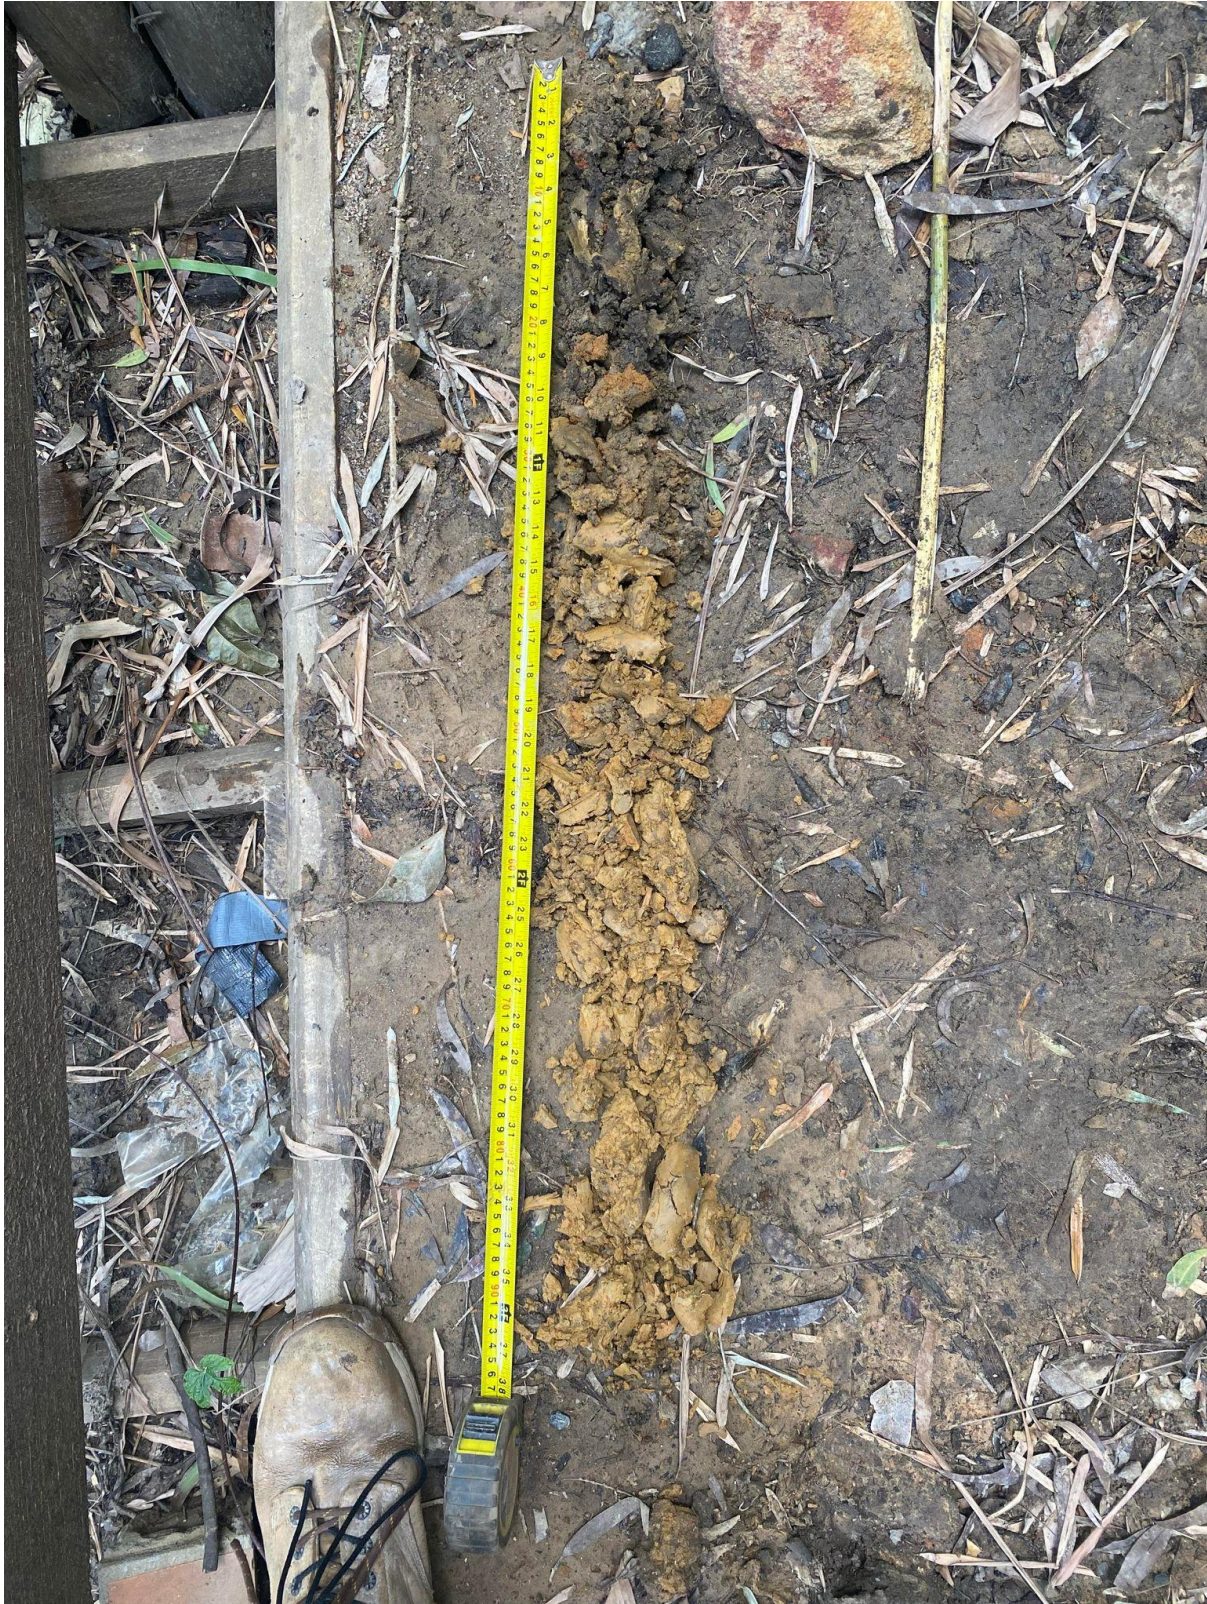
Photo 8 (Top to Bottom)

AUGER HOLE 1 (~RL29.0) – AH1 (Photo 8)

Depth (m)	Material Encountered
0.0 to 0.2	FILL , brown and yellow clay, fine grained, stiff, dry.
0.2 to 1.0	CLAY , orange, fine grained, stiff, dry.

Refusal on Rock @ 1.0m. Auger grinding. No water table encountered.

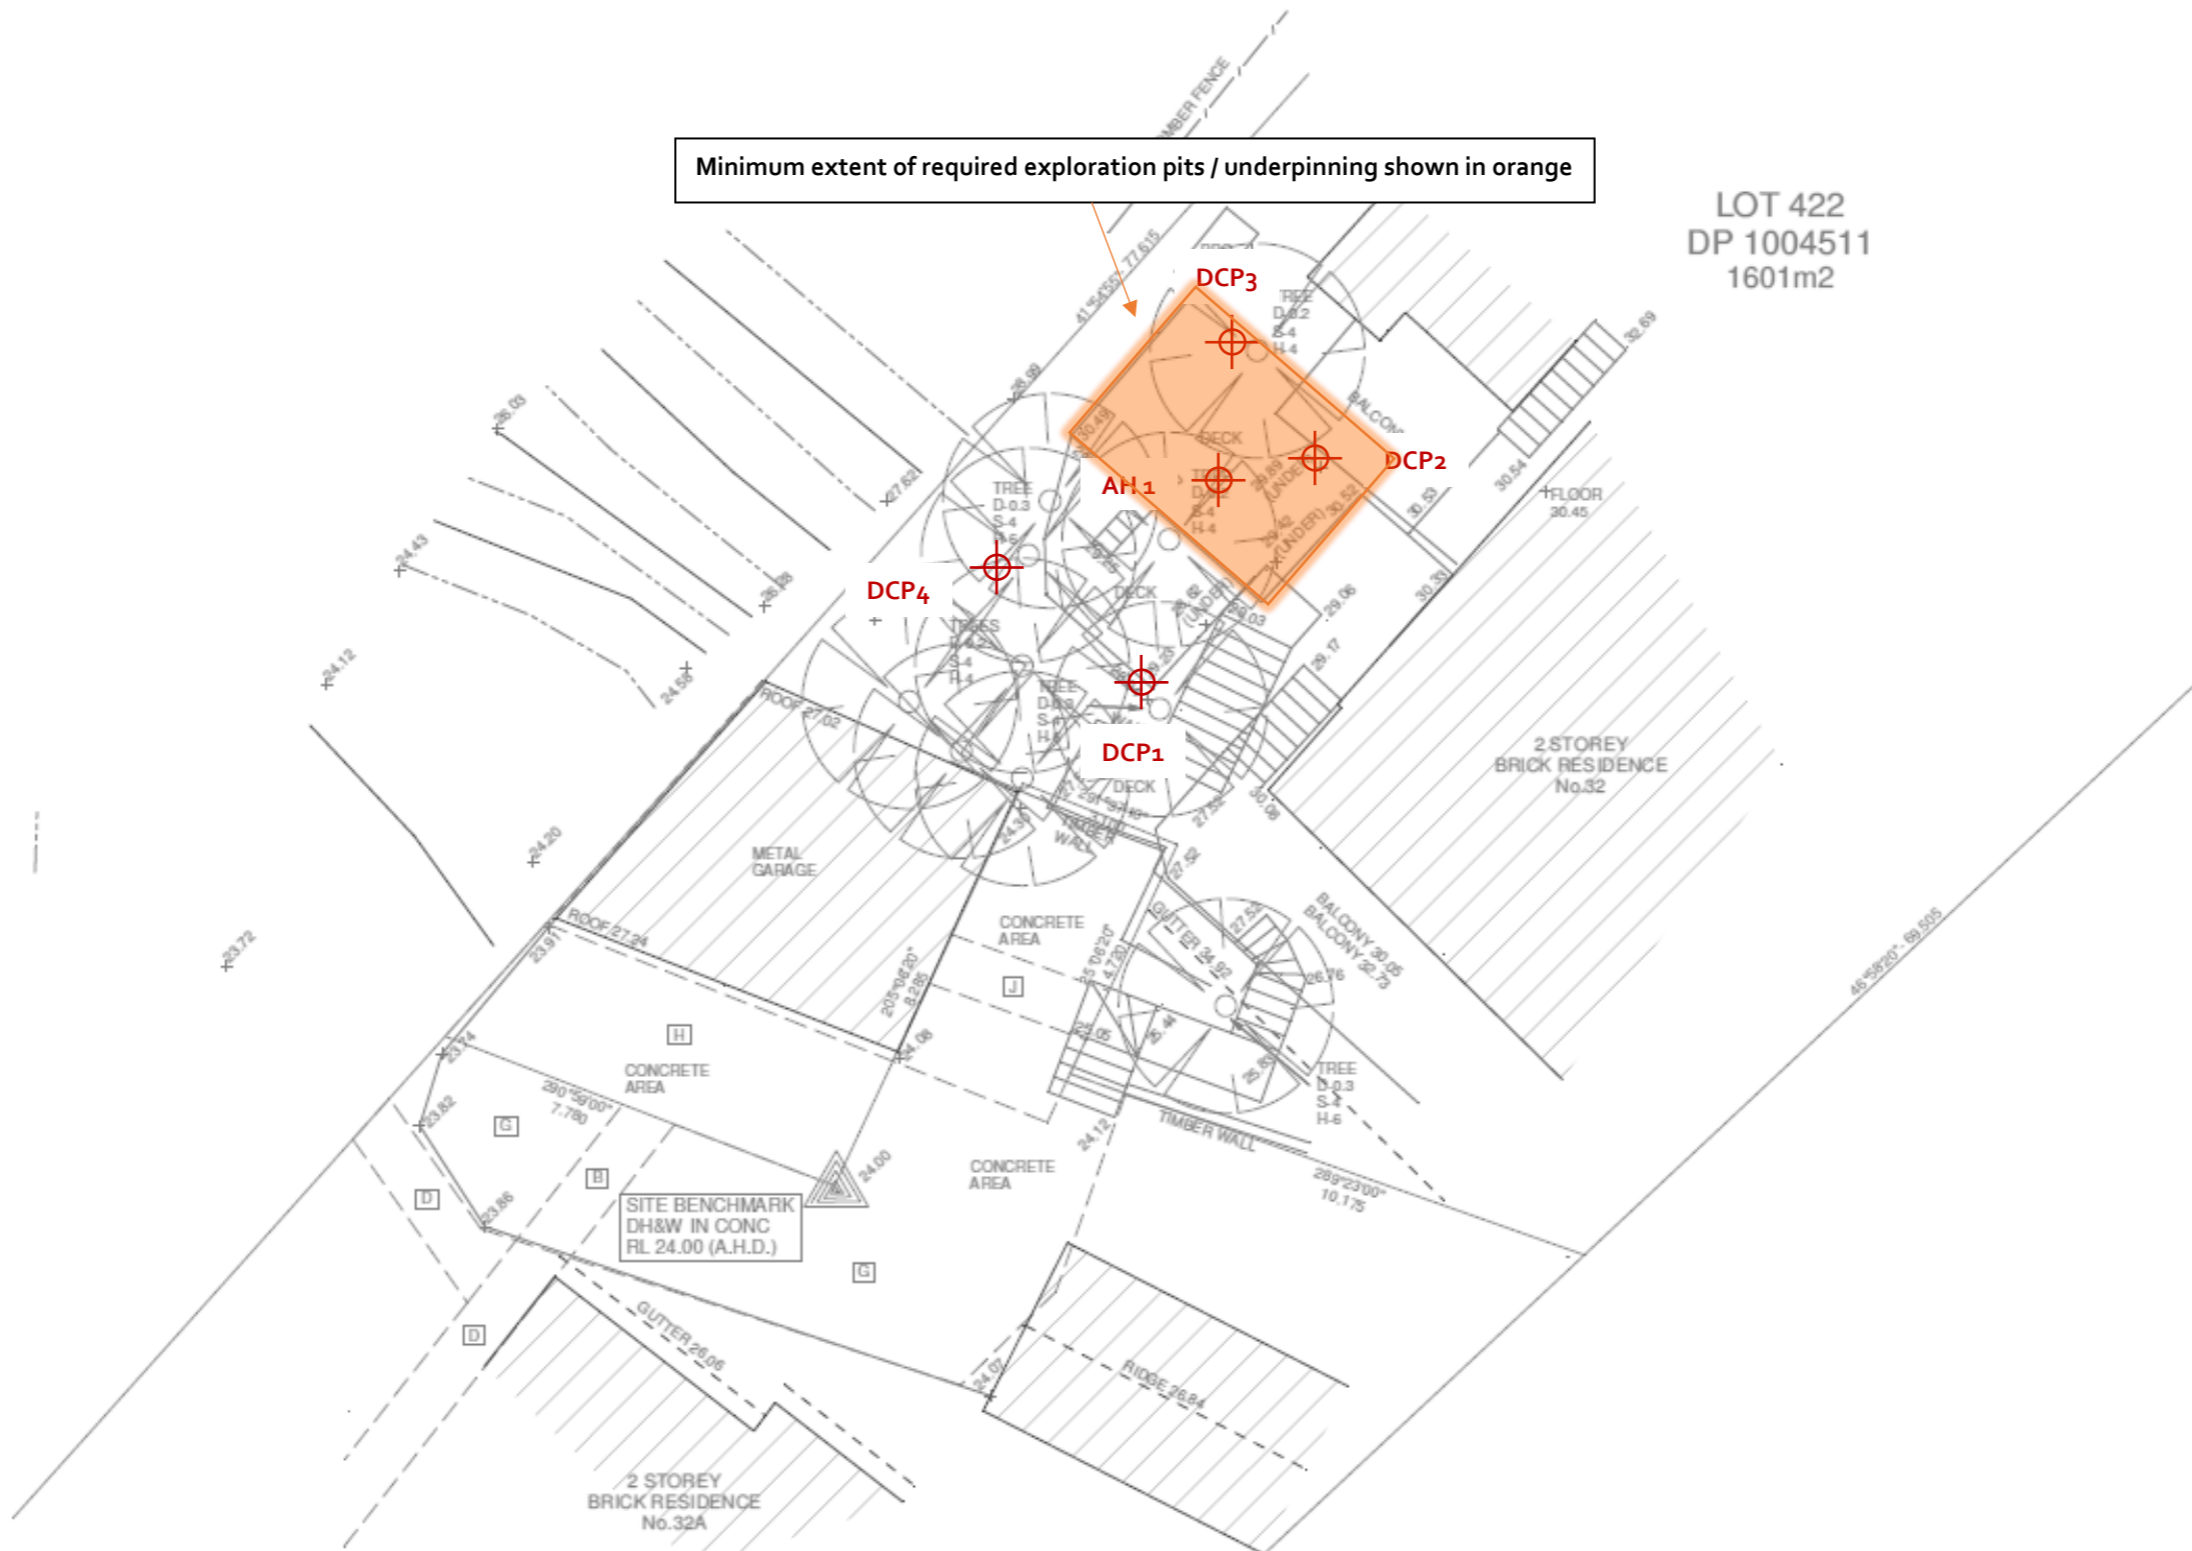
SITE SURVEY – showing test locations and required exploration pits / underpinning

One hand Auger Hole (AH) was put down to identify soil materials. Four Dynamic Cone Penetrometer (DCP) tests were put down to determine the relative density of the overlying soil and the depth to weathered rock. The locations of the tests are shown on the site plan attached. It should be noted that a level of caution should be applied when interpreting DCP test results. The test will not pass through hard buried objects so in some instances it can be difficult to determine whether refusal has occurred on an obstruction in the profile or on the natural rock surface. This is not expected to be an issue for the testing on this site. However, excavation and foundation budgets should always allow for the possibility that the interpreted ground conditions in this report vary from those encountered during excavations. See the appended "Important information about your report" for a more comprehensive explanation. The results are as follows:

Minimum extent of required exploration pits / underpinning shown in orange

Where the remaining posts of the subject house fall within the zone of influence of the excavation, exploration pits will need to be put down by the builder to determine the foundation depth and material. These are to be inspected by the geotechnical consultant.

The house will need to be propped with the props supported beyond the zone of influence of the proposed store room excavation. Alternatively, the supporting posts can be underpinned to rock or to below the zone of influence of the cut prior to the excavation commencing. See the site plan attached for the minimum extent of the required underpinning.

Where room permits, the fill and soil portion of the excavation is expected to stand temporarily at batter angles of 30° (1.0 Vertical to 1.7 Horizontal). Where there is not room for these batters, such as along the NW side of the excavation, the excavation through fill and soil will need to be temporarily or permanently supported prior to the commencement of the excavation, or during the excavation process in a staged manner, so cut batters are not left unsupported. The support will need to be designed / approved by the structural engineer. See the site plan attached for the minimum extent of the required shoring.
