Report Title: Geotechnical Report 58 Whale Beach Road, Avalon  
Report Date: 8/7/22

## **GEOTECHNICAL INVESTIGATION:**

Alterations and Additions and New Pool and Granny Flat at **58 Whale Beach Road, Avalon**

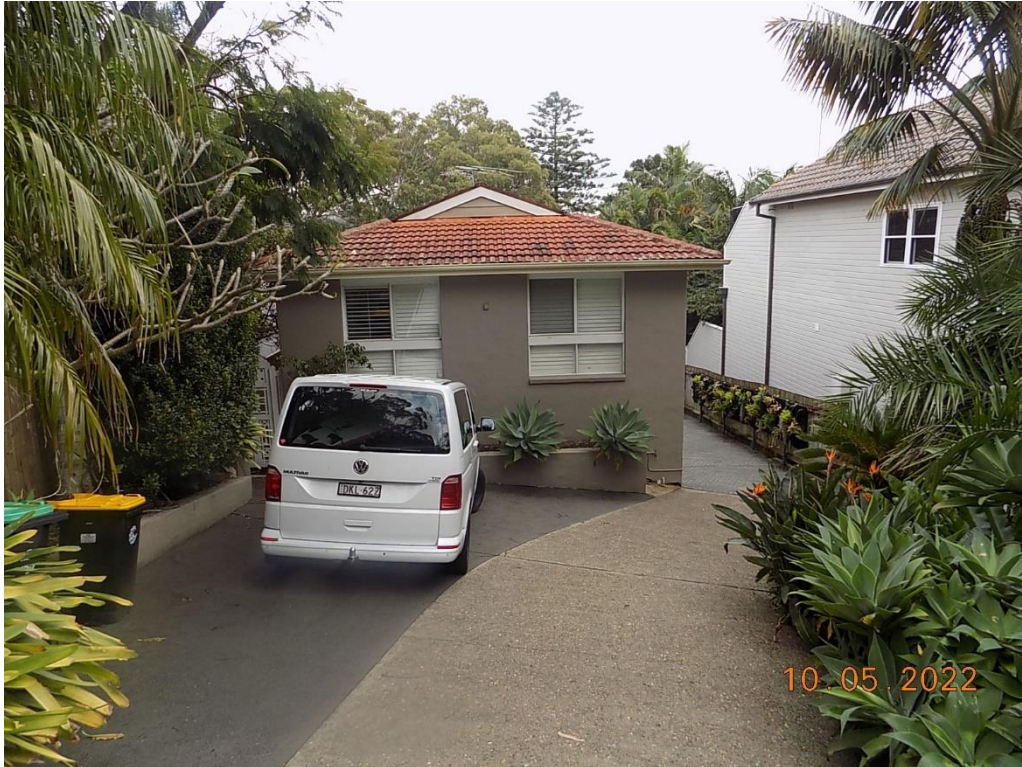
Photo 1

- 2.1** The site was inspected on the 10<sup>th</sup> May, 2022.
- 2.2** This residential property is on the low side of the road and has a W aspect. It is located on the gently to moderately graded upper reaches of a hillslope. The natural slope falls across the property at an average angle of ~7°. The slope above the property increases in grade to the crest of the slope, and the slope below the property continues at similar angles.
- 2.3** At the road frontage, a concrete driveway runs to a parking area on the uphill side of the property, and past the house to a carport on the downhill side of the property (Photo 1 & 2). The carport is to be demolished as part of the proposed works.

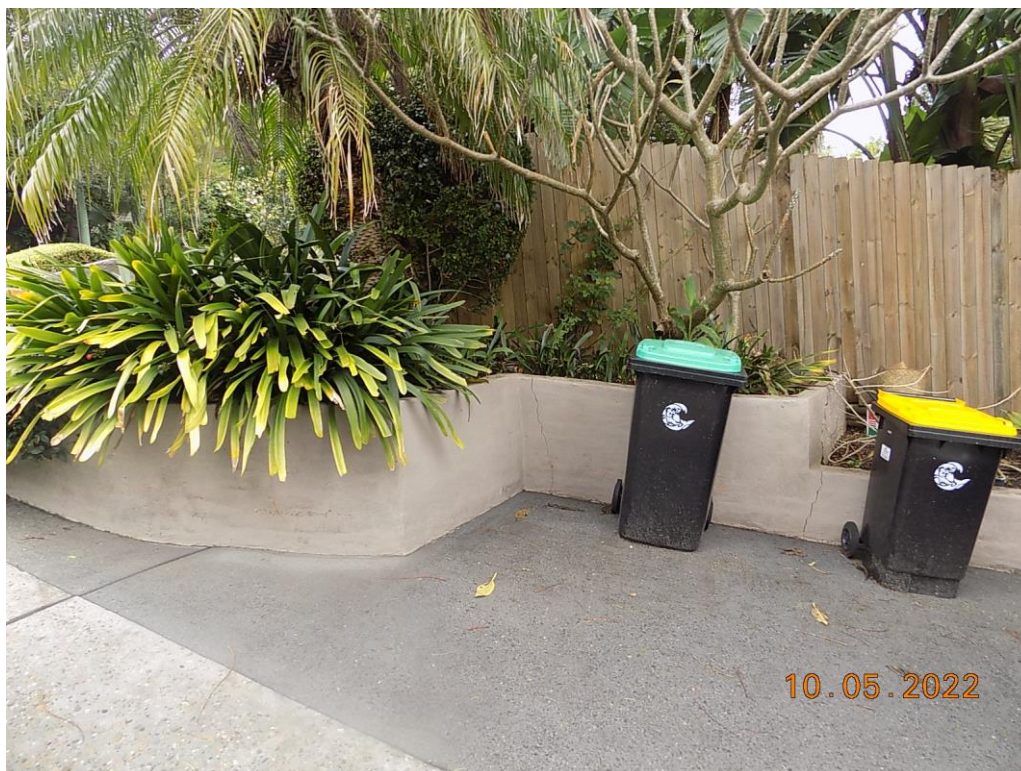
Photo 3

A ~0.8m high rendered masonry retaining wall supports a fill for a garden bed in between the road frontage and the house (Photo 3). There is some small stepped cracking through the render present, but otherwise the wall is in good condition. The two-storey rendered brick house is supported on external brick walls. The external brick walls show no significant signs of movement. A stable rendered masonry retaining wall reaching up to ~1.0m in height supports a cut for a gently sloping patio area on the downhill side of the house (Photo 4). A gently sloping lawn area extends from the downhill side of the patio to a metal shed at the lower common boundary (Photo 5).
