GEOTECHNICAL INVESTIGATION

23-25 BASSETT STREET, MONA VALE

**REPORT GG11415.001
12 MARCH 2024**

Geotechnical Investigation for proposed alterations and additions to an aged care facility at 23-25 Bassett Street, Mona Vale

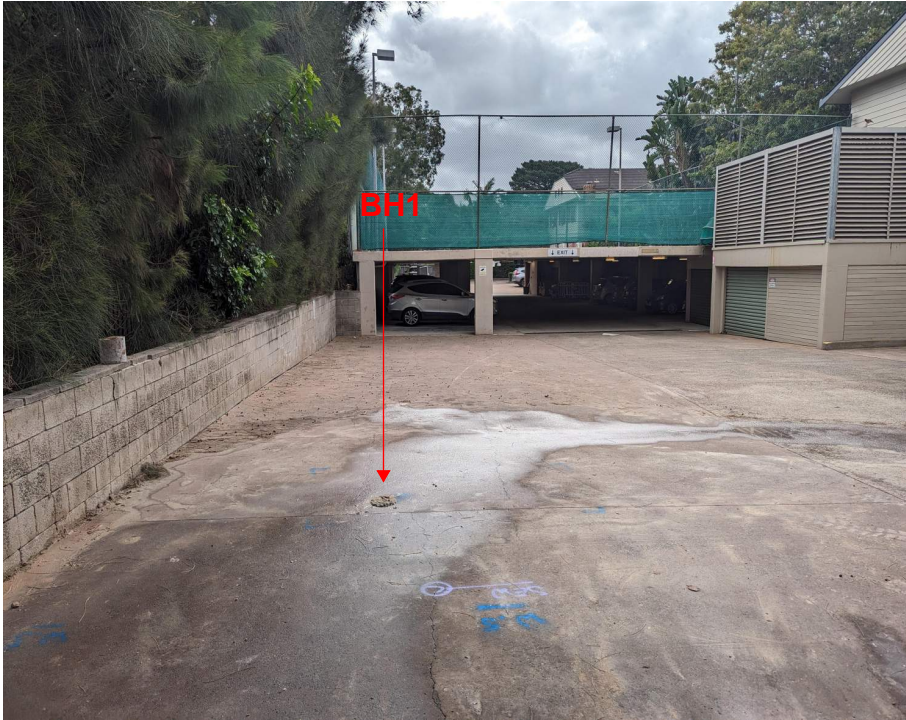
Position of BH1

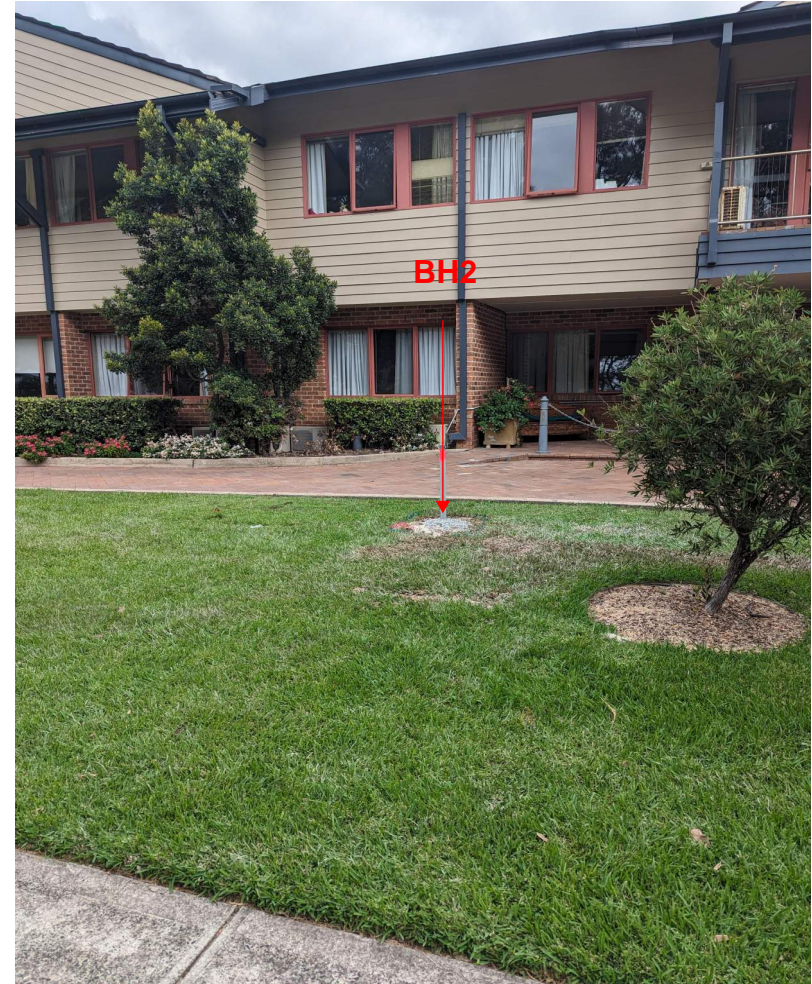
Position of BH2

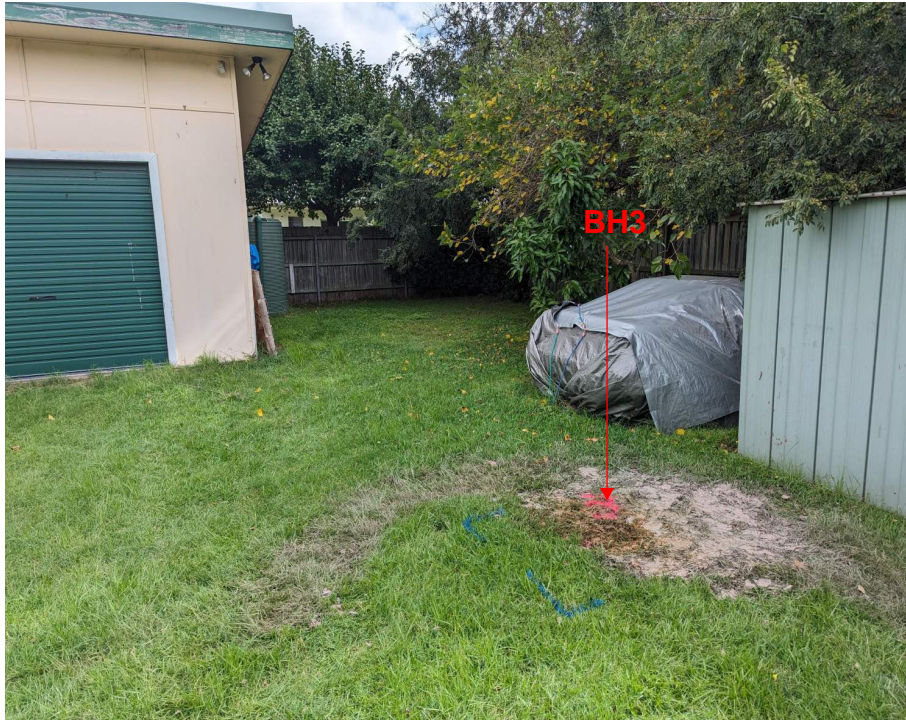
Position of BH3

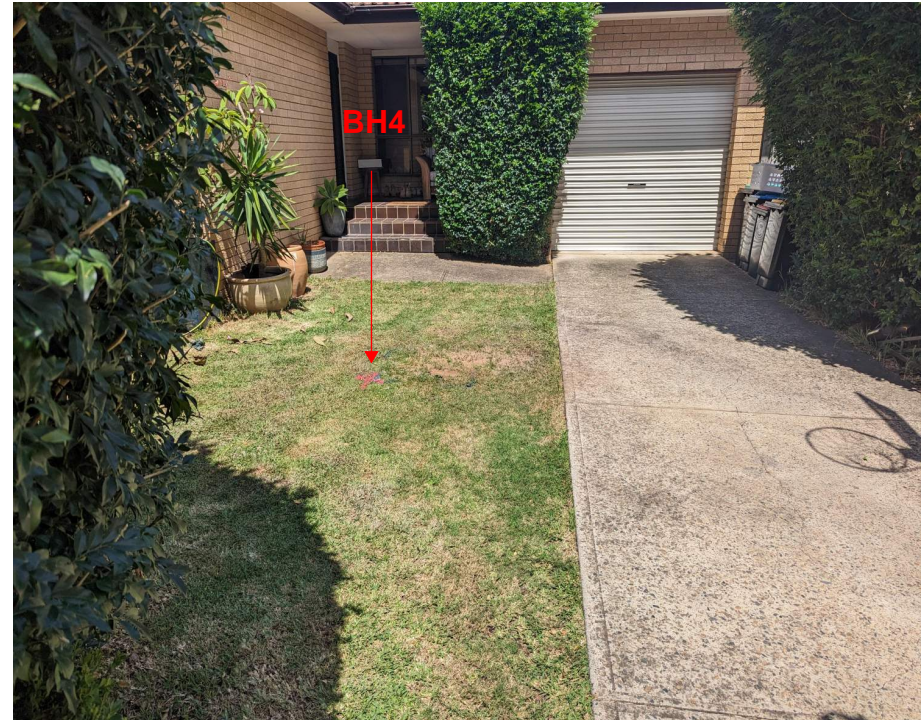
Position of BH4

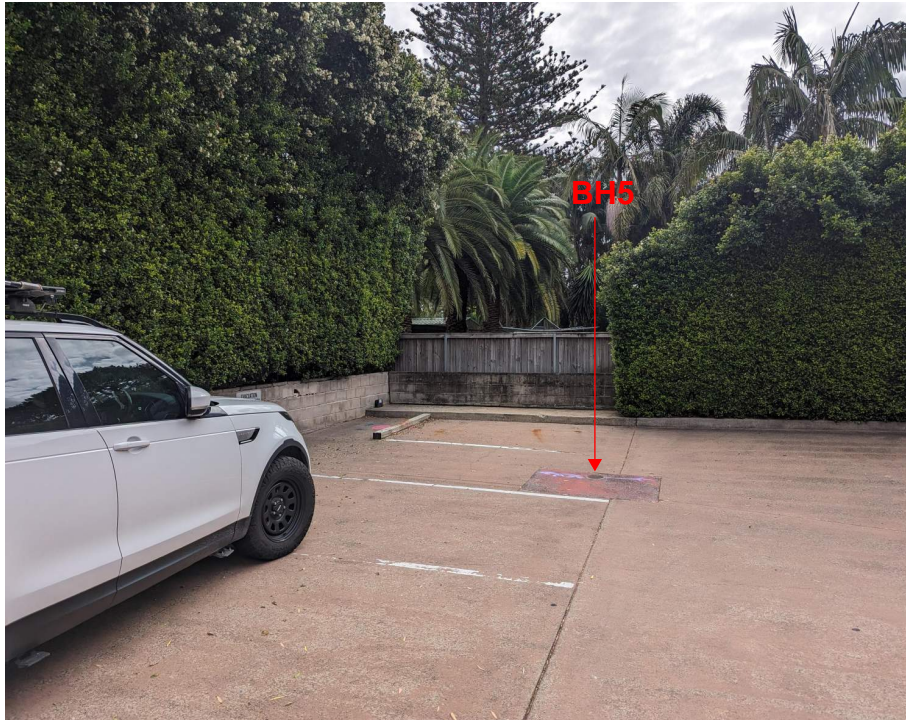
Position of BH5

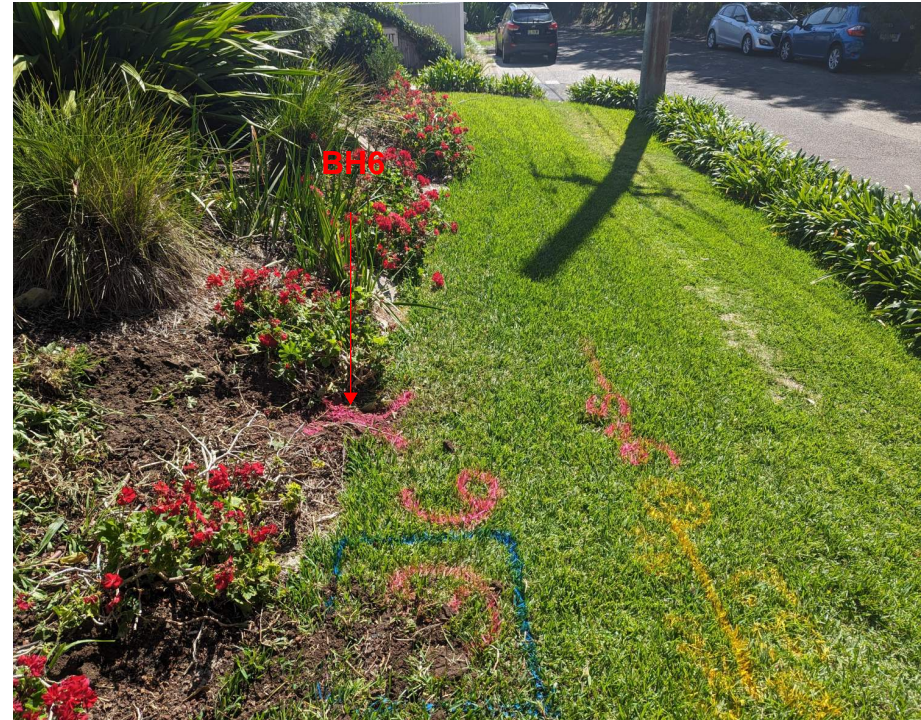
Position of BH6
