## Alterations & Additions to North Narrabeen SLSC Building

Statement of Environmental Effects

Prepared For:	Northern Beaches Council	
Project Name:	Alterations and Additions to North Narrabeen Surf Life Saving Club	
Rhelm Reference:	J1877	
<b>Document Location:</b>	RR-01-1877-01 Nth Narrabeen SLSC	
<b>Client Reference:</b>	N/A

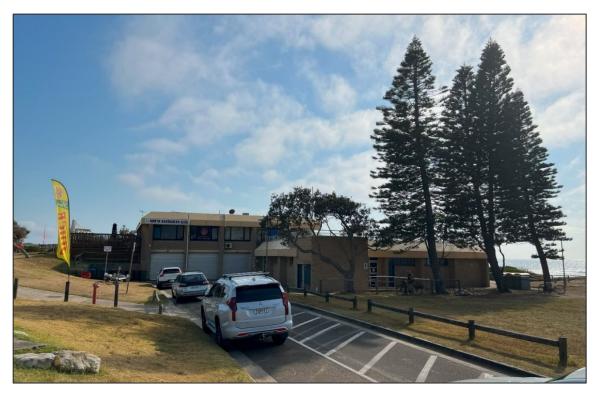
Figure 3-3 The existing building, as seen from the reserve to the south (source: NBP)

Surrounding development is varied, with shop top housing development, restaurants/cafes, and low and medium density residential development in the immediate vicinity of the site. Images of the site, the existing surf club building and surrounding development are provided in **Figure 3-3 to Figure 3-8**.

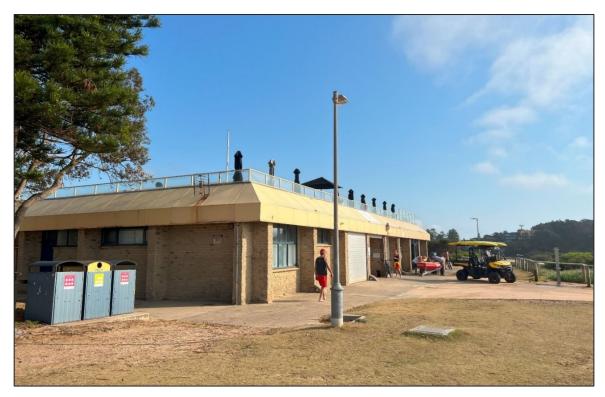
Figure 3-4 The existing building, as seen from the reserve to the south-east (source: NBP)

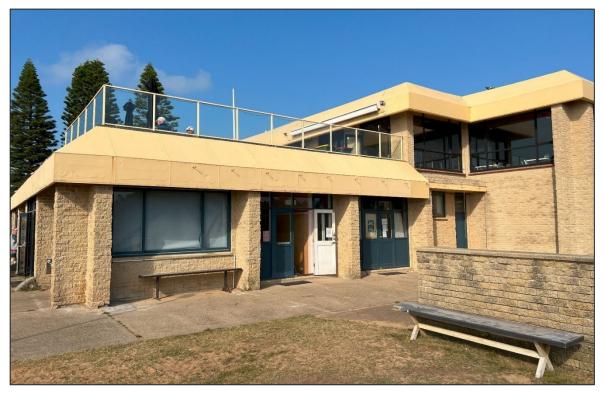
Figure 3-5 The existing building, as seen from the reserve to the north-east (source: NBP)

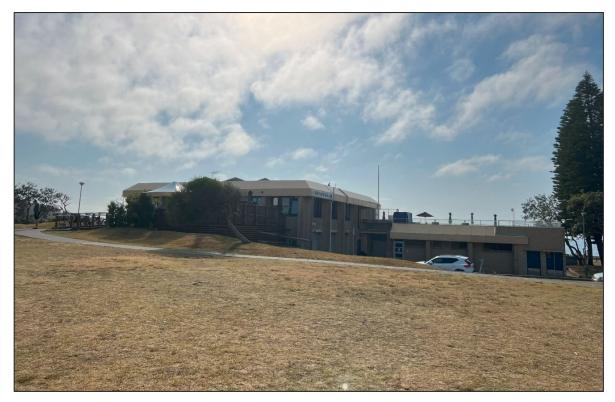
Figure 3-6 The existing building, as seen from the reserve to the west (source: NBP)

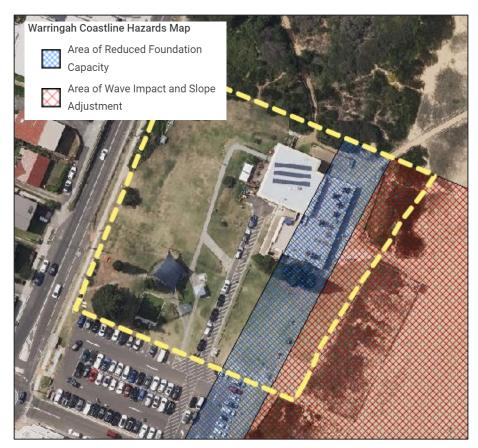
Figure 3-16 WLEP 2011 Coastline Hazards Map (Planning Horizon to 2074) (source: ePlanning Portal Spatial Viewer, accessed 18/12/2023)

The site is subject to coastal hazards, intersecting both the Zone of Reduced Foundation Capacity (ZRFC) and the Zone of Slope Adjustment (ZSA) (refer **Figure 3-16**). These lines are consistent with those presented in the Coastal Zone Management Plan (CZMP) for Collaroy-Narrabeen Beach and Fishermans Beach (NBC, 2016) and correspond to a planning horizon of 2074.

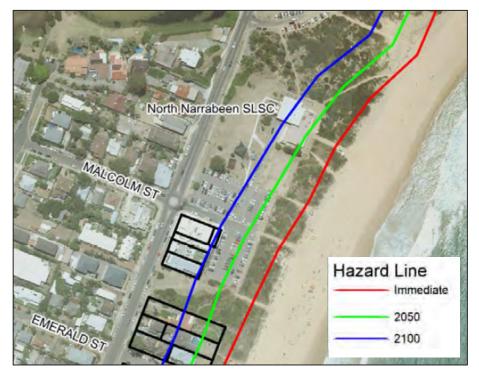
Figure 3-17 Coastal erosion hazard lines (located at the landward edge of the ZSA; after: Warringah Council & Royal Haskoning, 2014)

The earlier hazard mapping provided in the earlier CZMP for Collaroy-Narrabeen Beach and Fishermans Beach (Warringah Council and Royal Haskoning, 2014) adopted a similar erosion hazard assessment methodology as the 2016 CZMP, but derived the ZSA for the immediate (present day), 2050 and 2100 planning horizons. The ZSA and ZRFC lines from the 2014 CZMP are presented in **Figure 3-17** and **Figure 3-18** respectively. Based on that assessment, it is expected that between 2040 and 2050, the SLSC may be in the area where erosion hazard could impact on the capacity of the building foundations (i.e. part of the building is likely to be located within the ZRFC), but the SLSC is not expected to be in the active erosion zone.

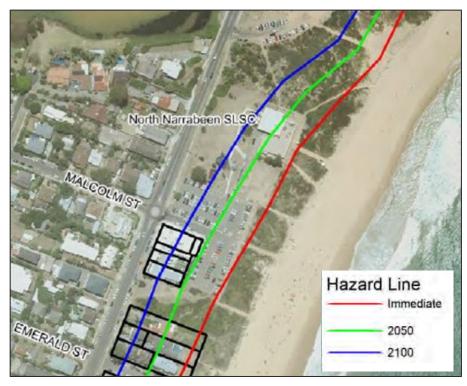
Figure 3-18 Coastal erosion hazard lines (located at the landward edge of the ZRFC; after: Warringah Council & Royal Haskoning, 2014)

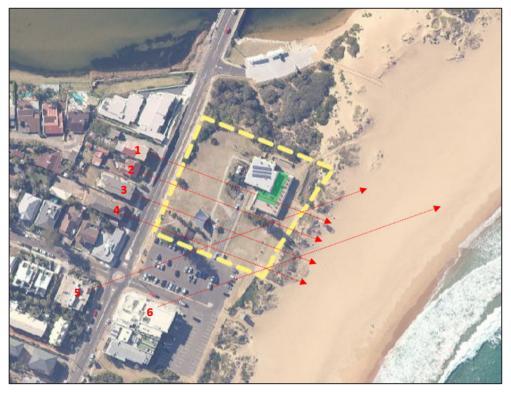
Figure 5-4 Aerial image of the site with outline of first floor roof shown in green and potential view corridors shown in red

Dwellings on the opposite side of Ocean Street appear to enjoy ocean views over and across the subject site. In consideration of the works proposed, any potential impact to these views is limited to the portion of these views currently obtained over the existing first floor balcony. The potentially affected view corridors are indicated in **Figure 5-4**.

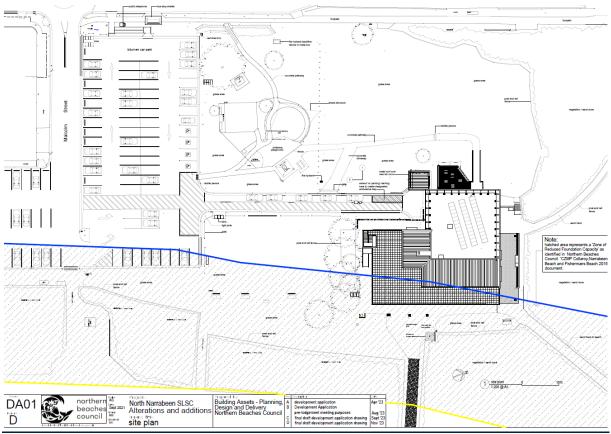
Figure 2: Site Plan for North Narrabeen SLSC Alterations and Additions (DA01-D)

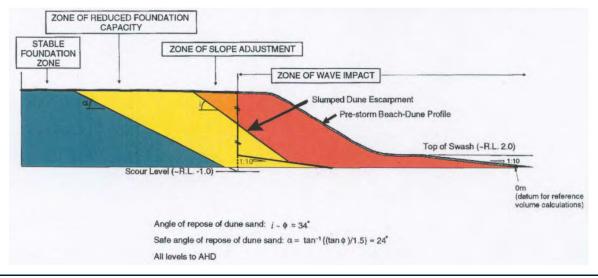
Figure 4: Erosion hazard zones including the Zone of Reduced Foundation Capacity (ZRFC) as defined by Nielsen *et al* (1992).

planning period, the Zone of Reduced Foundation Capacity (ZRFC) may impact on the SLSC. The ZRFC was included in the 2016 CZMP based on the beach erosion and slope adjustment model of Neilson *et al* (1992) which is schematically presented in Figure 4. The coastal engineering assessment summarised in the following section has focused on the potential impact of the ZRFC on the SLSC, particularly in the context of remaining asset life to 2050.

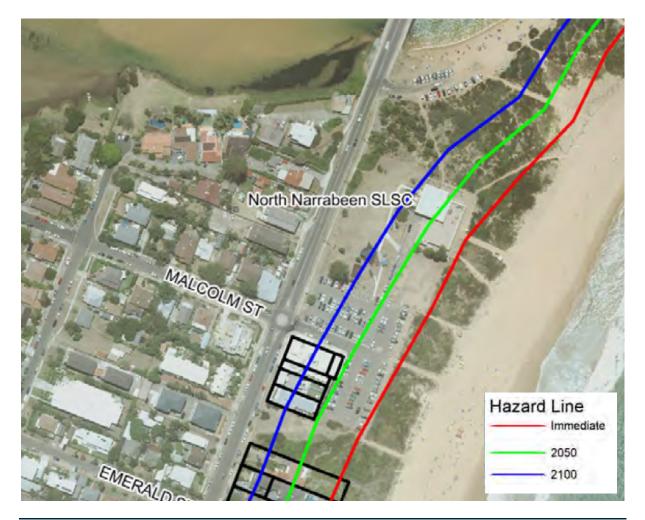
Figure 5: Immediate, 2050 and 2100 Coastline Hazard Lines (located at landward edge of ZRFC) at northern end of Narrabeen Beach (Figure I17, Warringah Council & Royal Haskoning, (2014).

Whilst the 2016 CZMP defined that the SLSC was potentially impacted by coastal erosion in the 2074 planning period, the 2014 CZMP which adopted a similar erosion hazard assessment as the current 2016 CZMP defined that at present day, and for the planning horizon to 2050, the SLSC was landward of the Zone of Reduced Foundation Capacity (ZRFC) as referred to in Figure 4. Figure 5 presents the immediate (2014), 2050 and 2100 coastal hazard lines from the 2014 CZMP. Based on that assessment, the SLSC is landward of the ZRFC at present (2023) and it is expected that between 2040 and 2050, the SLSC may be in the area where erosion hazard could impact on the capacity of the building foundations, but the SLSC is not expected to be in the active erosion zone.

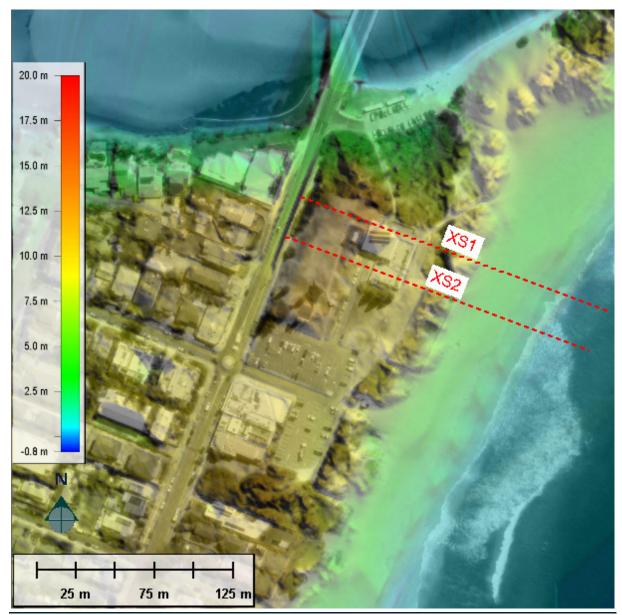
Figure 6: Cross sections analysed for Zone of Reduced Foundation Capacity (ZRFC).

An assessment of the lower level of the ZRFC has been completed using LiDAR and site survey data, and the hazard lines presented in the CZMP as indicated in Figure 2. Figure 6 presents two cross-sections that have been analysed to determine the minimum vertical level where soil bearing capacity can be assumed. This is generally referred to as the minimum vertical level where piled foundations can assume soil strength based on Neilson et al (1992). Figure 7 presents the calculated maximum vertical level where soil capacity can be assumed based on the 2074 hazard lines I the CZMP. If erosion resilient foundations were required for the SLSC for the 2074 planning period, the foundations would need to be founded in soil layers below the levels indicated on Figure 7. However, based on the 2014 and 2016 CZMP's, it is estimated that by 2050, there is approximately a 1% per annum probability that the SLSC may be impacted by the ZRFC during or following a severe erosion event.

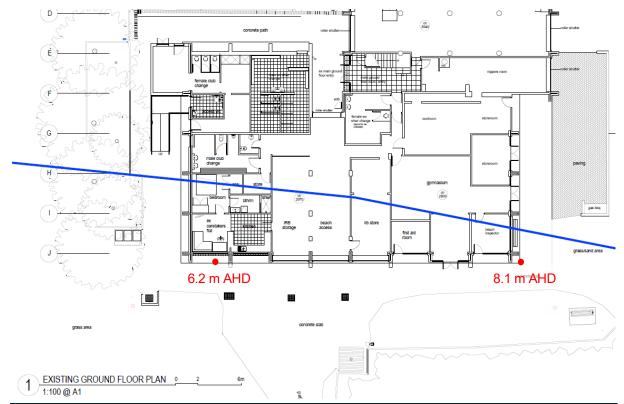
Figure 7: SLSC Existing ground floor: maximum vertical elevation for piled foundations to assume soil capacity based on ZRFC (see Figure 4).

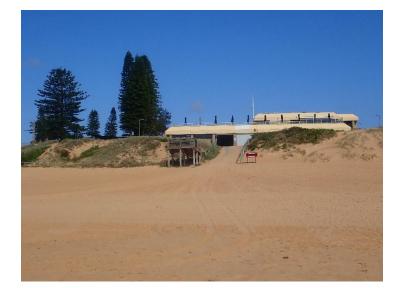
Figure 13. North Narrabeen SLSC building from the beach (looking west)

In general, the landform appears to have been modified and levelled for the construction of the SLSC building and addition. Visual inspection confirmed that there has been some impact to the sand dune as a result of historical development and natural erosion. No Aboriginal objects were identified during the site inspection.

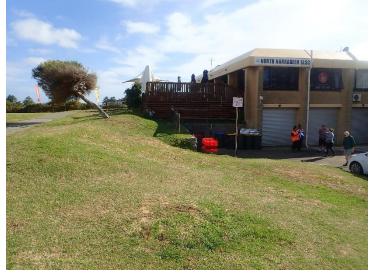
Figure 14. Western side of SLSC building showing cut into the adjoining land (looking north)

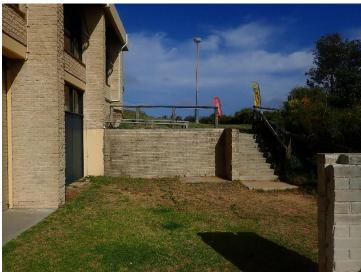
Figure 15. Retaining wall on northern side of SLSC building (looking west)

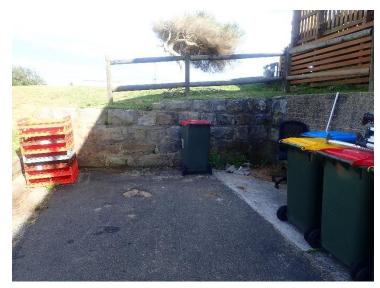
Figure 16. Retaining wall on southern side of SLSC building (looking west)

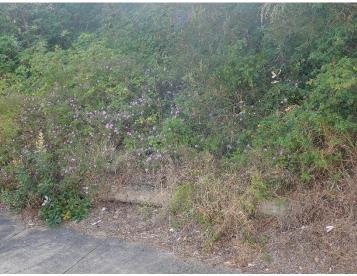
Figure 17. Old foundations with overlying material, along the eastern side of Ocean Street, looking east

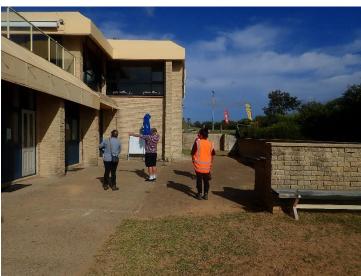
Figure 18. Area proposed for extension, on the north side of the building, looking west

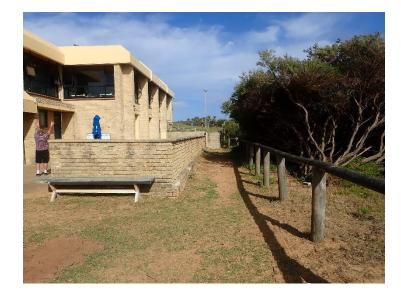
Figure 19. Sand in exposures (looking west), to the north of the SLSC building

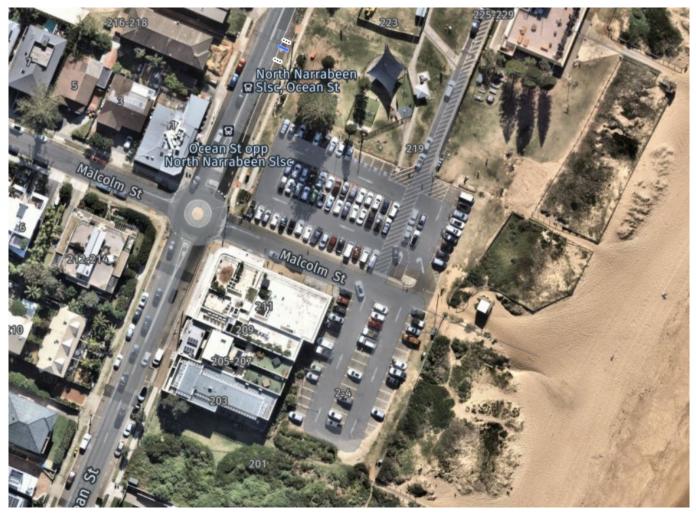
Figure 2.2: Car Park Aerial (Source: Nearmap, July 2023)

Currently, there are 123 (approximately 8 unlined parallel) regular spaces and 4 accessible parking spaces with paid parking treatment. This is shown in Figure 2.2.

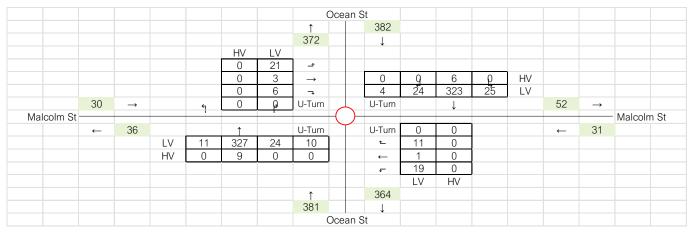
Figure 2.4: 2023 Surveyed Traffic Volumes (PM)

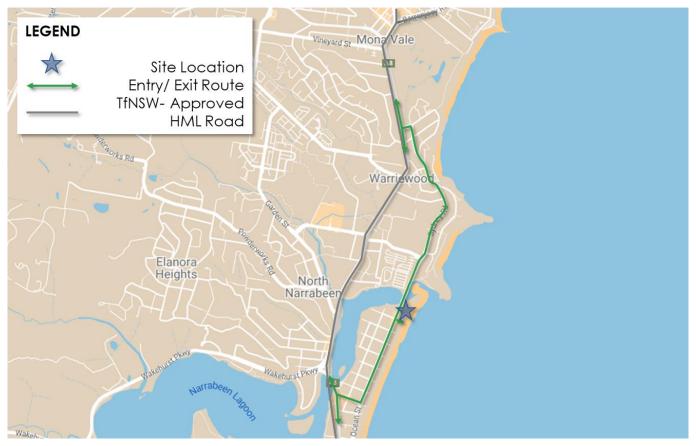
Figure 3.2: Proposed HRV Access Route

A Vehicle Movement Plan (VMP) reflecting the proposed haulage routes for a 12.5m HRV is shown below and can be found in **Appendix B**.

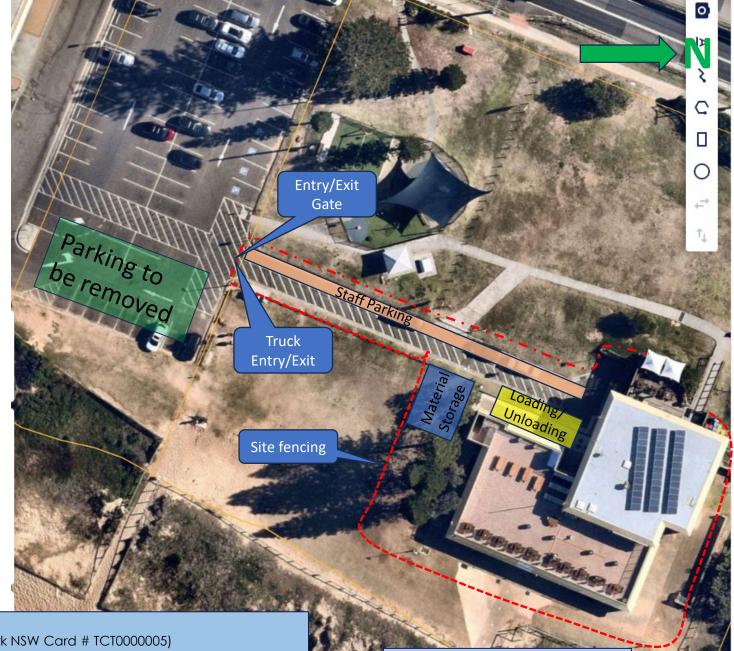
Appendix A – Site Management Plan

Date: 17/08/2023 Author: Abdun Noor( Safework NSW Card # TCT0000005) Project: North Narrabeen SLSC Client: Northern Beaches Council SITE MANAGEMENT PLAN

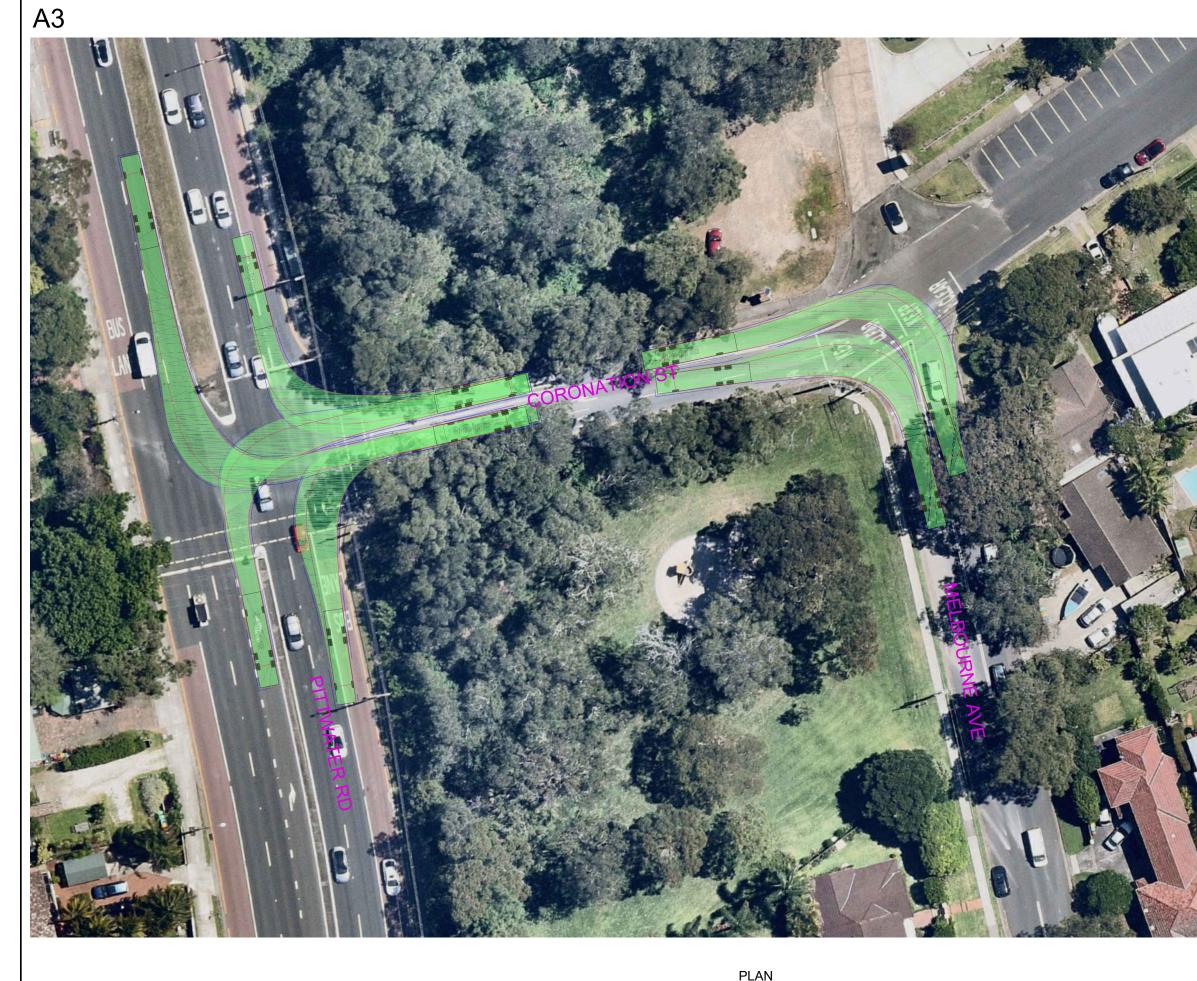
SCALE 1:500		
R	EV AMENDMENT	ISSUED	DATE	BARKER	SYDNEY	HUNTER	Client:		NORTH NARRABEEN SLSC	Designed:	ш
	A SWEPT PATH	JH	14/08/23	DARKER	P: 02 9659 0005 CENTRAL COAST	P: 02 4966 8388 S.E. QLD				ľ	JH
				RYAN	P: 02 4325 5255	P: 07 5582 6555			SWEPT PATHS		
				STEWART				NORTHERN BEACHES COUNCIL	PITTWATER RD, CORONATION ST AND MELBOURNE AVE	Checked:	AN
				TOTAL PROJECT SOLUTIONS		ww.brs.com.au ail@brs.com.au					
				ENGINEERING   PLANNING   PROJECT MANAGEMENT   SURV		3N: 26 134 067 842			230478-TR1-01

The largest heavy vehicle proposed to be used is a 12.5m Heavy Rigid Vehicle (HRV). It is noted that no significant geometrical constraints were found at any of the proposed access or egress routes which would affect the access of heavy vehicles. Swept paths for HRVs along the proposed haulage routes can be found in **Appendix C**.

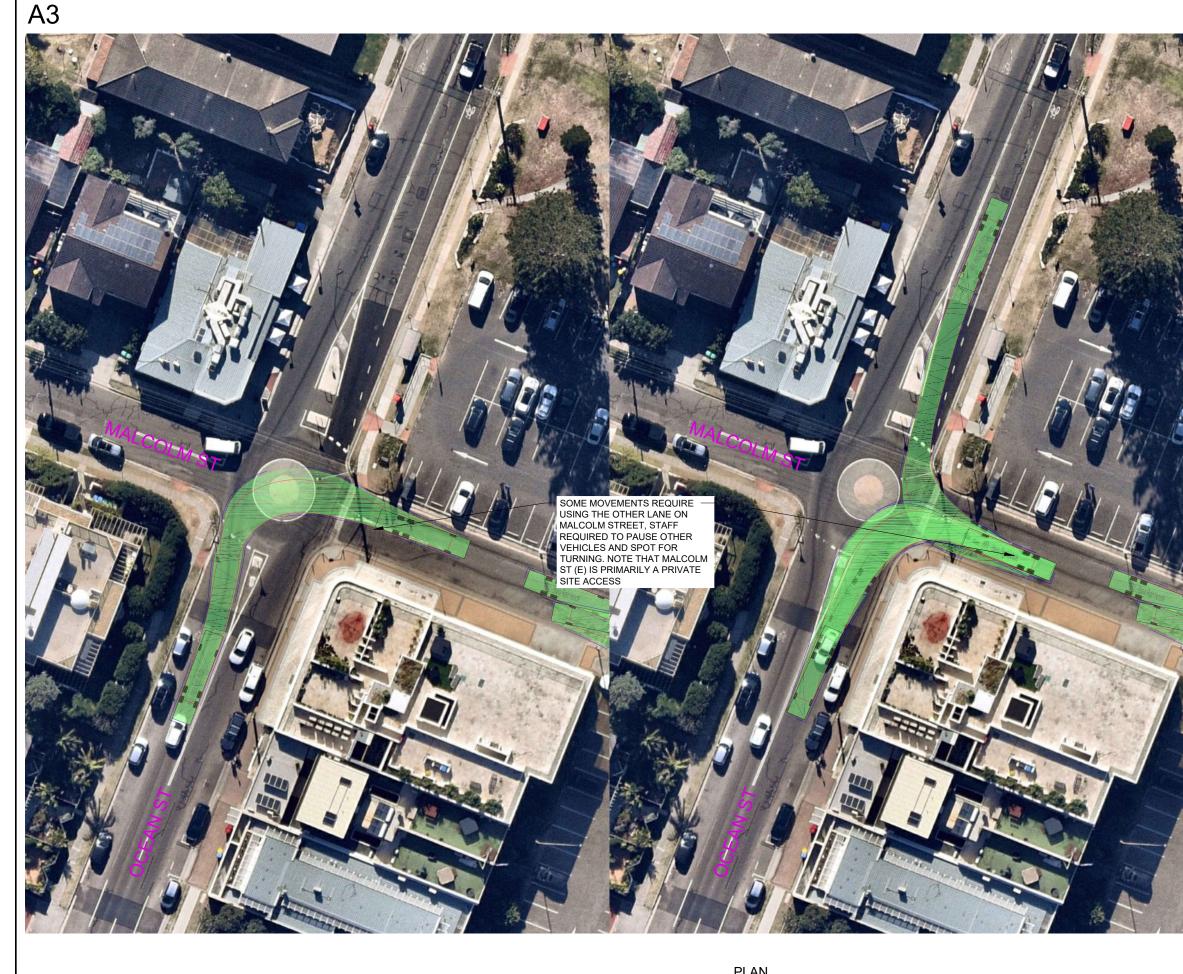
SCALE 1:500		
REV	AMENDMENT	ISSUED	DATE	BARKER	SYDNEY	HUNTER	Client:		NORTH NARRABEEN SLSC	Designed:	Ľ
Α	SWEPT PATH	JH	14/08/23		P: 02 9659 0005 CENTRAL COAS	P: 02 4966 8388				Ŭ	
				RYAN	P: 02 4325 5255	P: 07 5582 6555			SWEPT PATHS		JH
				STEWART				NORTHERN BEACHES COUNCIL	MALCOLM ST AND OCEAN ST	Checked:	AN
						www.brs.com.au mail@brs.com.au					
				TOTAL PROJECT SOLUTIONS ENGINEERING   PLANNING   PROJECT MANAGEMENT   SURVE		ABN: 26 134 067 842			230478-TR1-02

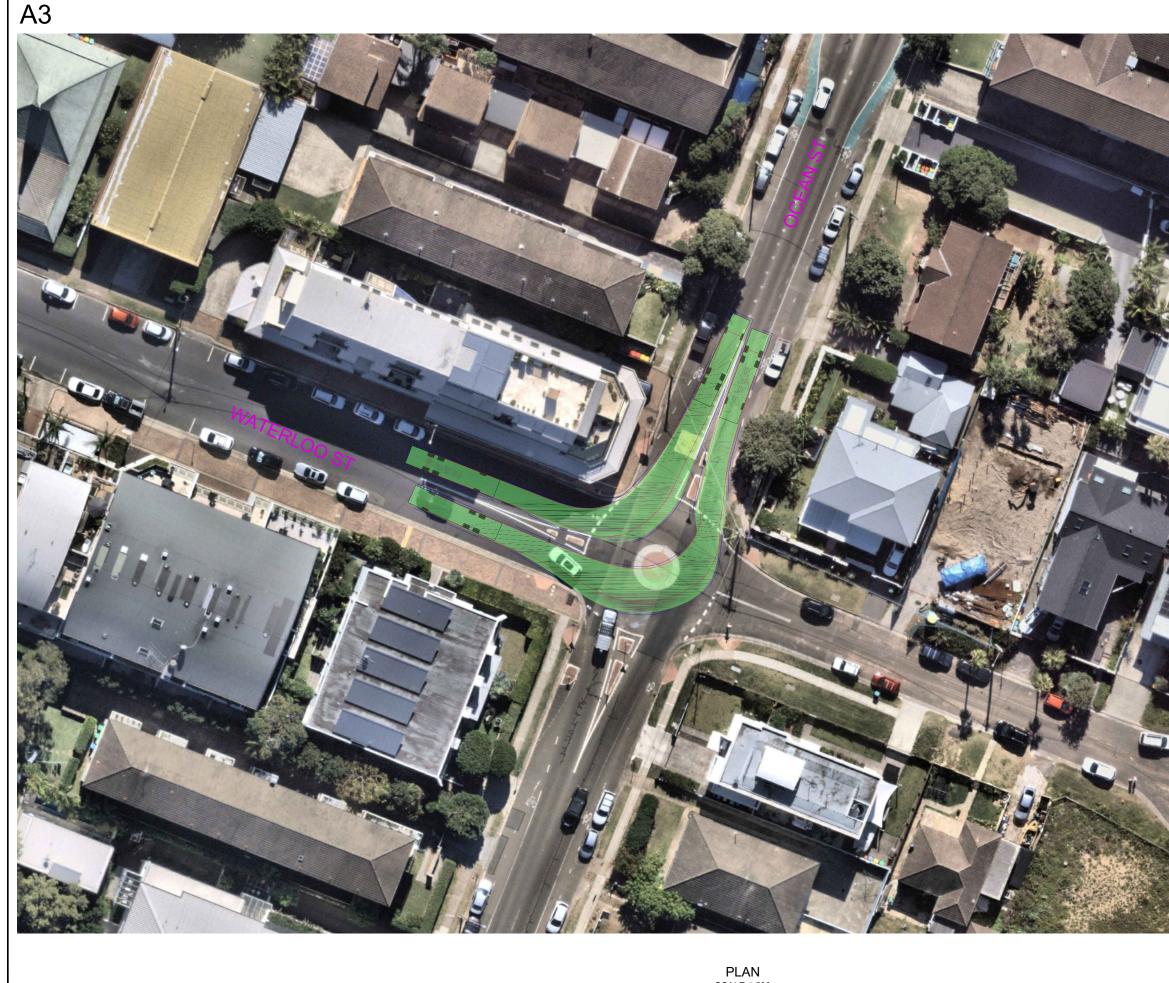
SCALE 1:500		
REV	AMENDMENT	ISSUED	DATE	BARKER	SYDNEY	HUNTER	Client:		NORTH NARRABEEN SLSC	Designed:	
Α	SWEPT PATH	JH	14/08/23		P: 02 9659 0005 CENTRAL COAST	P: 02 4966 8388 S.E. OL D				ľ	
				RYAN	P: 02 4325 5255	P: 07 5582 6555			SWEPT PATHS	Drawn:	JH
				STEWART				NORTHERN BEACHES COUNCIL	OCEAN ST AND WATERLOO ST	Checked:	AN
						ww.brs.com.au ail@brs.com.au		00011012			
				TOTAL PROJECT SOLUTIONS ENGINEERING   PLANNING   PROJECT MANAGEMENT   SURVE		ali@brs.com.au IN: 26 134 067 842			230478-TR1-03

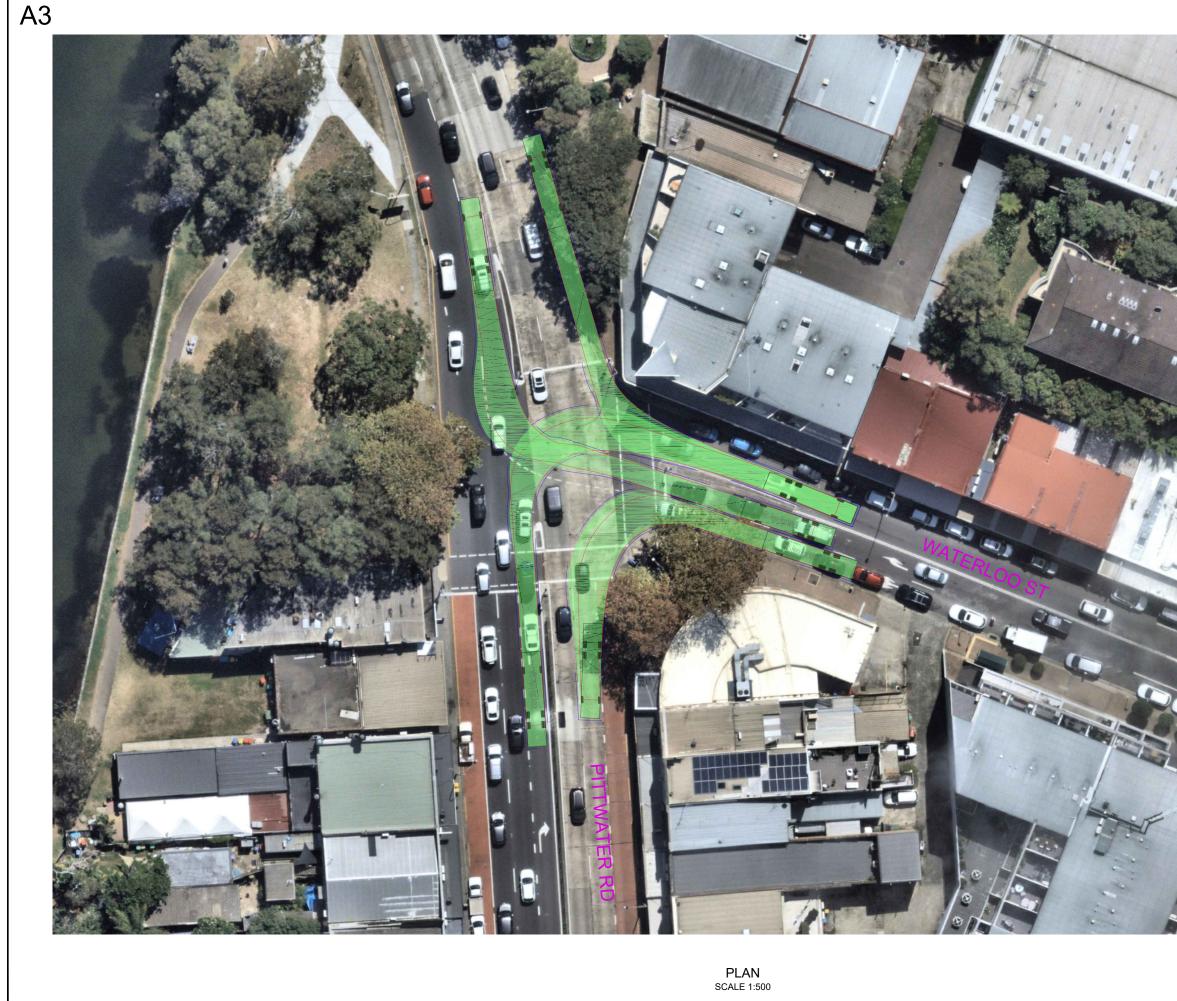
REV	AMENDMENT	ISSUED	DATE		YDNEY HL	UNTER	Client:		Designed:	лн
Α	SWEPT PATH	JH	14/08/23		: 02 9659 0005 P: 0 ENTRAL COAST S.E	02 4966 8388 F OLD		NORTH NARRABEEN SLSC	Ű	0.1
						07 5582 6555	NORTHERN BEACHES	SWEPT PATHS	Drawn:	JH
				STEWART			COUNCIL	PITTWATER RD AND WATERLOO ST	Checked:	AN
				TOTAL PROJECT SOLUTIONS	www.brs mail@br	rs.com.au ors.com.au			I	
				ENGINEERING   PLANNING   PROJECT MANAGEMENT   SURVEYING		6 134 067 842		230478-TR1-04	1

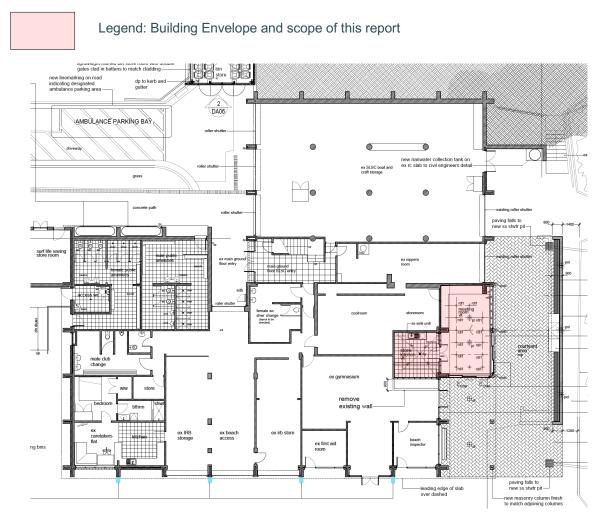
Figure 1 - Building Envelope - Ground Floor

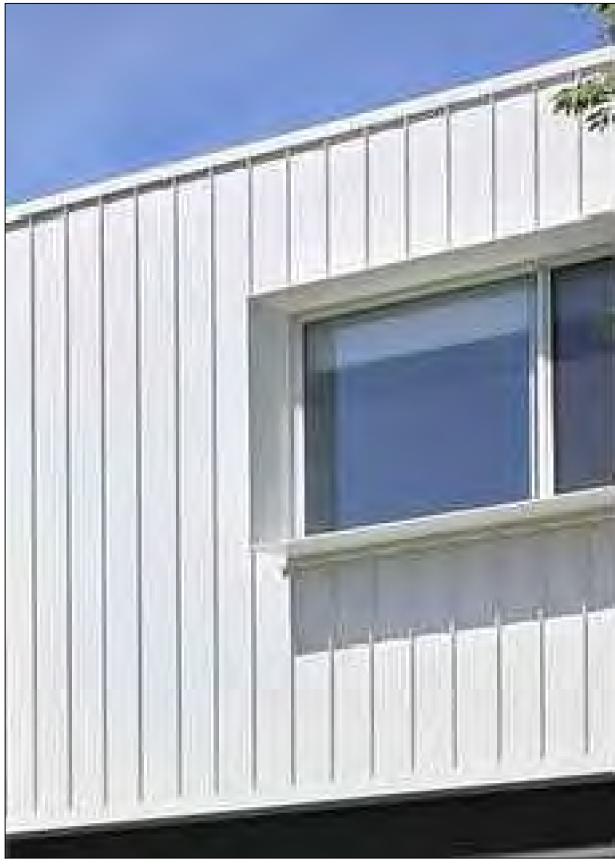
proposed raised seam PREFA aluminium metal cladding in Prefa White P.10 colour

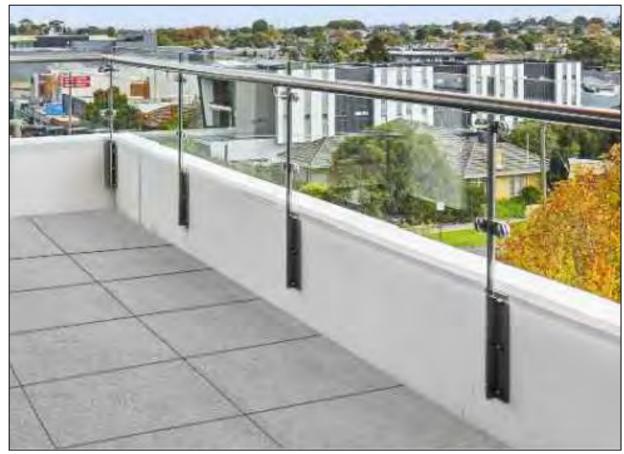
example of proposed frameless glass balustrade with integrated ss tubular handrail and fixing arrangement (balcony upstand however to be tiled)

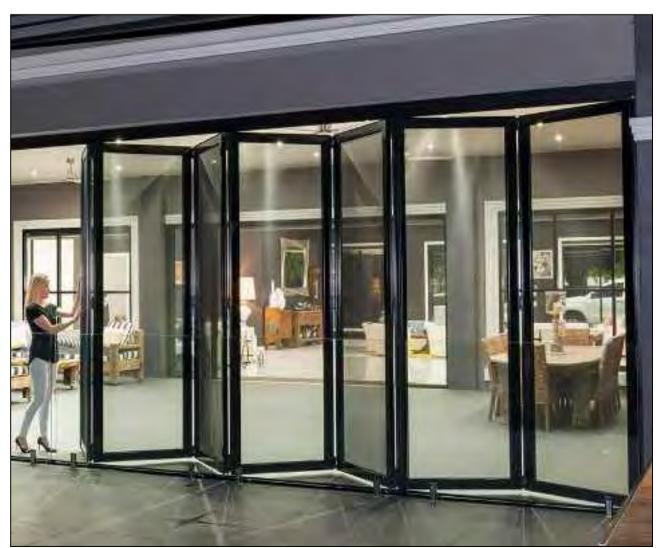
concertina type black satin powdercoated aluminium doors ie between existing cafe and new enclosed room on balcony

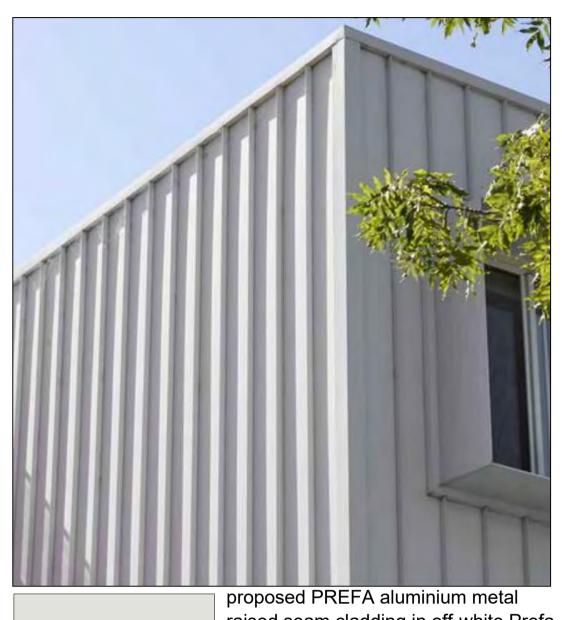
raised seam cladding in off-white Prefa White P.10 colour

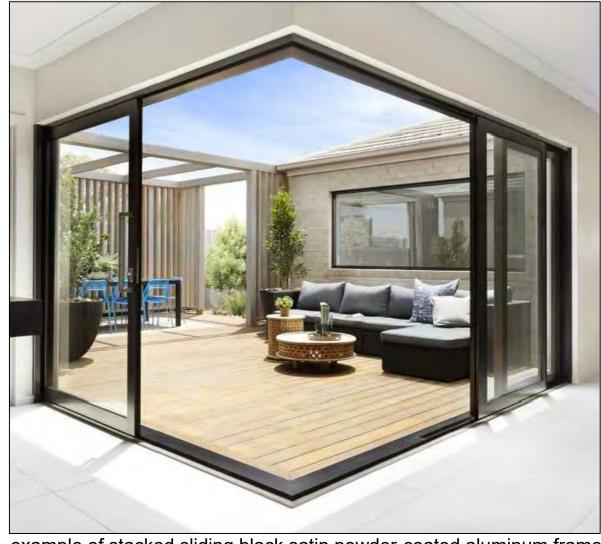
example of stacked sliding black satin powder-coated aluminum framed glass doors concept ie between new enclosed space on balcony and open balcony space. Showing full open corner scenario proposed.

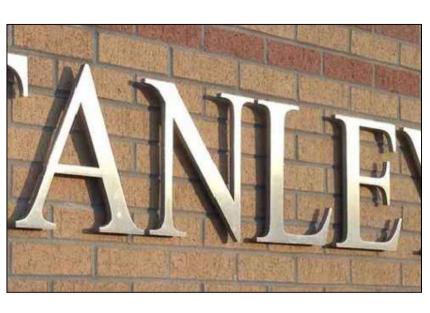
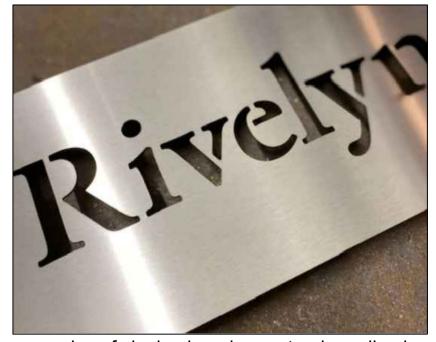
examples of single pinned-on natural anodised aluminium letter sign and natural anodised aluminium plate building sign

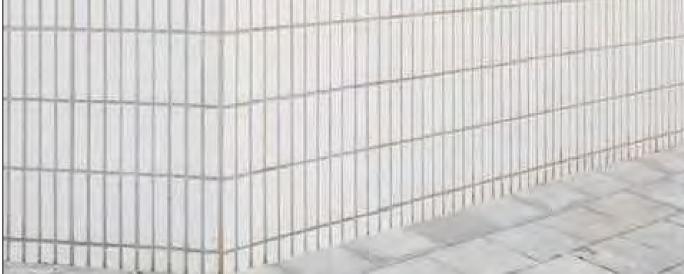
vitrified white wall tile (ie 80x240) to inside and outside face of rc up-stand element of balustrade on upper deck - and the proposed stack bond look in context

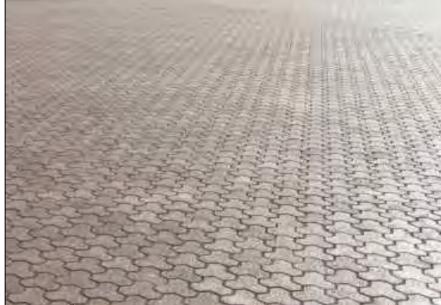
honed conrete 'Trihex' type pavers to new paved area on north side of building

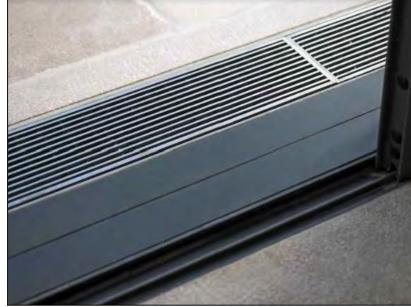
example of stainless steel slot drain to front of stacking sliders b/w new enlcosed room and open balcony

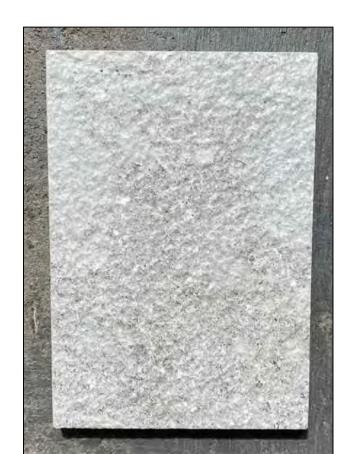
example of 600x300 vitrifed floor tile for balcony and proposed new enclosed room on existing balcony (non slip finish for external area tile)

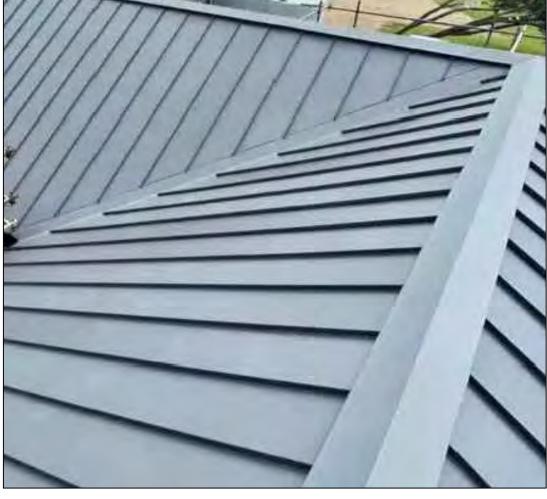
proposed raised seam metal deck roofing in light grey colour sim 'Shale Grey' Colorbond

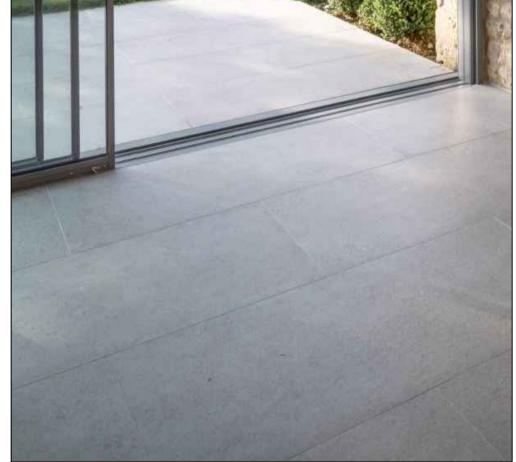
stacked sliding black satin powdercoated aluminum framed glass doors concept ie between new enclosed space on balcony and open balcony space
