Application for Building Certificate
Environmental Planning & Assessment Act, 1979 (as amended)
Section 149A, B, C, D

SURVEY REPORT

Ref: No.3 Beaconsfield Street, Newport.

**RE: 3 BEACONSFIELD STREET, NEWPORT, NSW - GEOTECHNICAL
REPORT**

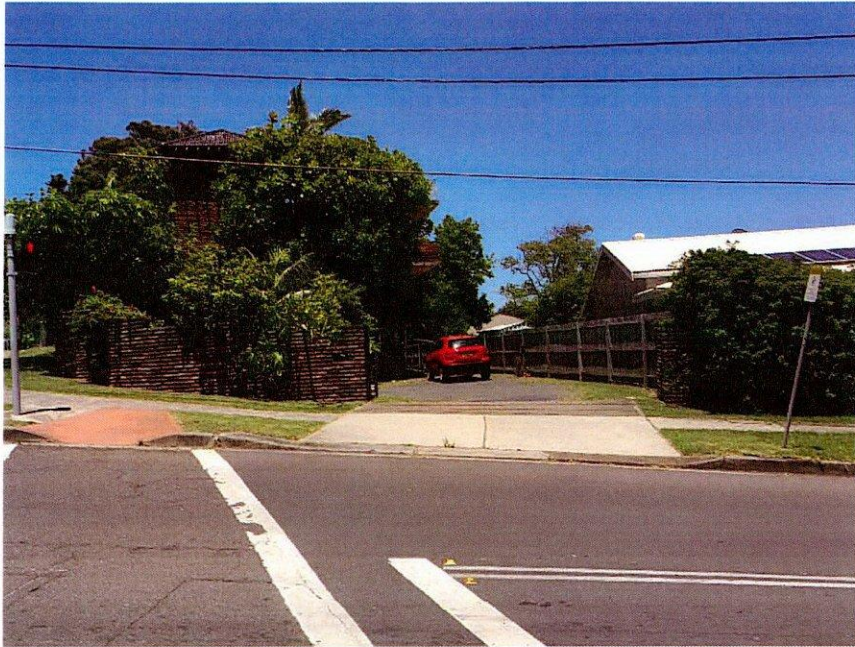
The site is rectangular in outline with a three storey brickwork residential property occupying the central portion of the site. The site is accessed via a level gravel and concrete driveway from Beaconsfield Street (see Plate 1). The lower floor of the house is accessed from the driveway and comprises a partial basement cut into the slope behind.

Plate 1 – Driveway access to property from Beaconsfield Street

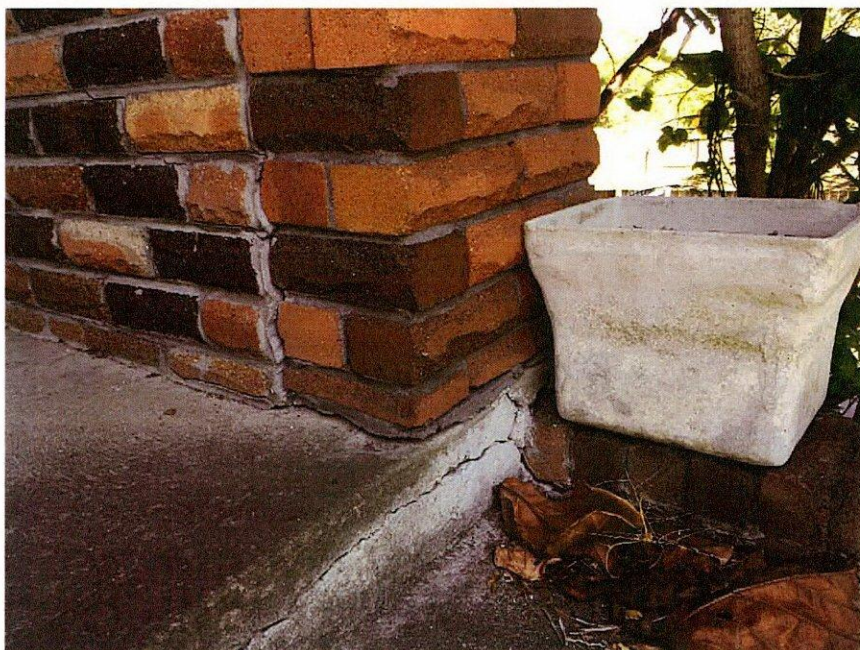
A grassed lawn and planted garden area with trees slopes down at approximately 5 degrees from a brickwork porch and concrete steps at the front of the property. Cracking of the porch and steps was observed (see Plate 2). Low height (approximately 1m) brickwork retaining walls border the driveway adjacent to the porch.

Plate 2 – Cracking of brickwork porch and concrete steps

Groundwater seepage was not observed at the time of this assessment. The observations relating to garden brick walls and concrete slabs are considered to be related to poor construction (including insufficient depth of footings) rather than ground instability. No evidence of ground movement or slope instability was observed such as tension cracks, sloping trees or bulging/ hummocky ground.

- a) Any proposed new external hardstand slabs or boundary wall footings should be taken below any topsoil/subsoil, root affected material and any ground showing evidence of disturbance or that is assessed as having the potential for creep movement. Where practicable, footings should be taken to rock.
- b) The occupant of the house should carry out regular inspections and maintenance of existing drainage and retaining structures.
- c) Further recommendations with regards to Good Hillside Practices are attached to this letter report.
