**RE: Preliminary Slope Stability Assessment at 292 Condamine Road, North Manly****1 INTRODUCTION**

# In-Situ Permeability

(WGC Pro Shop) 292 Condamine Street,  
North Manly

64338-IDF

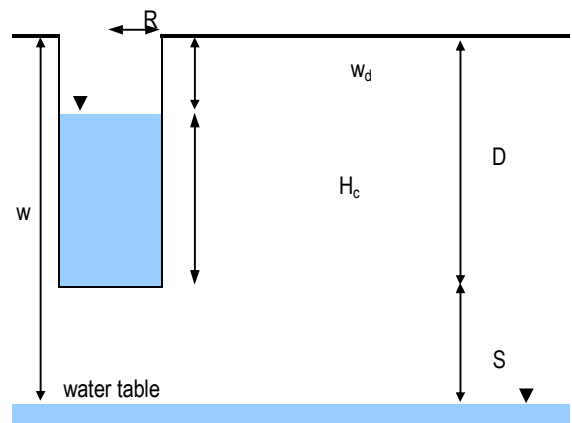
<b>Job ref / borehole ref:</b> BH1 <b>Test Method :</b> AS /NZS 1547:2000 Appendix 4.1F Soil Permeability measurement - constant head method The borehole was soaked with potable water for 10 minutes prior to commencing the test. Applies where $S > 2H_c$	<b>test location:</b> Refer to plan (refer to sketch)
---	--

Hole Radius, R :	0.05	m	
Hole Depth, D :	1.00	m	
Depth to Water, wd :	0.10	m	
Constant Head, Hc :	0.90	m	
Depth to Water			
Table, w (if known) :	NA	m	
- date & time :	12/07/23 1:30pm

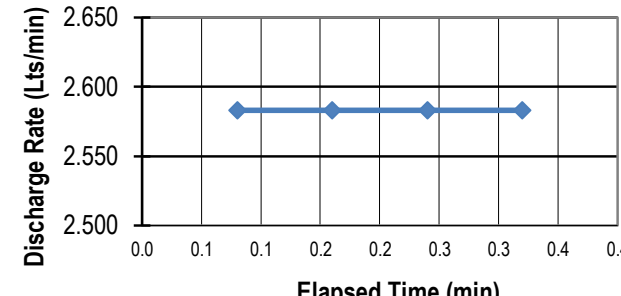
**Discharge Rate versus Time**

Discharge Rate Q = <b>2.5832</b> litres/min <b>Hydraulic Conductivity, K =</b> $\frac{Q \{ \sinh^{-1} (H_c/R) - 1 \}}{2 \pi H_c^2}$

<table><tr> <td style="width: 50%;"><b>2.2E-05</b></td> <td style="width: 50%;"><b>m/sec</b></td> </tr><tr> <td><b>1.8888</b></td> <td><b>m/day</b></td> </tr><tr> <td><b>78.70</b></td> <td><b>mm/hr</b></td> </tr></table>

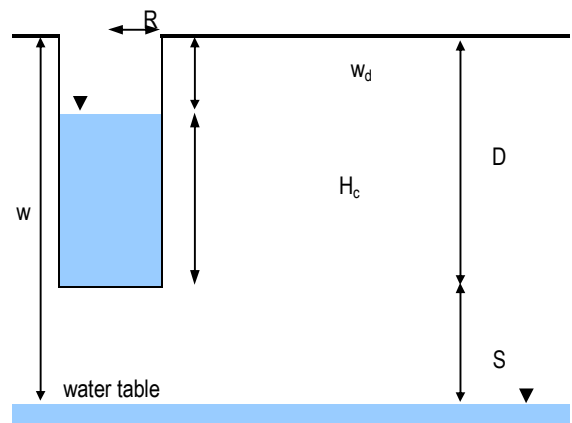
<b>Job ref / borehole ref:</b> BH2 <b>Test Method :</b> AS /NZS 1547:2000 Appendix 4.1F Soil Permeability measurement - constant head method The borehole was soaked with potable water for 10 minutes prior to commencing the test. Applies where $S > 2H_c$	<b>test location:</b> Refer to plan (refer to sketch)
---	--

Hole Radius, R :	0.05	m	
Hole Depth, D :	1.00	m	
Depth to Water, $w_d$ :	0.10	m	
Constant Head, $H_c$ :	0.90	m	
Depth to Water			
Table, w (if known) :	NA	m	
- date & time :	12/07/23 1:30pm

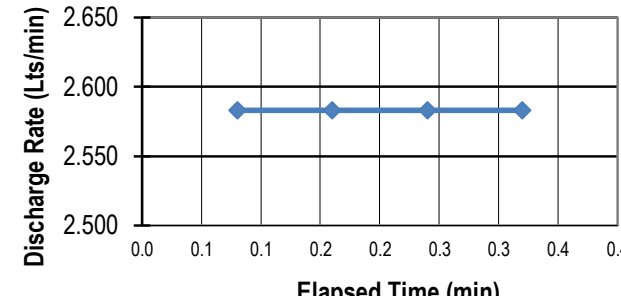
**Discharge Rate versus Time**

Discharge Rate Q = <b>2.5832</b> litres/min <b>Hydraulic Conductivity, K =</b> $\frac{Q \{ \sinh^{-1} (H_c/R) - 1 \}}{2 \pi H_c^2}$

<table><tr> <td style="width: 50%;"><b>2.2E-05</b></td> <td style="width: 50%;"><b>m/sec</b></td> </tr><tr> <td><b>1.8888</b></td> <td><b>m/day</b></td> </tr><tr> <td><b>78.70</b></td> <td><b>mm/hr</b></td> </tr></table>
