## **Marine Habitat Survey**

**Address | 139 – 141 Riverview Road, Avalon Beach**

**Survey Date | 14 February 2024**

**Job Number 24-048-05 B**

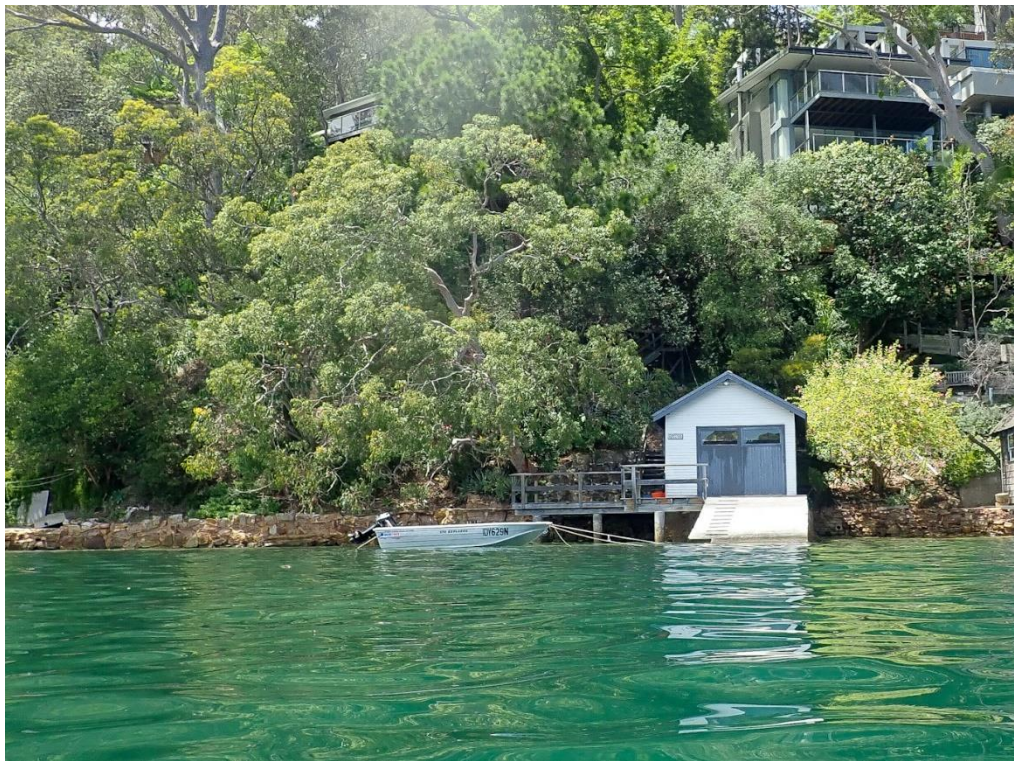
**Photo 1.** The foreshore and existing structures at The Property, as viewed from the navigation limit line.

The existing structures present at The Property at the time of the on-site survey (Photos 1 - 4) included:

- a boatshed on the southern side of The Property, surrounded on the northern and western sides by a timber deck (the deck finished approximately 5 m beyond the MHWM);
- a timber skid ramp (6.75 x 2.8 m) located out the front of the boatshed south to the boatshed's southern building line and placed on top of an area of stacked rocks;
- a concrete ramp (5.5 x 2.9 m) that is an extension of the timber skid ramp and was crumbling away at the seaward end.

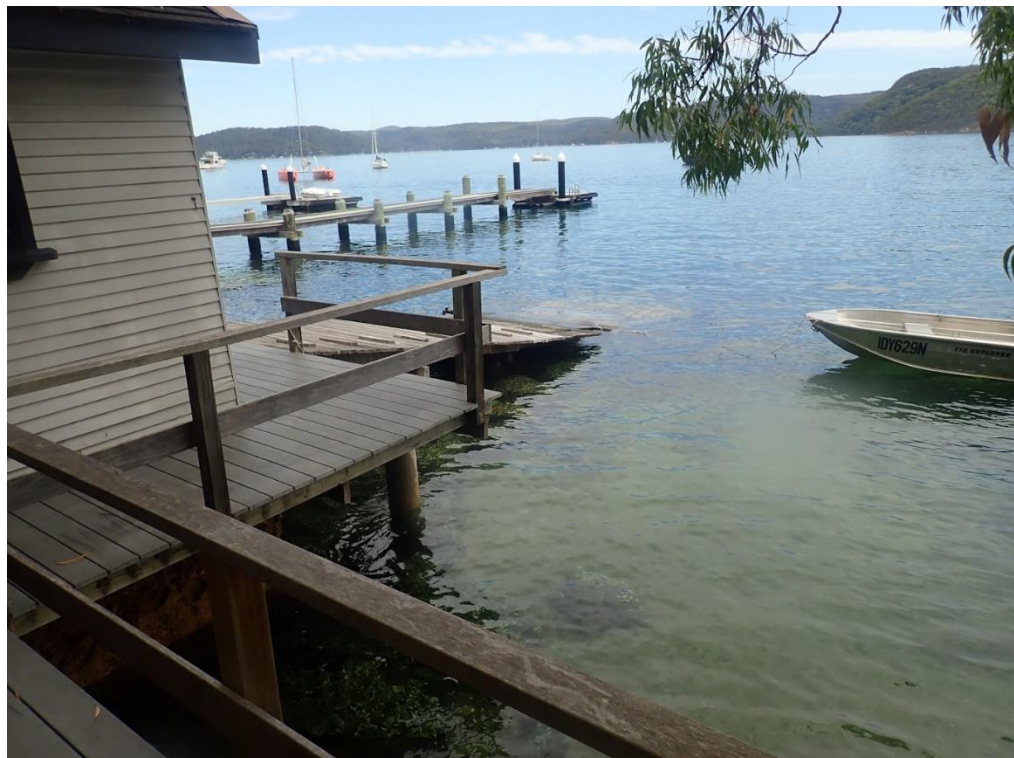
**Photo 2.** The northern side of the boatshed, timber deck and timber skid ramp.

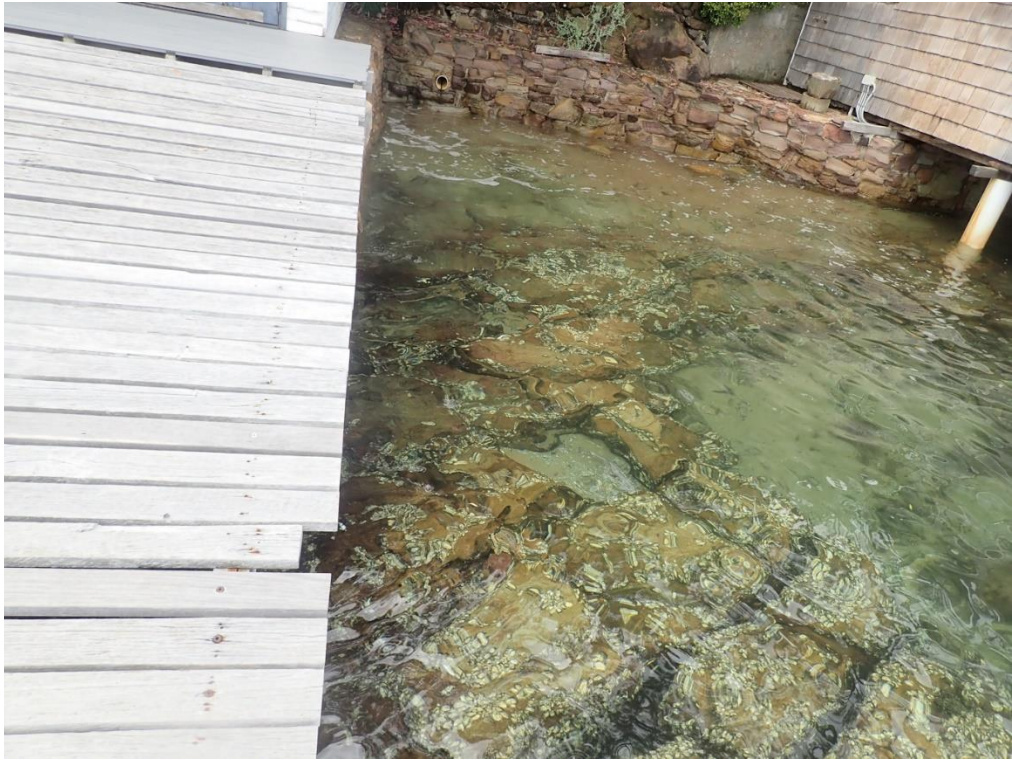
**Photo 3.** The intertidal habitats of seawall, sand and boulders on the southern side of the skid and boatshed.

The intertidal zone at The Property consisted of artificial and natural habitats. A stacked stone seawall stretched across the width of The Property (Photo 3). The seawall was fronted by bedrock covered in a layer of intertidal sand. The sandy seabed was covered in numerous large boulders and rocks on the southern side of the boatshed and skid ramp (Photos 3 - 5) and an area of stacked boulders and large rocks under the timber skid. This rocky intertidal habitat extended out to the end of the existing timber skid ramp. The intertidal habitat to the north of the skid ramp and boatshed consisted predominantly of sand on bedrock.

The seawall was devoid of intertidal biota. The boulders and rocks under the skid ramp and on the southern side of The Property were colonised by a medium to high density cover of Sydney rock oysters (*Saccostrea glomerata*). The outermost 2 - 3 m of rocky substrata was colonised by clumps of brown Neptune's necklace (*Hormosira banksii*). The intertidal sand was unvegetated.

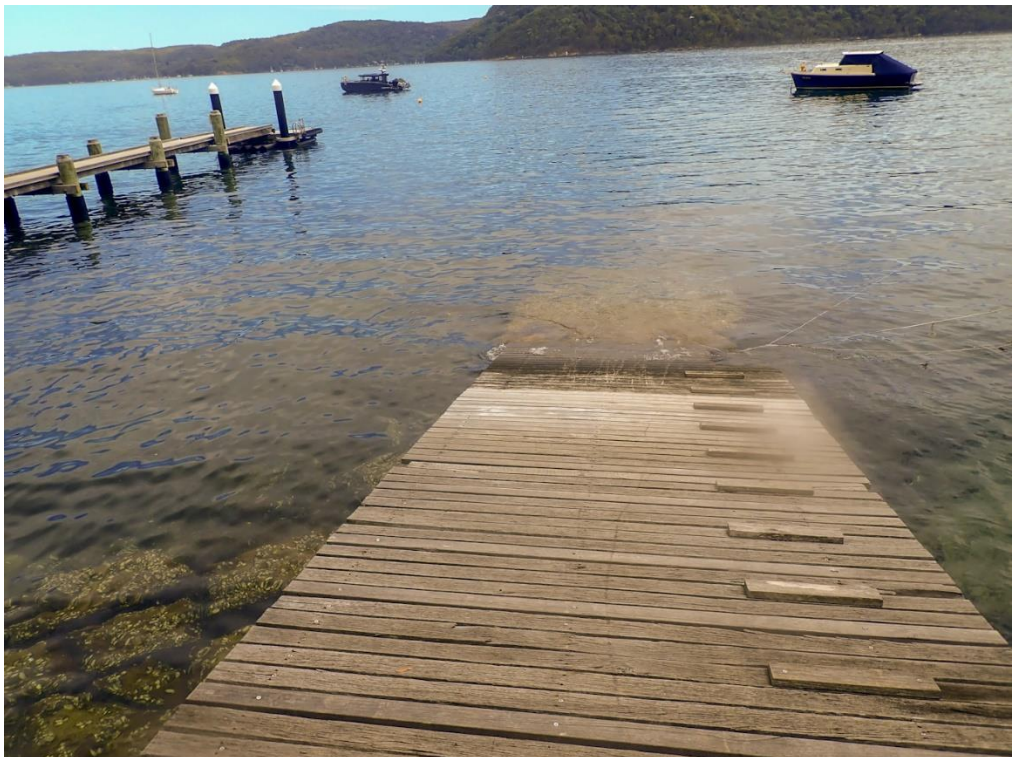
**Photo 4.** The timber skid ramp and submerged concrete ramp, with intertidal boulders on the left hand side of the skid ramp.

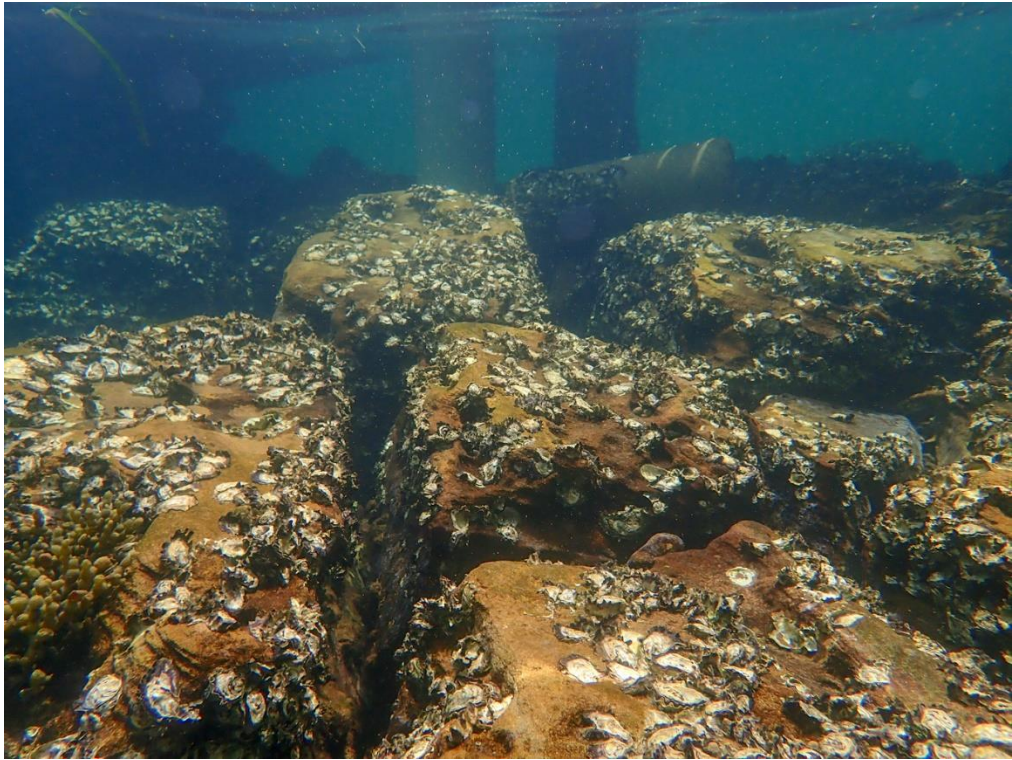
**Photo 5.** Submerged intertidal boulders on the southern side of the skid ramp, colonised by oysters and Neptune's necklace.

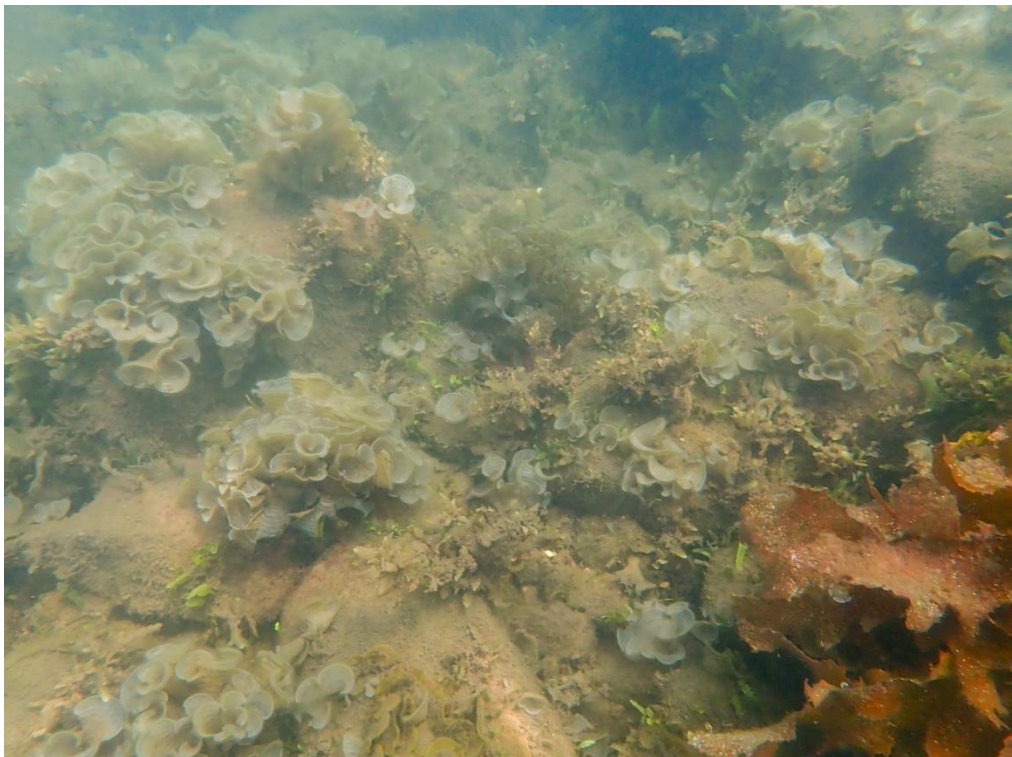
**Photo 6.** Shallow, subtidal rocky reef on the southern side of the concrete ramp, colonised by brown macroalgae.

The subtidal zone within the on-site survey area of The Property started off the end of the existing timber skid ramp and consisted of a gradually sloping seabed composed of sand covered with a high proportion of rocks and rubble (Photo 6). The rocks and rubble continued offshore for 11 m (Photo 7), before transitioning to a gradually sloping seabed of sand (Photos 8 - 10) which continued uniformly offshore beyond the survey area.

The rocky substrata that stretched offshore for 11 m beyond the end of the timber skid ramp (Photos 6 - 7) was colonised by a high density cover of brown macroalgae (bubbleweed *Sargassum* sp., kelp *Ecklonia radiata*, scrollweed *Padina* sp. and turfing filamentous), along with a low density cover of the green invasive weed *Caulerpa taxifolia*. The entire sandy subtidal seabed across The Property was colonised by seagrass (Photos 7 - 10). There was a narrow bed of medium density *Zostera* that started at the end of the rocky reef followed by a wider bed of mixed seagrass - medium density *Zostera* and *Halophila* along with low density scattered clumps of *Posidonia* (see section c. below for more seagrass density and distribution details). The mixed seagrass bed extended offshore to 31 m beyond the end of the timber skid ramp, at which point the sandy seabed became unvegetated.

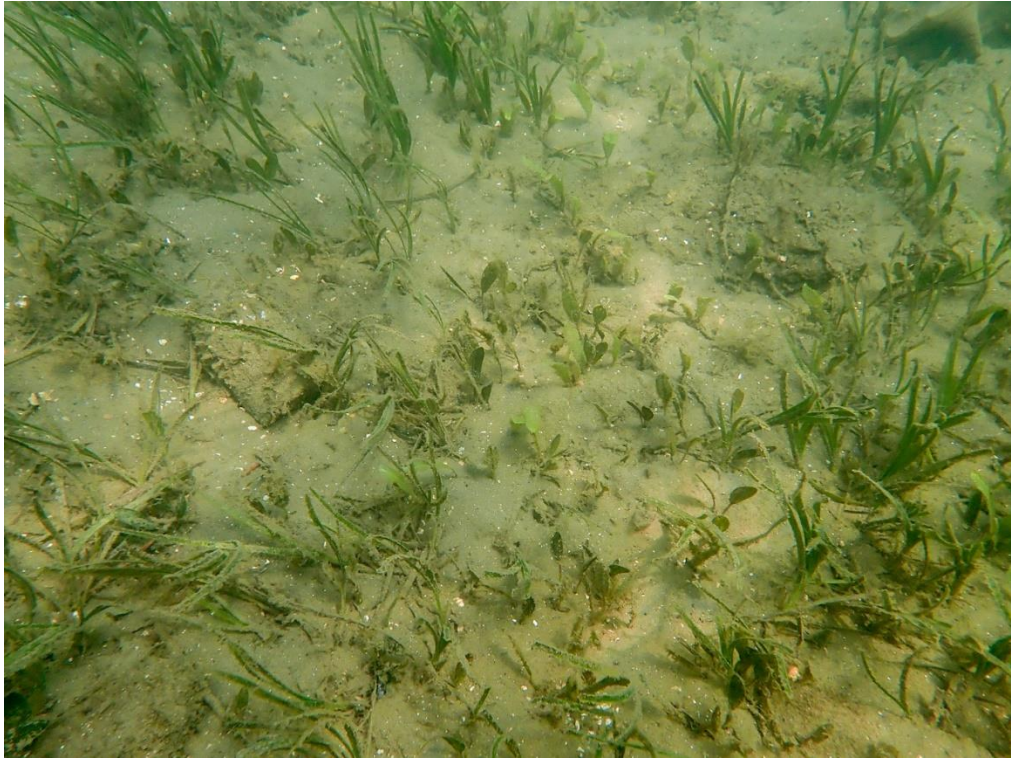
**Photo 9.** Mixed bed of medium density *Halophila* and low density *Zostera* (HalC2L/ZosC1L). There were scattered clumps of *Posidonia*, with 2 - 3 m gaps between each clump, within this bed - but the absence of *Posidonia* in this photo is evidence of its patchiness.

There was a narrow bed of medium density, long leaved *Zostera* (ZosC2L; Photos 7 - 8) that started at the end of the rocky reef and extended offshore for 5.4 m. The above *Zostera* bed transitioned to a 14 m wide bed of mixed seagrass (Photos 9 - 10). The mixed bed consisted of low to medium density, long leaved *Zostera* (ZosC1/2L); medium density *Halophila* (HalC2L); low density clumps of long leaved *Posidonia* (PosA1L) that were scattered across the seabed, with gaps of up to 2 - 3 m between each clump (Photos 9 - 10); and a low density cover of the green invasive weed *Caulerpa taxifolia*.

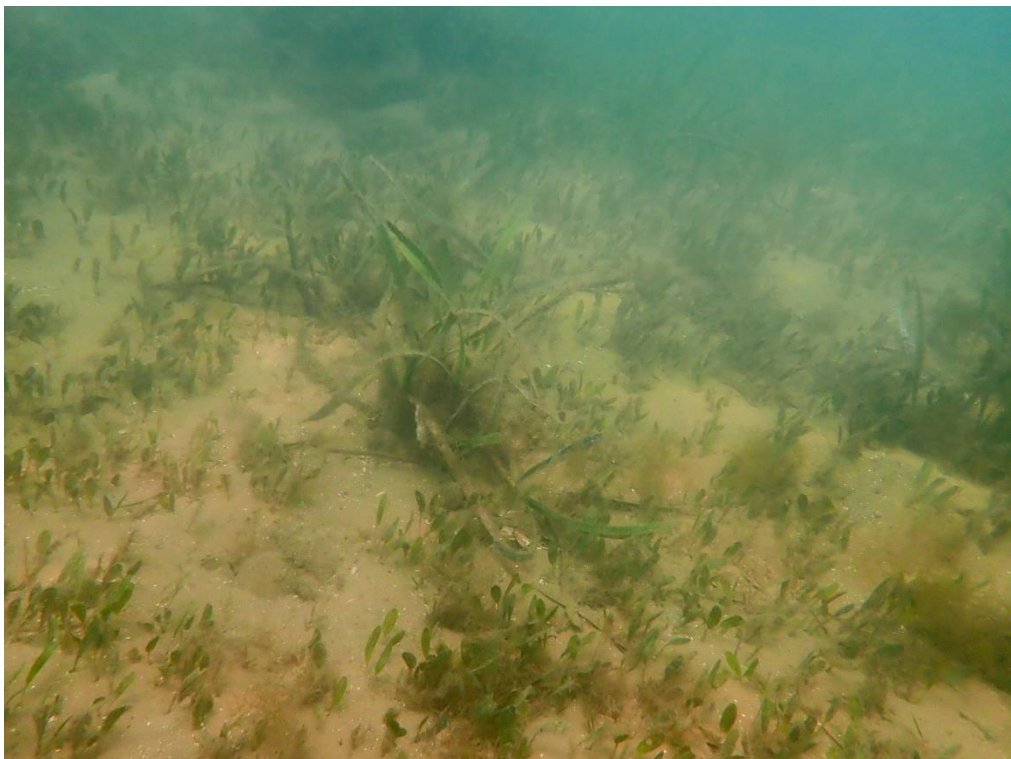
**Photo 10.** Mixed bed of medium density *Halophila*, low density *Zostera* and scattered clumps of low density *Posidonia* (HalC2L/ZosC1L/PosA1L).

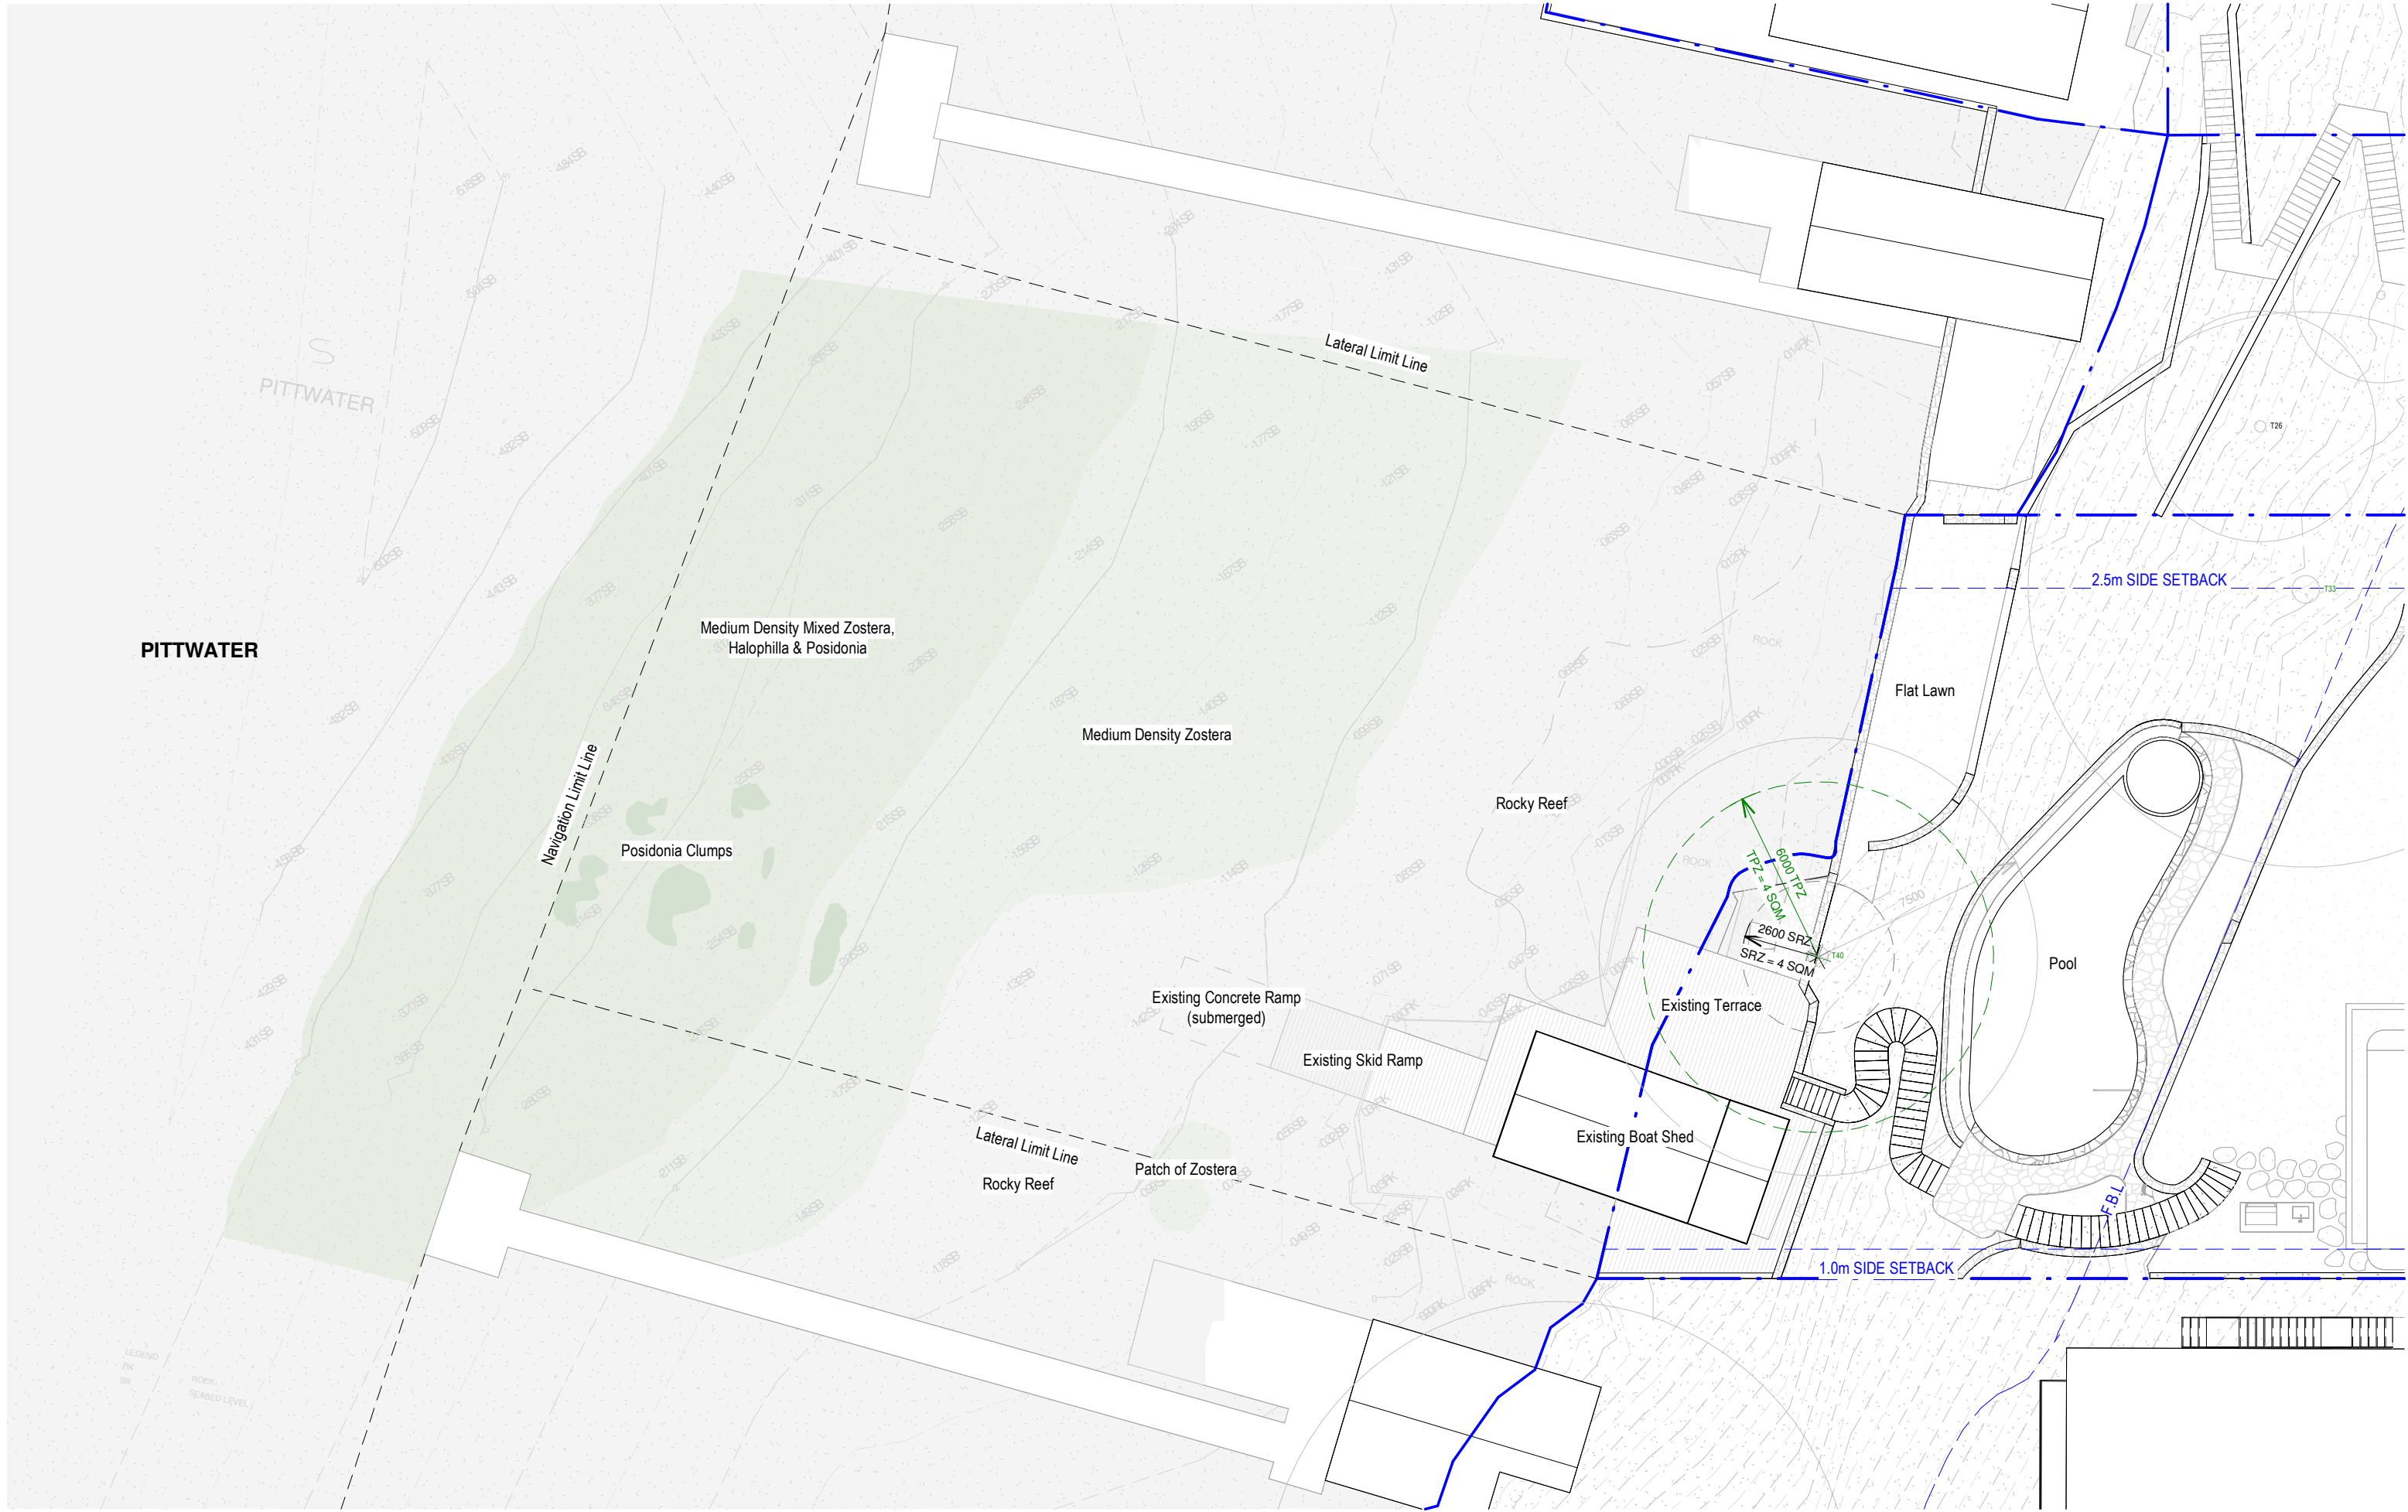
The proposed foreshore plan (provided by CM Studio) and mapped seagrass at 139 – 141 Riverview Road, Avalon Beach is provided overleaf.

The entire sandy subtidal seabed across The Property was colonised by seagrass (see seagrass mapping in Appendix B). The seagrass habitats extended further inshore on the northern side of The Property, but the measurements of seagrass bed widths and species composition presented here are for the seabed located offshore of the concrete ramp.

The proposed minor foreshore works at The Property are all located above the MHW (see attached Foreshore Plan provided by CM Studio in Appendix B). The minor works consist of:

- flat lawn area on the northern side of site, behind the seawall;
- additional space behind the existing boatshed; and
- associated retaining walls.
