ARBORICULTURAL IMPACT ASSESSMENT

Lot 1/-/DP749530

168 Whale Beach Road, Whale Beach NSW 2107

Prepared on: 18/03/2021

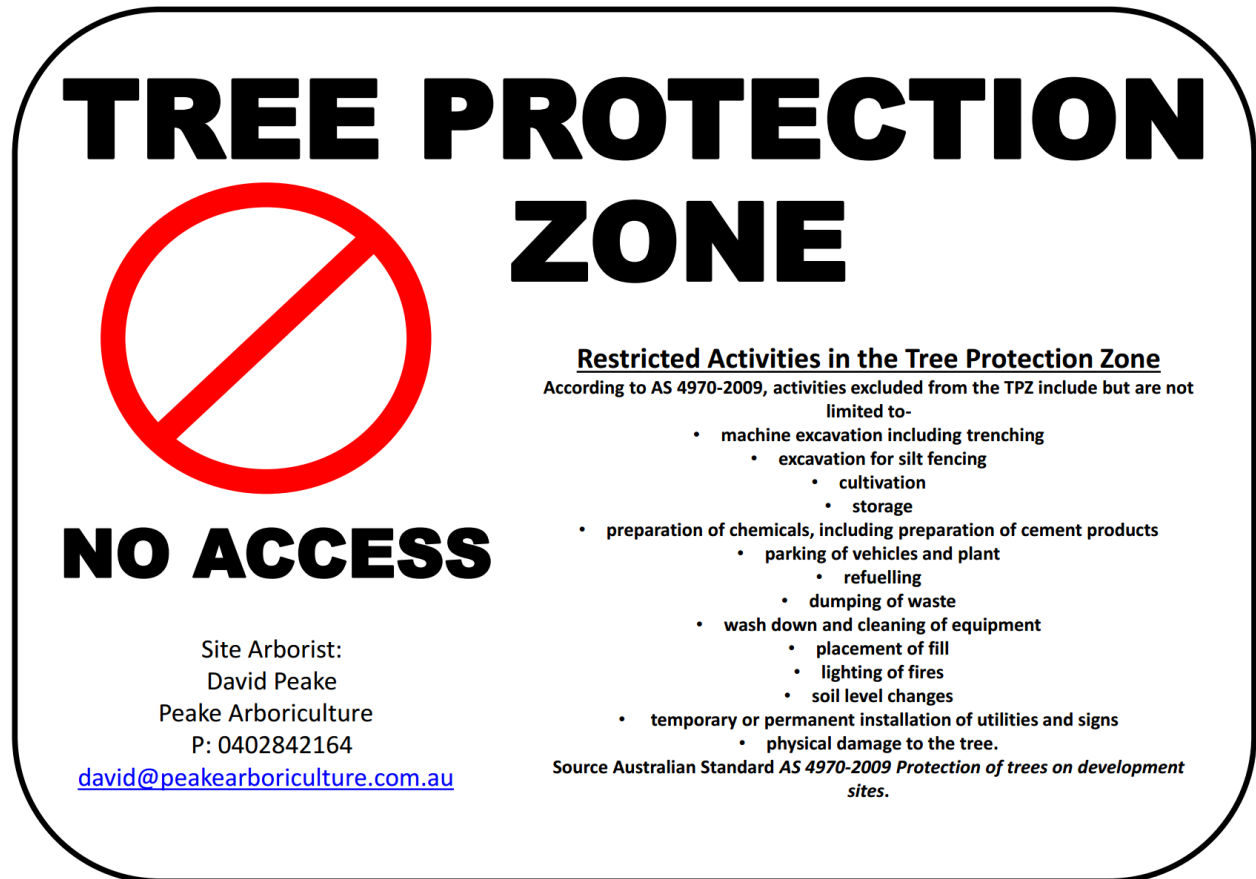
A tree protection zone sign must be affixed to all Fenced Tree Protection Zones. (Example Below)

TREE PROTECTION ZONE

NO ACCESS

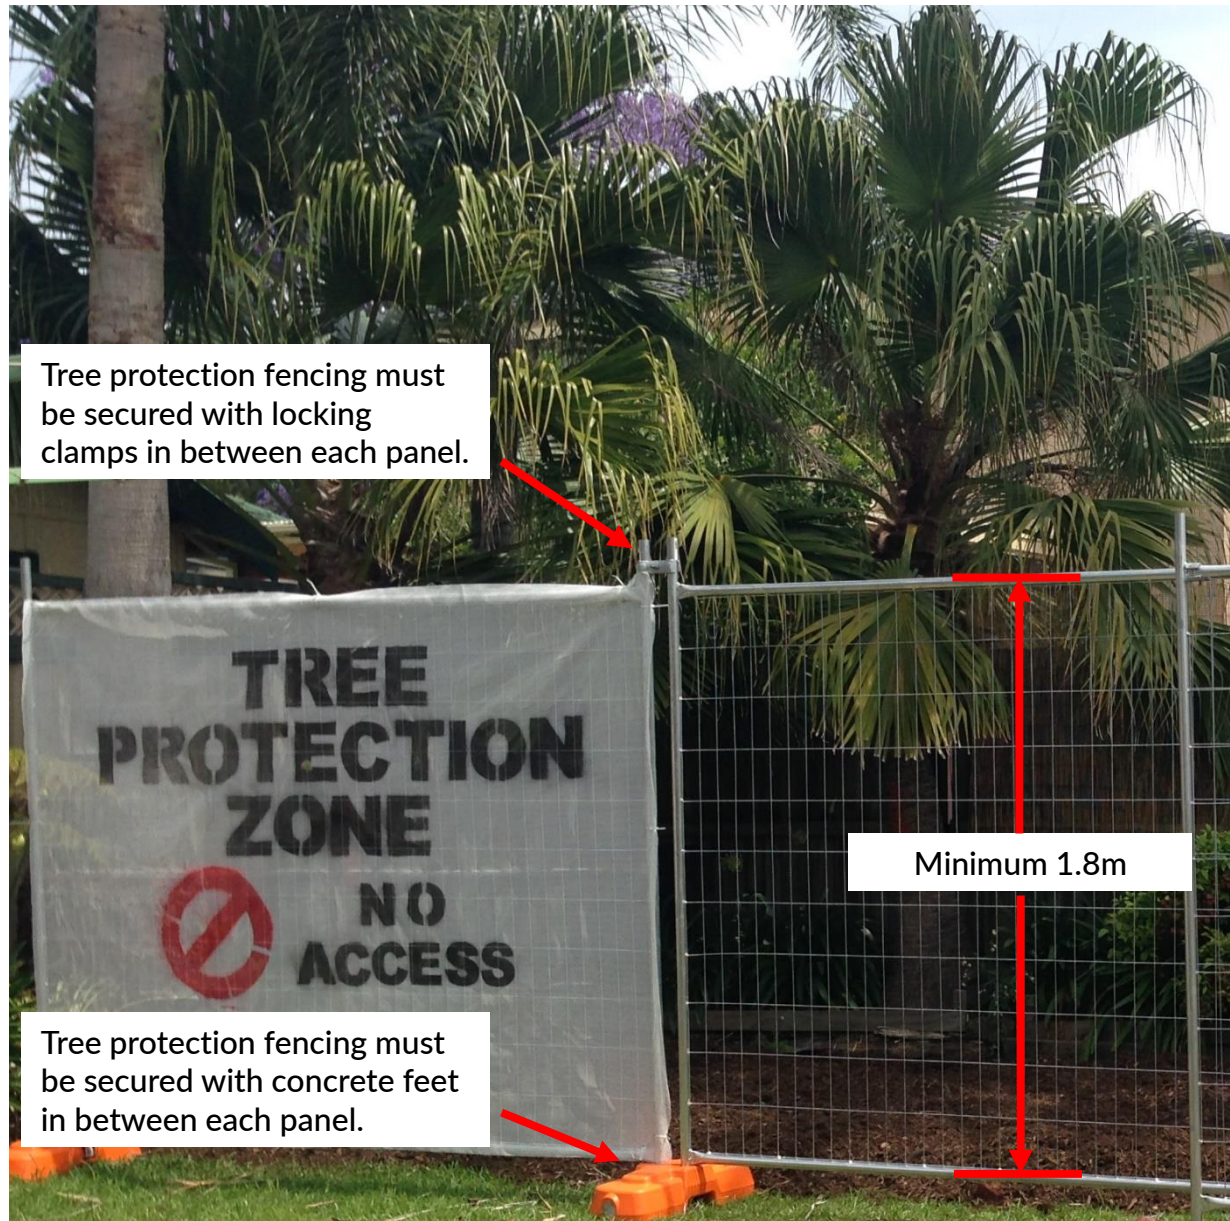
An Example of Temporary Fencing

Tree protection Fencing must be a minimum of 1.8 metres in height and be held in place with locking clamps in between each panel, see Figure 2 below.
