## ARBORICULTURAL IMPACT ASSESSMENT (AIA) REPORT

Prepared For: Bonnie McDonald  
Site Address: 110 Woorarra Ave North Narrabeen  
Inspection Date: 27 May 2022  
Report Date: 30 May 2022

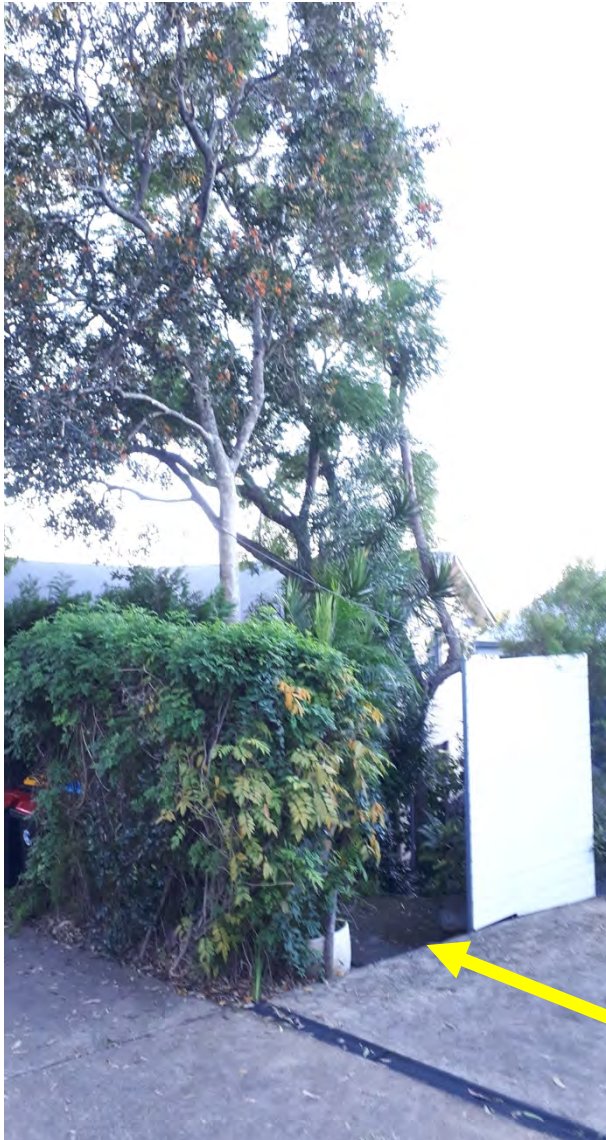
All assessed trees were within close proximity to the construction. All appeared in good health and condition. Three mature trees were located close to the north western boundary. The survey shows T1 straddling the boundary with T2 & T3 shown located within neighbouring property.

*Photo 2: Trees T1, T2 & T3 along north western side boundary.*

T1: The driveway extension, new front walls and modular fencing occur within both the SRZ and TPZ of the tree. Tree sensitive methods of constructions are required as per AS 4970-2009 *Protection of trees on development sites* - specifically section 3.3.4.

T2 & T3 – Both mature Jacaranda trees and located within neighbouring property No 112 Woorarra Avenue. These trees are exempt listed as per directives of Northern Beaches Council. The modular boundary fence is to extend from T1 and ending approximately in line with the front of the dwelling. This fence is in very close proximity to the trunks of both trees.

It is anticipated structural roots will be present within this area therefore it is recommended isolated piers and footing, flexible in positioning, be considered rather than continuous strip footings.

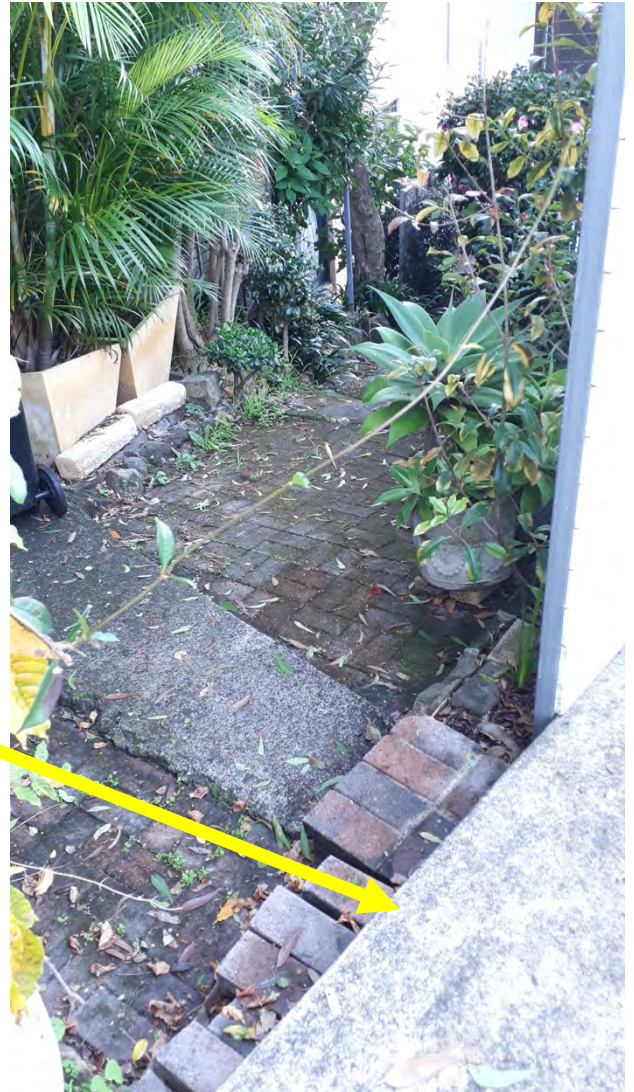
T1: Given the reduction in levels between the existing driveway and the paved pathway adjacent to this tree, an assumption is made that the driveway extension will be constructed above existing grade and supported by isolated piers.

*Photo 3: Height difference at edge of driveway and side path.*

Driveway: given the existing land height differences, an assumption is made the driveway extension will be suspended above grade and supported by isolated piers. Much of the TPZ/SRZ already is covered by hard surface. Depending upon the final engineered design of driveway and proposed walls, water ingress points could be provided for to reduce/alleviate the “rain shadow” effect created by the extended covering. Should the extended driveway “tie in” with the existing (at the front of property’s line of easement to neighbouring property DA-01A) will marginally reduce the garden area (deep soil).

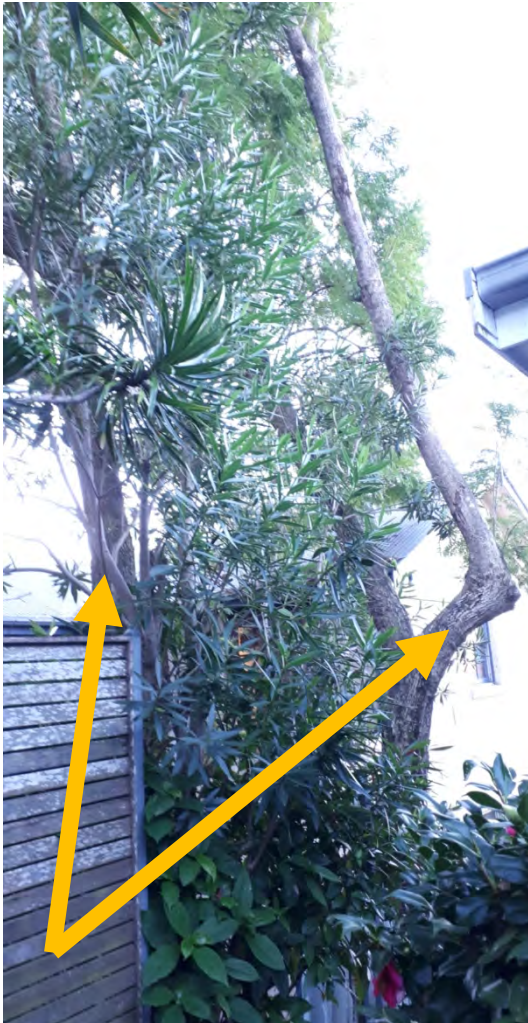
Trees T2 and T3, both Jacaranda mimosifolia Jacaranda are exempt listed, and T4 and T5 both Lilli Pilli had not attained a height of 5 metres.

Photo 5: Trees T2 & T3 - neighbouring Jacaranda

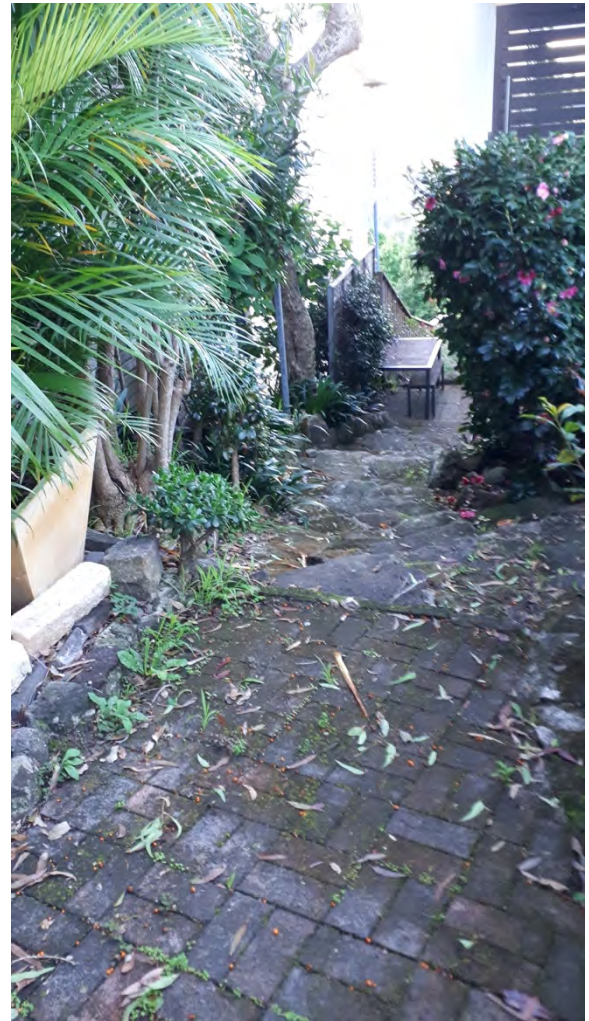
Photo 4: Existing hard stand beneath Trees T1, T2 & T3. T3 in distance.

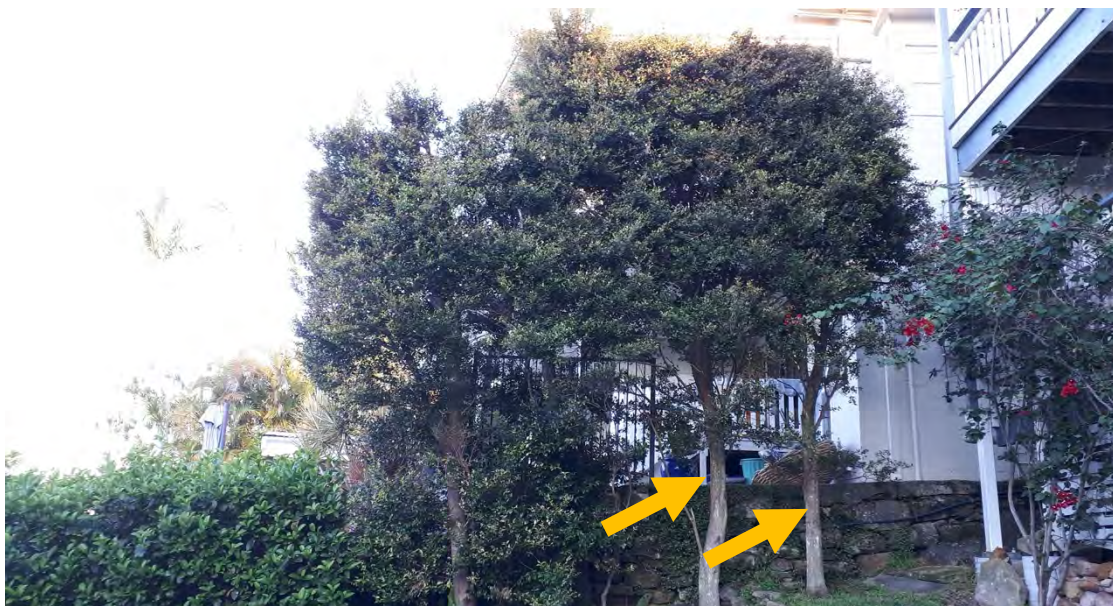
Photo 6: T4 & T5 (Arrow).

T4 & T5: Both Lilli Pilli trees are exempt as they have not attained a height of 5 metres. A permit for pruning or removal is not required in this instance.
