ARBORICULTURAL IMPACT ASSESSMENT

40 Maxwell Street, Mona Vale

Version 2

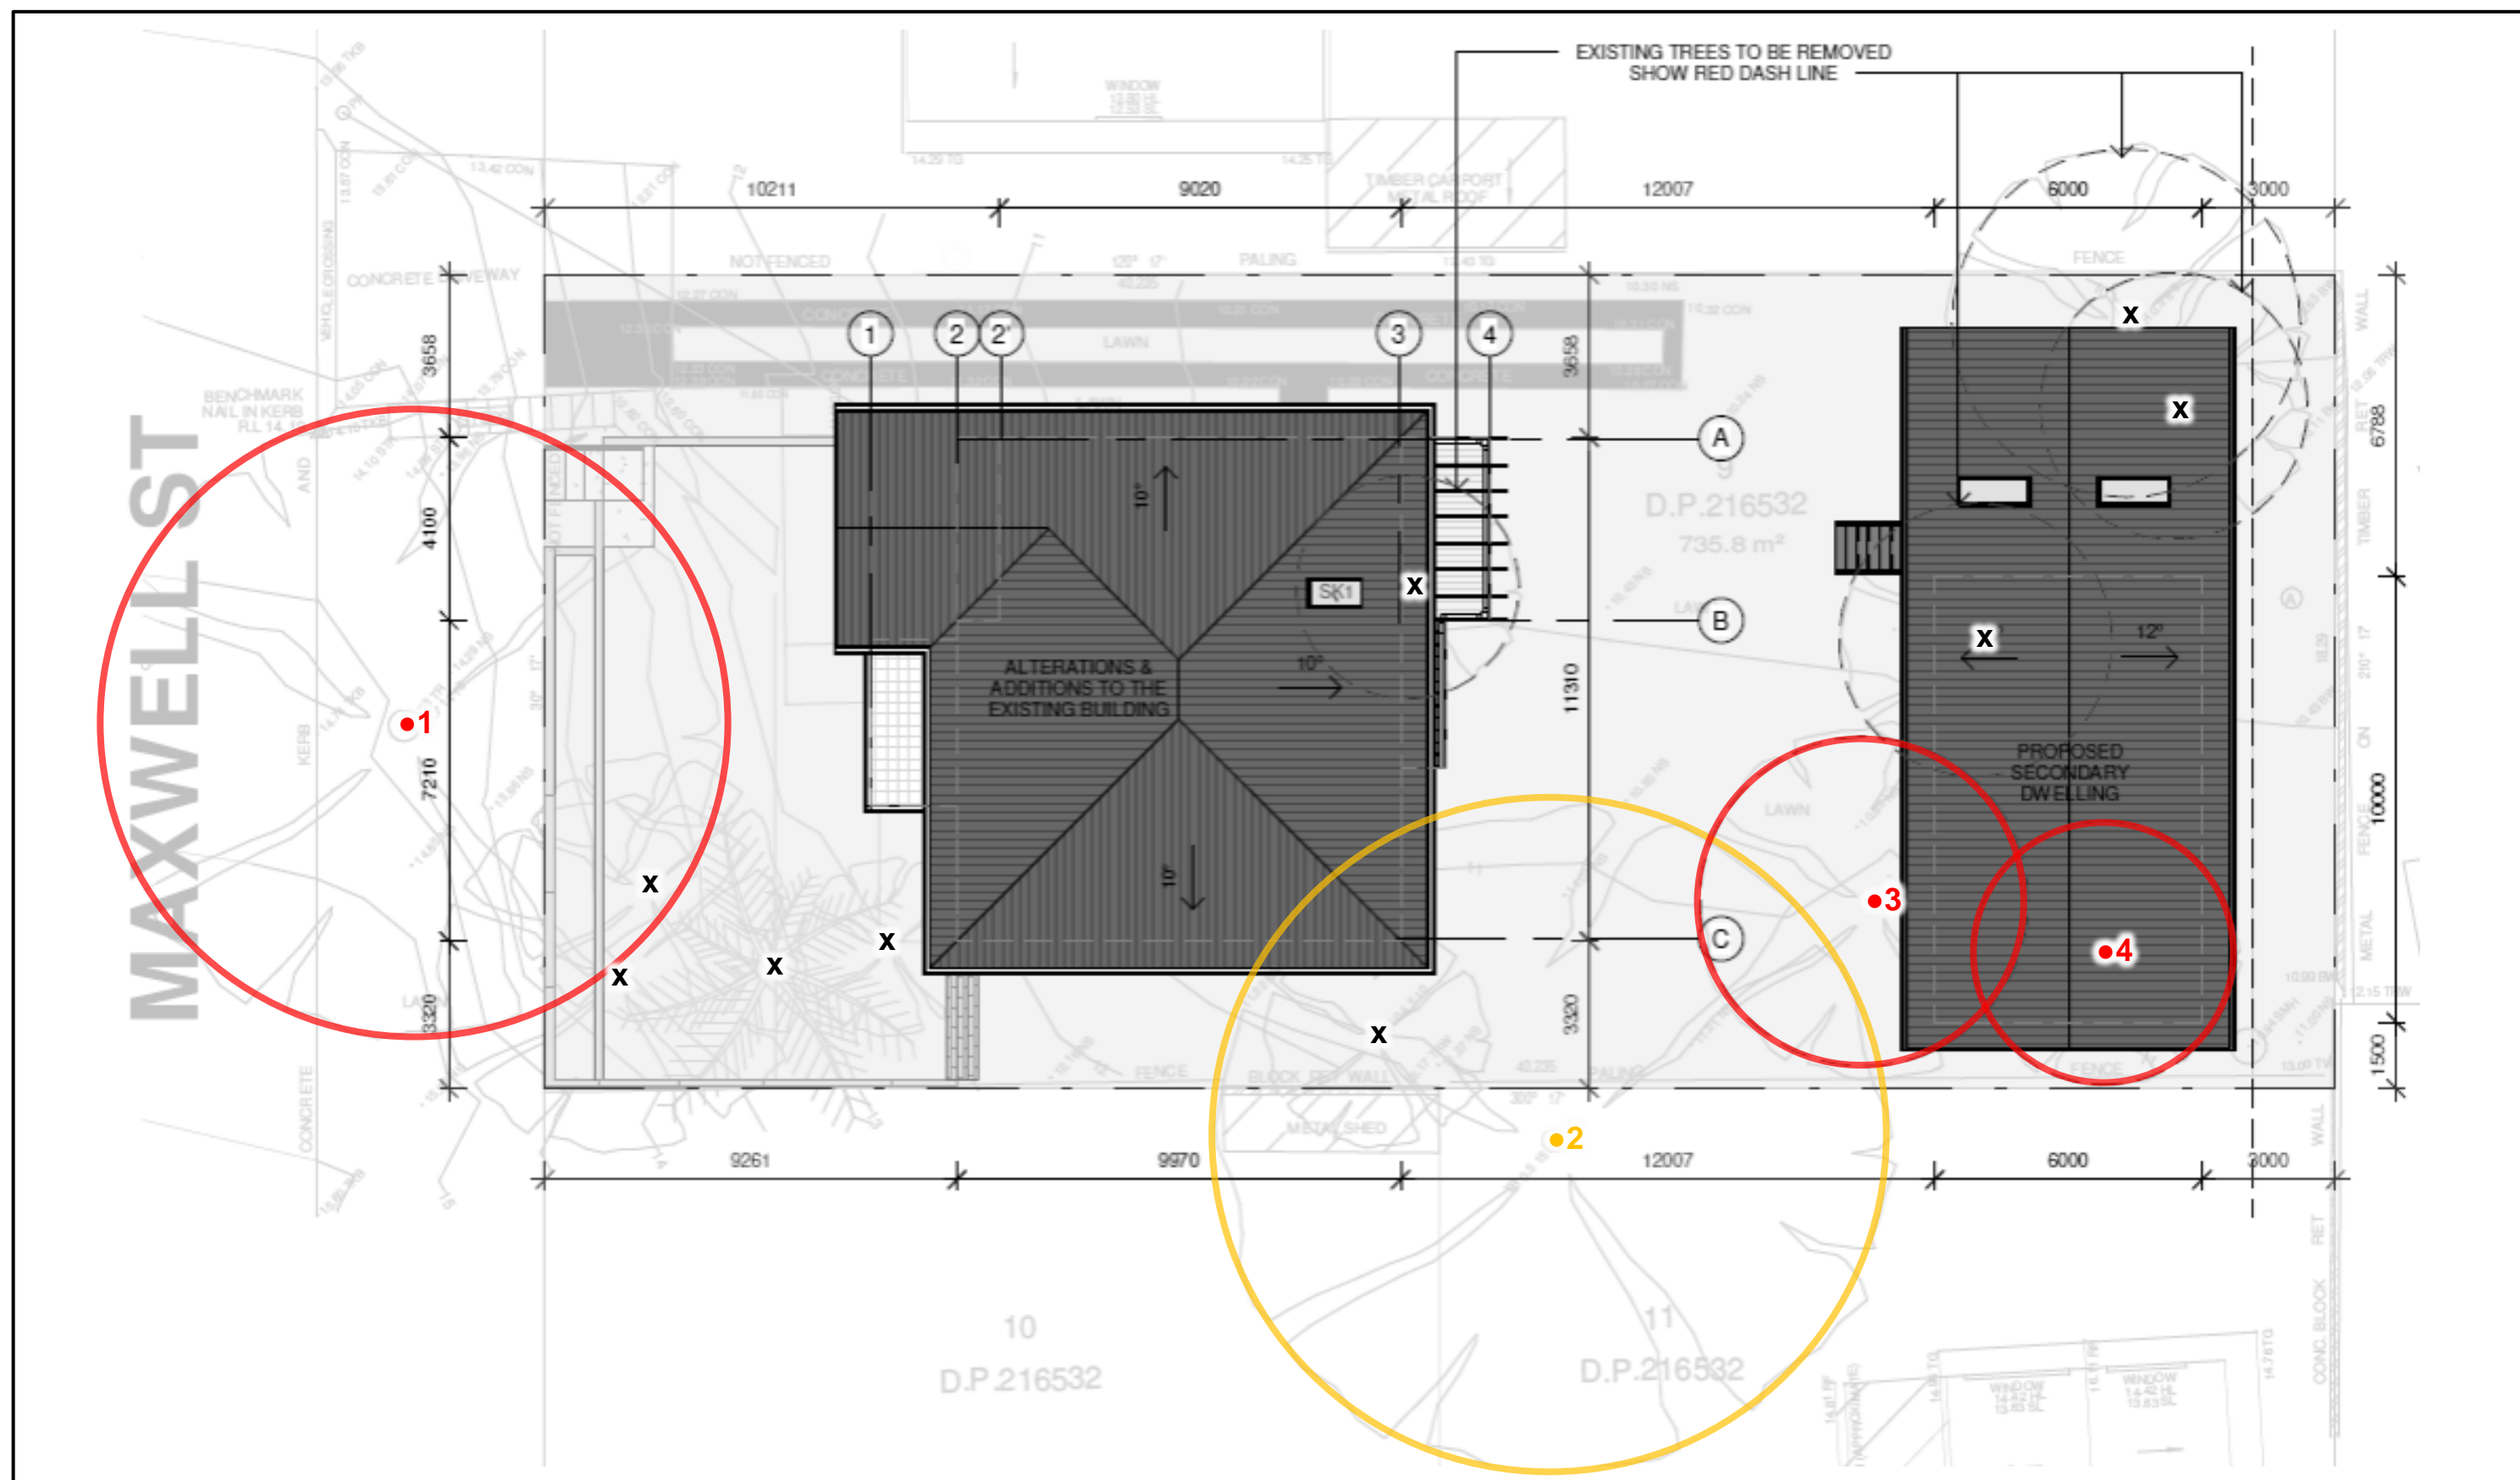
Appendix I: No encroachment, minor encroachment, major encroachment, x = tree removed prior to site inspection

- **Tree 2** will be subject to a minor encroachment of approximately **4%** within the TPZ. The encroachment will not impact upon the SRZ and is unlikely to impact the overall health or condition of the tree. Under the current proposal, this tree can be successfully retained.

- **Tree 1** will be subject to a major encroachment of approximately **19%** within the TPZ. The proposed encroachment is **3m** from the subject tree and will be caused by the installation of the proposed retaining walls. The encroachment will not impact upon the SRZ and is unlikely to impact the overall health or condition of the tree. Under the current proposal, this tree can be successfully retained.
- **Tree 3** and **4** are located inside of the proposed construction footprint. These trees cannot be retained under the current proposal.

- **Tree 3** and **4** are located inside of the proposed construction footprint. These trees cannot be retained under the current proposal.

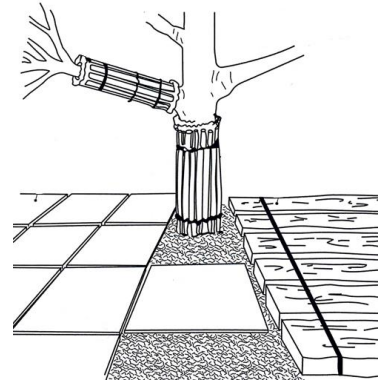
If temporary access for vehicle, plant or machinery is required within the TPZ ground protection shall be installed. The purpose of ground protection is to prevent root damage and soil compaction within the TPZ. Where possible, areas of existing pavement shall be used as ground protection.

- Permeable membrane such as geotextile fabric.
- Layer of mulch or crushed rock (at minimum depth of 100mm)

- Permeable membrane such as geotextile fabric.
- Layer of lightly compacted road base (at minimum depth of 200mm)
- Geotextile fabric shall extend a minimum 300mm beyond the edge of the road base.

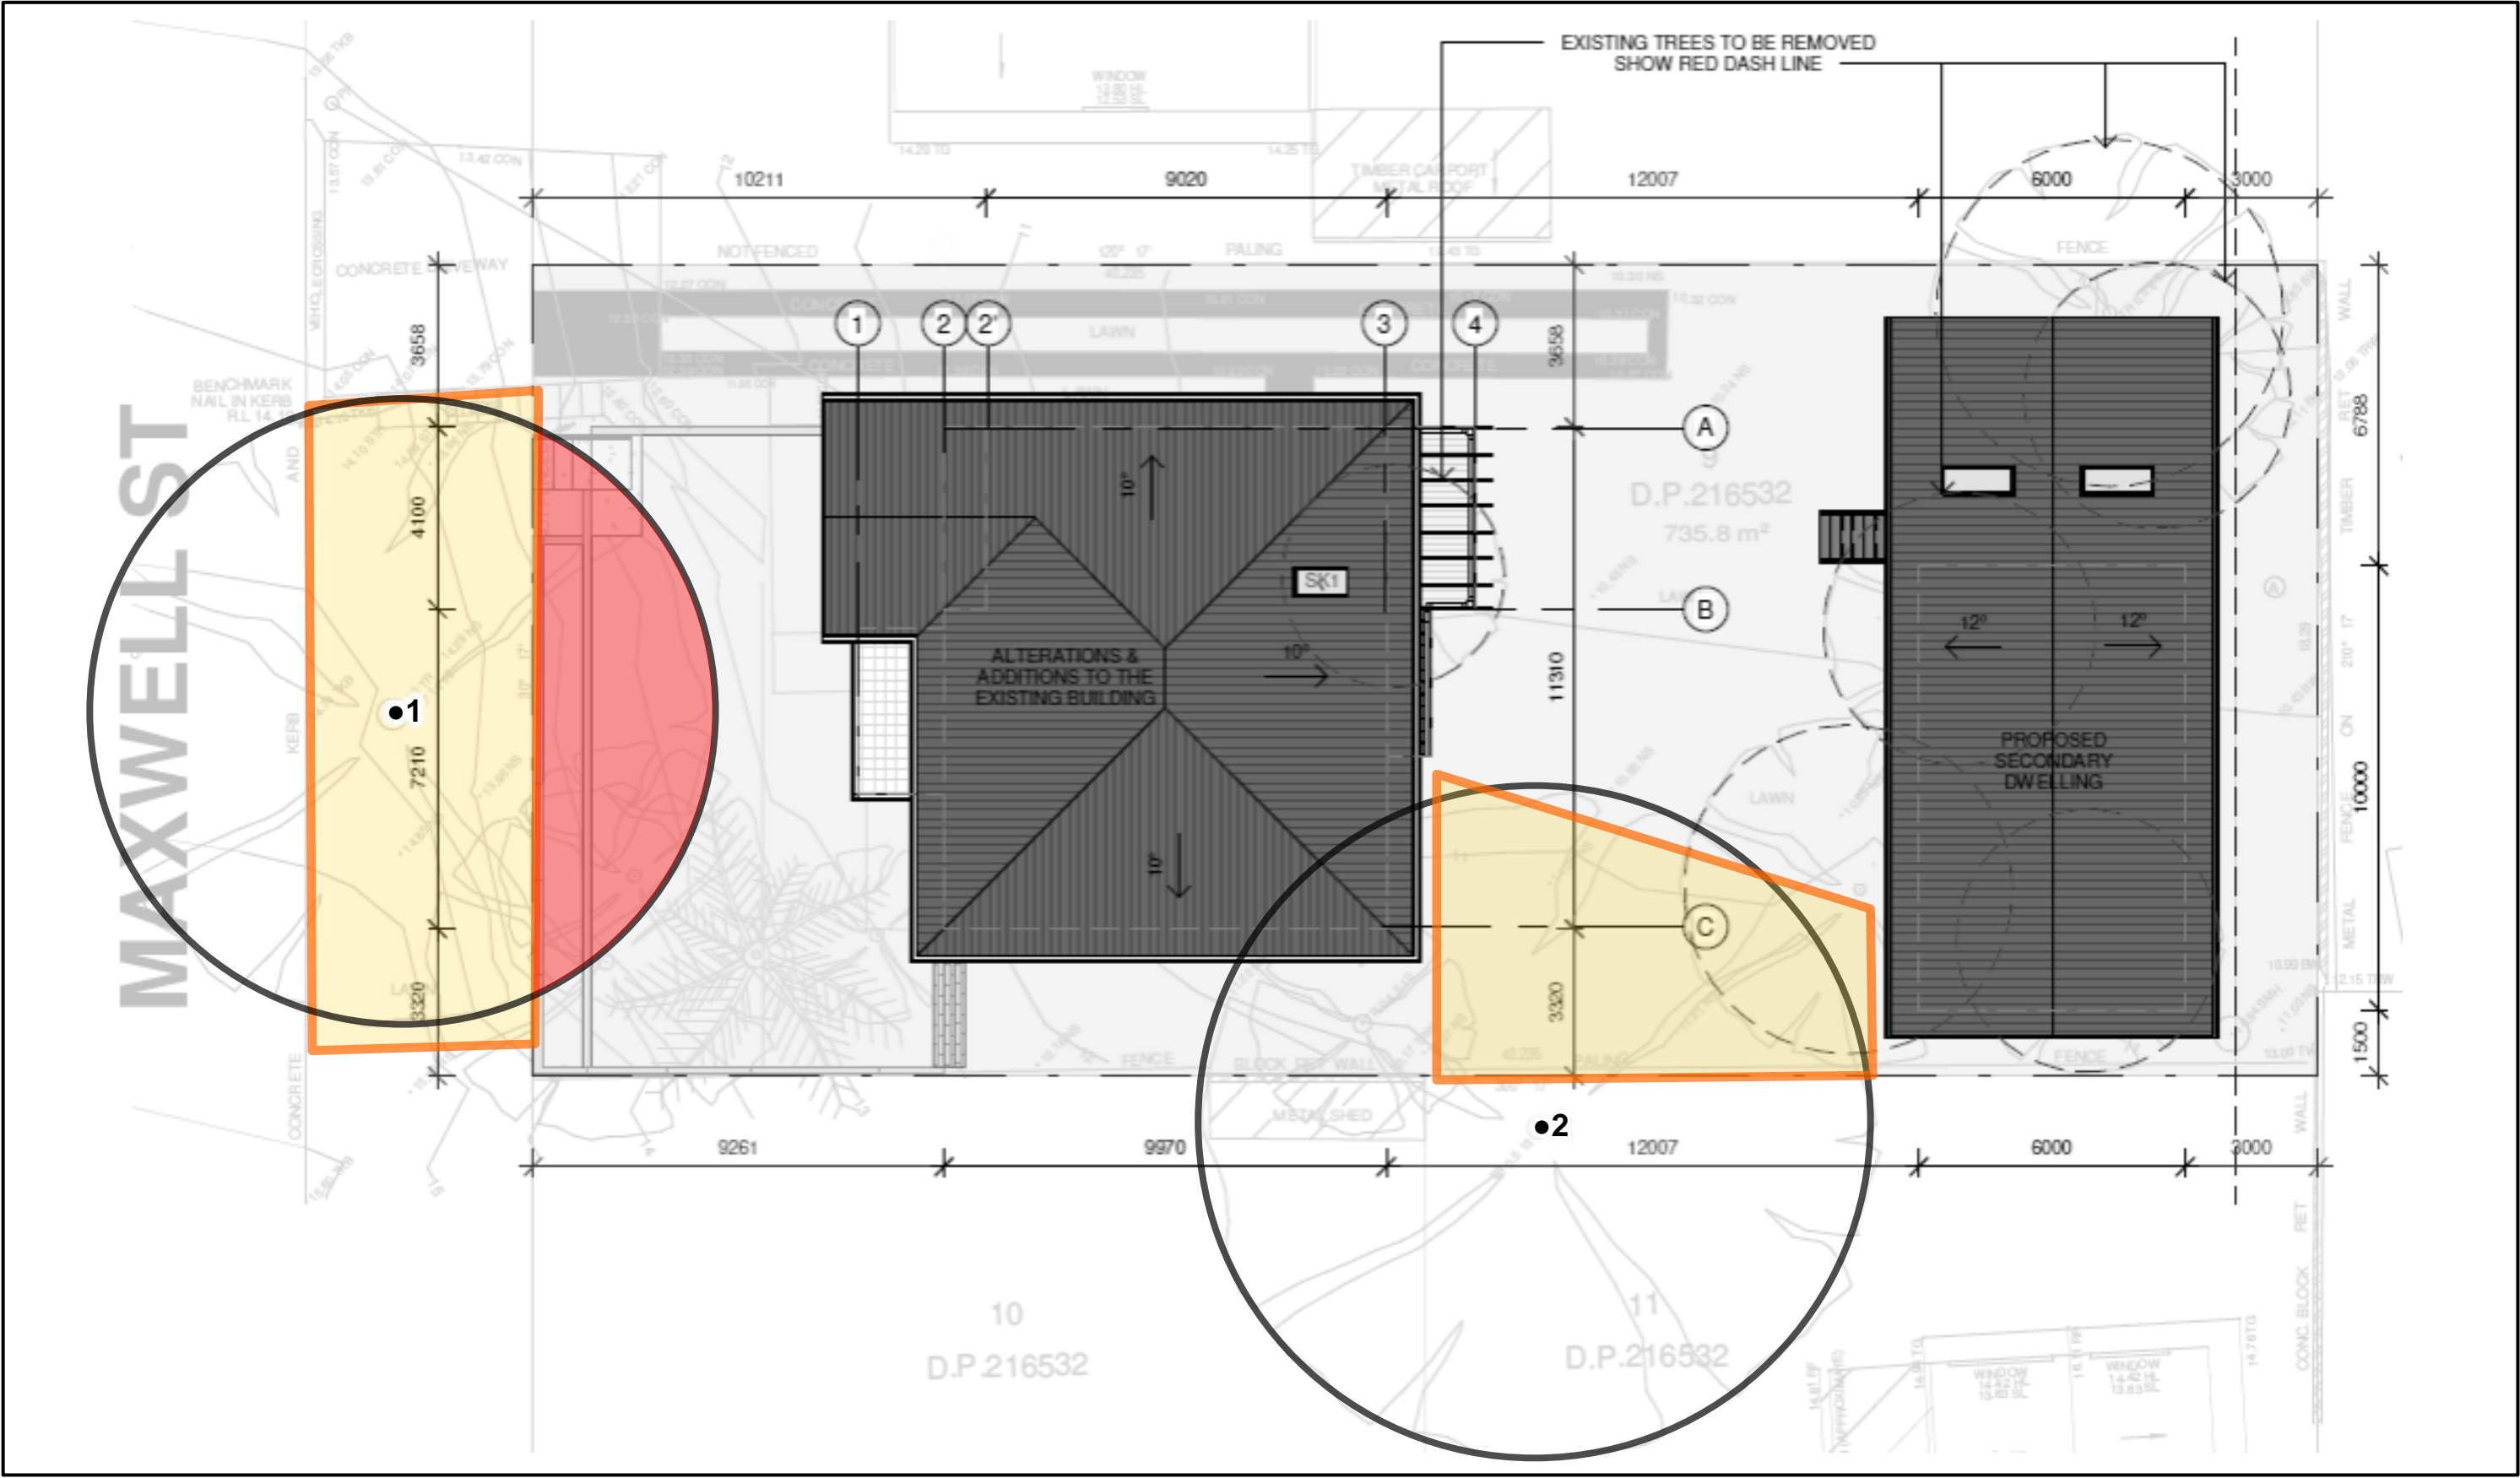
Appendix III: Tree protection zone, tree protection fencing, sensitive zone - arborist supervision required

Tree protection fencing must be established in the locations shown in **Appendix III**. Existing fencing, site hoarding or structures (such as a wall or building) may be used as tree protection fencing, providing the TPZ remains isolated from construction footprint.

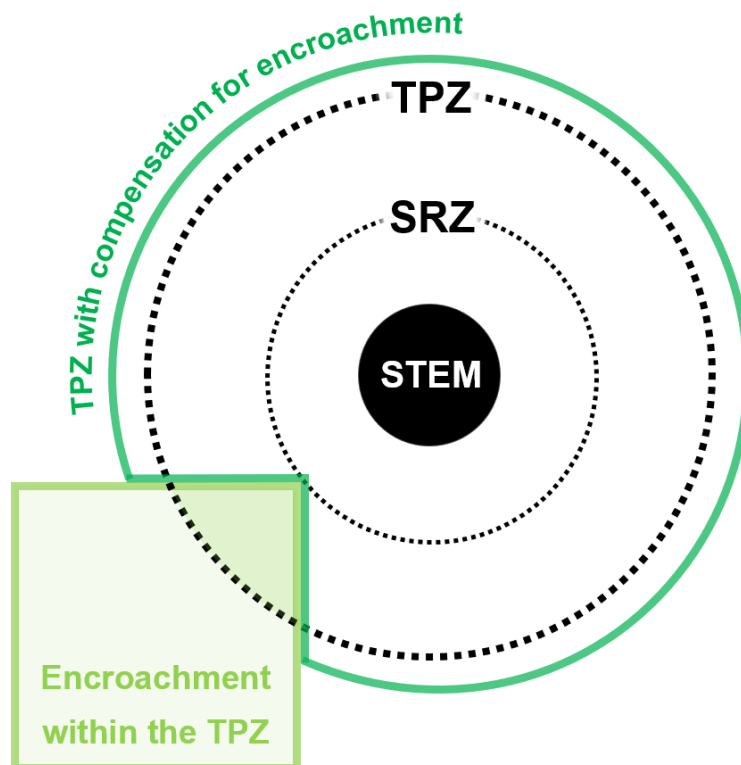
The images below show how encroachment within the tree protection zone can be compensated for elsewhere.

- The tree protection plan (**Appendix II**) must be implemented.
- The area lost to this encroachment should be compensated for elsewhere, contiguous with the TPZ (see **Appendix IV**).
