PHASE 1 (PRELIMINARY) ENVIRONMENTAL SITE ASSESSMENT

181 FOREST WAY, BELROSE

PREPARED FOR: Chiroseph Pty Ltd

DATE: 7 September 2018

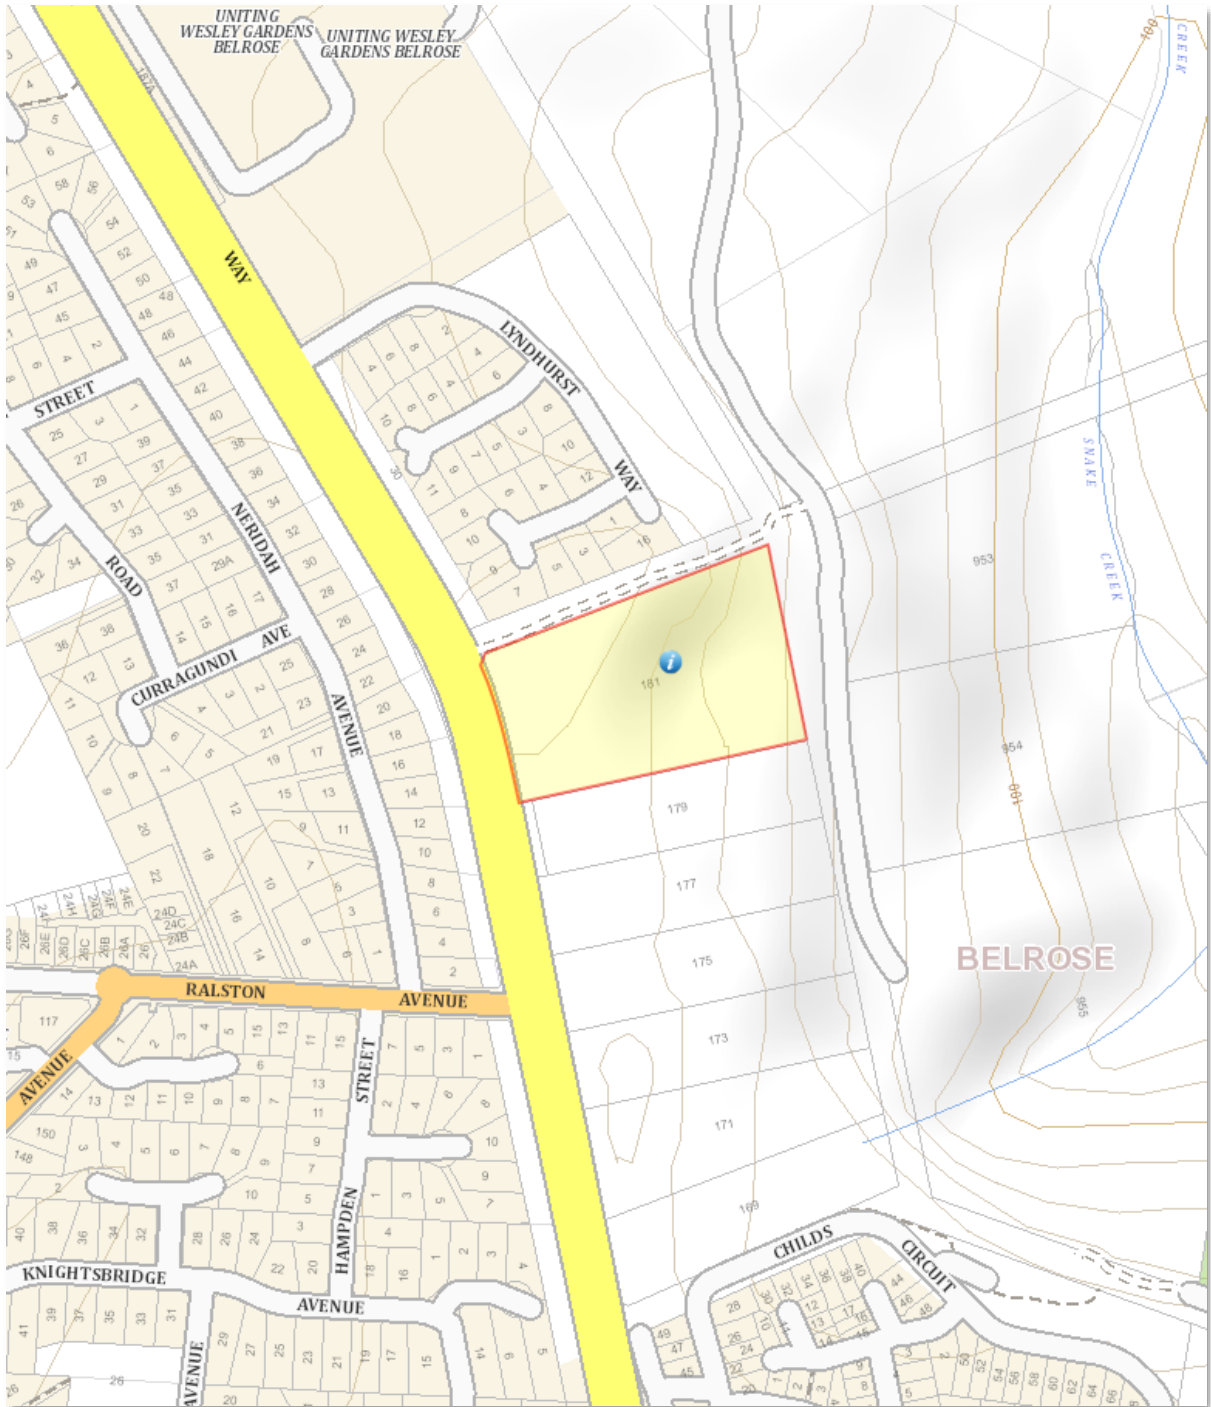
The study site is 181 Forest Way, Belrose (Lot 3 of DP 805710). It is located on the eastern side of the road and occupied approximately 2.1 Ha (Figure 1).

Figure 1: Site Location (NSW Spatial Information Exchange)

The site occupies an east facing side slope of approximately 5% - 25% gradient (Figure 1). A review of Soil Landscape Mapping for the area (Appendix C) indicates the site occurs on the Somersby and Gynea Soil Landscapes.

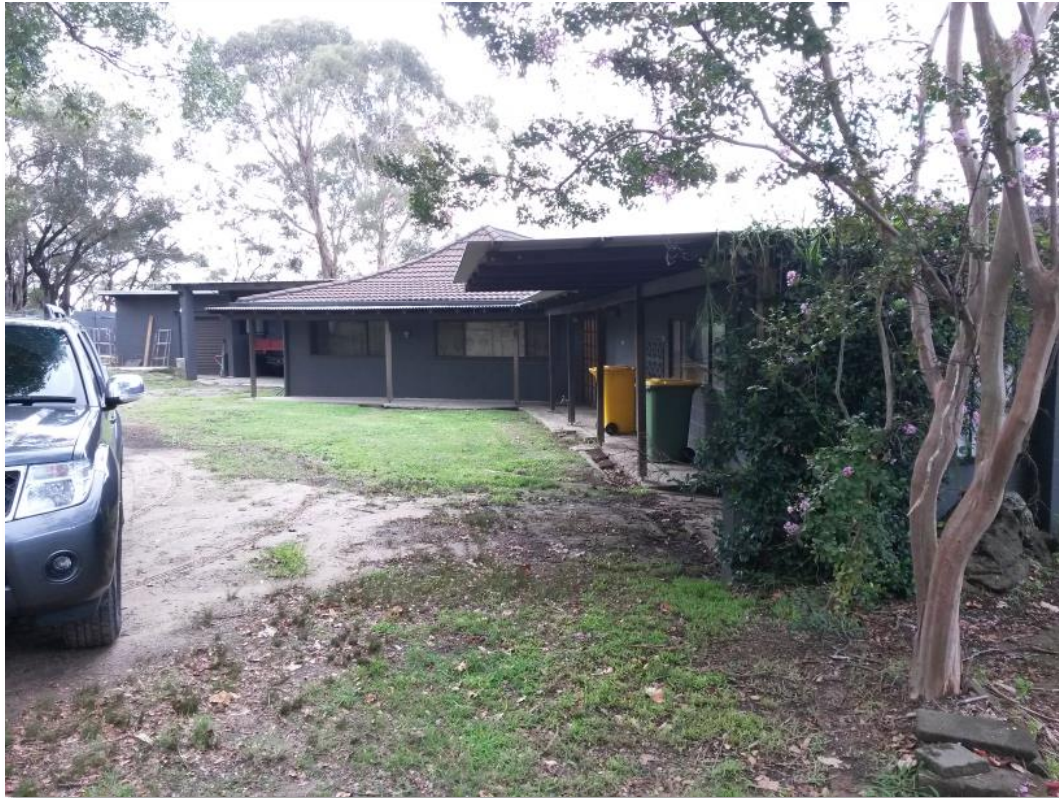
- Buildings on the site of such an age that they may contain hazardous building materials such as asbestos and lead based paints.

Figure 2: Building of Concern - Existing Residence

- Prior to any demolition works it is recommended that existing structures are first inspected by licensed building inspectors for the presence of any hazardous building materials (HAZMAT). Recommendations provided within that HAZMAT report must then be implemented.

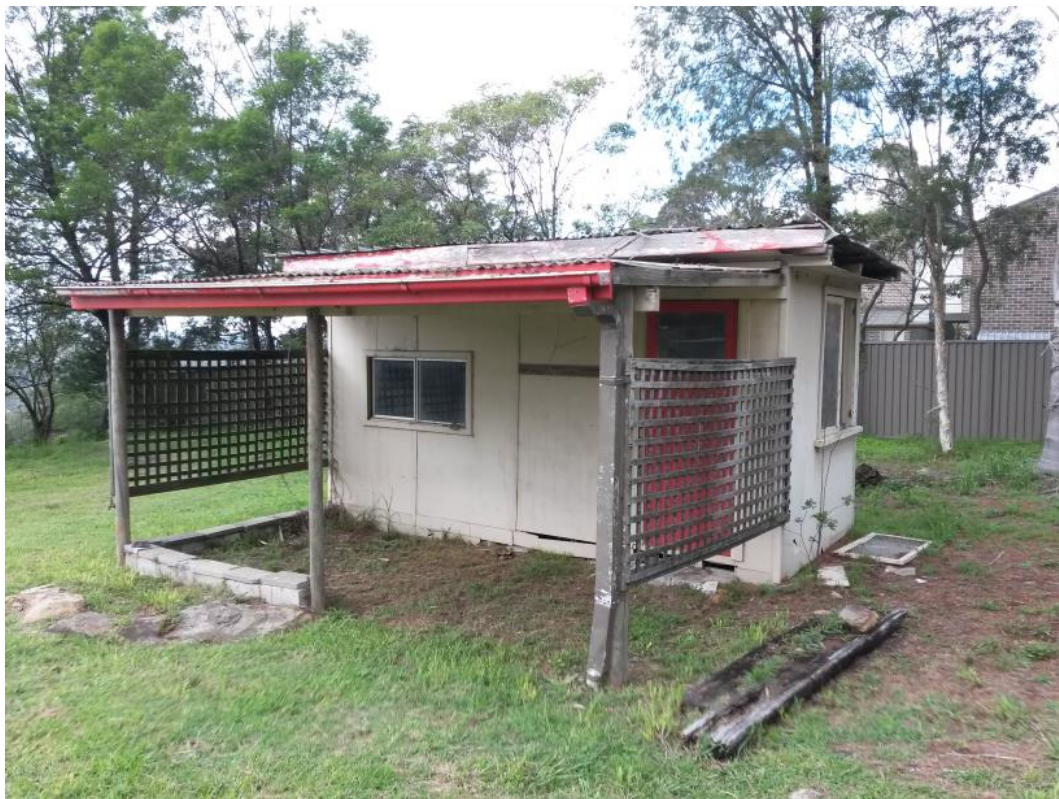
⁽¹⁾ ALS analysis of (Appendix D) samples collected on site confirmed the presence of both lead based paint and asbestos containing materials within a small shed south of the home (Appendix A). No sampling of the main residence was undertaken.

Figure 3: Building of Concern - Existing Shed (*confirmed to contain both asbestos containing materials and lead based paint – Appendix D*).
