Re: Proposed redevelopment of 181 Forest Way, Belrose, NSW (Lot 3 in DP 805710)

Aboriginal archaeological due diligence assessment

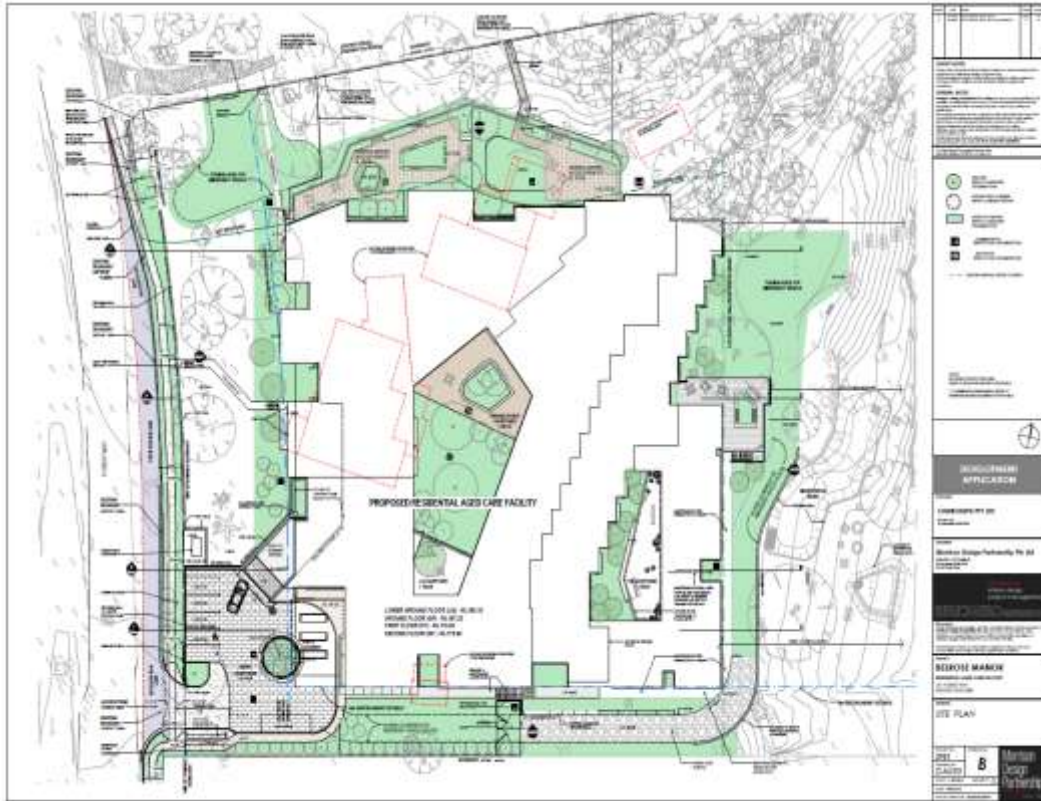
Proposed redevelopment plan (Morrison Design Partnership 2018 – Issue B)

The proposed development will result in the clearance of 0.62 ha out of a total of 1.99 ha of vegetation that remains on the site (Cumberland Ecology 2018). The DA seeks approval to demolish the existing residence and outbuildings, and to construct over the existing house and landscaped garden footprint a new 138 bed Residential Aged Care Facility over four storeys containing basement car parking for 46 cars.

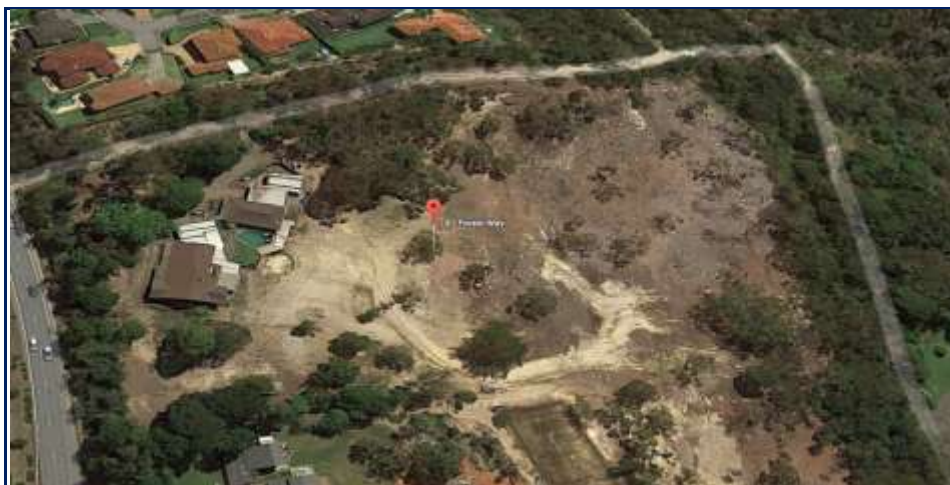
*The proposed redevelopment footprint will take in the existing house, outbuildings and garden area on the block, and will extent towards the break in slope to the east where the sloping sandstone shelved and benched landforms that are present in the eastern two-thirds of the property will remain unaffected by the proposal*

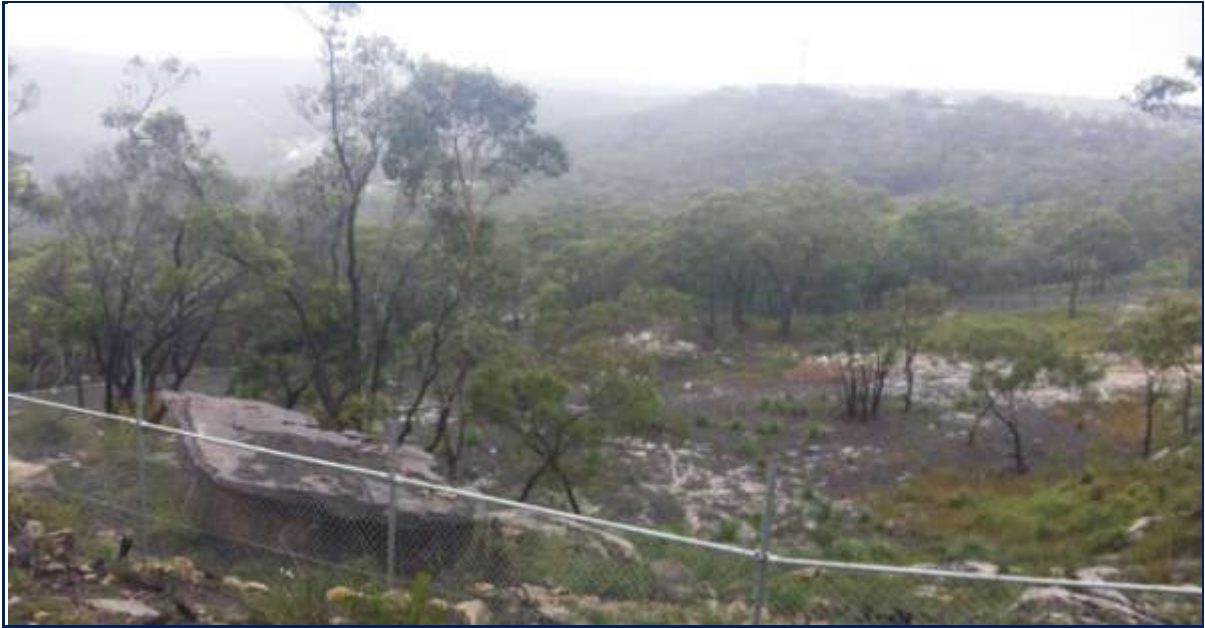
*Looking south over the sloping sandstone shelves and benches that are present in the eastern two-thirds of the property that will not be affected by the redevelopment proposal*

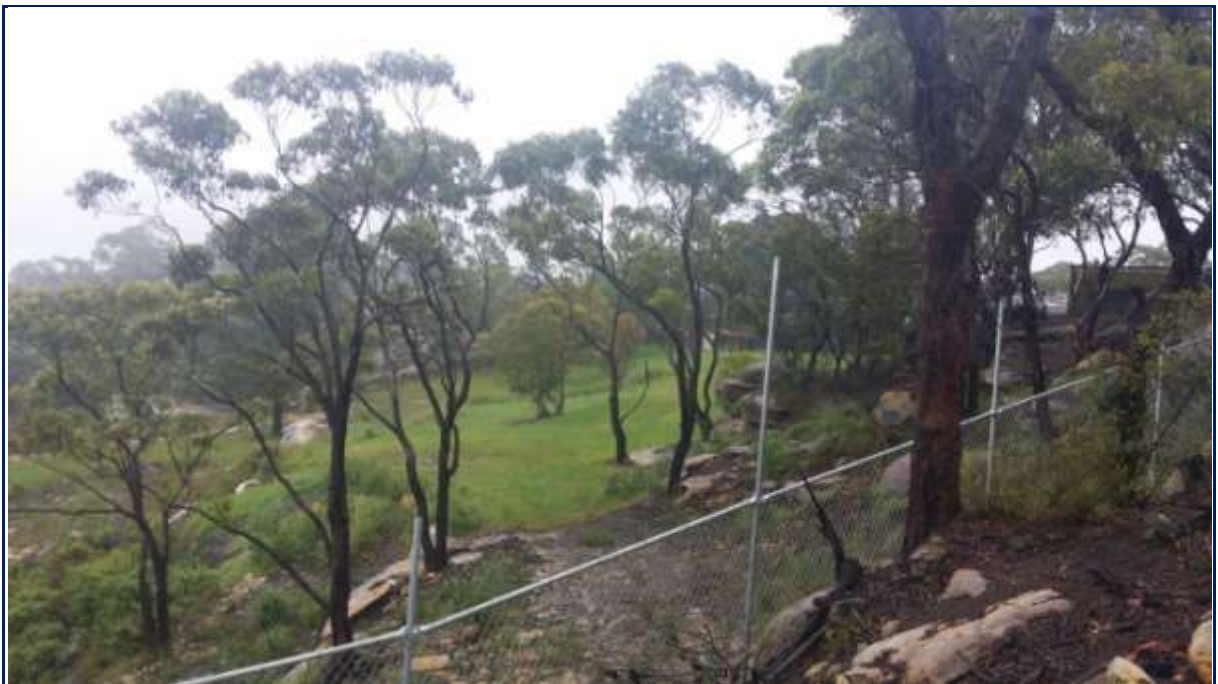
*Nature of the grassed-over landscape between the existing house and garden in the western third of the property (right) and sandstone slopes (left) to the east*

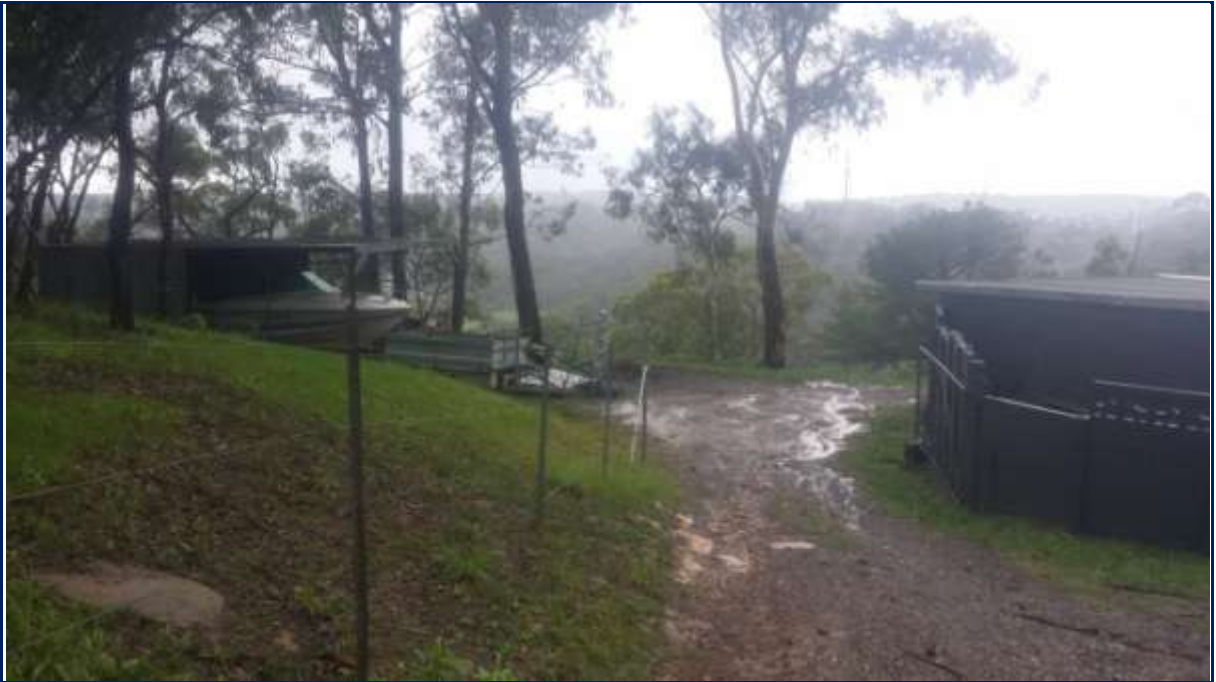
*Carport to the left and house to the right, separated by an unsealed gravel entrance drive. The grassed-over mound in the left foreground is likely to be excavated/graded spoil materials leftover from previous constructions and/or demolitions on the block*

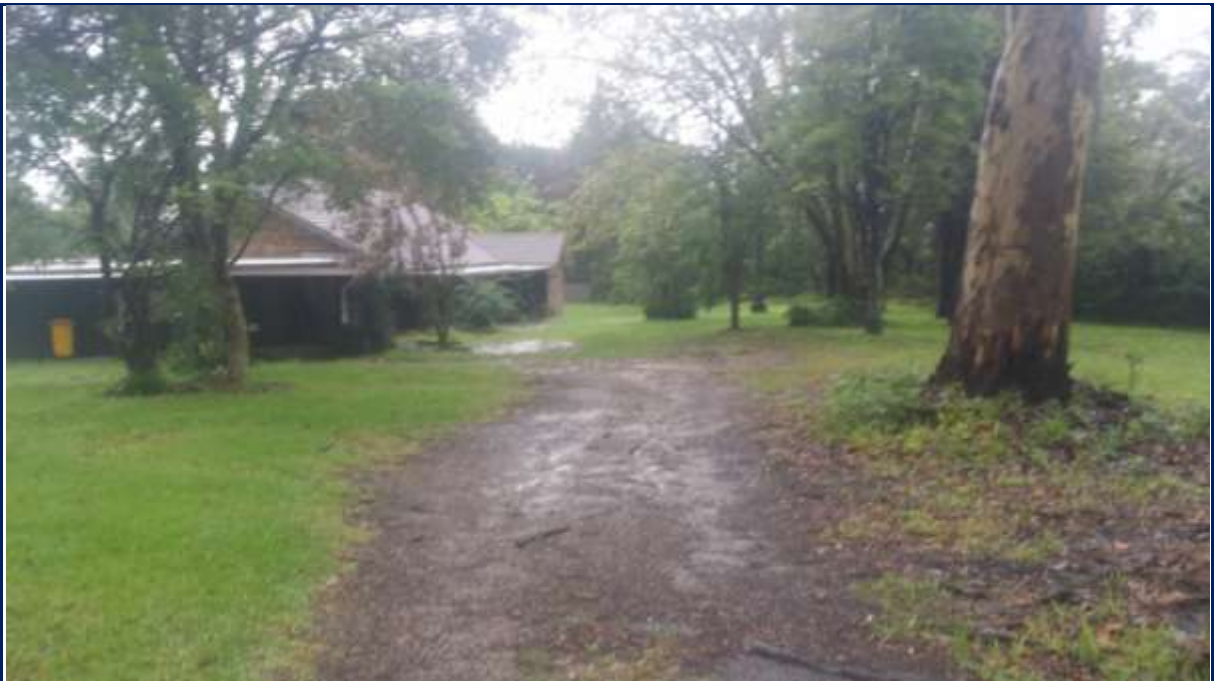
*The house and wrap-around garden area illustrated will be demolished for the new aged care facility. This land is gently undulating and does not have the slope gradients required to have formally retained large and overhanging outcropping (rock shelters). It is also expected that former sandstone surfaces that may have been originally been exposed in this part of the site will have been considerably impacted by site preparation and construction and landscaping works required during two separate building phases since the 1940s*

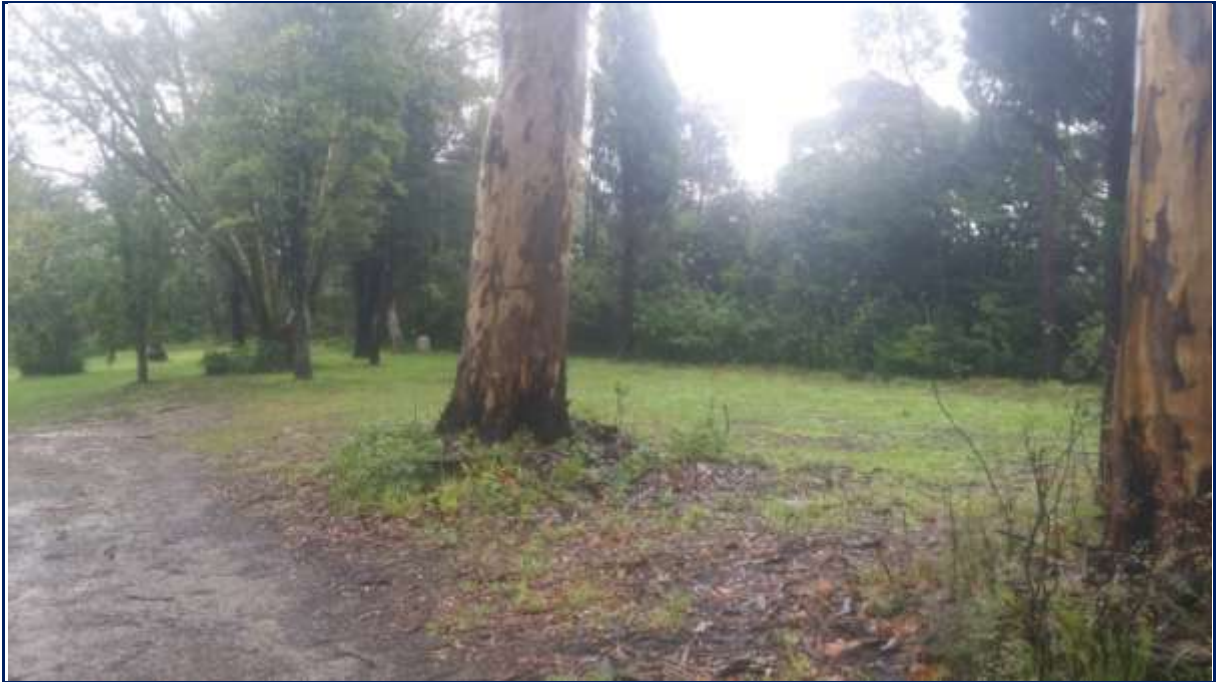
*A sub surface profile of sand and sandstone fragments is evident beneath the grass in various exposures where no in situ soil development is apparent. It is unlikely that any intact soil profiles with the potential to contain any Aboriginal archaeology survive here*

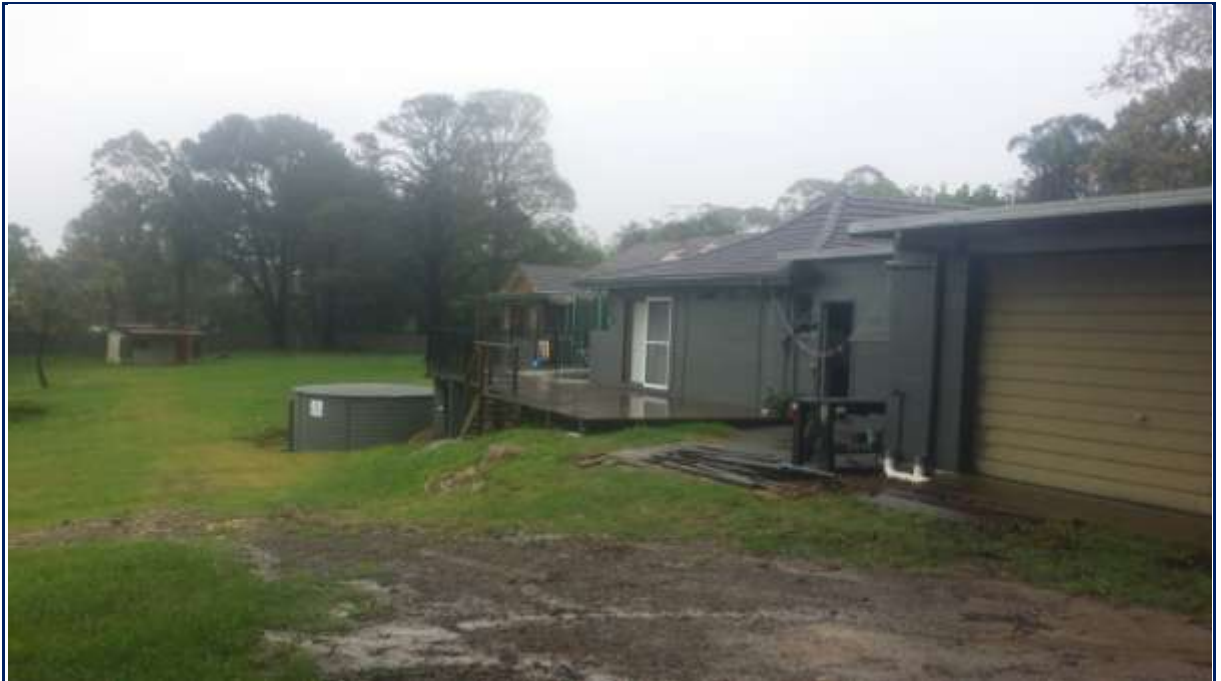
*The excavations required to create the building platform for the existing house are evident in this image*

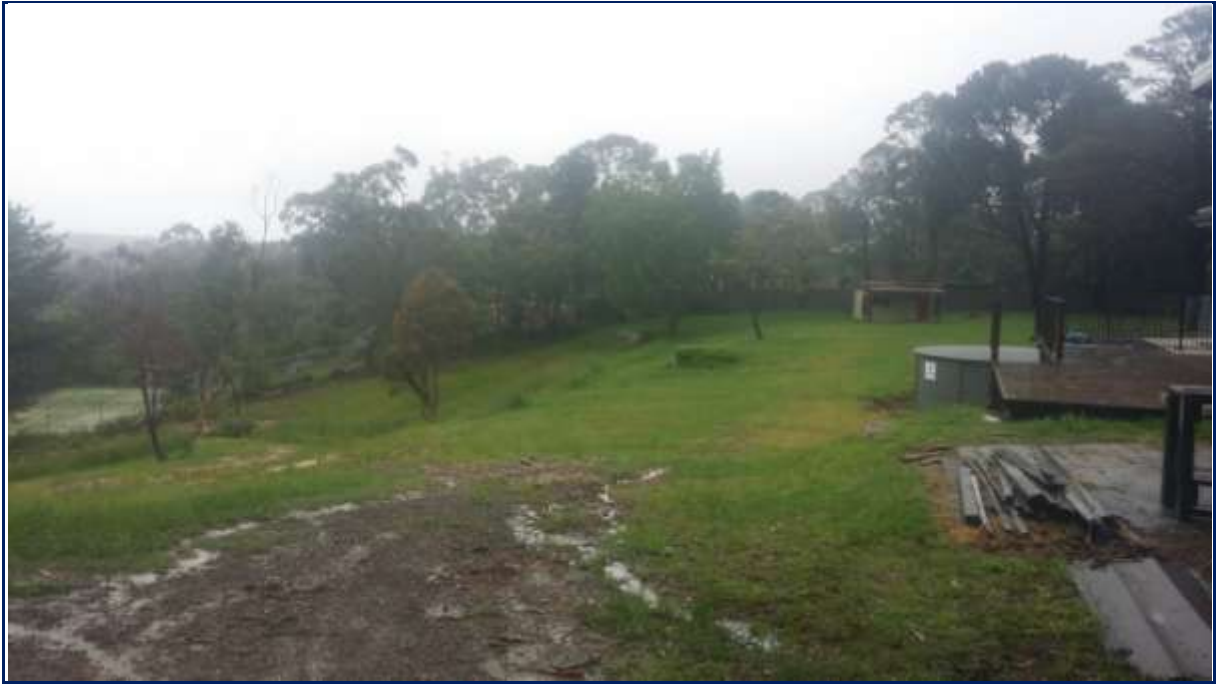
*Relationship of the already disturbed building and landscaping footprint created by the ongoing occupation and use of the block, and the break in slope marking the commencement of the main sandstone benched and shelved rock outcrops that characterise the more steeply sloping eastern two-thirds of the property*

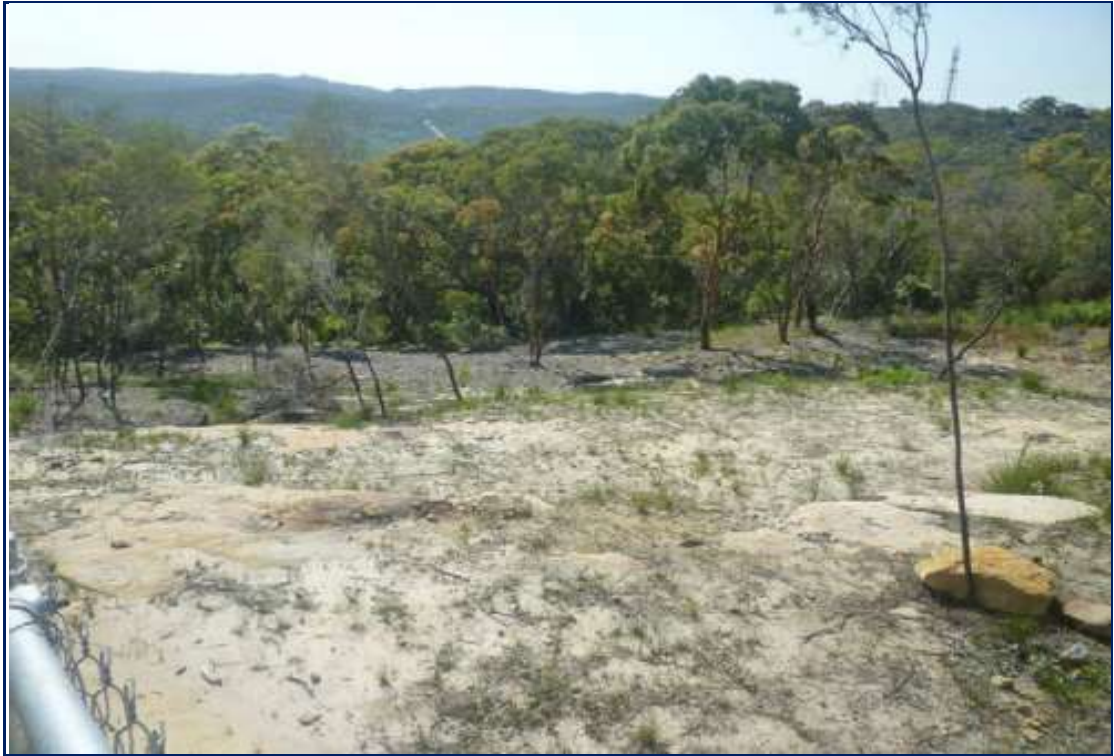
- No rock engravings have been identified on the surfaces of the exposed sandstone bedrock within the property. The majority of the horizontal and sloping surfaces of the exposed sandstone (all outside of the proposed development area) are irregular and eroded with friable and undulating surfaces that may have been unsuitable (or at least unattractive and not first choice ) to Aboriginal people for the creation of engraved (see below).

*Sandstone benches and horizontal surfaces exposed in the eastern part of the site (looking east) in December 2016 (Travers Ecology and Bushfire 2016: Photograph 5)*

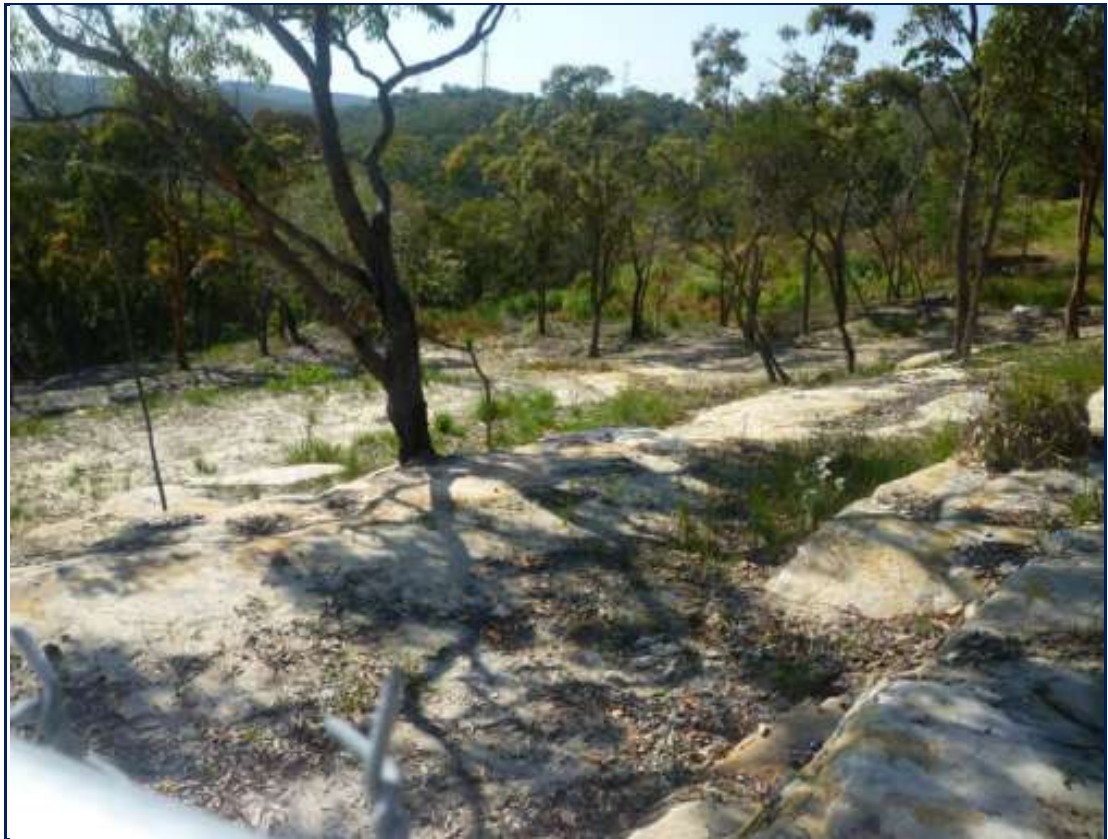
*The surfaces of these sandstone exposures are extremely soft and friable and irregular and thereby unlikely to have been suitable for engraving if exposed in the past (Travers Ecology and Bushfire 2016: Photograph 6)*
