## **REPORT ON GEOTECHNICAL SITE INVESTIGATION**

### **PROPOSED NEW RESIDENTIAL DEVELOPMENT**

**No.75-No.77 FOAMCREST AVENUE, NEWPORT,  
NSW**

**Project No.: 2020-202**

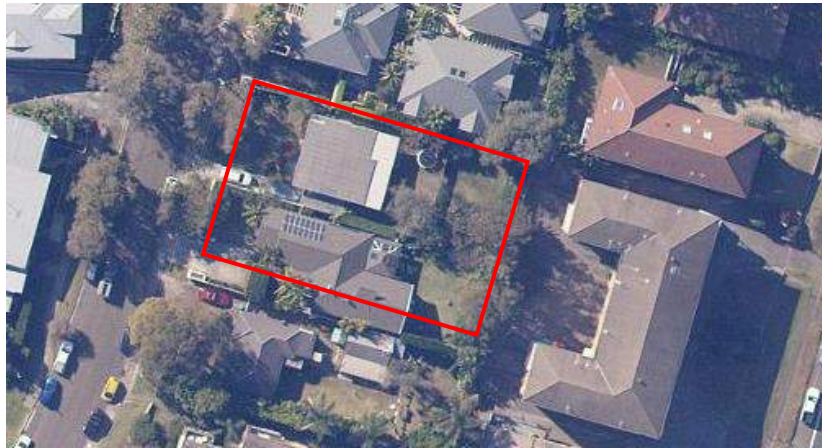
*Photograph-1: Aerial photo of site and surrounds.*

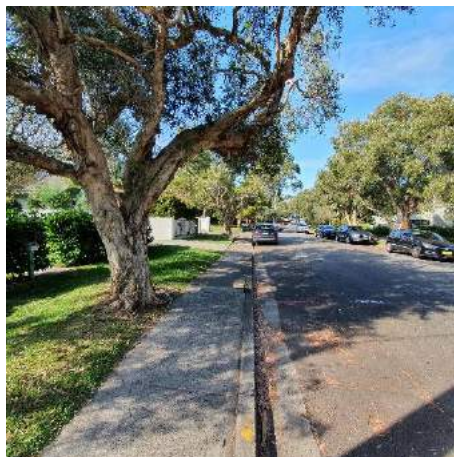
The site is located on the low east side of Foamcrest Avenue within gently east dipping topography. Foamcrest Avenue is formed with a gently south dipping bitumen pavement where it passes the site, with low concrete gutter and kerbs, a concrete pathway, grass lawn and two trees (up to  $\leq 10.0\text{m}$  height). The road pavement and road reserve appeared in good condition, there were no signs of significant undulations, deformations or underlying geotechnical issues.

*Photograph-7: Foamcrest Avenue road reserve. View looking south.*

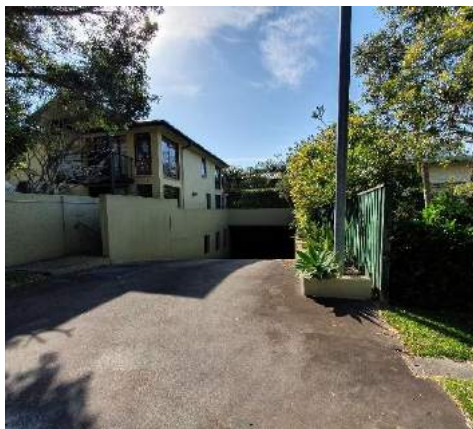
The neighbouring property to the north (No.79-83 Foamcrest Avenue) contains two separated two storey rendered unit buildings (within the west and east side of the property) that extend south to within approximately 4.50m to 7.00m from the common boundary at similar GSL to the site. The south-west corner of the property contains a concrete driveway ramp (Photograph-8), that leads down east to a basement carpark at a level approximately 3.0m below the site's GSL. The neighbouring dwellings, driveway and observed structures appeared in good condition, significant deformation or cracking or underlying geotechnical issues were not observed within the neighbouring property.

*Photograph-8: No.79-No.83 Foamcrest's front driveway, directly to the north of the site. View looking east.*

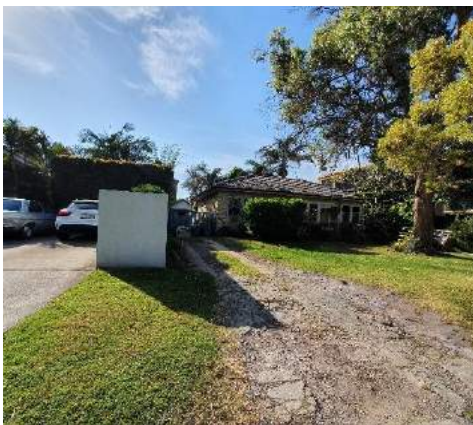
The neighbouring property to the south (No.73 Foamcrest Avenue) contains a single storey clad house with a detached fibro shed to the north east, front and rear grass lawns with a front strip driveway (Photograph-9) at the north-west corner of the property. The fibro shed is adjacent to the common boundary, whilst the dwelling extends north to approximately 2.50m from the common boundary. The front driveway and fibro shed, and rear grass lawn contain a similar GSL to the site. The property dwelling appeared in a relatively old condition, however significant deformation, cracking or underlying geotechnical issues were not observed within the neighbouring property.

*Photograph-9: No.73 front driveway, directly to the south of the site. View looking east.*
