142 OCEAN STREET

DEVELOPMENT PROPOSAL

ARBORICULTURAL IMPACT ASSESSMENT REPORT

Report Ref No- 8821

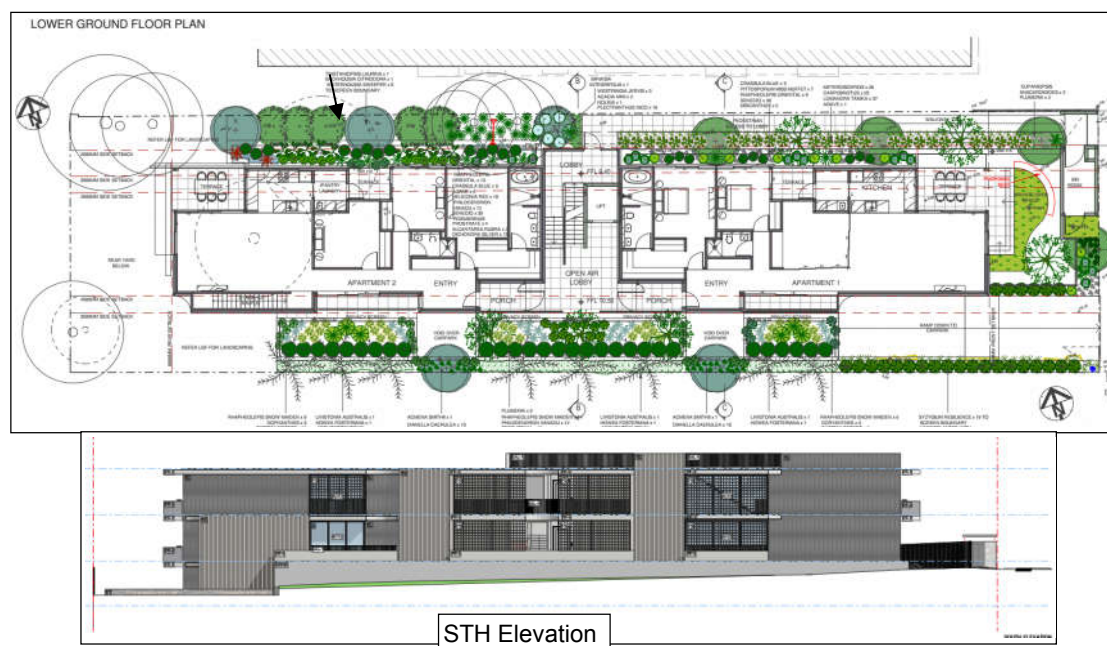
Figure 1, showing proposed design footprint

1.2.1 The proposal consist of constructing a multi-level apartment block facility with deep excavation to accommodate lower levels within tree protection zones setbacks.
