## **GEOTECHNICAL INVESTIGATION:**

### **New Garage and Driveway at 139 Lagoon Street, Narrabeen**

- 1.1** Construct a new driveway, garage and entryway on the W side of the property by excavating to a maximum depth of ~2.9m.
- 1.2** Details of the proposed development are shown on 7 drawings prepared by MHDP Architects, project number 2122, drawings numbered A001, A100, A101, A201, A211, A212 and SK10, dated 25/11/24.

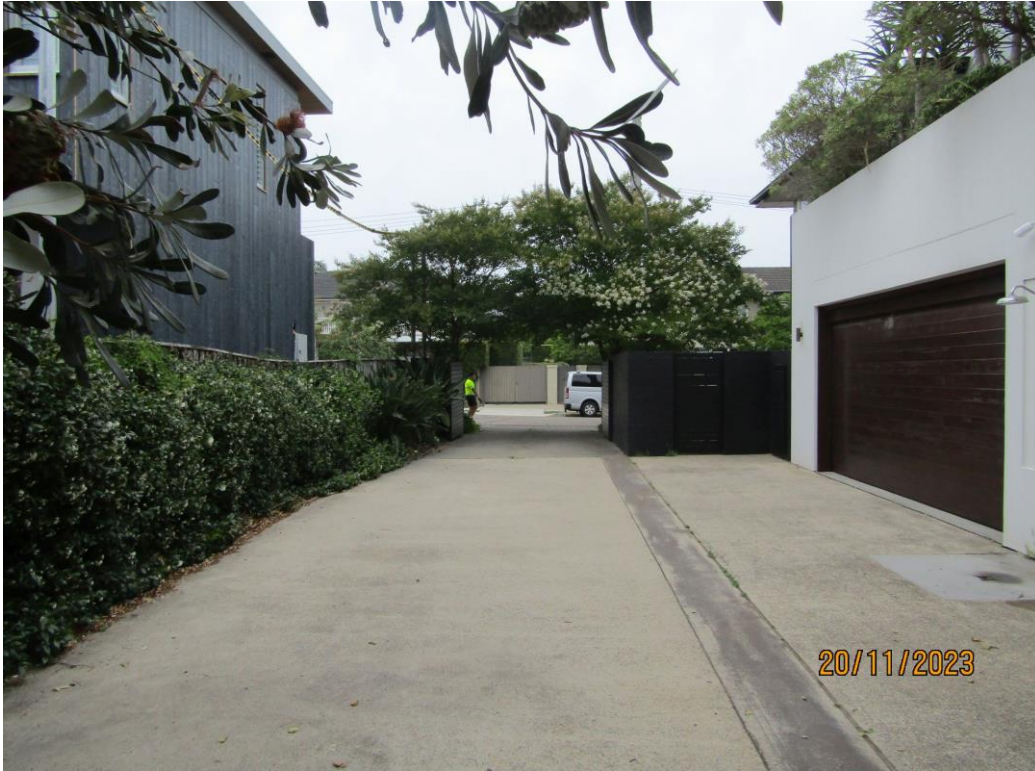
Photo 1

- 2.3** A concrete Right of Carriageway (ROW) runs from Malcom Street to a garage on the ground floor of the house (Photos 1 & 2). The part two storey brick and rendered masonry house is supported on masonry walls (Photos 2 & 3). The external supporting walls show no significant signs of movement. A deck and balcony extend off the NW side of the house (Photo 4). Fill provides level platforms for lawn and garden areas on the W side of the house (Photos 5 & 6). The fill is supported by stable low timber retaining walls (Photo 6). No signs of slope instability were observed on the property. The adjoining neighbouring properties were observed to be in good order as seen from the street and subject property.

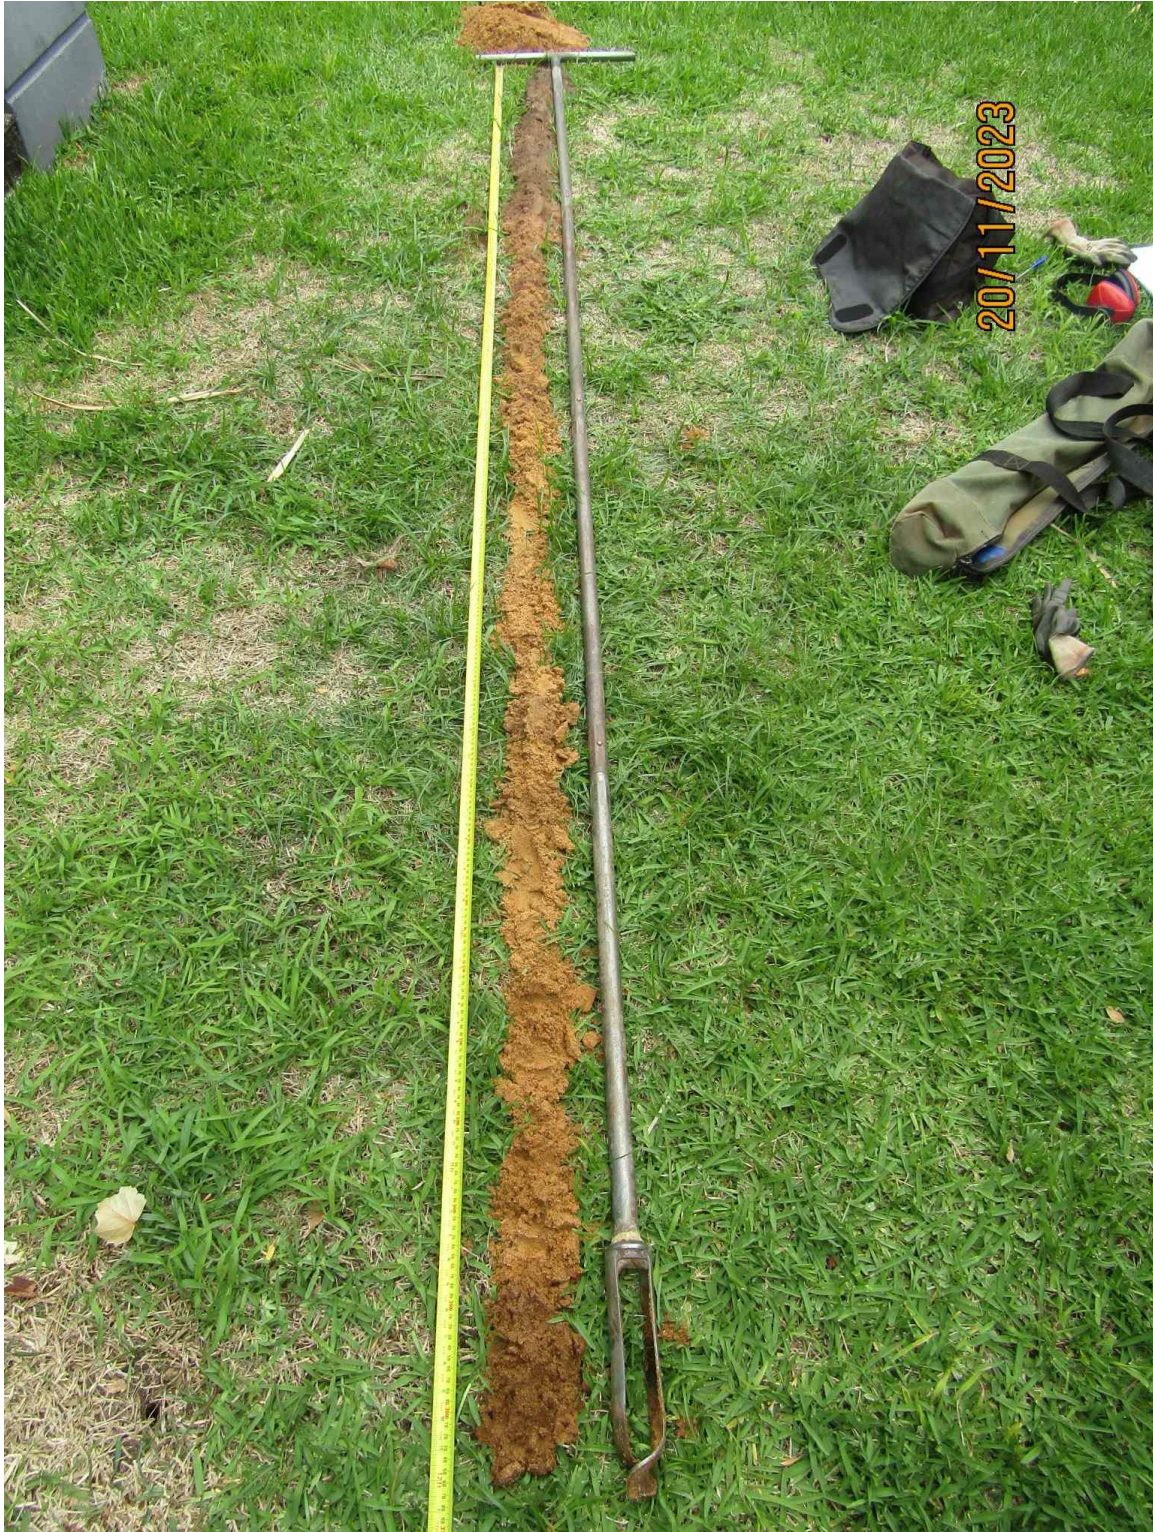
Photo 7: AH1 – Downhole is from top to bottom.

#### AUGER HOLE 1 (~RL8.0) – AH1 (Photo 7)

Depth (m)	Material Encountered
0.0 to 0.9	<b>SANDY FILL</b> , sandy soil and silty sand, with some rock fragments, dark brown, brown, grey, medium dense, dry, fine to coarse grained.
0.9 to 3.7	<b>SAND</b> , orange, orange brown, yellow brown, brown, medium dense, dry to moist, medium grained.

End of Test @ 3.7m in Medium Dense Sand. No water table encountered.
