Construction Impact & Management Statement & Preliminary Plan of Management

February 2024 – updated November 2024

35A Queens Avenue, Avalon Beach NSW 2107

Prepared by: Kyle A Hill

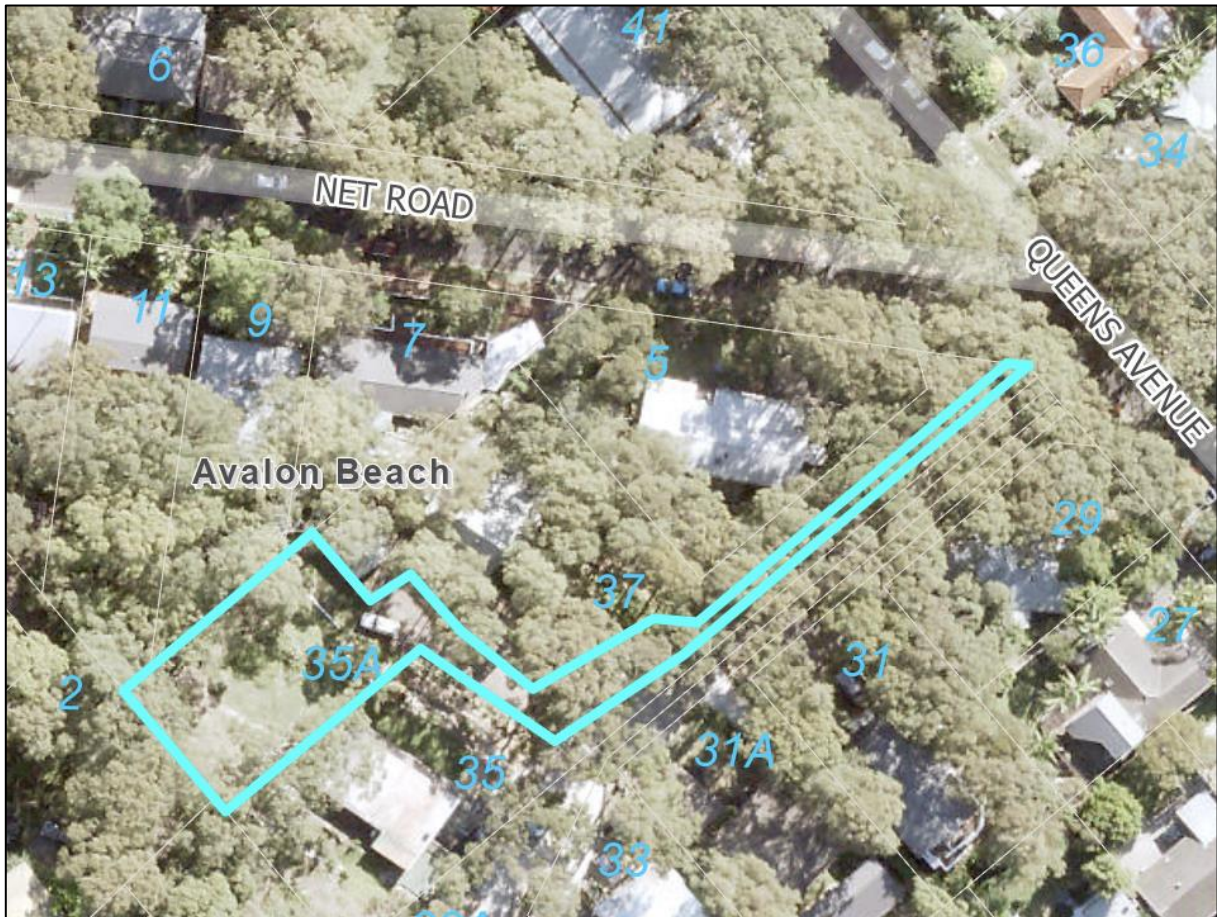
FIGURE 1: ABOVE ILLUSTRATES THE DISCUSSED TREES RELATIVE TO THE SITE 35A QUEENS AVENUE, AVALON BEACH NSW 2107. (AERIAL PHOTOGRAPH FROM MAP DATA NBC IMAGE, JACOBS AEROMETREX)

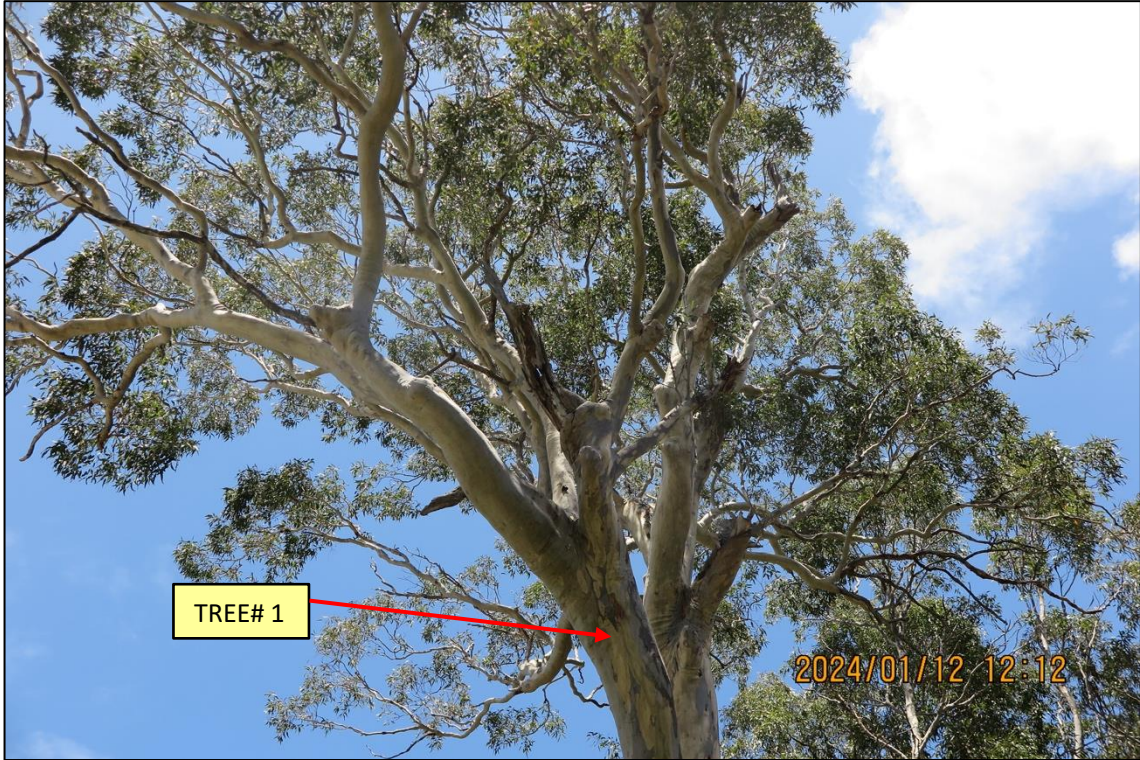
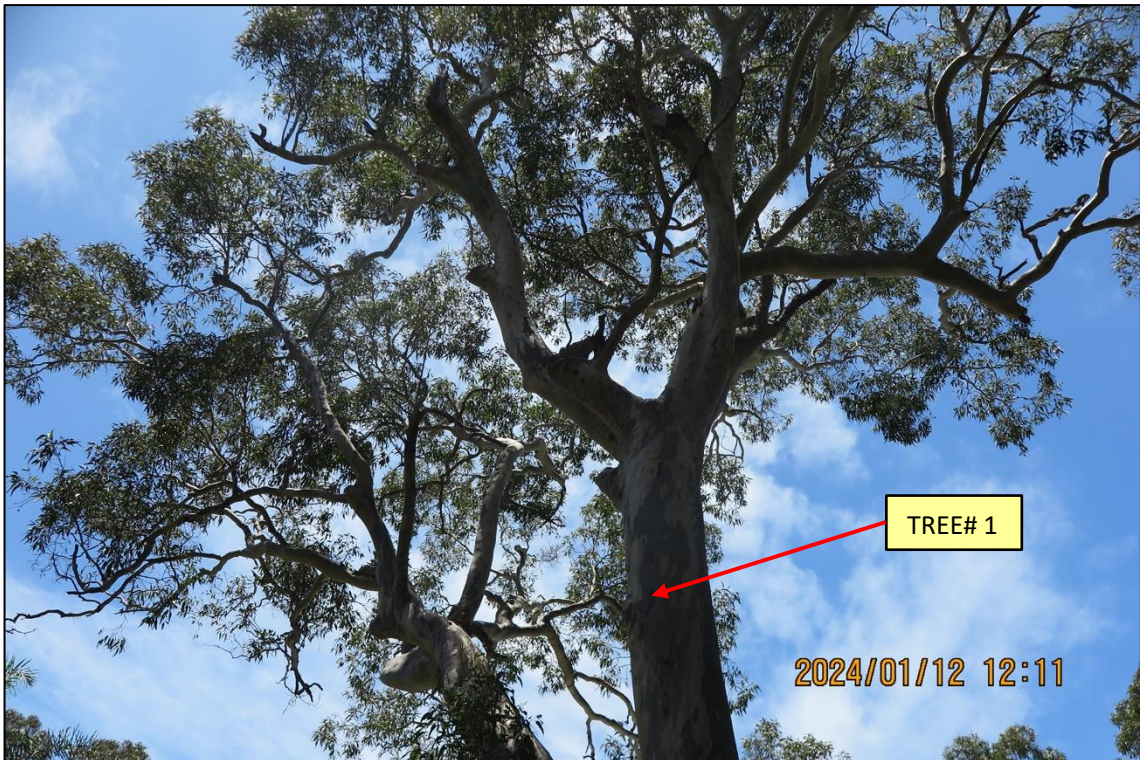
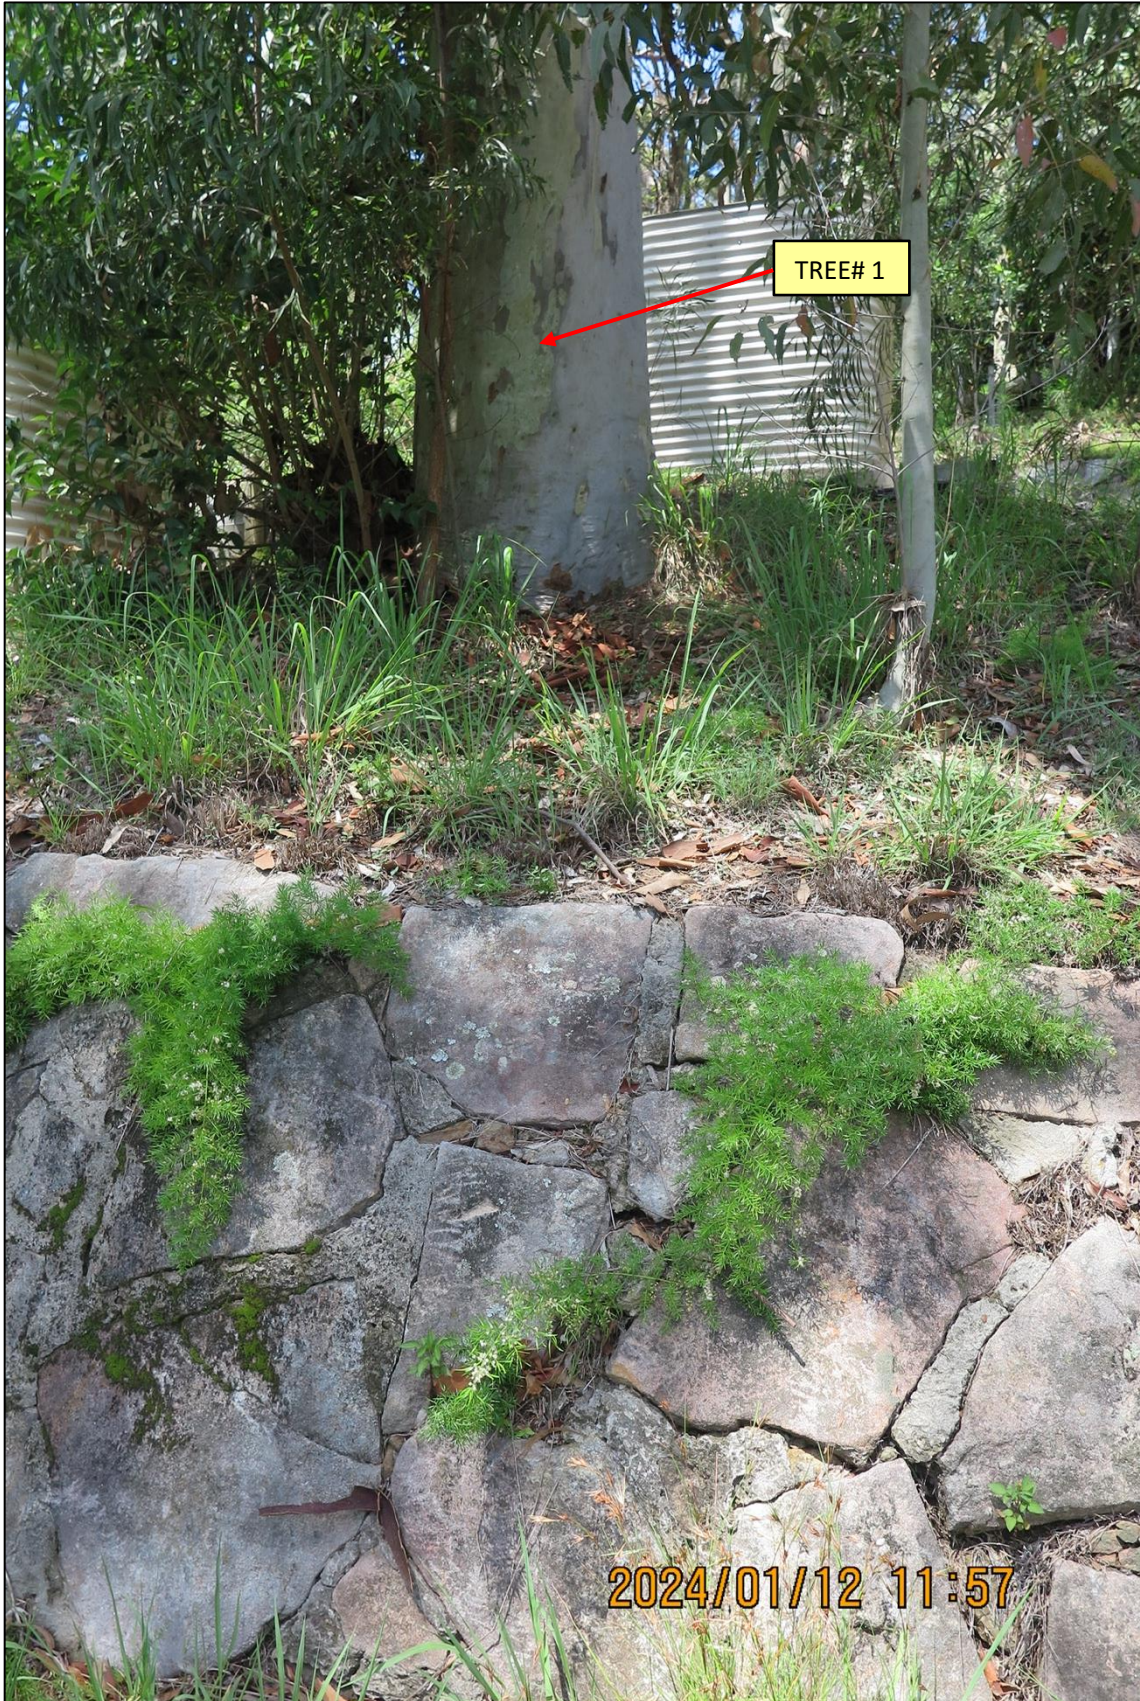
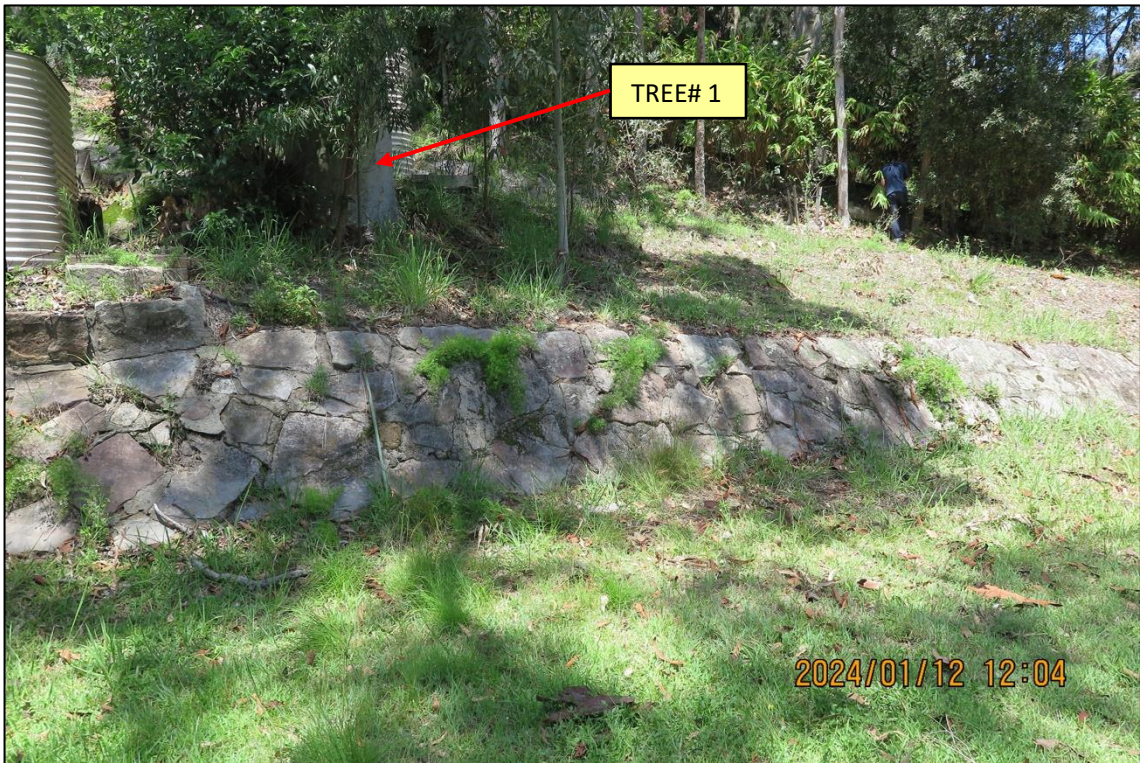
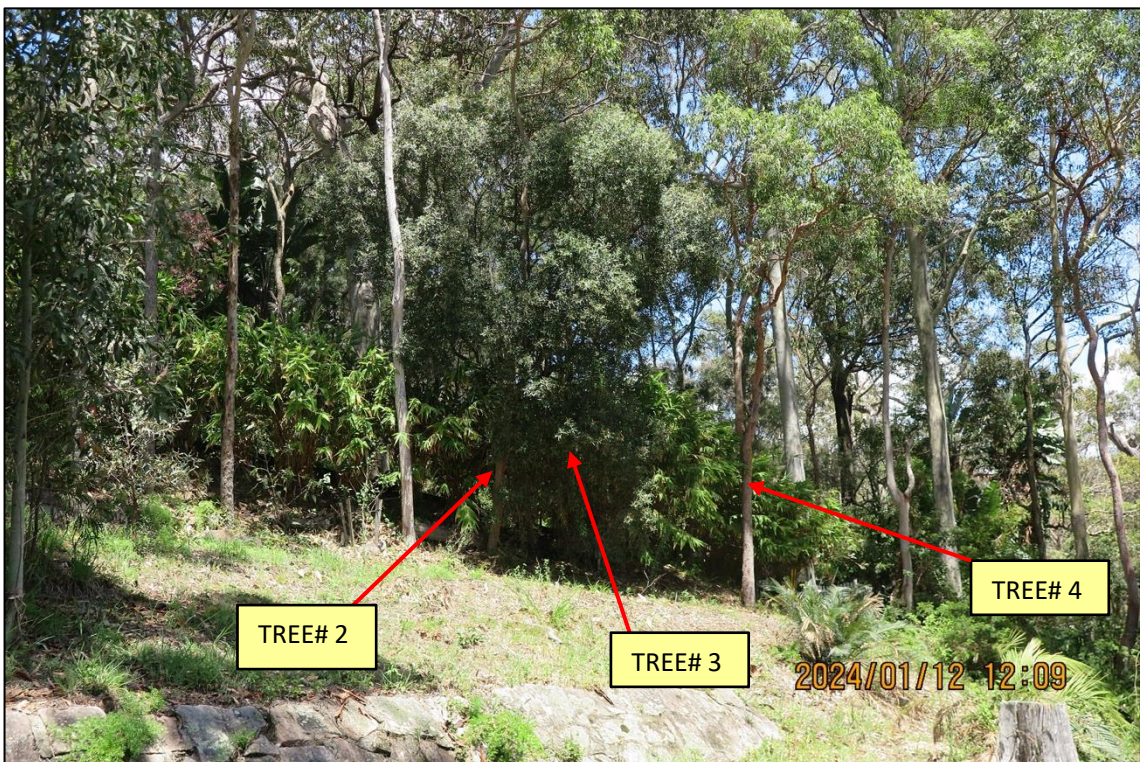
FIGURE 16: ABOVE & PREVIOUS PAGE PHOTOGRAPHS ILLUSTRATES THE FOUR (4) DISCUSSED TREE LOCATIONS & SITE FEATURES

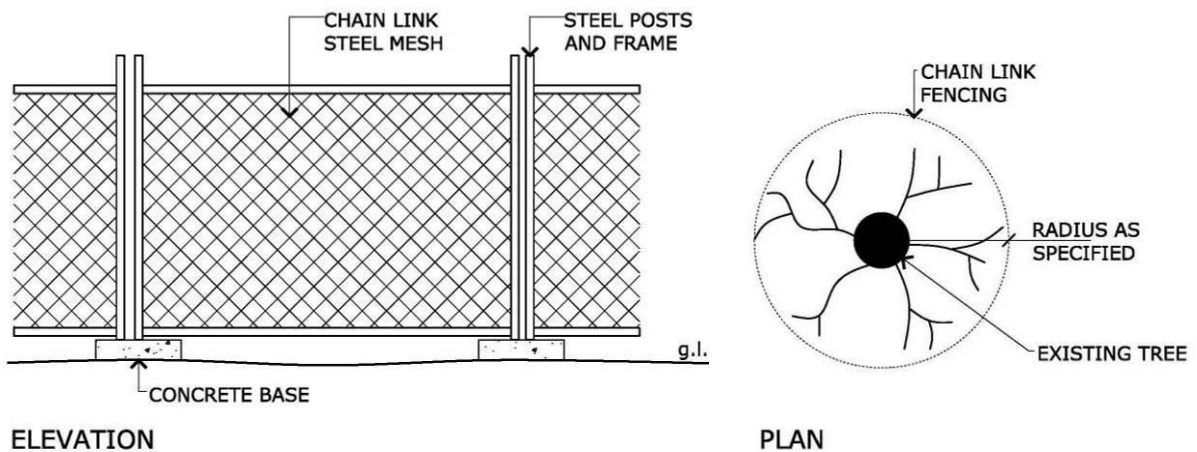
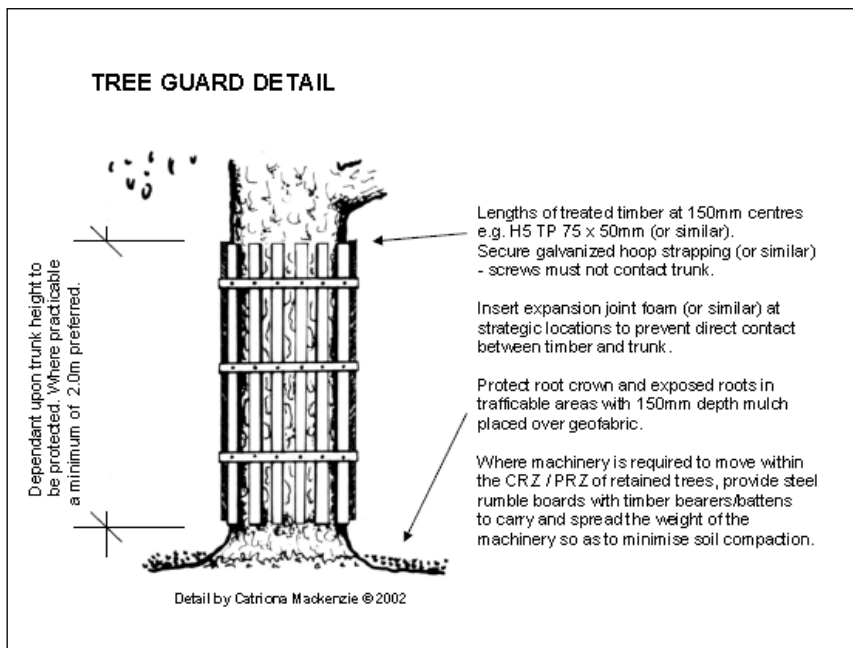
The installation of Tree Protection Zone (TPZ) fencing is to be carried out prior to commencement of all works. The most suitable fencing material is 1.8m tall chain link mesh with 50mm metal pole supports, see **detail 1: tree protection fencing**.
