Report Title: Geotechnical Report 54 Irrubel Road, Newport

## **GEOTECHNICAL INVESTIGATION:**

New Office Studio at **54 Irrubel Road, Newport**

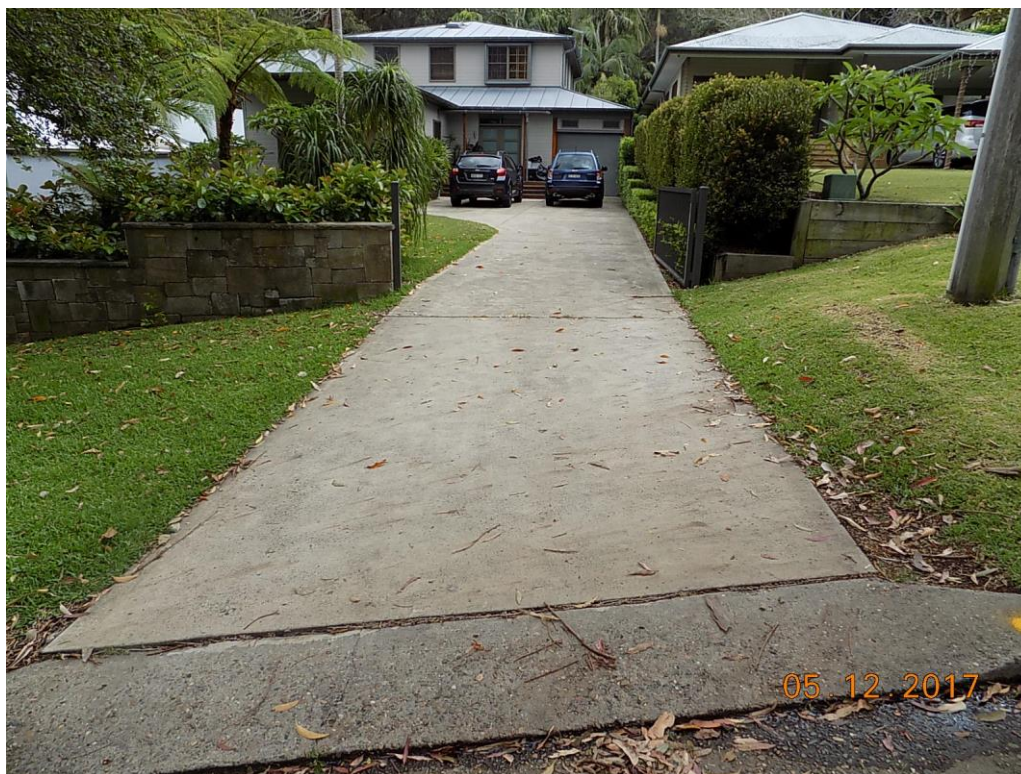
Photo 1

- 2.3** From the road frontage, a concrete driveway runs to a garage on the ground floor of the house (Photo 1). Between the road frontage and the house is a gently sloping lawn. The part two-storey rendered brick and weatherboard clad house is supported on rendered brick walls and brick piers (Photo 2). No significant signs of movement were observed in the supporting brick walls and the supporting brick piers stand vertical. A near-level lawn-covered fill extends off the uphill side of the house (Photo 3). The fill is supported by a stable, stepped treated timber retaining wall (Photo 4). The steps of the retaining wall are ~0.9m high each. A creek runs down and across the slope below the retaining walls (Photo 5). The creek banks have been lined

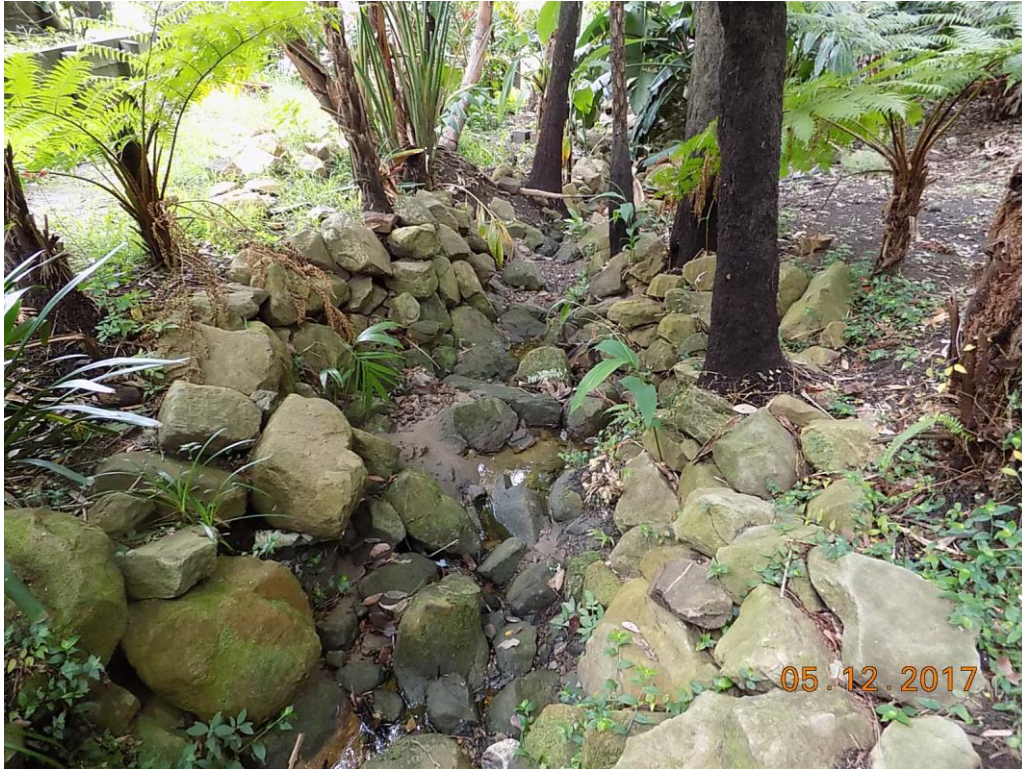
Photo 5

with sandstone boulders. The slope above the creek rises at moderate angles to the upper common boundary.

A small creek flows from NE to SW between the house and the upper common boundary (Photo 5).

There is fall to the creek below the proposed works (Photo 5). Roof water from the development is to be piped to the creek through any tanks that may be required by the regulating authorities.
