Report on
Geotechnical Investigation

Proposed Light Towers
120 South Creek Road, Cromer

Prepared for
Northern Beaches Council

Project 214270.00
July 2022

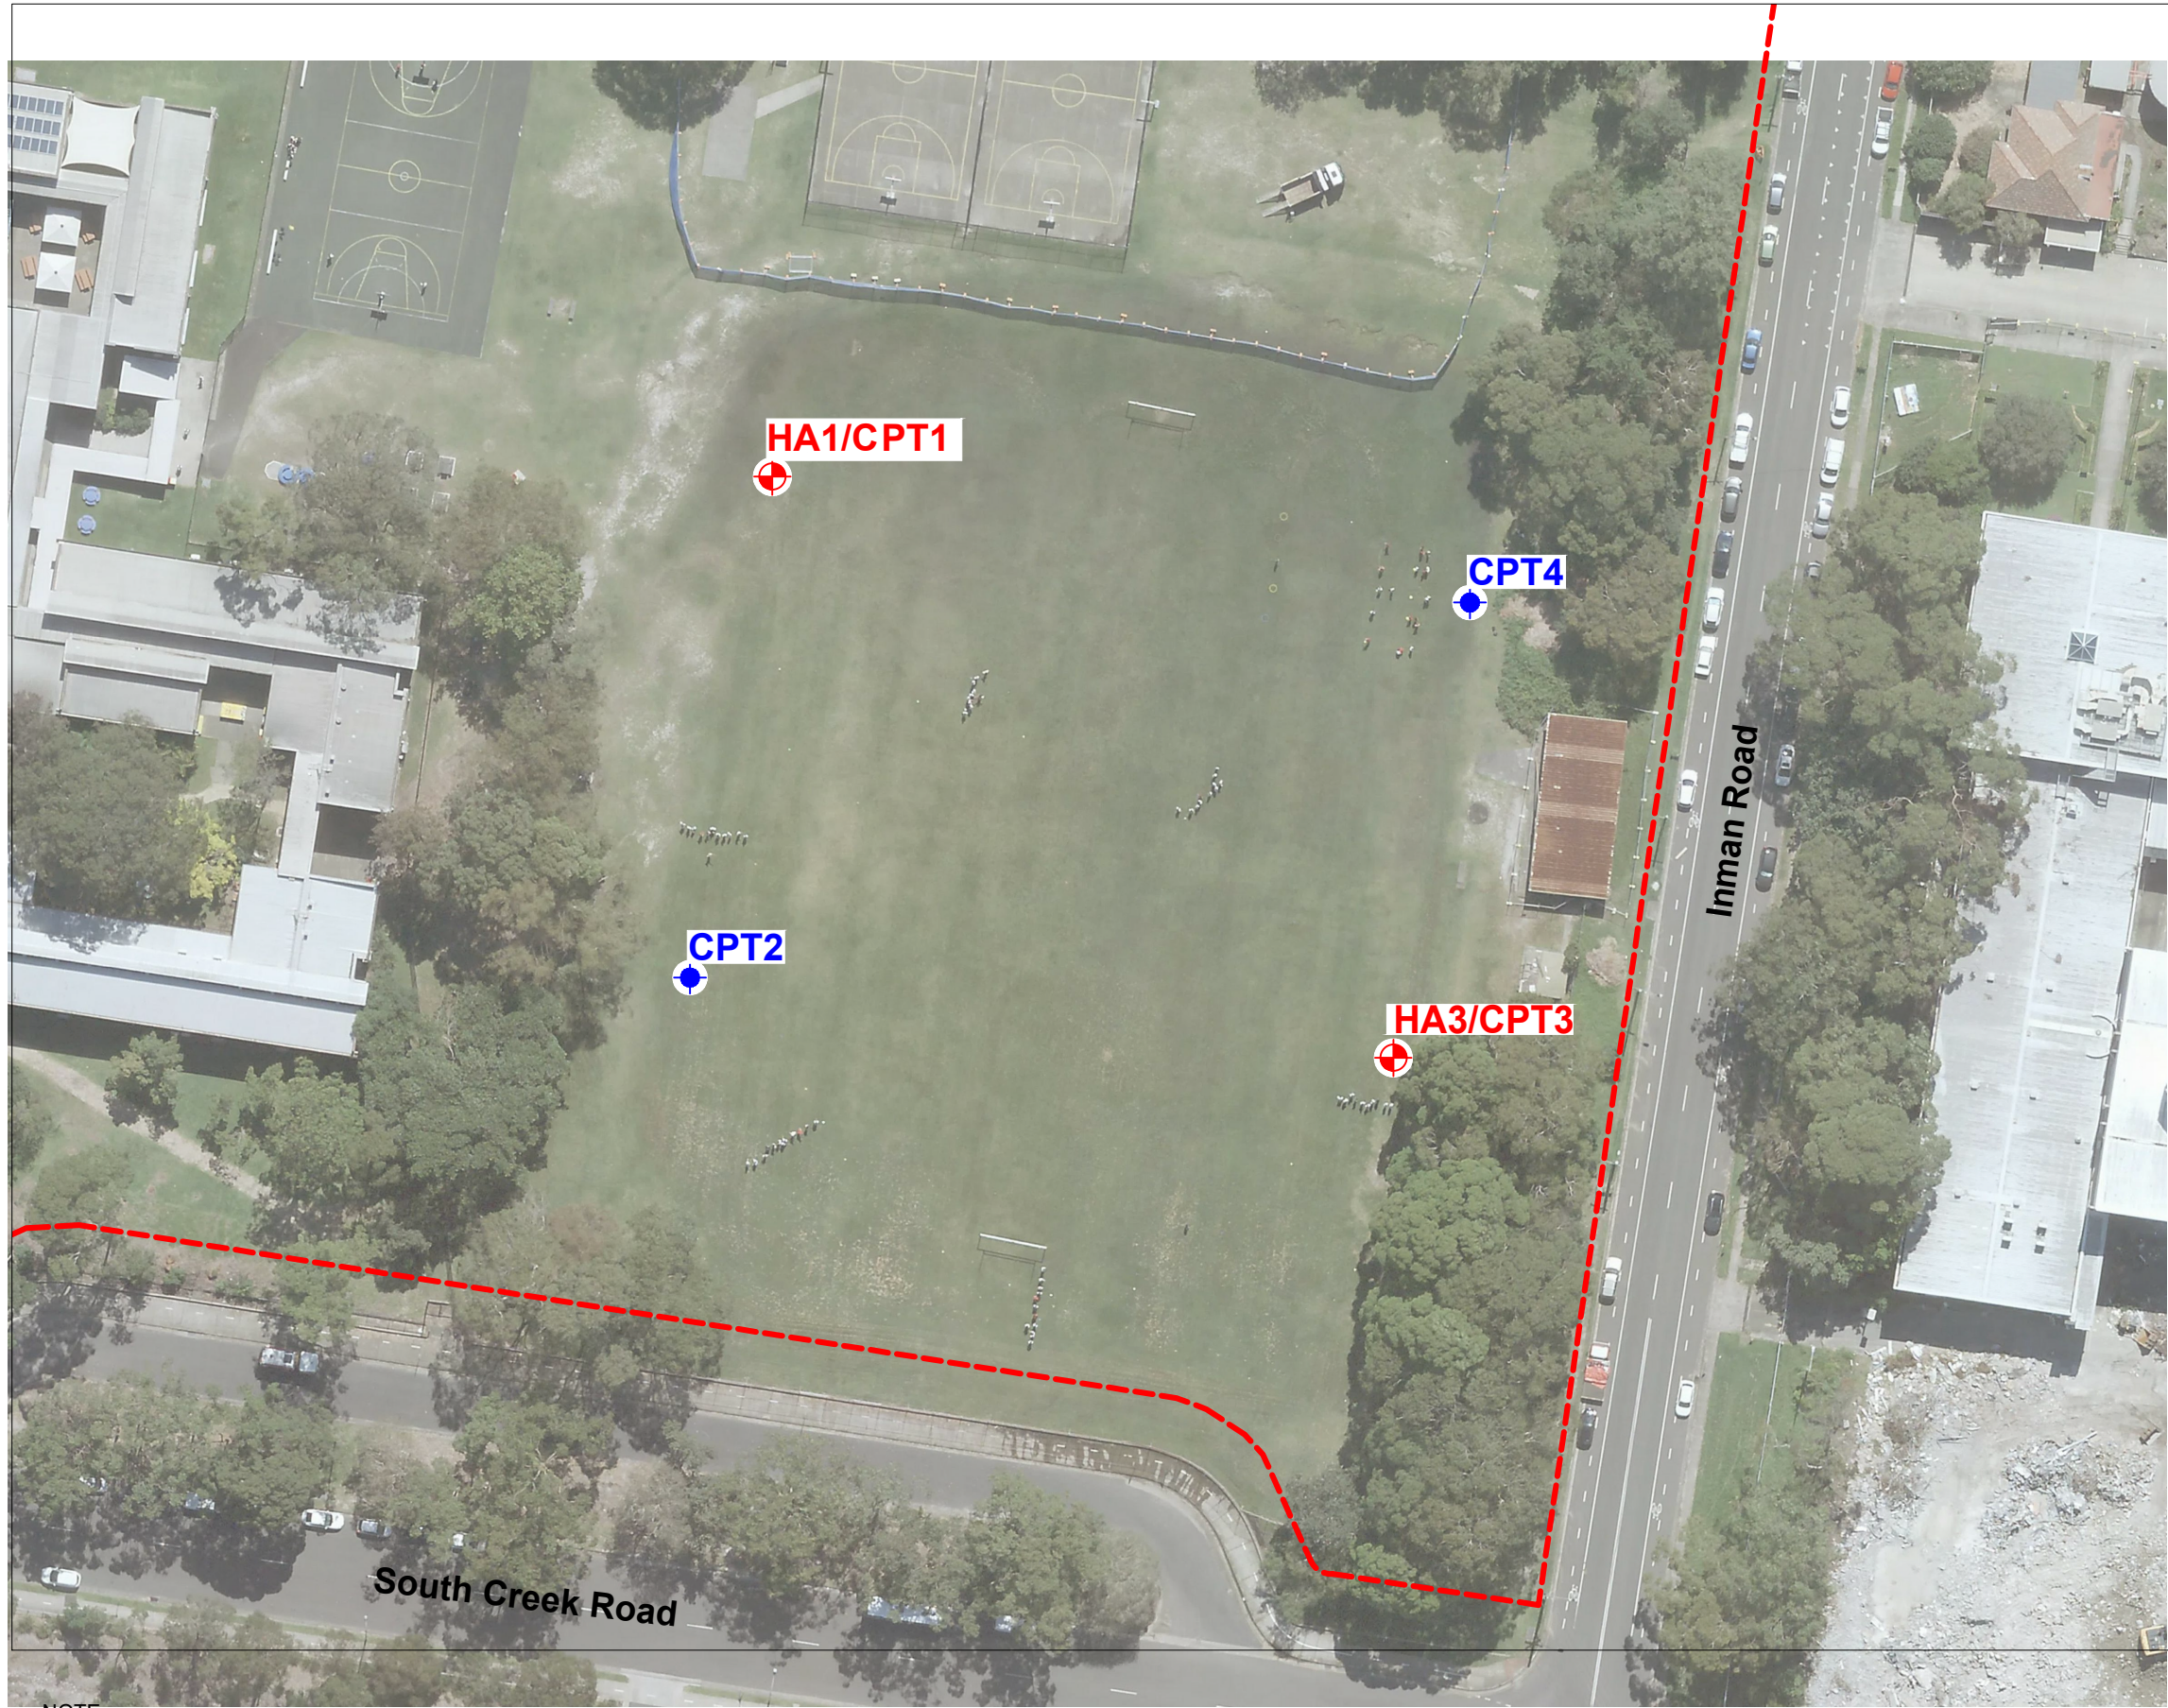
NOTE:
1: Base image from MetroMap (Dated 22.03.2022)

The locations of the boreholes and CPTs are shown on Drawing 1 in Appendix B. The co-ordinates and surface levels at the test locations, relative to Australia Height Datum (m, AHD), were interpolated from the provided site survey plan and are therefore approximate only. The levels are shown on the borehole and CPT logs, given in Appendix C.

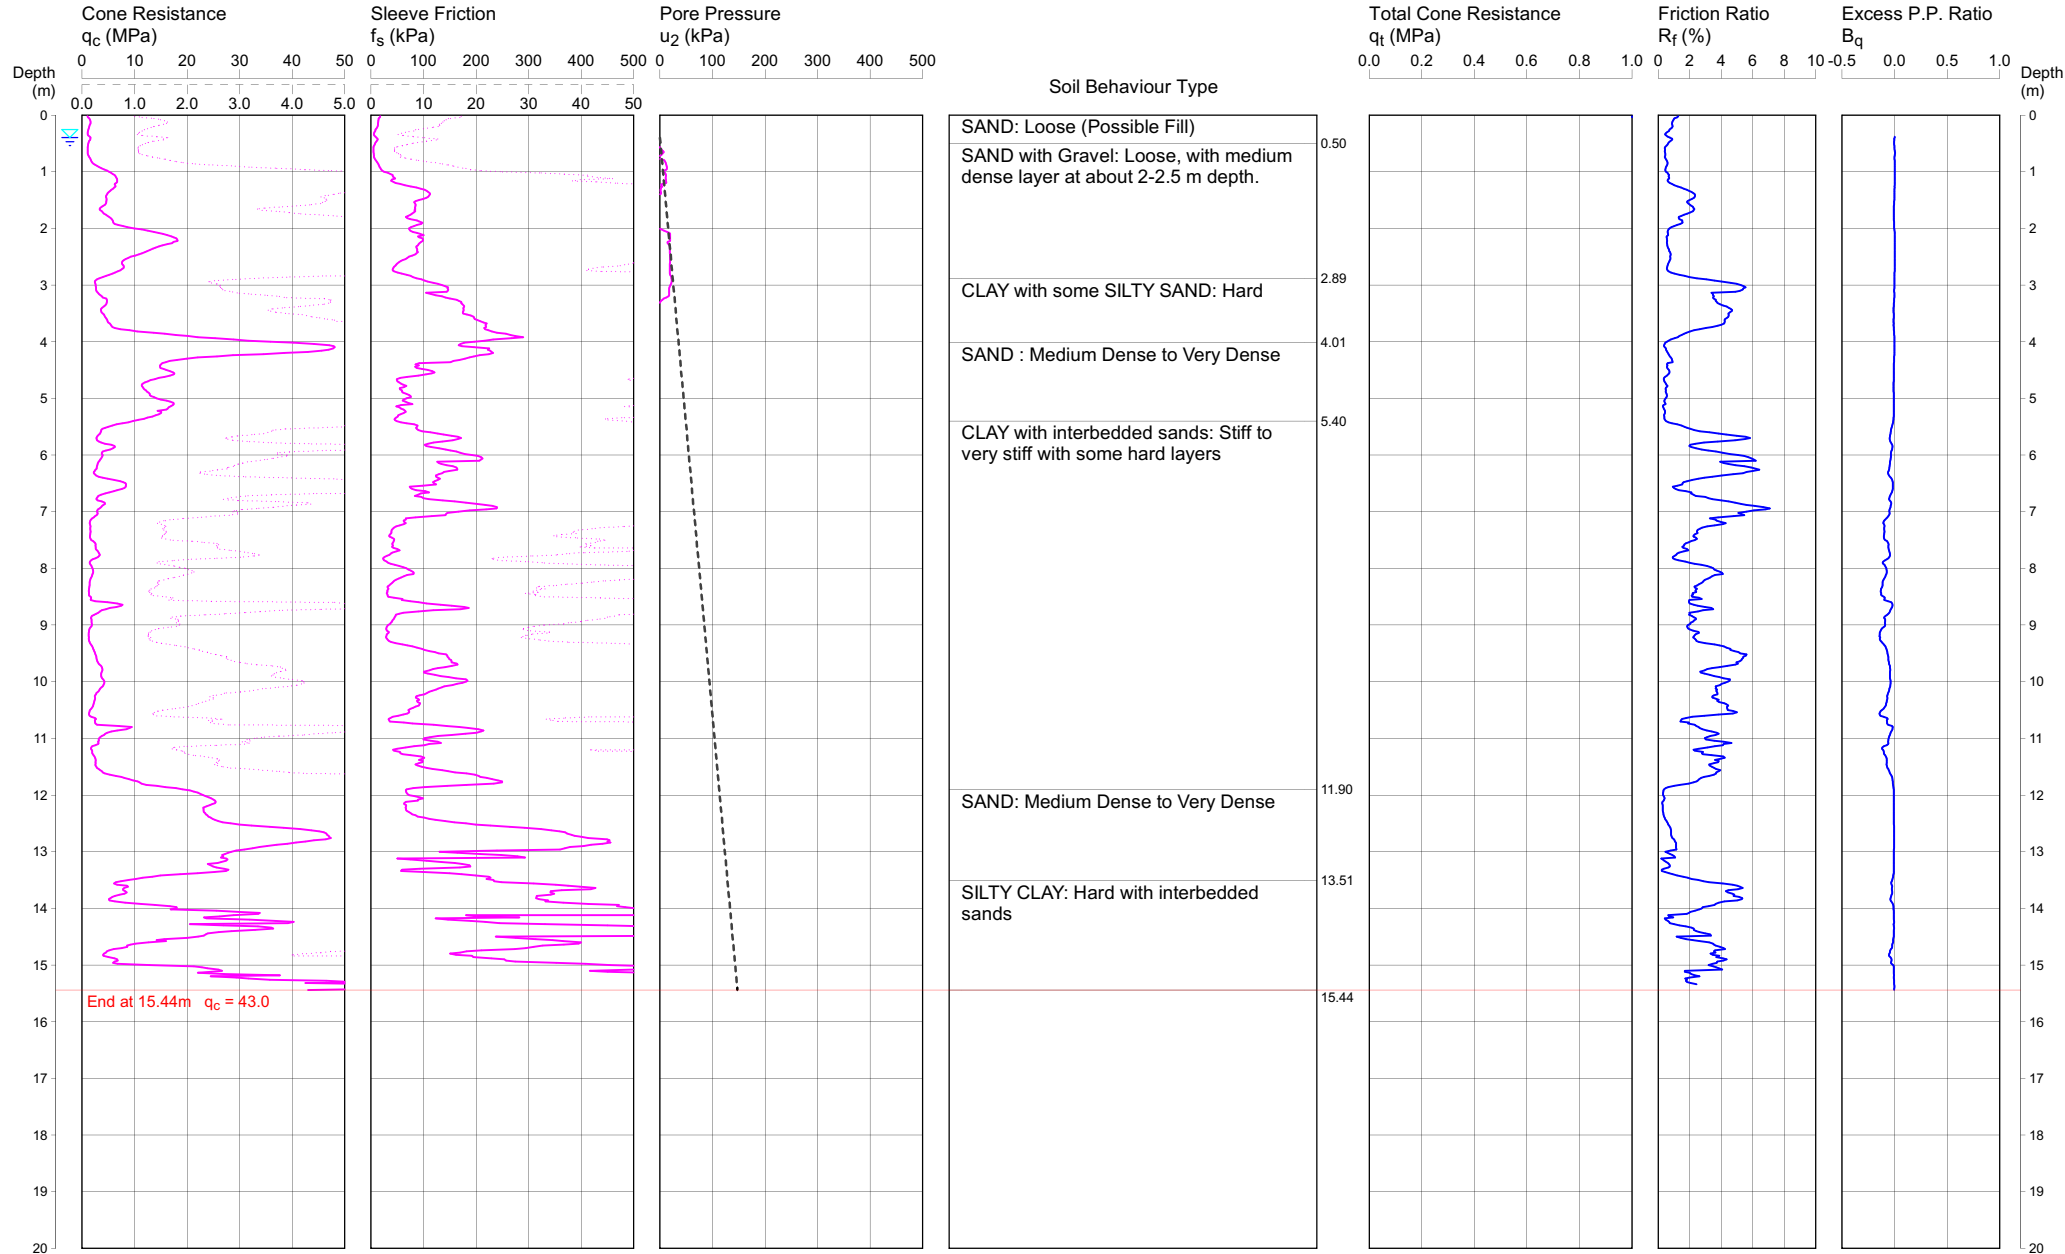
REMARKS: TEST DISCONTINUED DUE TO EXCESSIVE BENDING.
GROUNDWATER OBSERVED AT 0.4M

File: \\dpsynas02\Projects\214270.00 - CROMER, 120 South Creek Road\4.0 Field Work\4.2 Testing\214270.00 - Cromer\CPT1.CP5
Cone ID: 210732 Type: I-CFYP20-10

Groundwater was observed within CPT1, CPT2 and CPT4 after the withdrawal of the rods at levels of 0.4 m, 1.0 m and 0.5 m respectively (in the range of RL 13 to 13.6 m, AHD). Groundwater levels are transient and will fluctuate with weather and may be expected to rise by 1-2 m above the measured levels during periods following heavy rainfall. Extreme care must be exercised in the interpretation of groundwater levels from coneholes due to the small (35 mm) diameter of the hole following cone probe withdrawal.

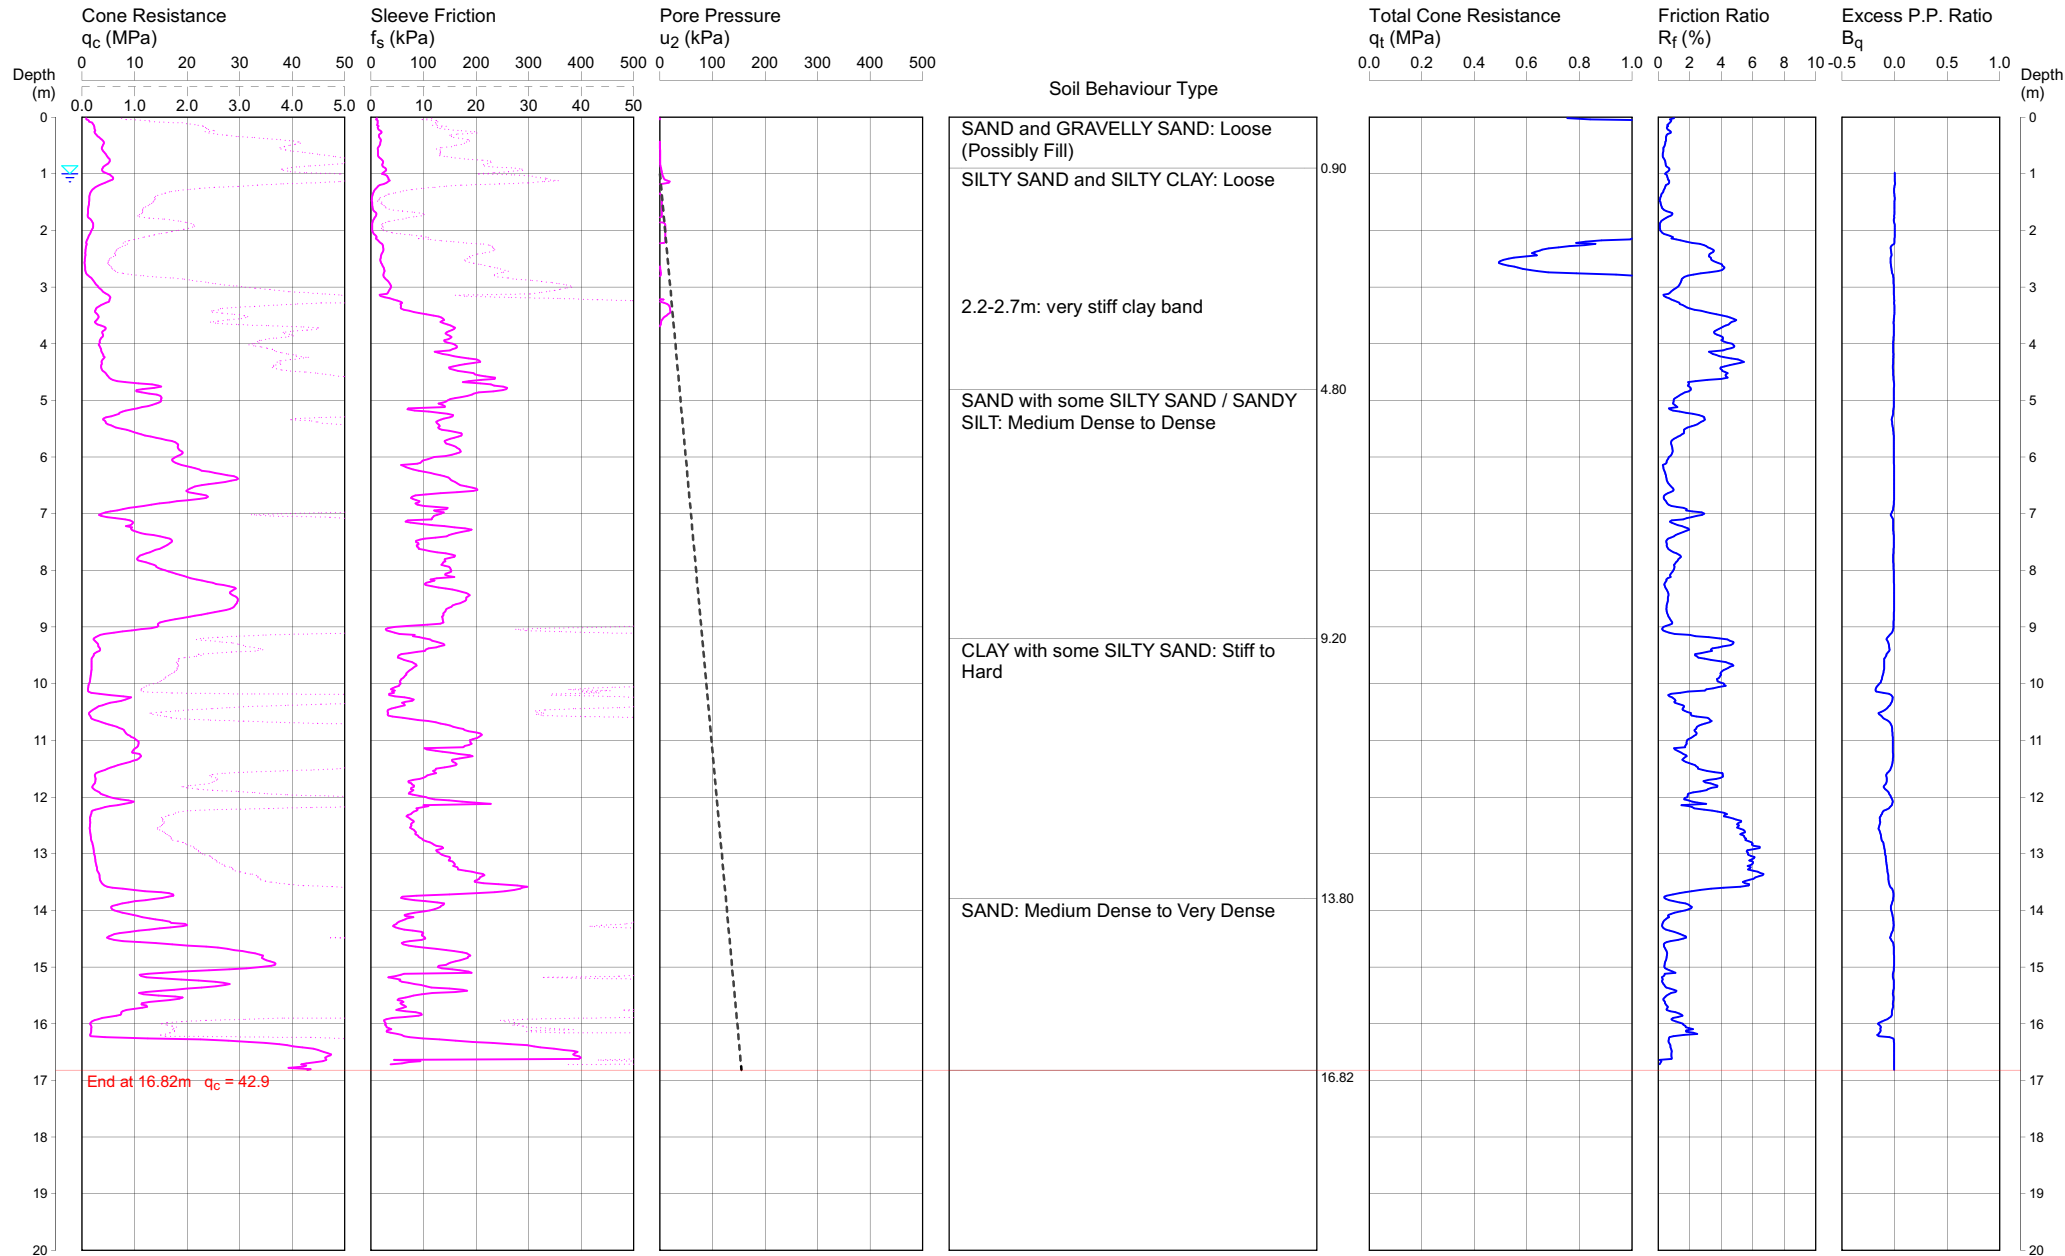
REMARKS: TEST DISCONTINUED DUE TO EXCESSIVE BENDING.
GROUNDWATER OBSERVED AT 1.0M

File: \\dpsynas02\Projects\214270.00 - CROMER, 120 South Creek Road\4.0 Field Work\4.2 Testing\214270.00 - Cromer\CPT2.CP5
Cone ID: 210410 Type: I-CFXYP20-10

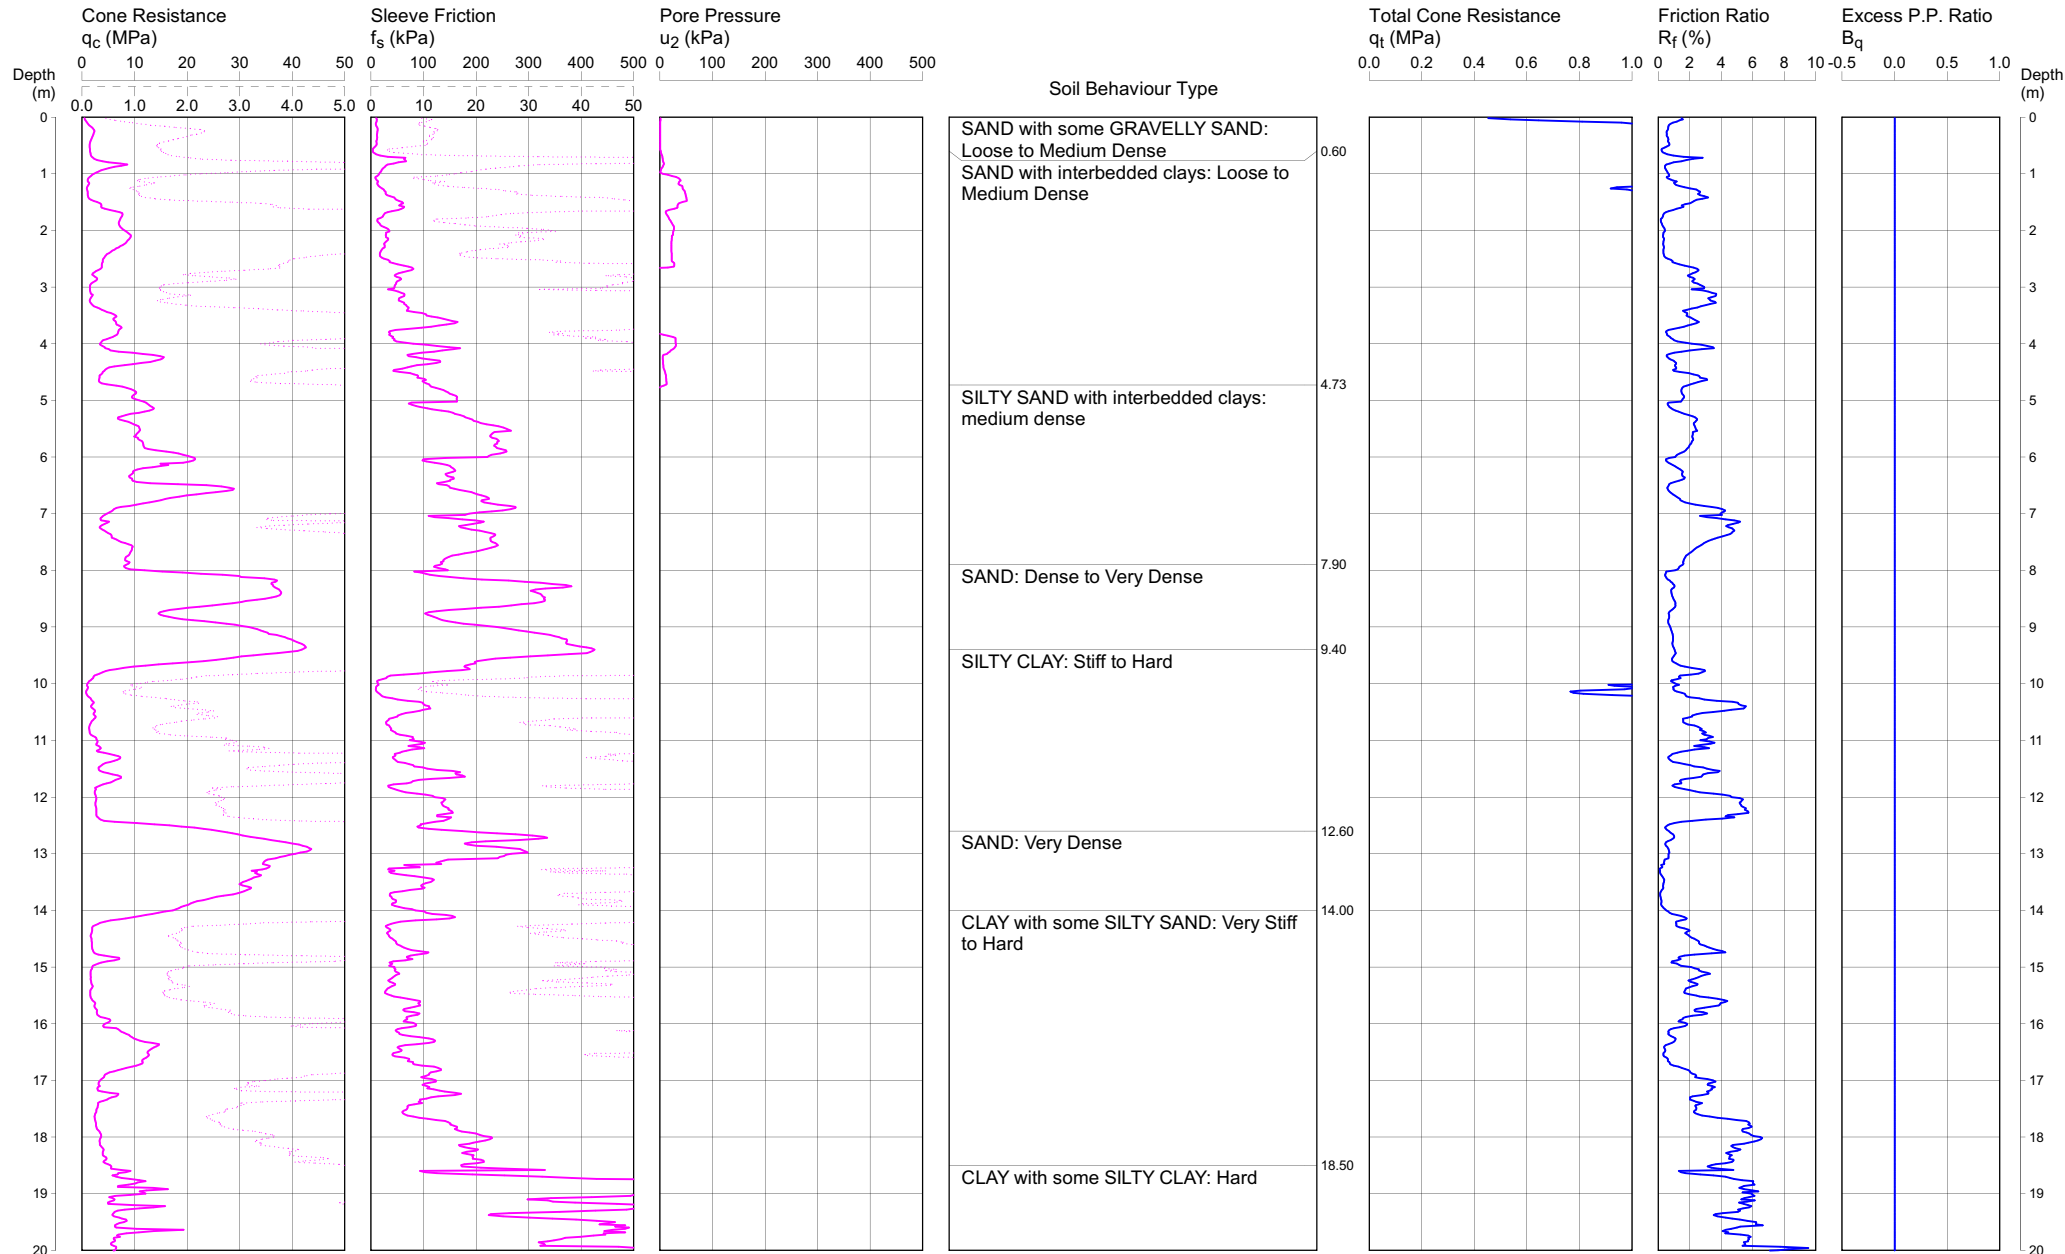
REMARKS: TEST DISCONTINUED DUE TO EXCESSIVE BENDING.
STANDING WATER LEVEL COULD NOT BE MEASURED

File: \\dpsynas02\Projects\214270.00 - CROMER, 120 South Creek Road\4.0 Field Work\4.2 Testing\214270.00 - Cromer\CPT3.CP5
Cone ID: 200309 Type: I-CFYYP20-10

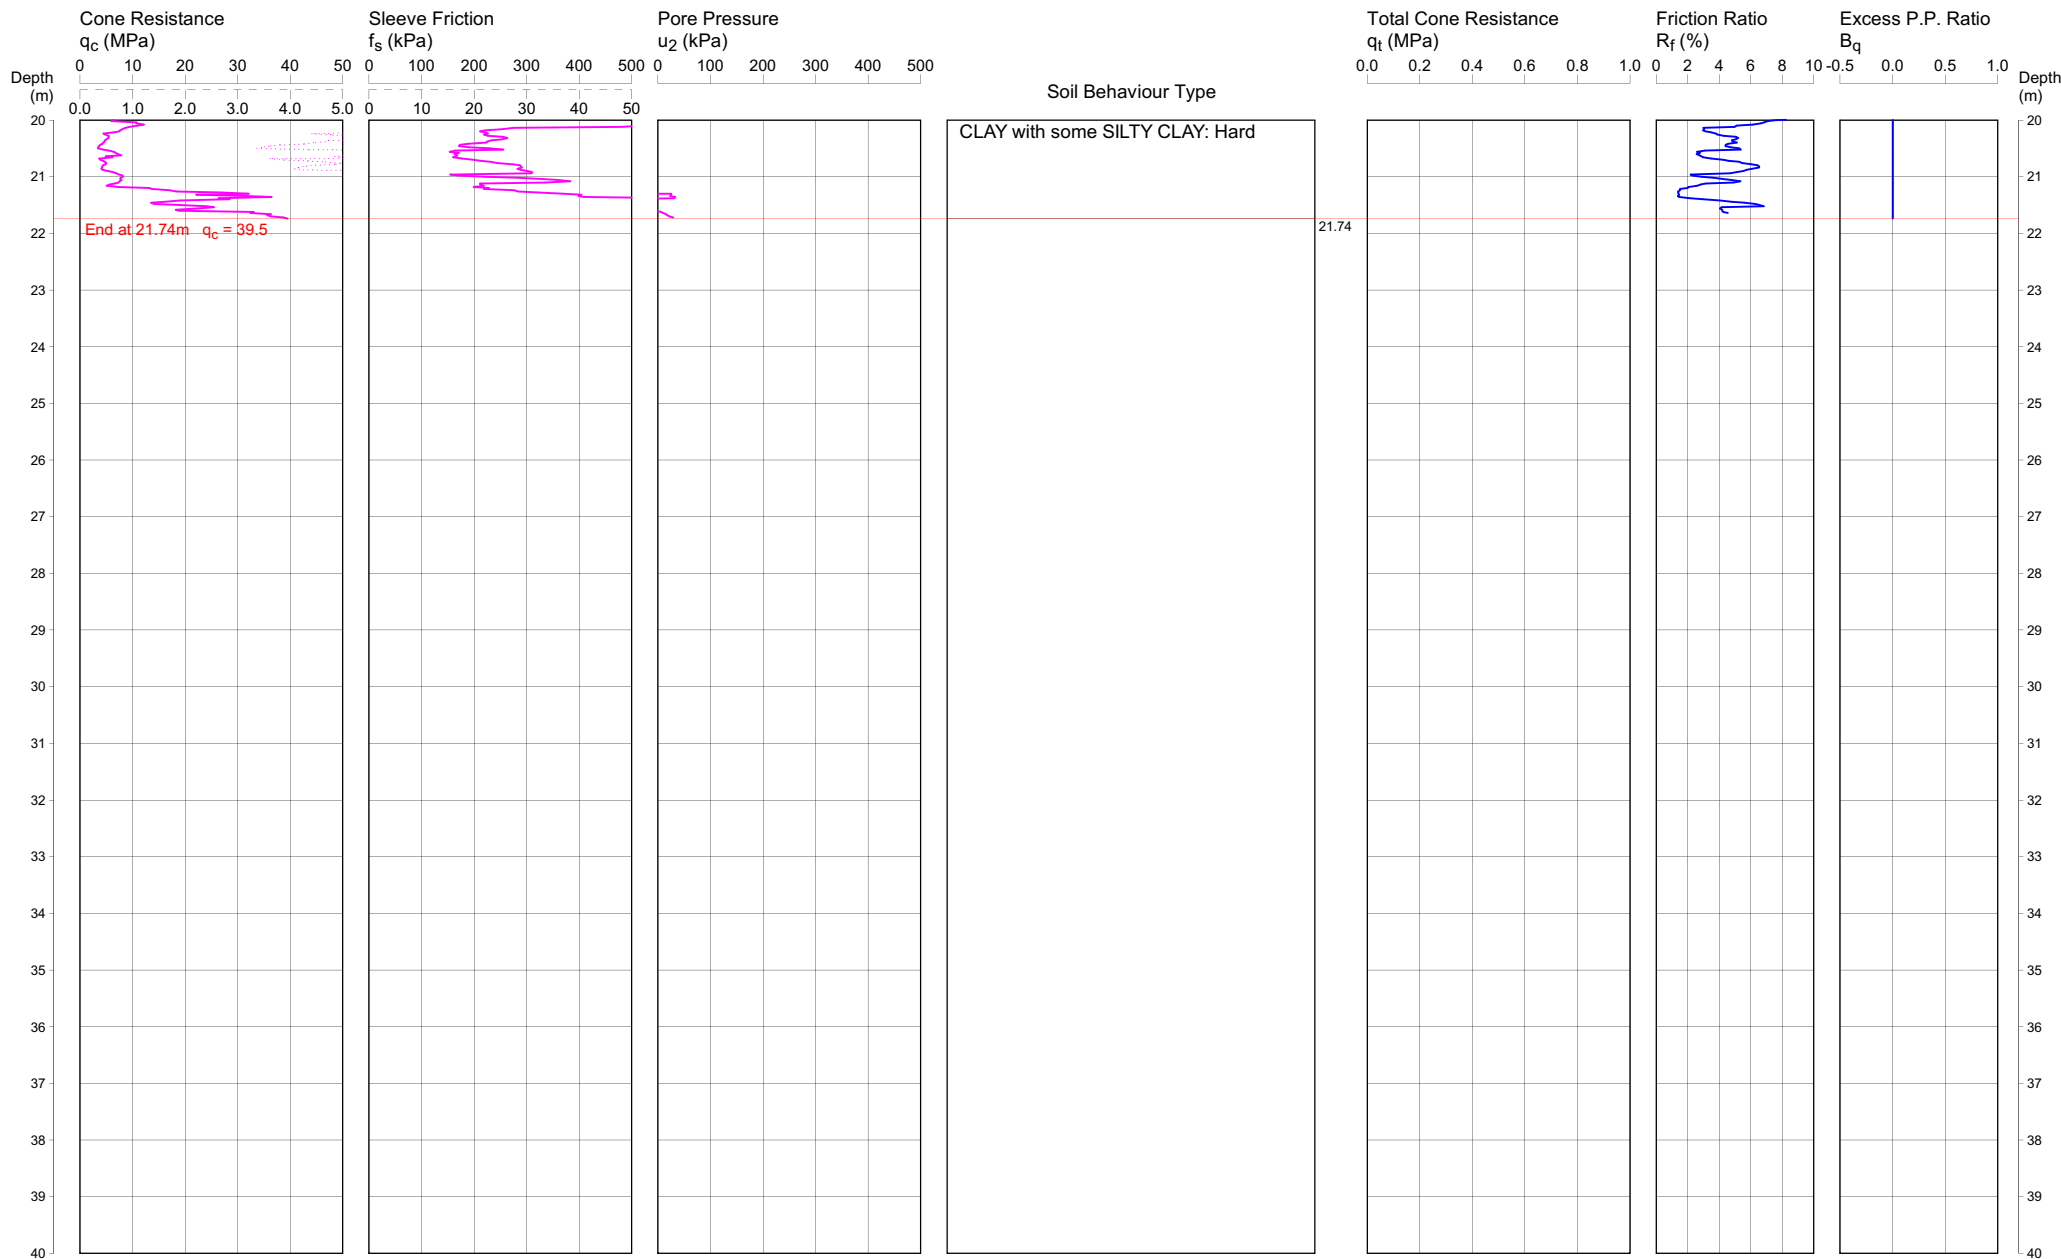
REMARKS: TEST DISCONTINUED DUE TO EXCESSIVE BENDING.
STANDING WATER LEVEL COULD NOT BE MEASURED

File: \\dpsydna02\Projects\214270.00 - CROMER, 120 South Creek Road\4.0 Field Work\4.2 Testing\214270.00 - Cromer\CPT3.CP5
Cone ID: 200309 Type: I-CFXYP20-10

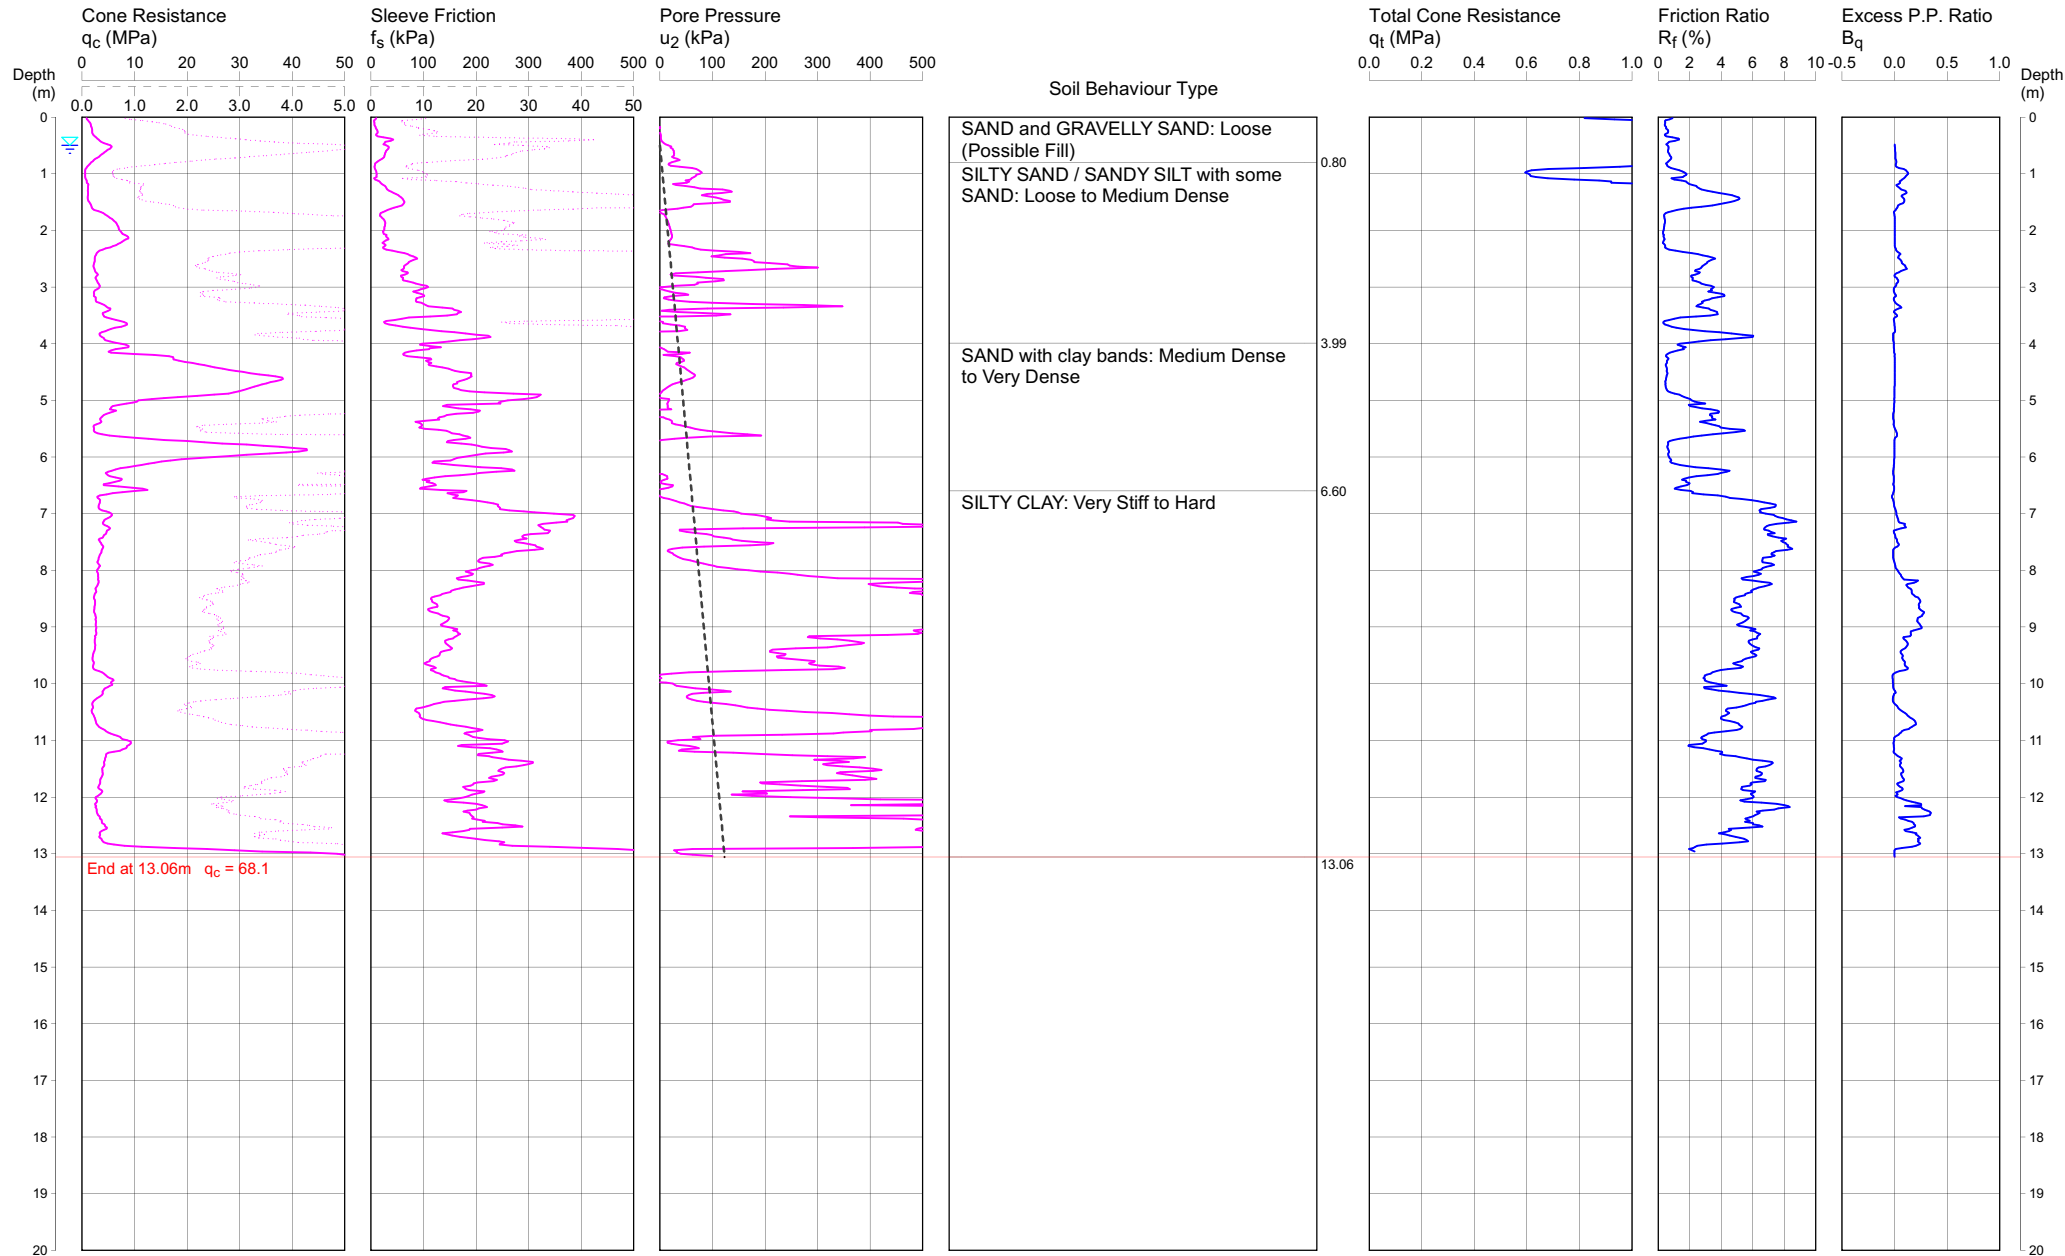
REMARKS: TEST DISCONTINUED DUE TO EXCESSIVE BENDING.
GROUNDWATER OBSERVED AT 0.5M

Water depth after test: 0.50m depth (measured)

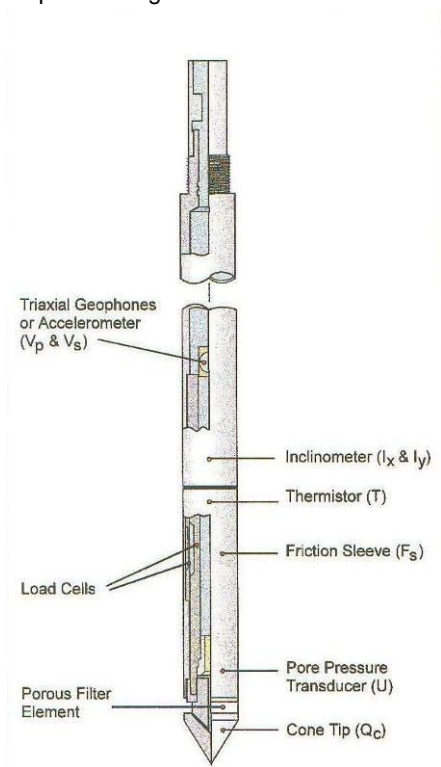
Figure 1: Cone Diagram

The soil parameters measured depend on the type of cone being used, however they always include the following basic measurements

- Cone tip resistance q_c
- Sleeve friction f_s
- Inclination (from vertical) i
- Depth below ground z

The inclinometer in the cone enables the verticality of the test to be confirmed and, if required, the vertical depth can be corrected.
