REPORT ON GEOTECHNICAL SITE INVESTIGATION

PROPOSED NEW THREE STOREY HOUSE WITH BASEMENT

25 LOCH STREET, FRESHWATER

Project No.: 2018-147

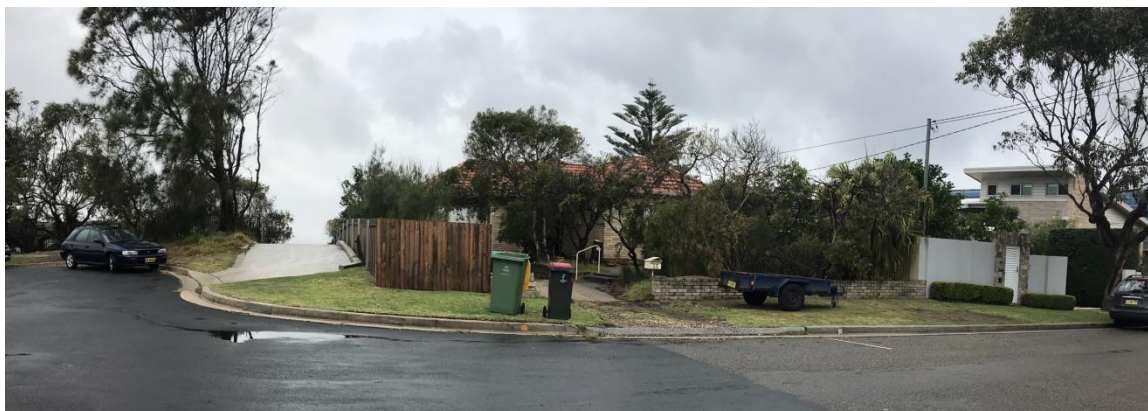
Photograph 1: View of the front of the site and immediate surrounds looking broadly east

The site is situated within gently then steeply east dipping topography and contains exposures of bedrock within the rear garden. The site is currently occupied by a one and two storey residential house with a partial basement garage. The front of the site contains a near level lawn and driveway ramp which provides access to the garage underneath the dwelling.

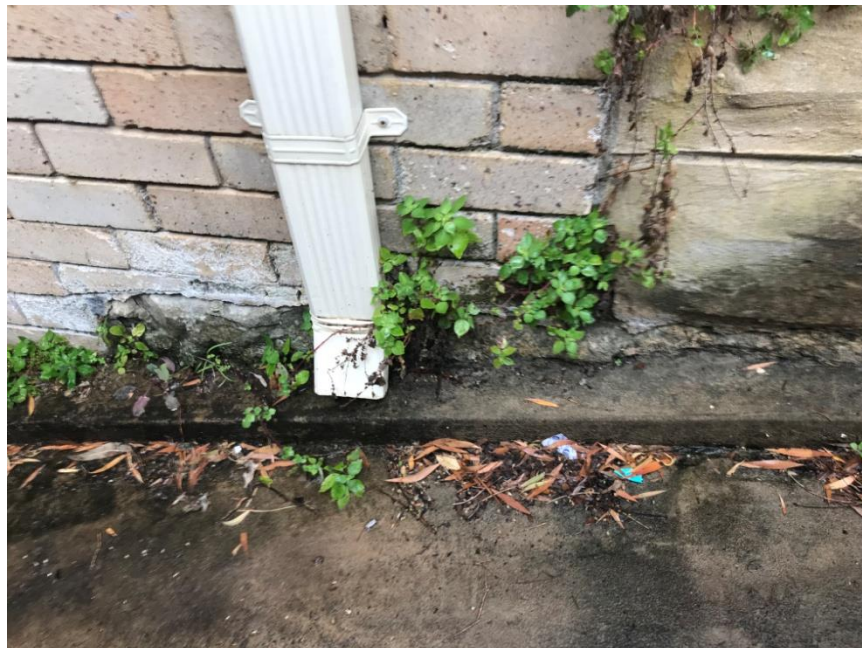
Near the base of the access ramp within the property, bedrock was also observed underlying an exterior wall as shown in Photograph 4. It is considered likely that the remainder of the dwelling is founded on bedrock given the absence of any cracking observed in the exterior brickwork.

Photograph 4: Existing house founded on bedrock
