Report Title: Geotechnical Report 5 Irrubel Road, Newport

Report Date: 17/03/20

## **GEOTECHNICAL INVESTIGATION:**

Alterations and Additions at 5 Irrubel Rd, Newport.

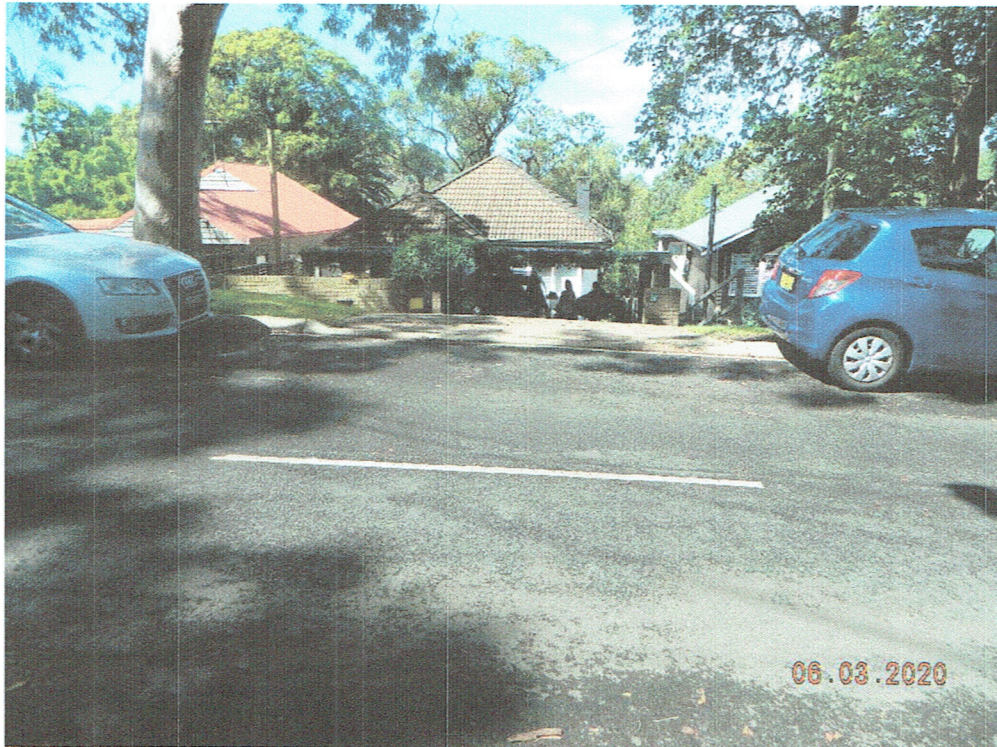
Photo 1

- 2.1 The site was inspected on the 6<sup>th</sup> of March, 2020.
- 2.2 This residential property is on the low side of the road and has a S aspect. The natural slope falls across the property at an average angle of ~9°. The slopes above and below the property continue at similar angles.
- 2.3 At the road frontage a concrete driveway leads to the existing carport (Photos 1 & 2). The part two storey rendered brick and timber clad house is supported by brick piers and brick walls (Photos 3 & 4). The supporting piers and walls stand vertical and show no signs of significant movement (Photo 5).

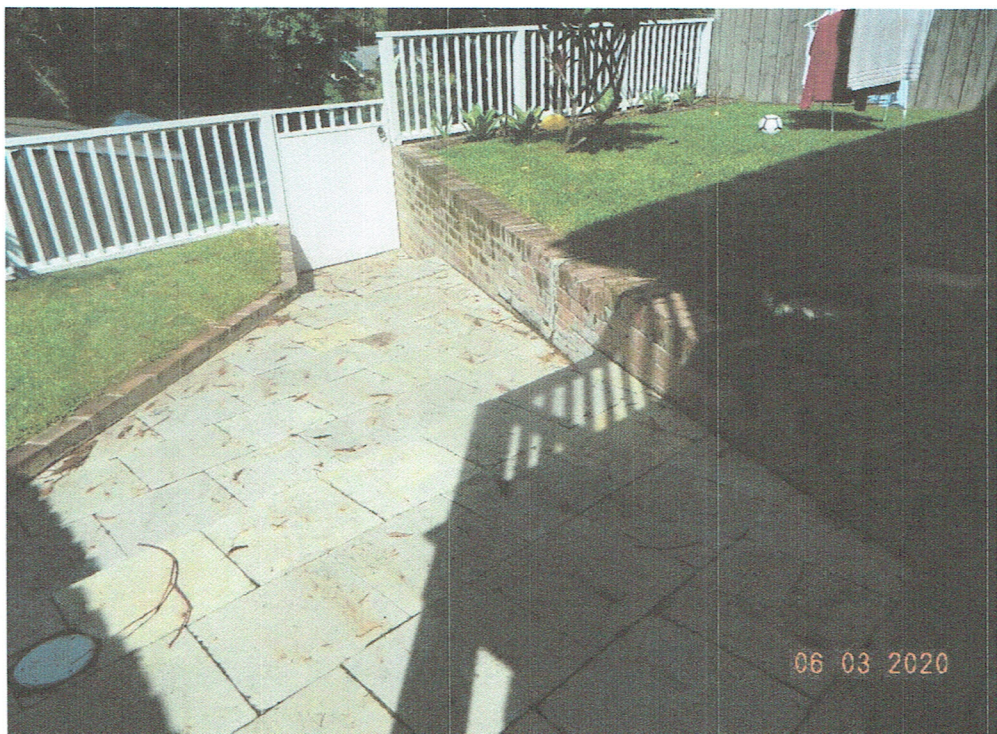
Photo 6

Fill provides a level platform for a tiled pavement and grass lawn that extend from the downhill side of the house (Photo 6). The fill is supported by stable brick retaining walls up to ~1.2m high (Photo 7). An existing metal shed that is in good condition will be demolished as part of the works (Photo 8). A gently sloping lawn extends from

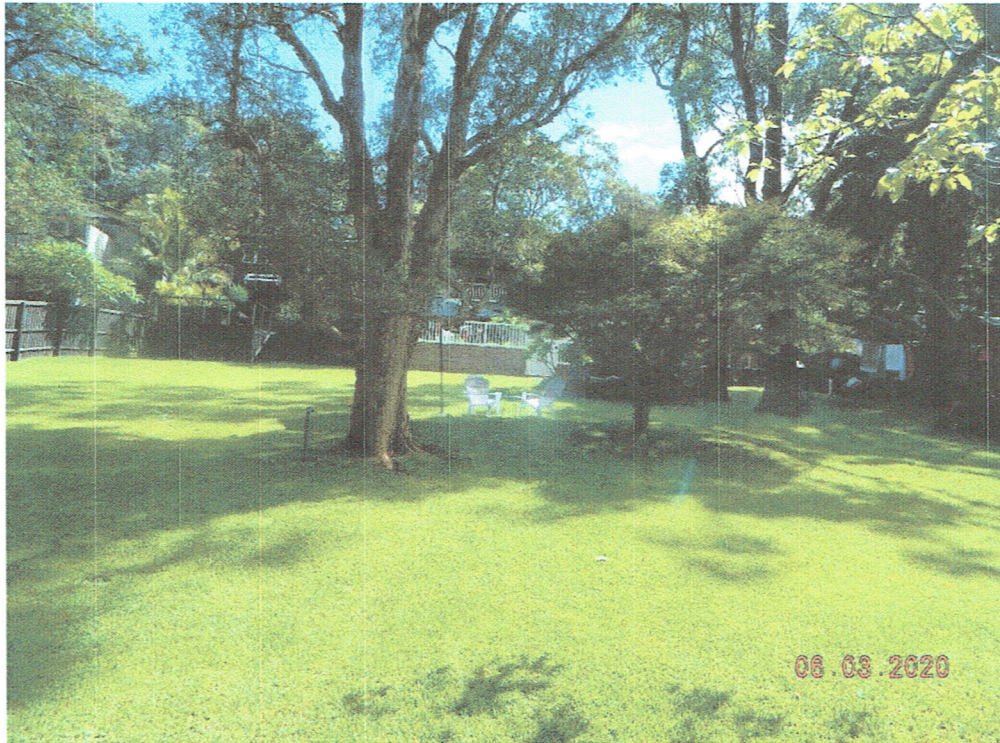
Photo 9

below the retaining walls to the downhill boundary of the property (Photo 9). A timber shed is located near the downhill boundary (Photo 10). No signs of slope instability were observed on the property. The adjoining neighbouring properties were observed to be in good order as seen from the street and subject property.

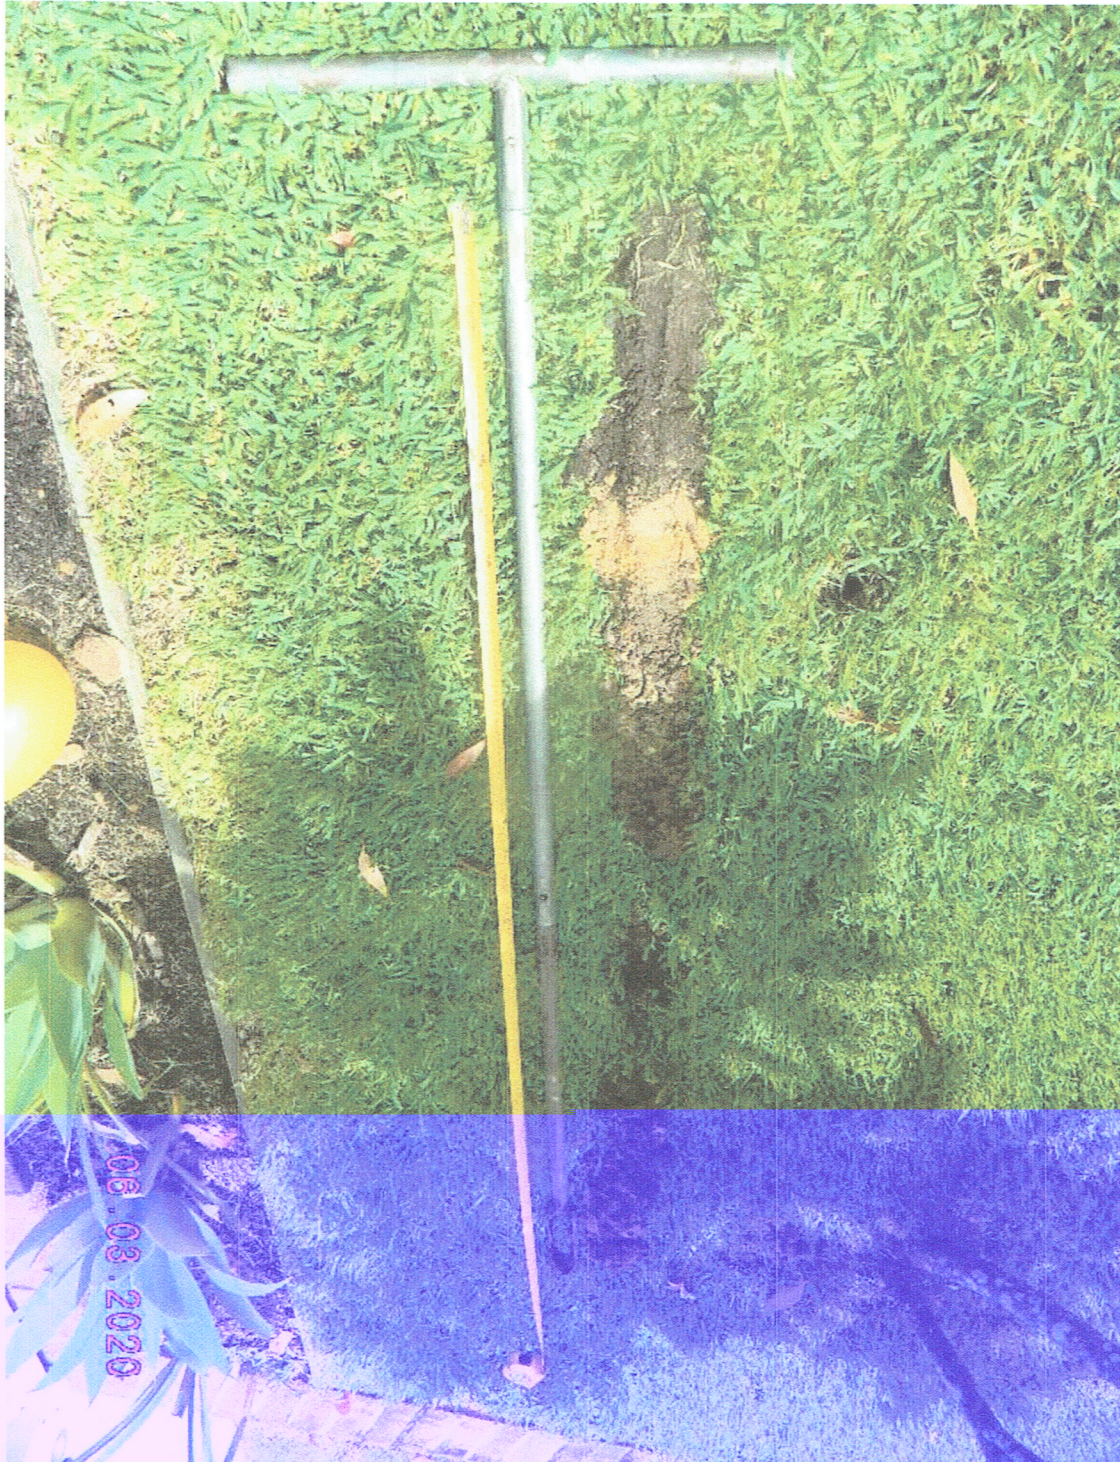
#### AUGER HOLE 1 (~RL24.7) – AH1 (photo 11)

Depth (m)	Material Encountered
0.0 to 0.3	<b>TOPSOIL</b> , brown, fine to medium grained, moist, fine trace organic matter.
0.3 to 1.1	<b>FILL</b> , yellow, brown and orange, moist.
1.1 to 1.4	<b>CLAYEY SOIL</b> , brown and orange, moist.
1.4 to 1.8	<b>CLAY</b> , orange and brown, firm to stiff, moist.

End of Hole @ 1.8m in Clay. No watertable encountered.

Photo 11:AH1 – Downhole is from top to bottom
