Project 45391.05
26 August 2024
R.001.Rev0
DEM:de

Geotechnical Report and Acid Sulfate Soil Management Plan Proposed Swimming Pool 1015 Barrenjoey Road, Palm Beach

Project 45391.04
September 2022

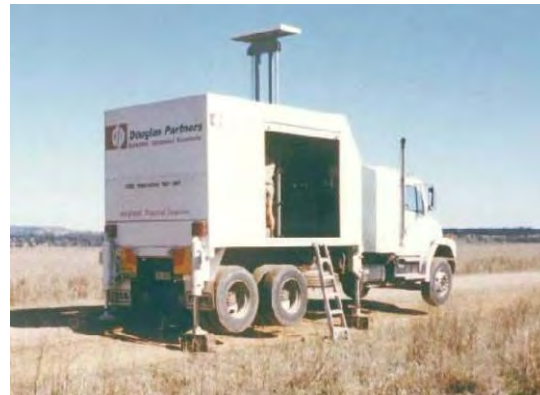
Figure 2: Purpose built CPT rig

The cone is thrust into the ground at a steady rate of about 20 mm/sec, usually using the hydraulic rams of a purpose built CPT rig, or a drilling rig. The testing is carried out in accordance with the Australian Standard AS1289 Test 6.5.1.
