## **PRELIMINARY ASSESSMENT: Acid Sulfate**

New House, Pool and Boatshed at **1744 Pittwater Road, Bayview**

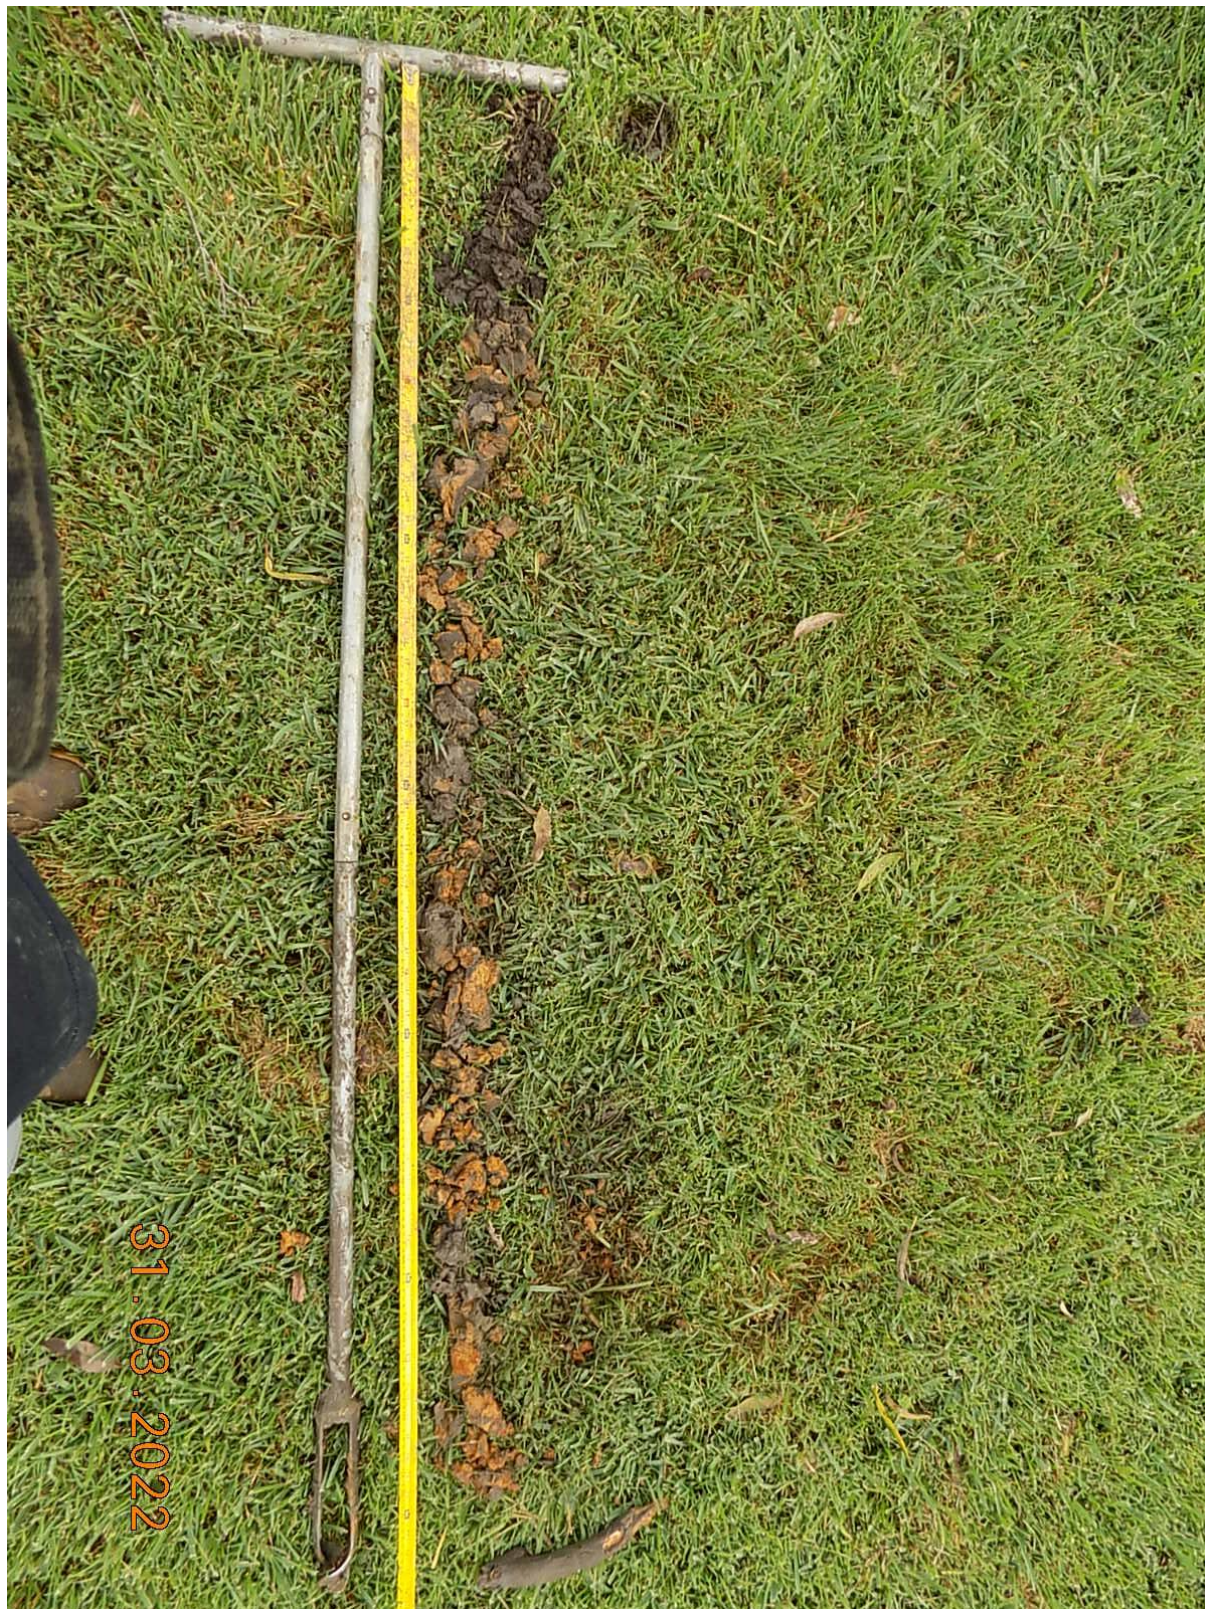
Photo 1: AH1 – Downhole is from top to bottom.

### AUGER HOLE 1 (~RL7.5) – AH1

| Depth (m) | Material Encountered |
| 0.0 to 0.2 | <b>CLAYEY SOIL</b> , dark brown to black, loose, damp, fine to medium grained with fine trace organic matter. |
| 0.2 to 0.8 | <b>CLAY</b> , yellow, brown, fine grained, dry. |
| 0.9 to 1.8 | <b>CLAY</b> , orange, red, mottled clay, derived from Extremely Low Strength Shale, damp. |

End of Test @ 1.8m in clay. No watertable encountered.

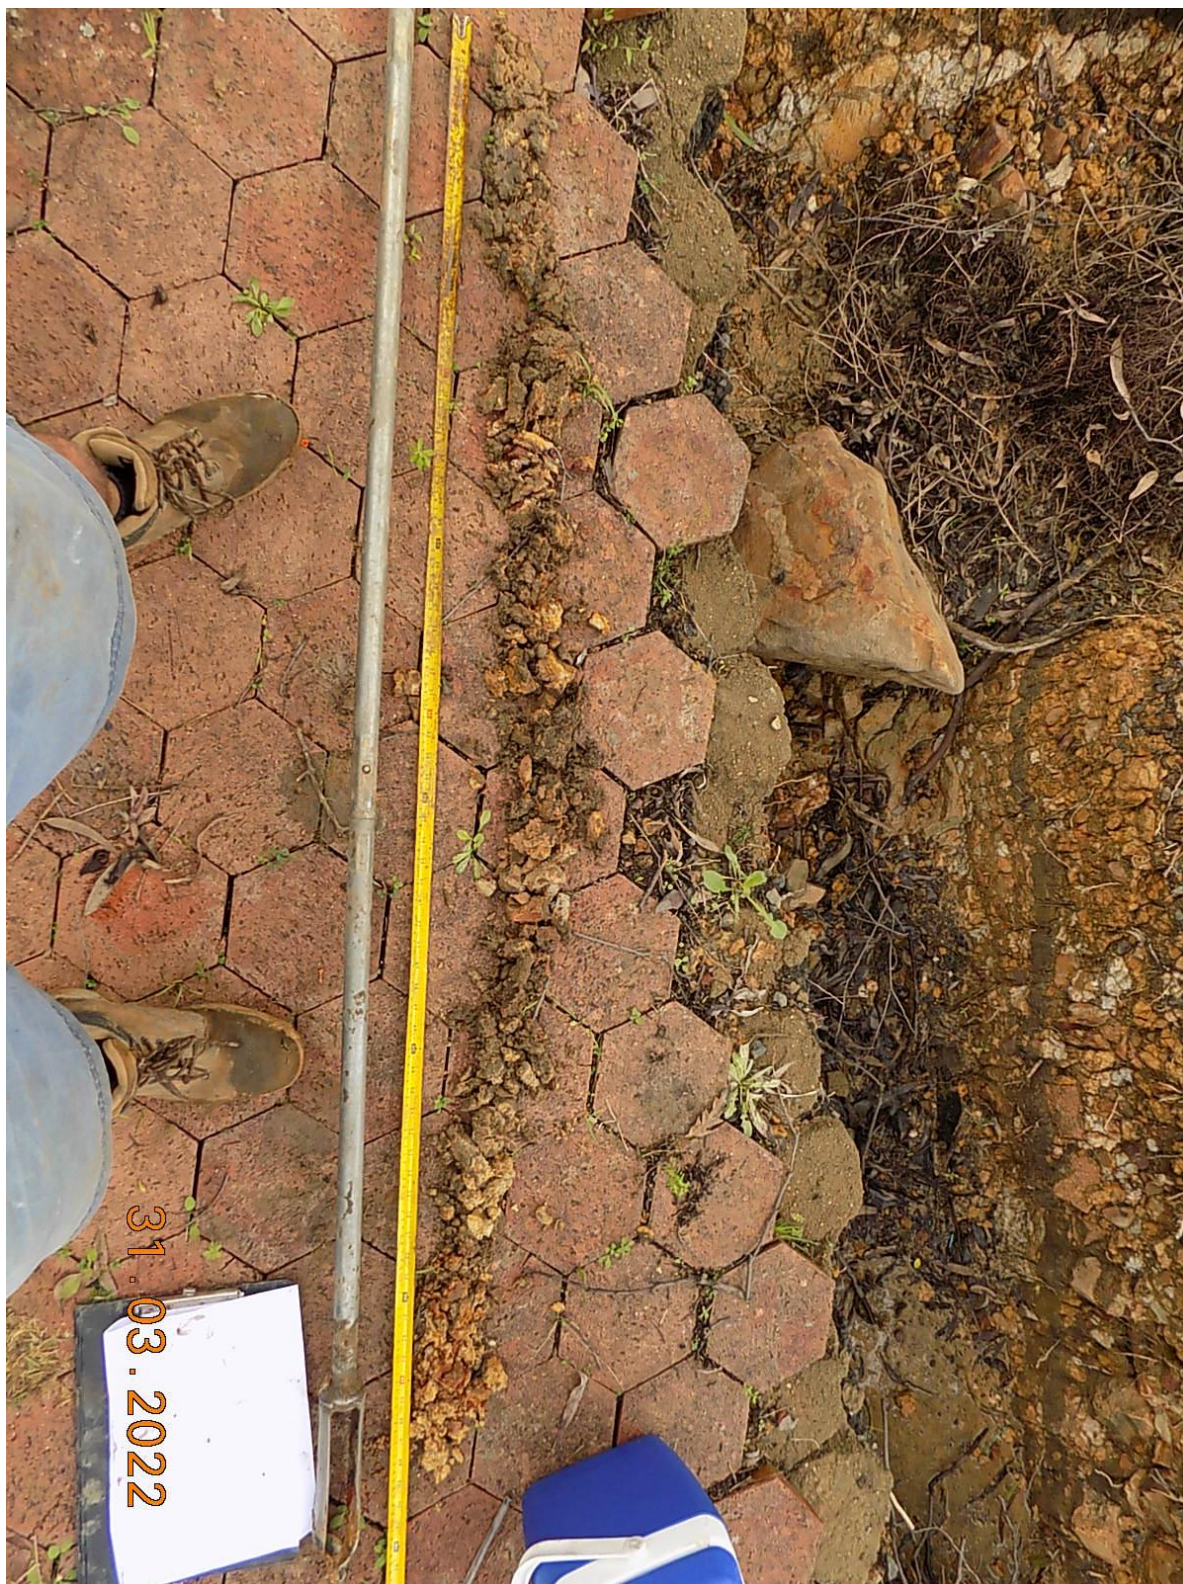
Photo 1: AH2 – Downhole is from top to bottom.

## AUGER HOLE 2 (~RL5.0) – AH2

| Depth (m) | Material Encountered |
| 0.0 to 0.4 | <b>FILL</b> , brown, red, yellow, sand and clay intermixed, loose, damp, fine to coarse grained. |
| 0.4 to 0.6 | <b>CLAY</b> , maroon, yellow, laminate fragments. |
| 0.6 to 0.9 | <b>CLAY</b> , yellow, brown, fine grained, dry. |
| 0.9 to 1.4 | <b>CLAY</b> , white, grey, red, dry, fine to medium grained. |
| 1.4 to 1.7 | <b>CLAY</b> , orange, red, mottled clay, derived from Extremely Low Strength Shale, damp. |

End of Test @ 1.7m in clay. No watertable encountered.

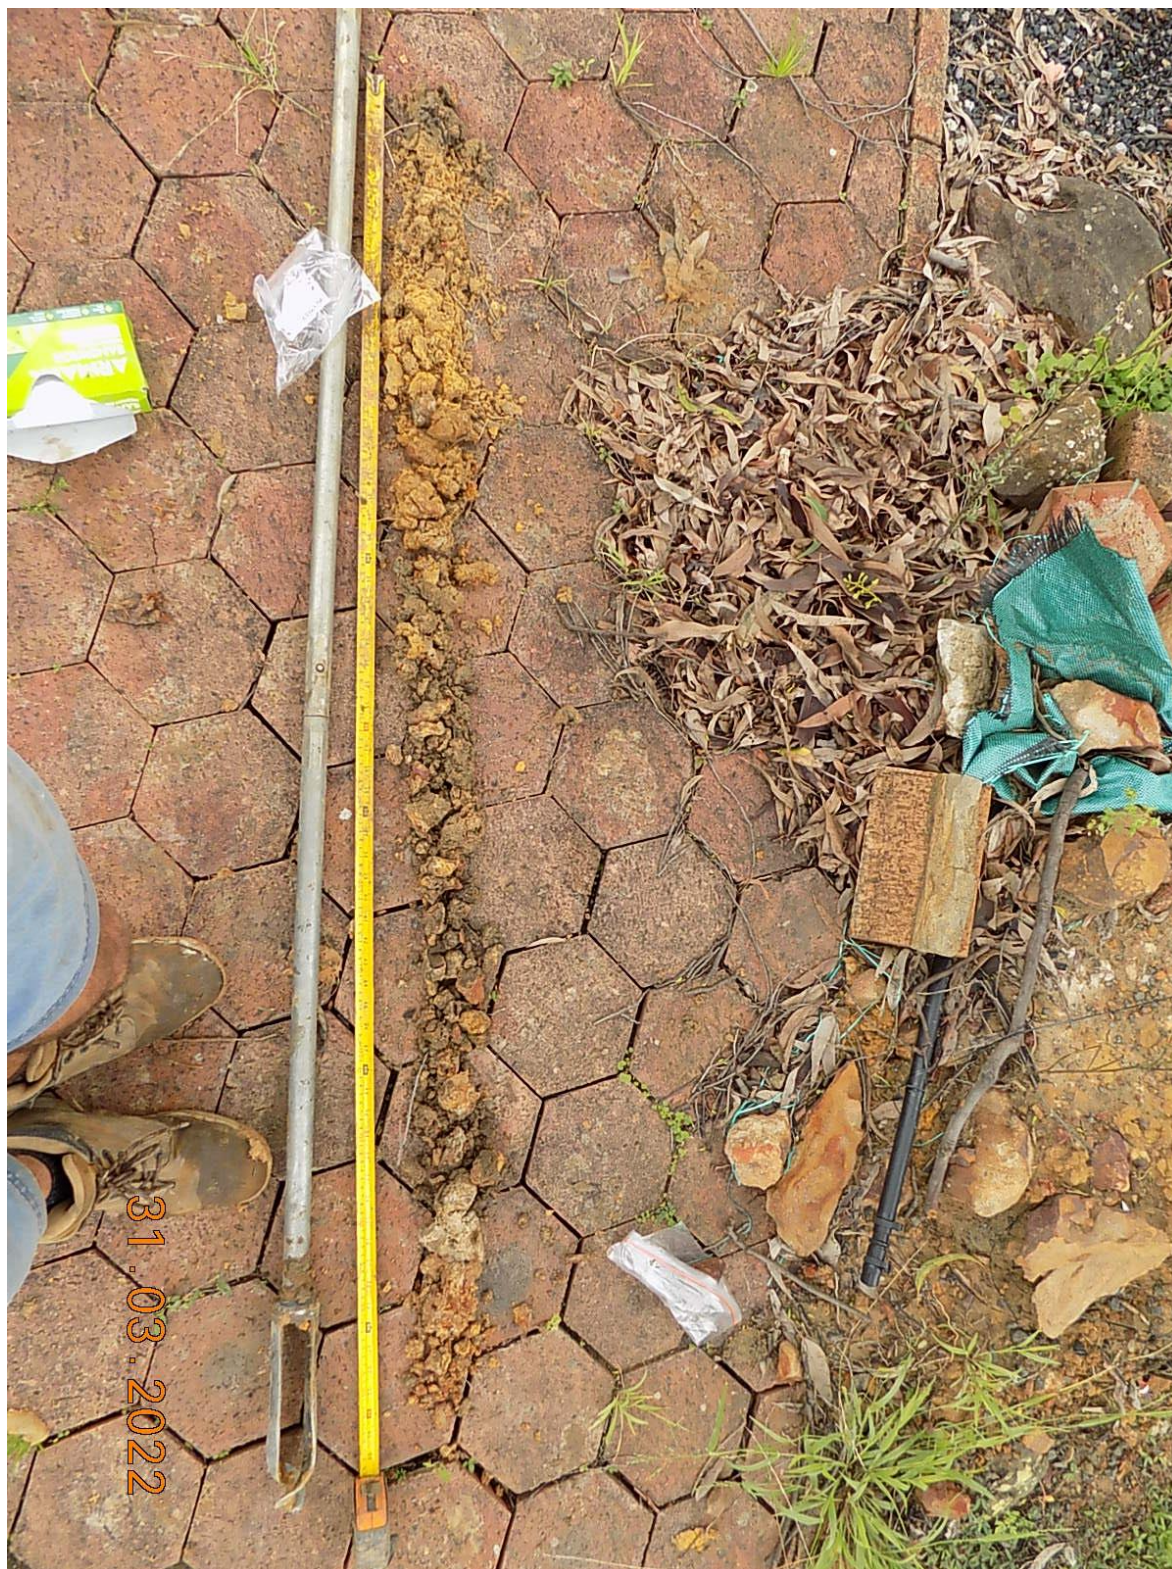
Photo 3: AH3 – Downhole is from top to bottom.

## AUGER HOLE 3 (~RL3.5) – AH3

| Depth (m) | Material Encountered |
| 0.0 to 0.1 | <b>TOPSOIL</b> , sandy clay, light brown, fine to medium grained, damp. |
| 0.1 to 0.4 | <b>SAND</b> , clayey, yellow, medium grained, damp. |
| 0.4 to 0.6 | <b>CLAY</b> , yellow, orange, fine grained, dry. |
| 0.6 to 1.3 | <b>CLAY</b> , maroon, brown, orange, yellow, damp, fine grained. |
| 1.3 to 1.5 | <b>CLAY</b> , white, fine grained, damp. |
| 1.5 to 1.6 | <b>CLAY</b> , red and yellow, mottled clay, derived from Extremely Low Strength Shale, damp. |

End of Test @ 1.6m in clay. No watertable encountered.
