Client	Mr Mc Auley
Location	2a West Street Balgowlah
Document Type	Arboricultural Impact Assessment
Date	10 th September 2018

1. Contents

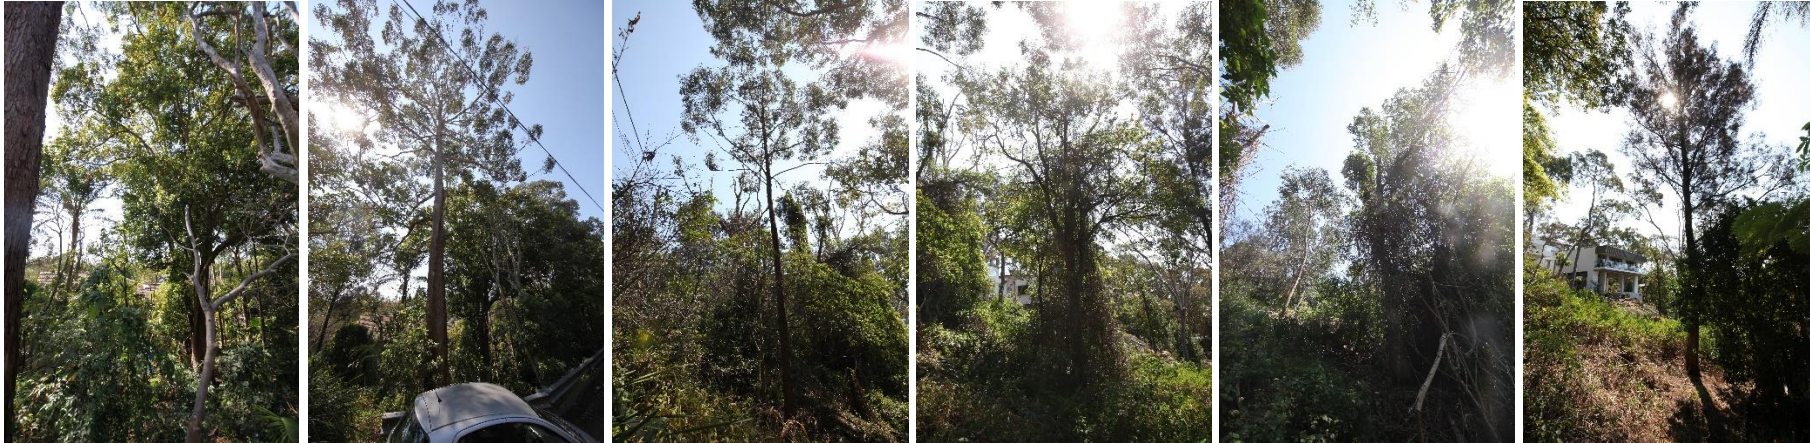
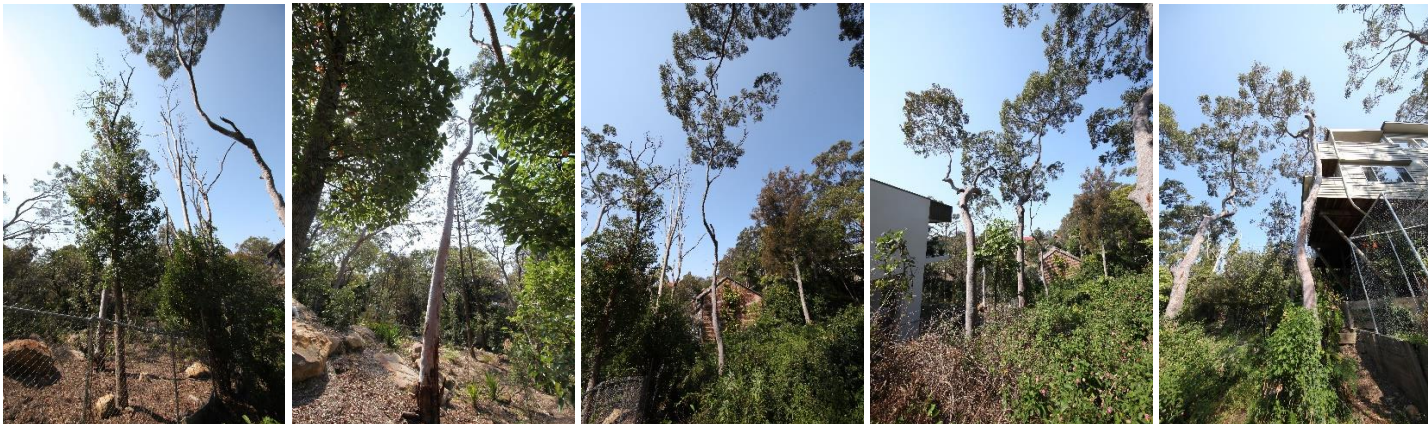
Appendix 3 Images of Tree

Image 1 above left shows tree 1 & 2 on the adjoining site. Image 2 above leftcentre shows tree 3 & 4. Image 3 above shows trees 5 & 6. Image 4 above centre shows tree 7 on site. Image 5 above right shows trees 9 & 10. Image 6 above right shows tree 12. Image 7 below left shows trees 13 & 14. Image 8 below left centre shows tree 16. Image 9 below centre shows tree 17. Image 10 below right centre shows trees 17 & 18. Image 11 below right shows trees 19, 20 & 21.
