Preliminary geotechnical study for Development Application at Fisher Rd, Dee Why, NSW

**GEOTECHNICAL STUDY
PROPOSED RESIDENTIAL BUILDING
DEVELOPMENT 15 - 23 FISHER ROAD,
DEE WHY, NSW**

GEOTLCOV24292AA-AB
29 June 2011

RE: Geotechnical Study at 15- 23 Fisher Road, Dee Why

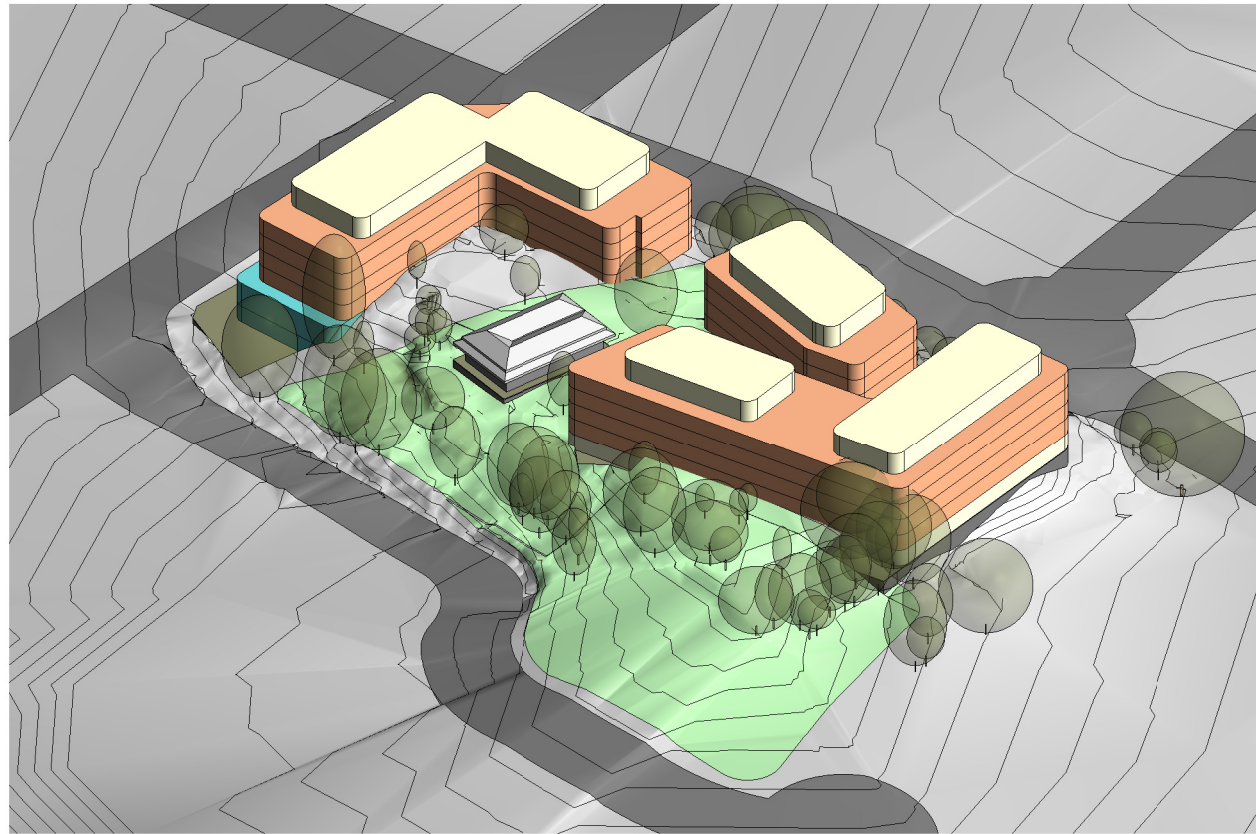
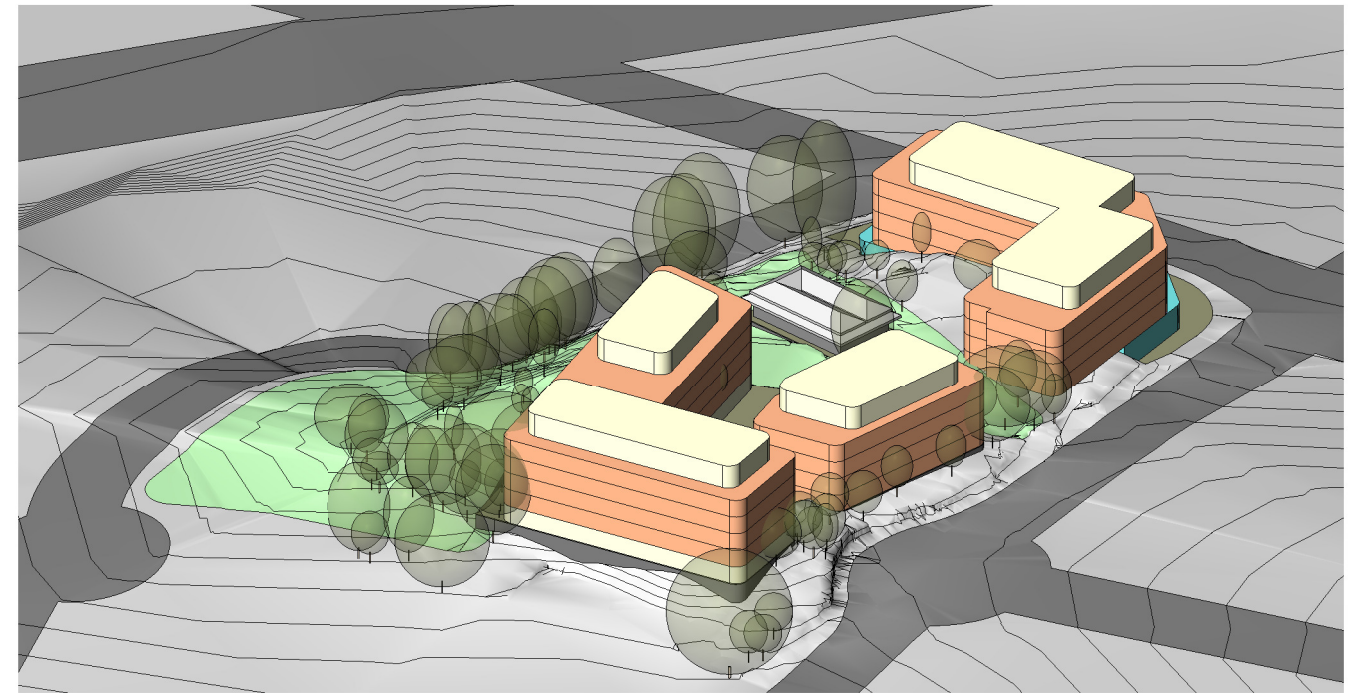
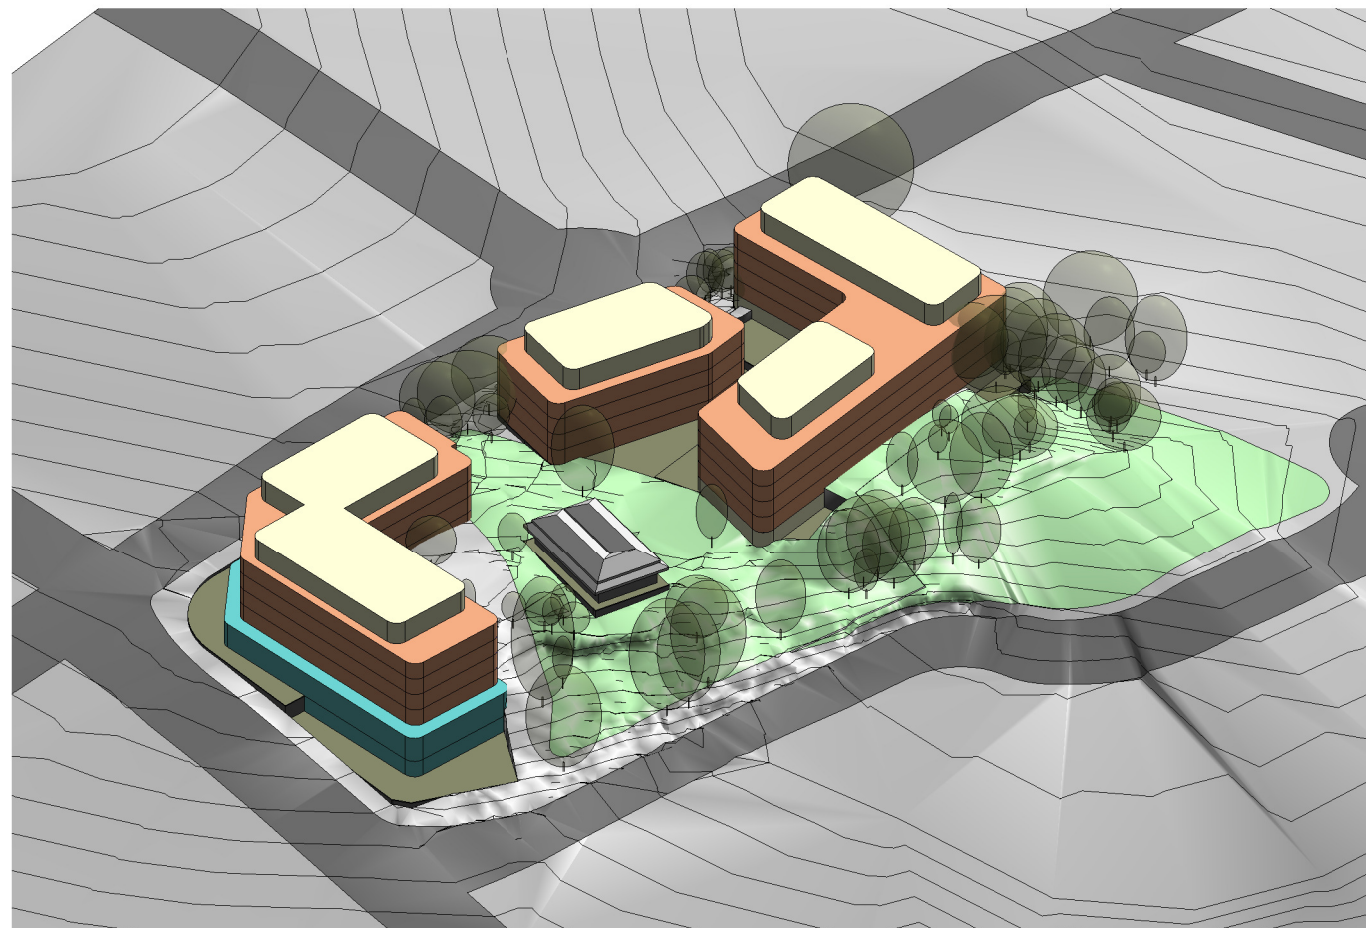
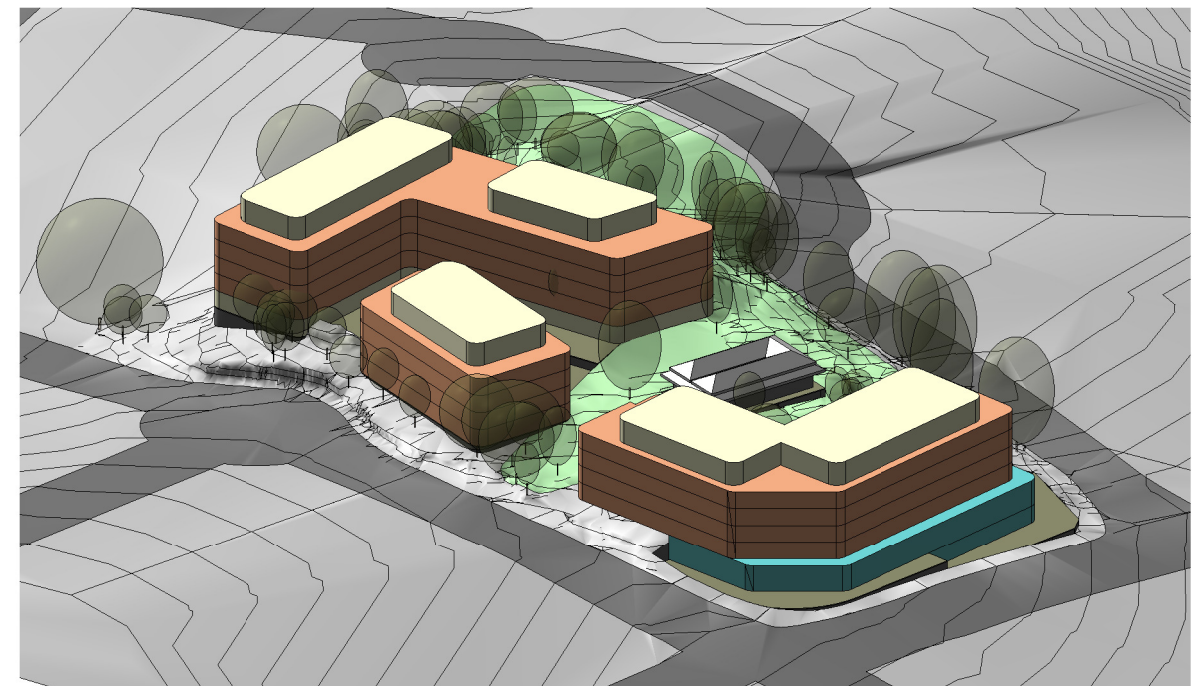
The current development concept has not changed with respect to the development footprint. An additional residential level has been added to each of the three proposed buildings, and a commercial level is proposed in one building. Although not shown on the attached concept drawing, we understand that an additional basement level may be added to one or more of the proposed buildings.

- approved stage 1 building envelope
- additional commercial level
- additional residential levels

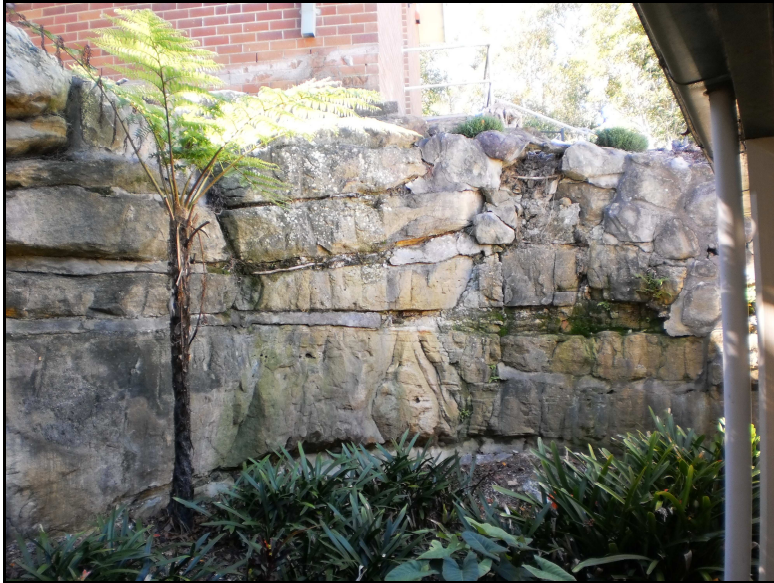
Sandstone was exposed at surface level at numerous locations across the site. The sandstone was generally fine to medium grained, slightly weathered to fresh, medium and high strength. Thin horizontal bands of extremely weathered, very low strength sandstone were present within the upper 1m of a rock cutting located within the more elevated, northern portion of the site (refer photograph 1).

Photograph 1 – Sandstone Cut Supporting Terraced Platform

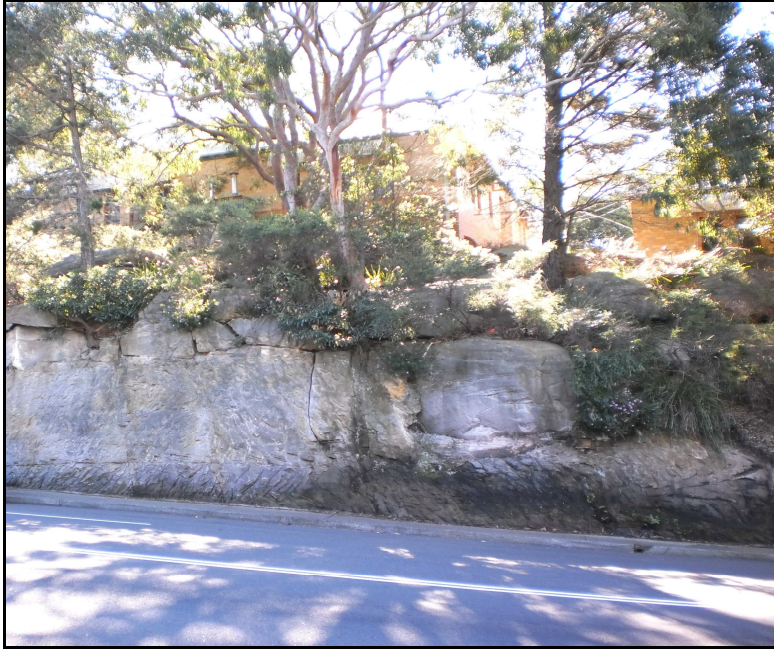
An approximately 0.5m to 3.5m high cut lies along the southern site boundary adjacent to St David Ave. The cutting was predominantly fresh, massive sandstone of high strength (refer photograph 2, above). A number of large sandstone boulders were also observed above this cut.

Photograph 2 – Sandstone Cutting along Southern Boundary

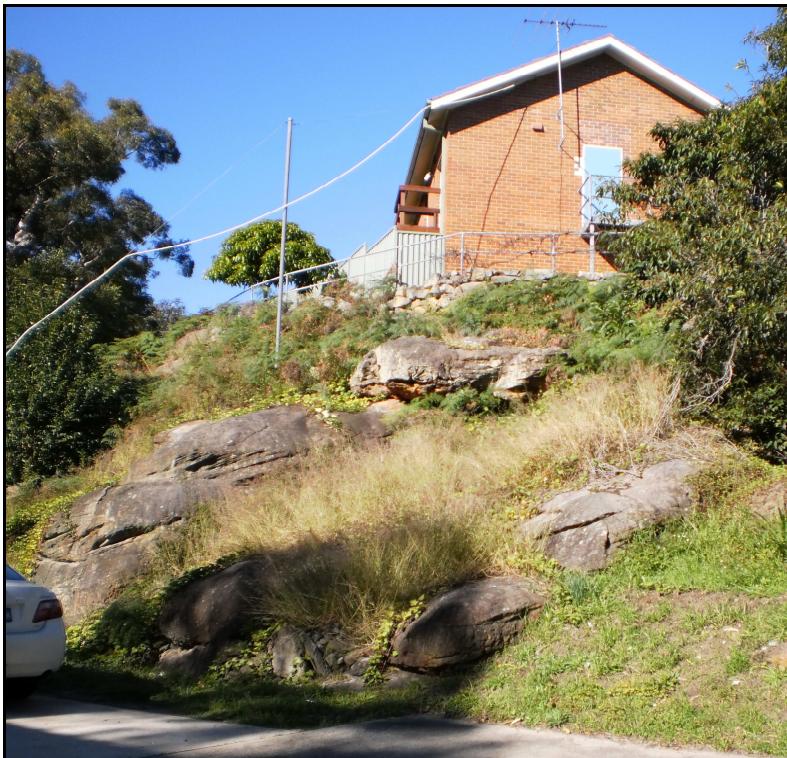
As shown in photograph 3, sandstone rock outcrops were also exposed in the steep, vegetated slope towards the northern boundary. The upper 2m to 3m of the slope appeared to have been landscaped and over steepened by placement of fill associated with the upslope building platform. Vertical cuts in sandstone were observed at the toe of the slope and likely to be associated with construction of the existing driveway and residential building.

Photograph 3 – Sandstone Exposures in North Facing Slope

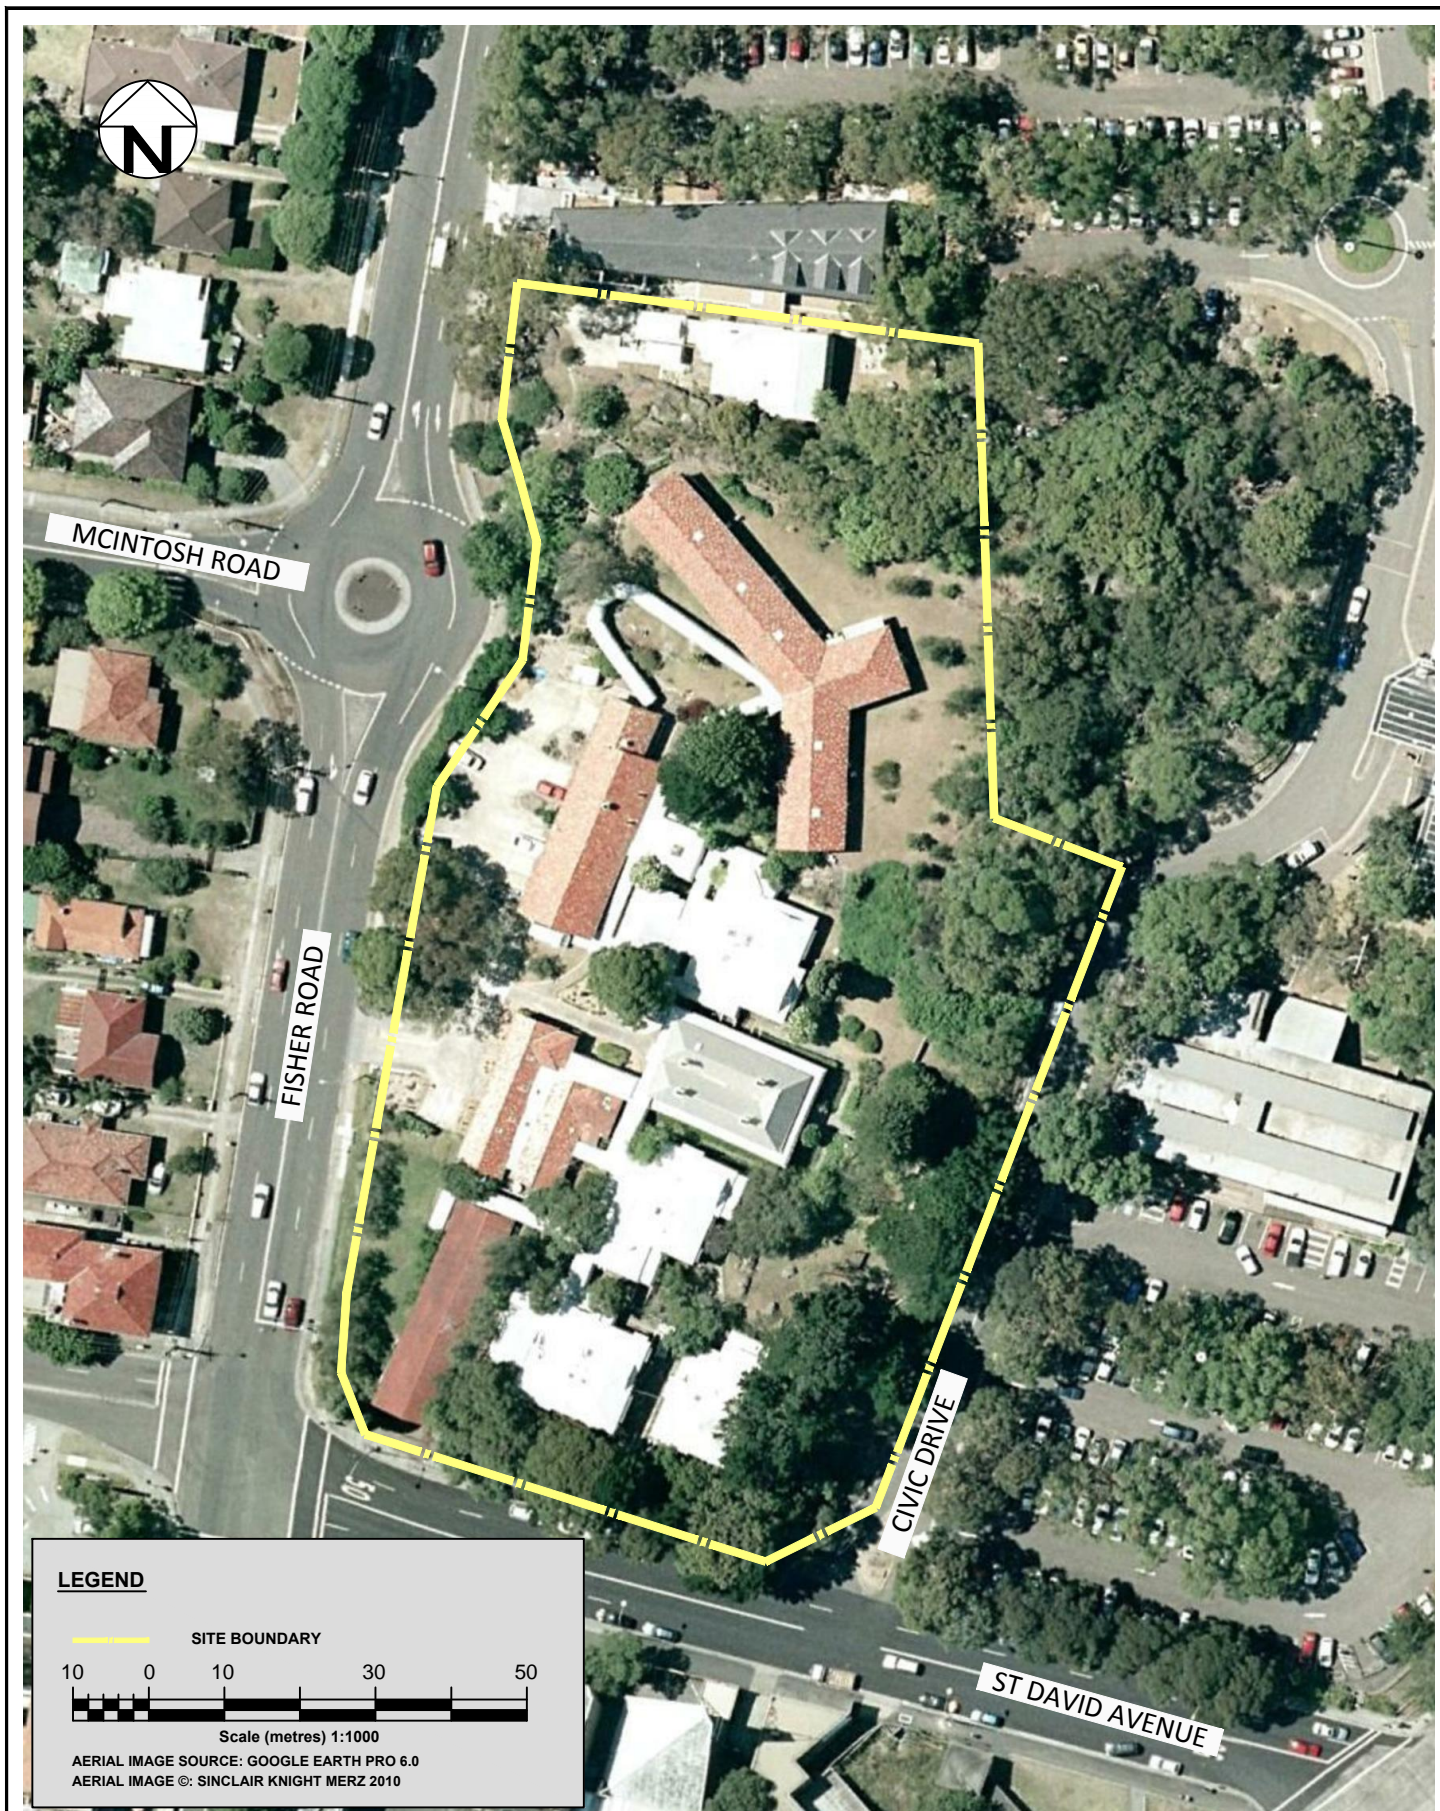
client:	THE SALVATION ARMY	
project:	GEOTECHNICAL STUDY 15-23 FISHER ROAD, DEE WHY, NSW	
title:	SITE PLAN	
project no:	GEOTLCOV24292AA	figure no: FIGURE 1

The extent of the proposed development is presented on Figure 1 and on the appended concept plans.

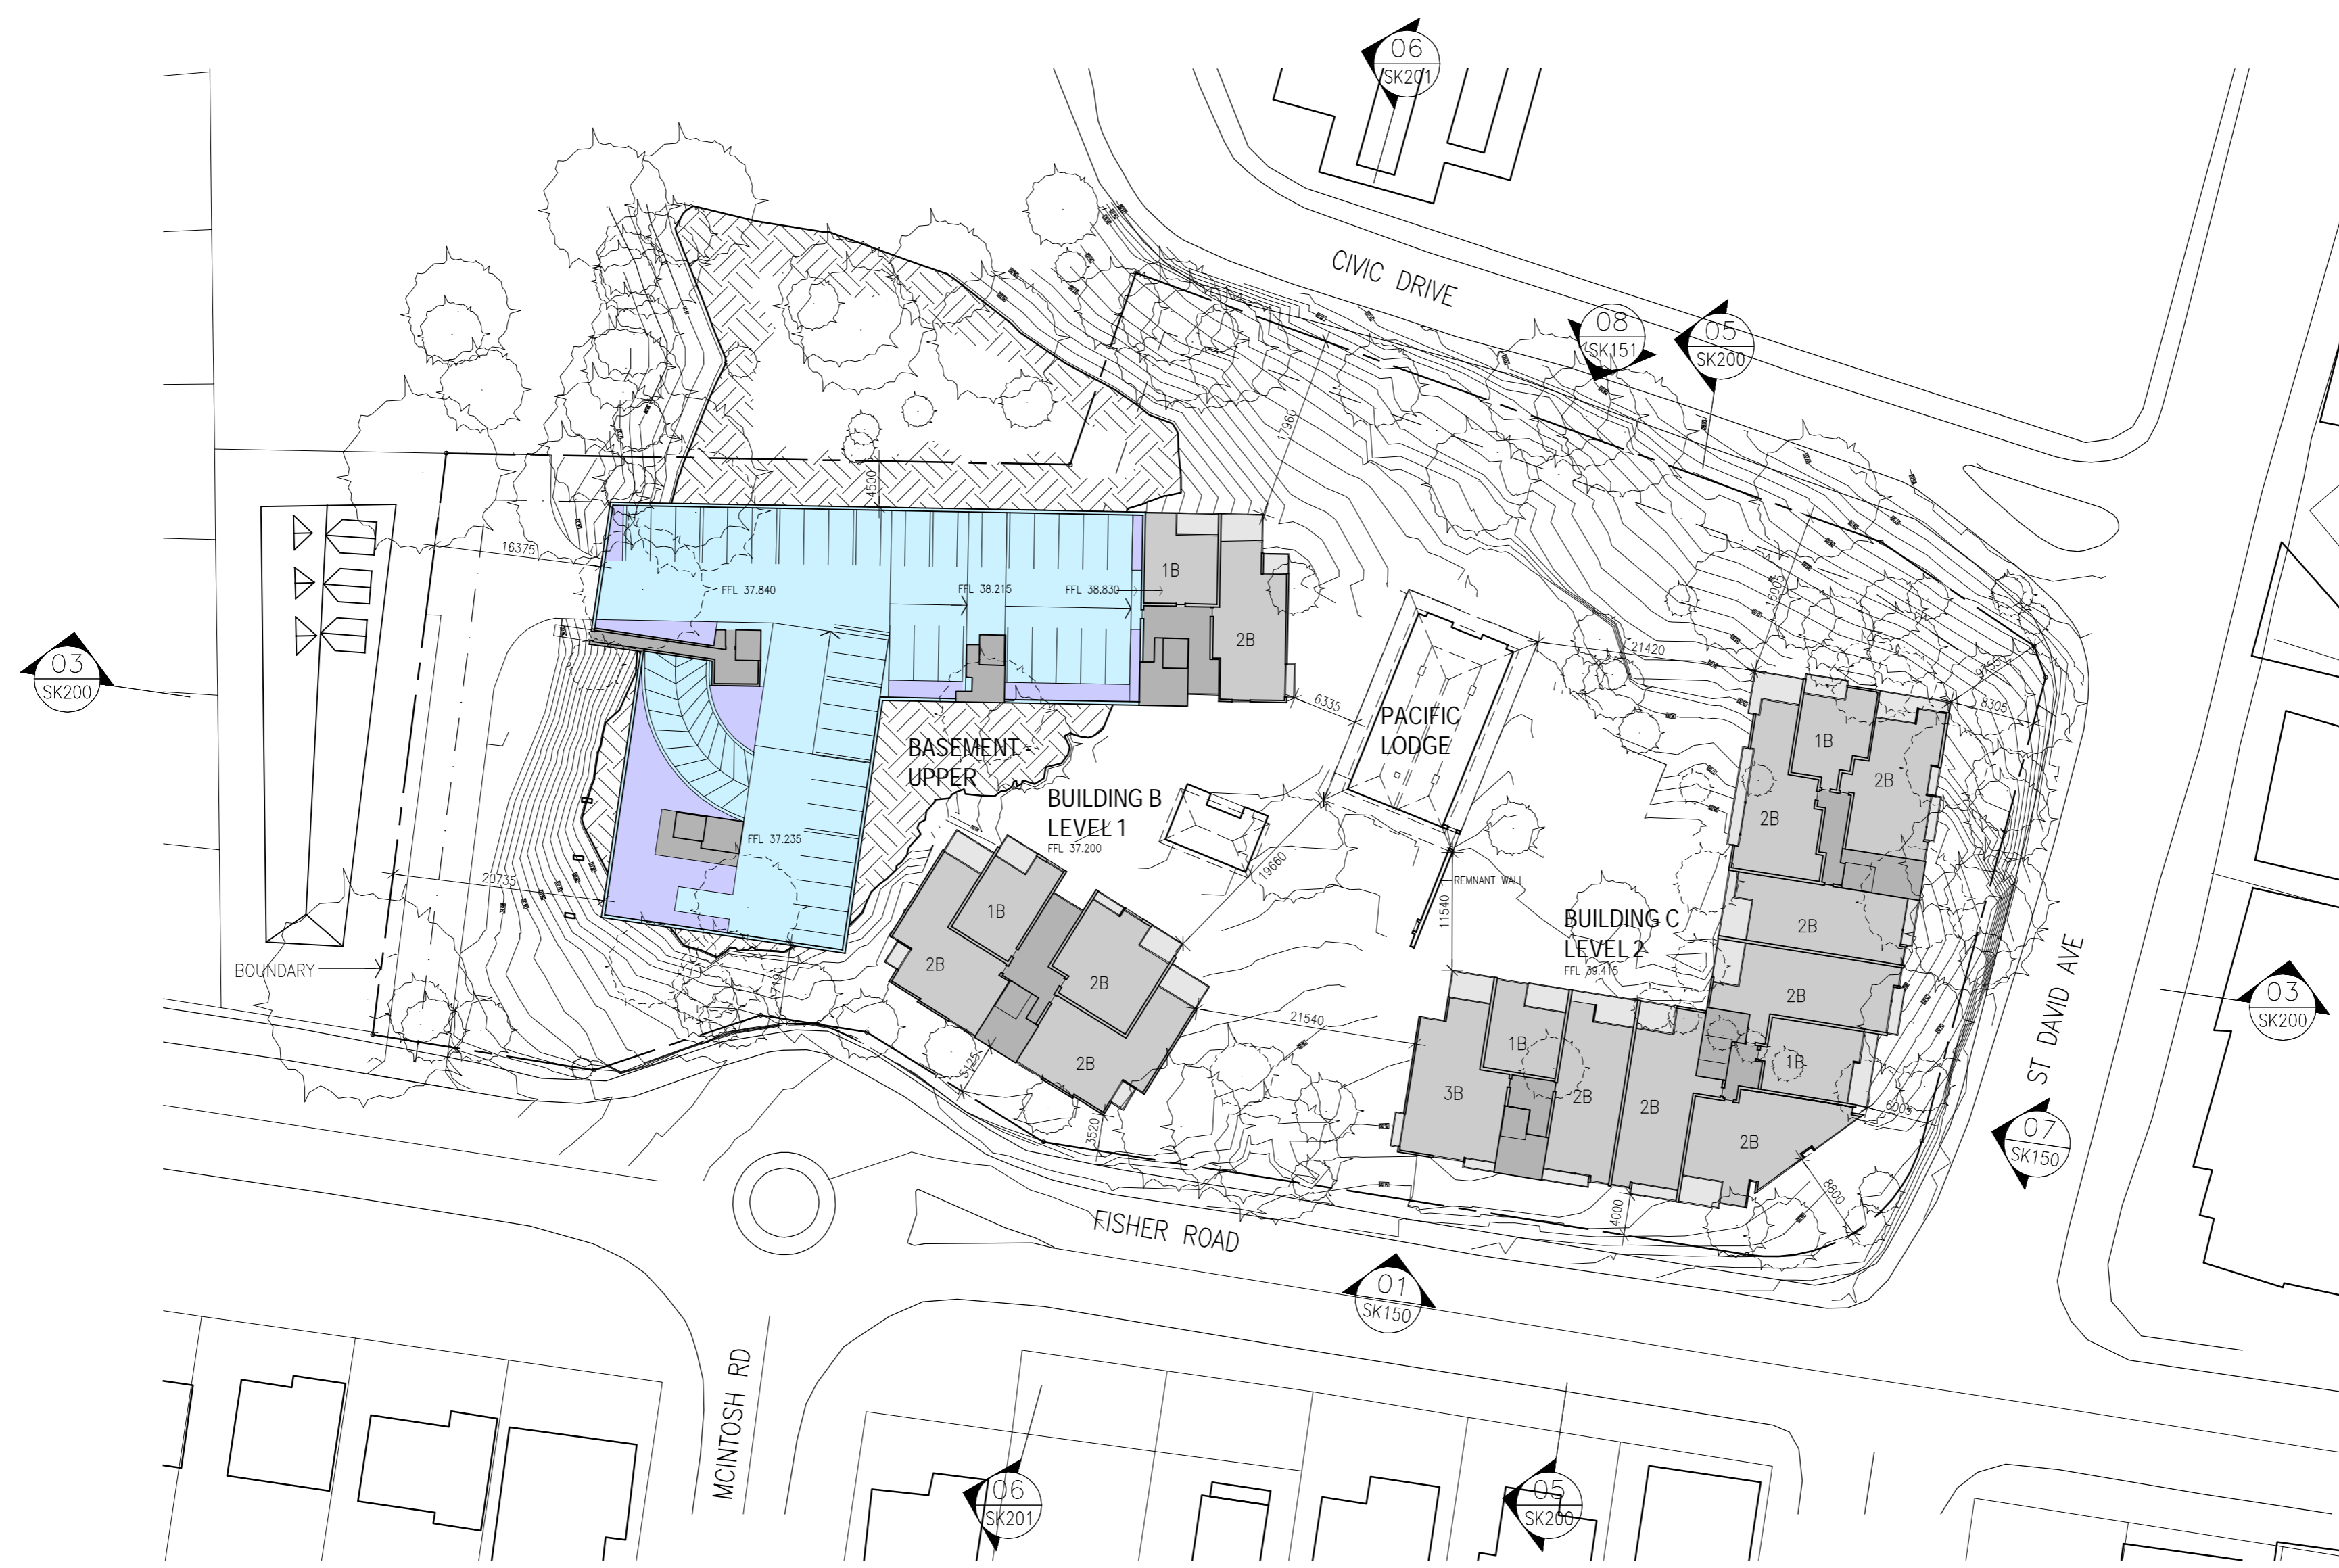
01 SITE PLAN
 1:500 AT A2

NOTES:
 - EXISTING TREES WITH HEIGHTS >5m SHOWN ONLY. SPREADS AND POSITIONS SHOWN ACCORDING TO REGISTERED SURVEY DRAWING.
 - SOLID / GLAZED ELEMENTS SHOWN INDICATIVELY.

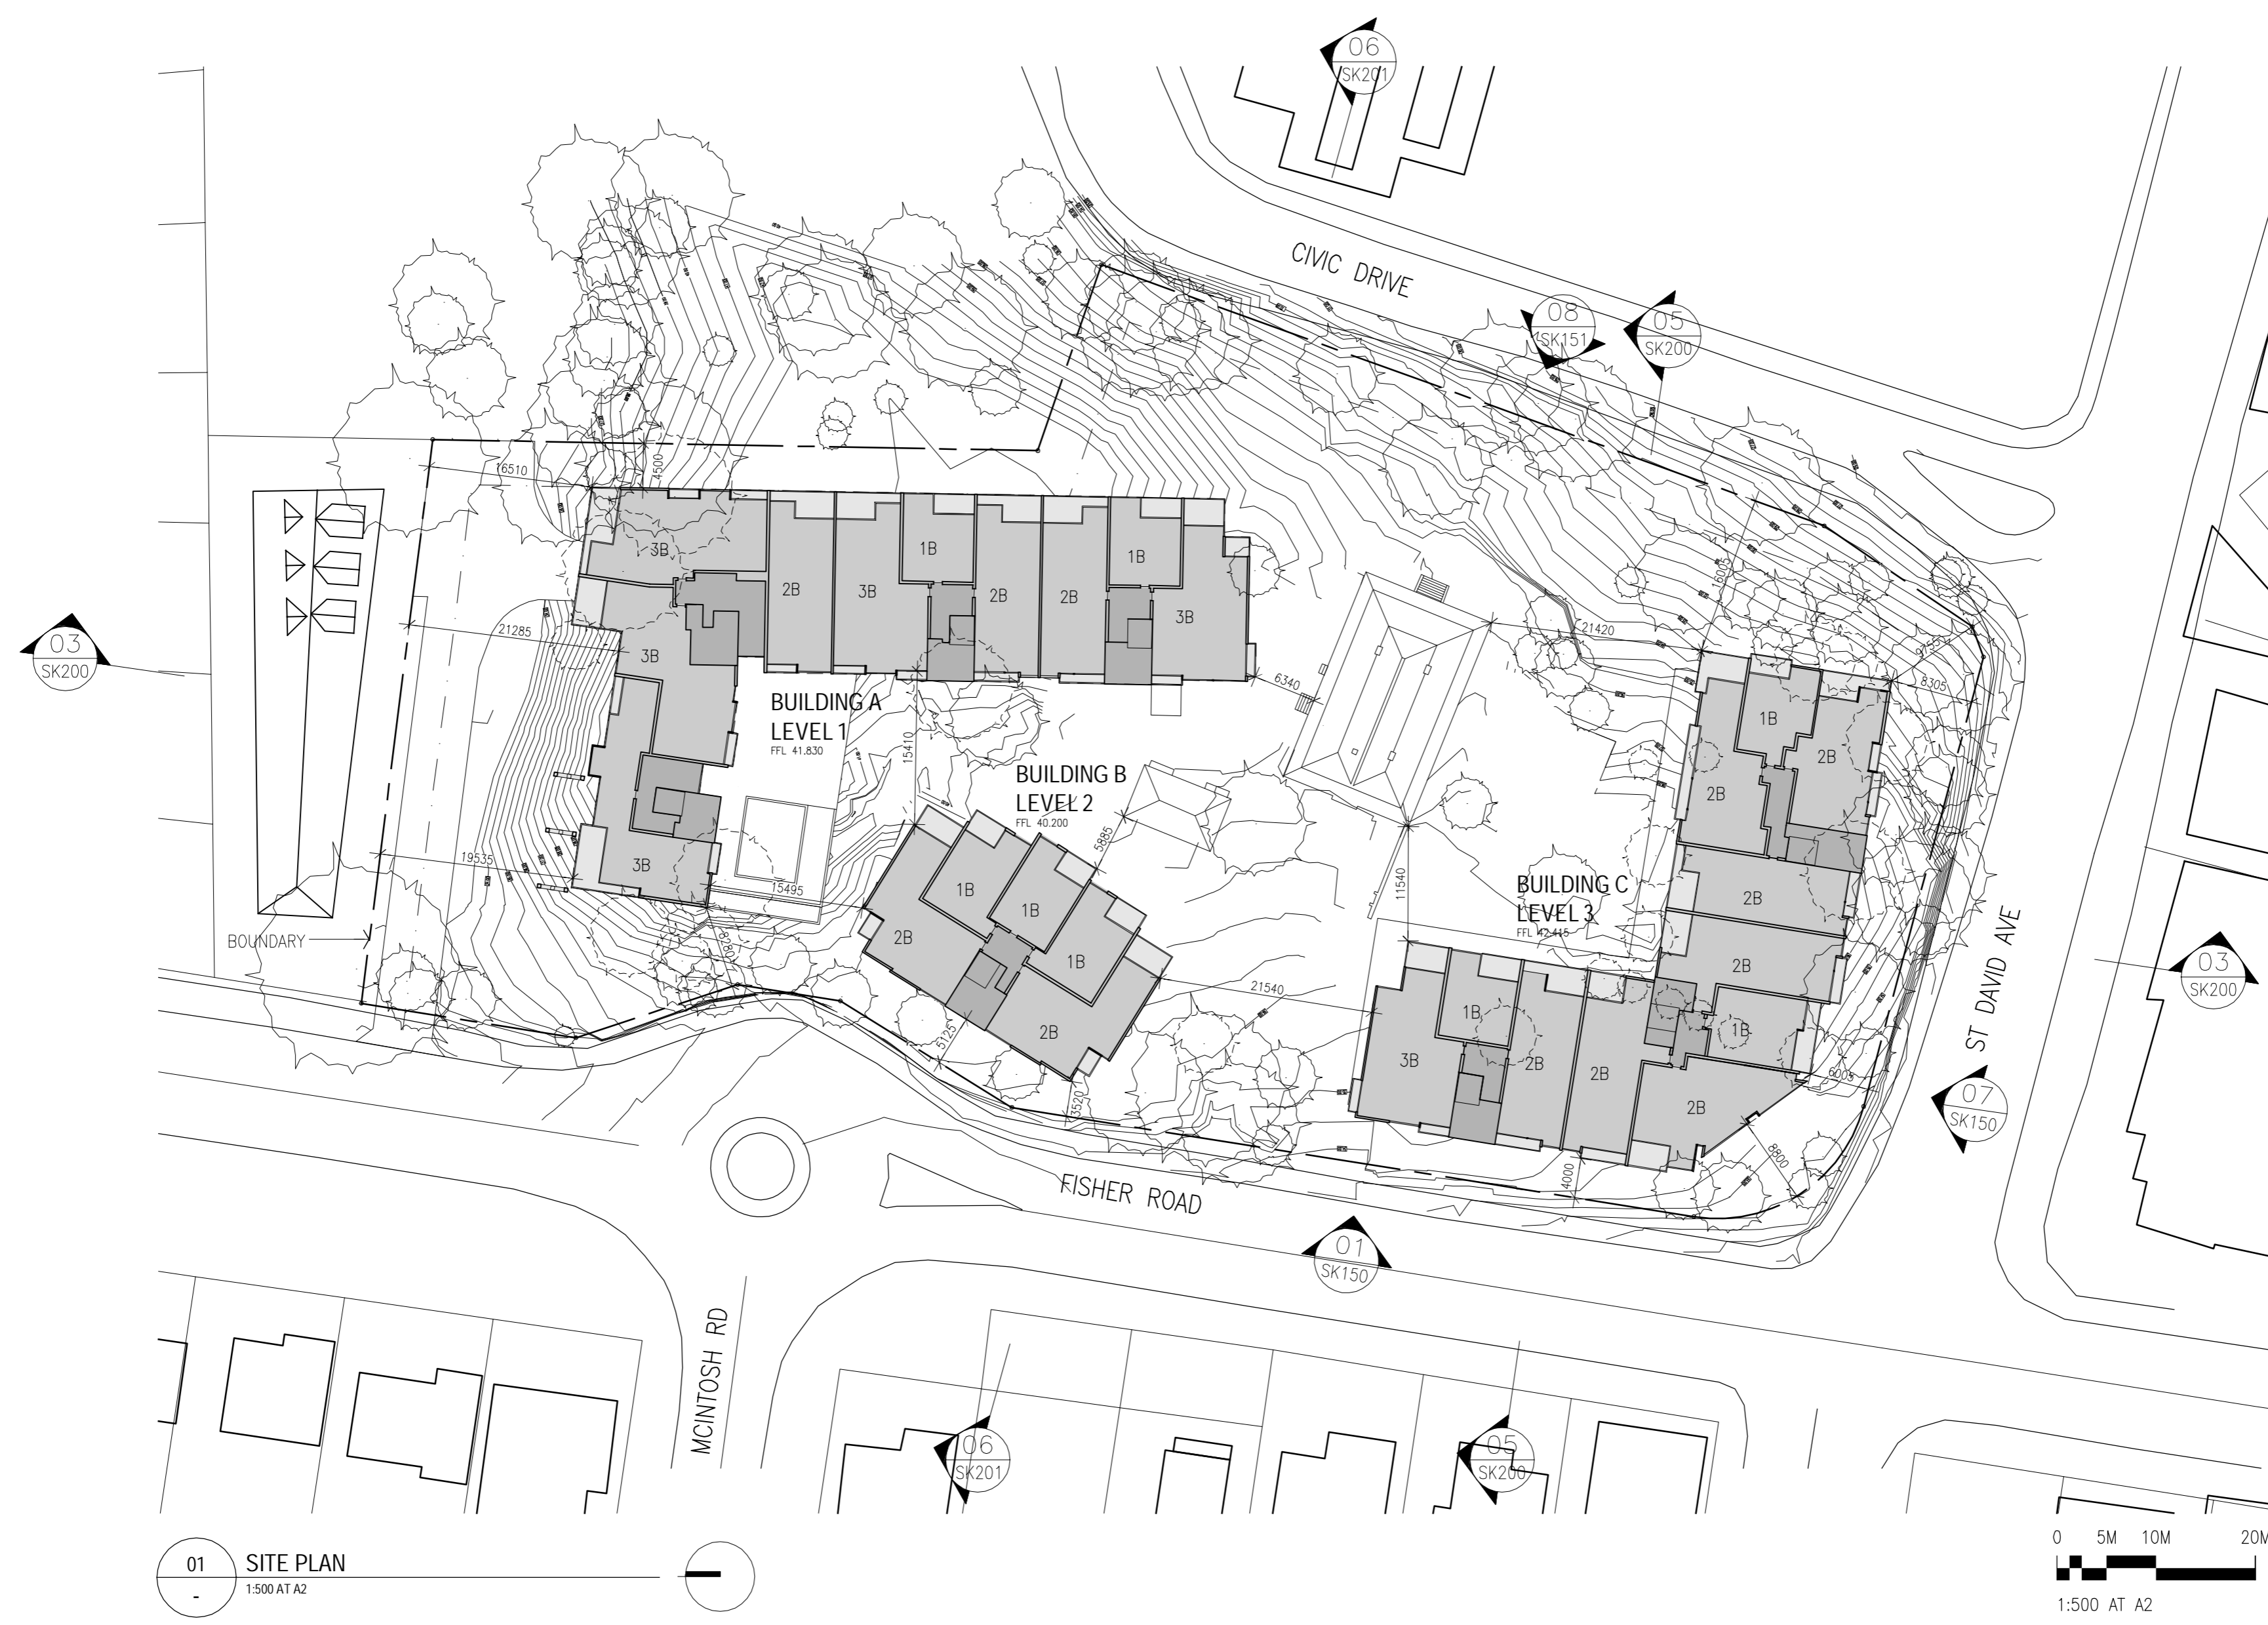
01 SITE PLAN
 1:500 AT A2

NOTES:
 - EXISTING TREES WITH HEIGHTS >5m SHOWN ONLY. SPREADS AND POSITIONS SHOWN ACCORDING TO REGISTERED SURVEY DRAWING.
 - SOLID / GLAZED ELEMENTS SHOWN INDICATIVELY.
