**Subject:** DA2022/0857 Demolition of an existing dwelling and construct new dwelling and swimming pool at 28 Goondari Road Allambie Heights

## Response to DA2022/0857 Submission

Regarding: DA2022/0857

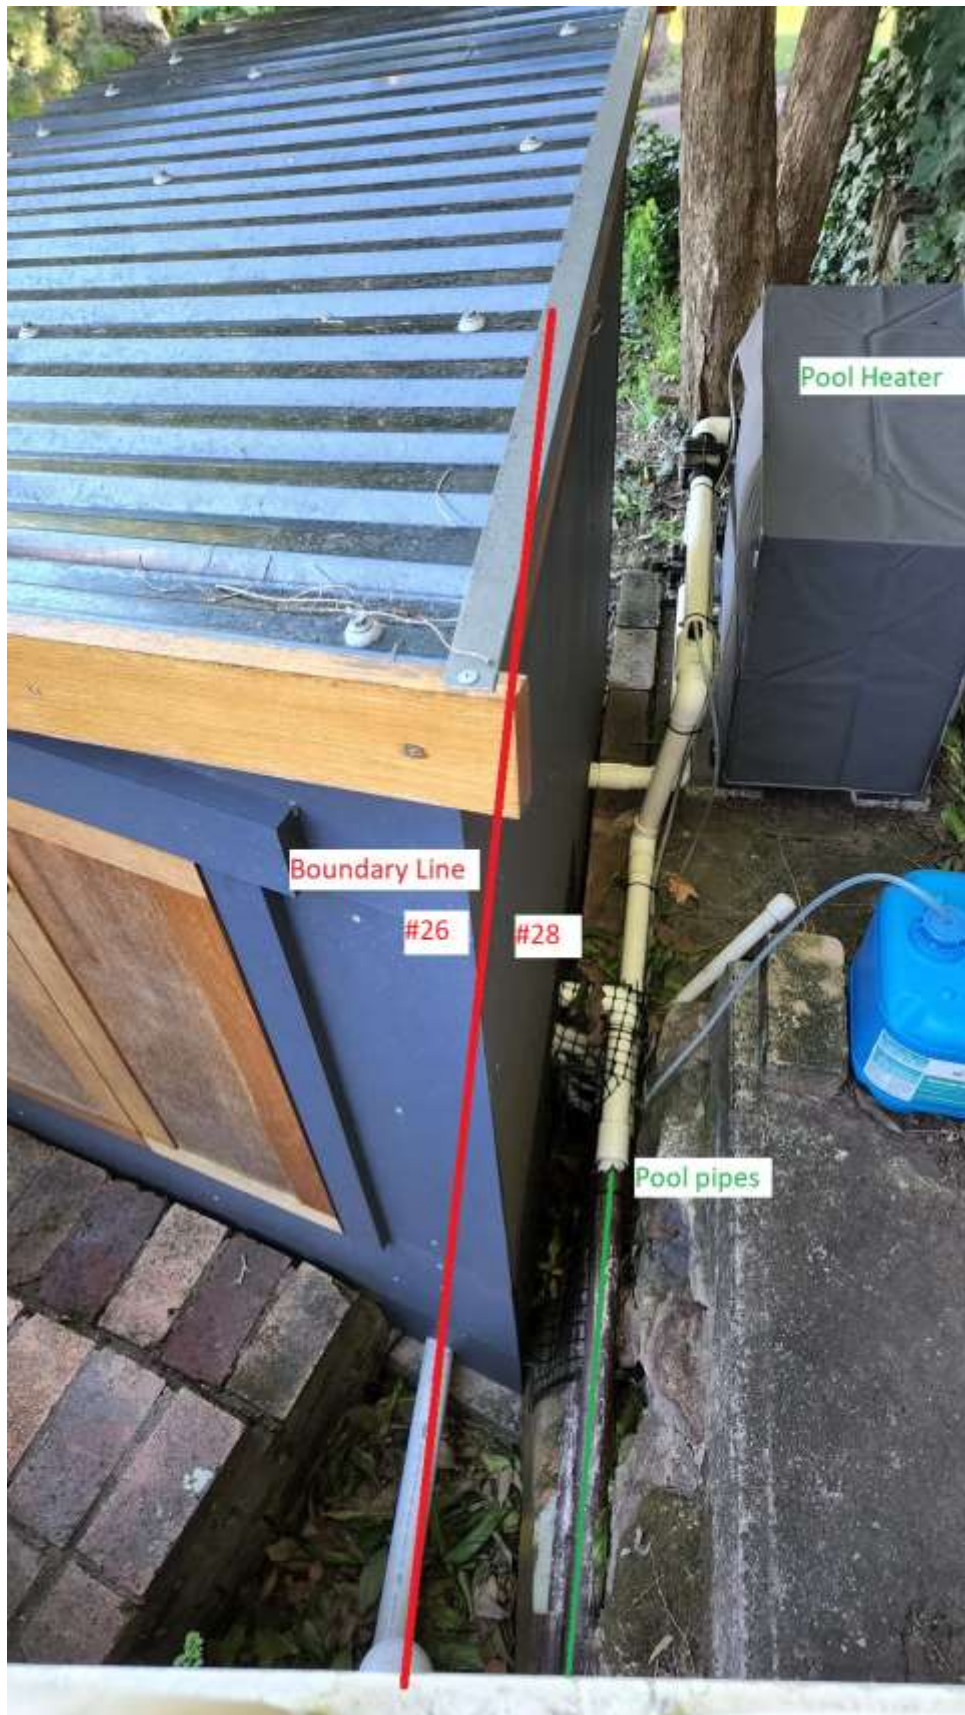
Photo 1 – Pool equipment structure, pool heater, and underground pool pipes.

**Issue #1** – While it appears that the concrete structure of the swimming pool at no. 26 is within the boundary of no. 26, the pool plumbing pipes that feed the pump and filter are underground and to the north of the swimming pool and pool equipment structure. This has not been shown in the DA submission. These pool plumbing pipes are approximately 300mm over the boundary to no. 28. The excavation as planned in the DA would result in the removal of these pool plumbing pipes and result in the loss of the swimming pool.

In addition to the plumbing pipes that feed the pump and filter, there are two additional plumbing pipes further to the east of the swimming pool buried in the rock garden bed to allow for future provision of solar heating on the roof of the house. One of these pipes extends the entire length of the boundary line from the corner of the house to the pool filter equipment shed.

**Issue #2** - The shape of the encroaching pool equipment structure as marked in the plan is not accurate as there is an entire side of the structure encroaching onto no. 28, not just a small corner as indicated in the DA submission. The dimension of the section of pool equipment structure that encroaches is roughly 250mm x 1800mm and the proposed construction would require demolition and rebuilding of the entire structure, including its concrete foundation. The construction of the proposed retaining wall directly on the boundary line, and the irregular shape of the remaining available land area on no. 26 side of the boundary line means there will not be sufficient space to rebuild the equipment structure in this location. This could result in loss of pool filtering capability, and mean the loss of the swimming pool altogether.

**Issue #3** – There has been an omission of pool heating equipment from the survey along-side the pool filter. Due to the irregular shape of the available area, the pool heater is located completely over the boundary line onto no. 28, but still within the fence line of no. 26.

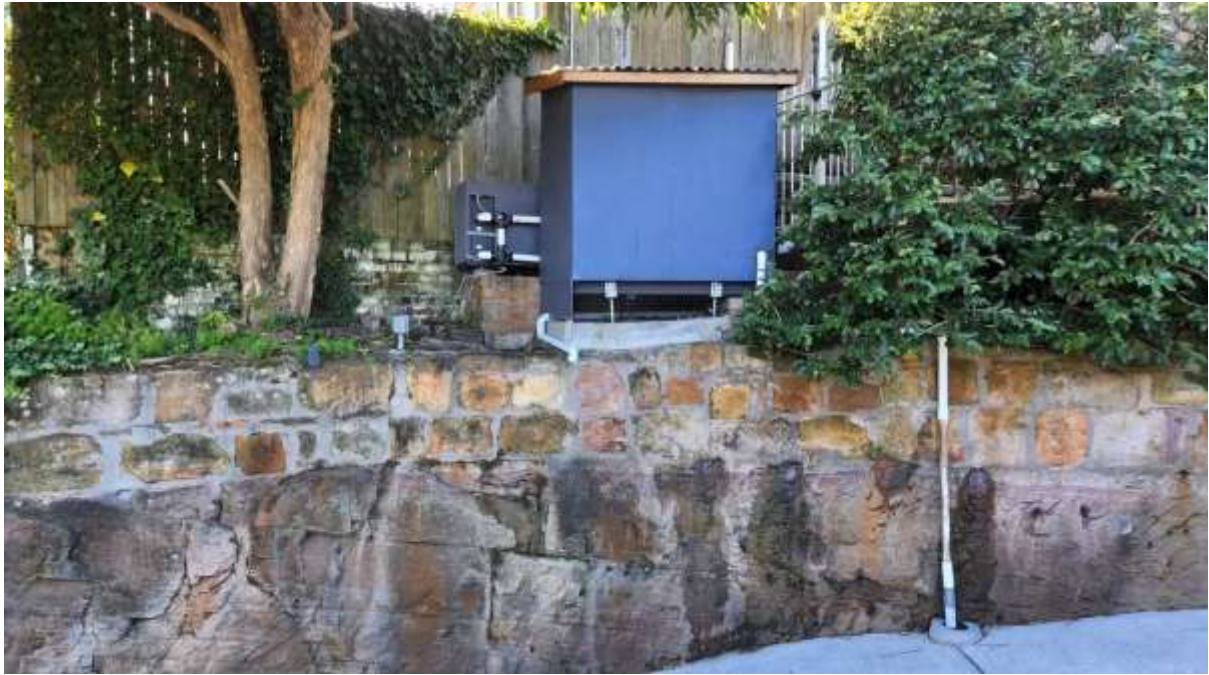
Photo 2 – Pool equipment structure location – angle 1

Refer [Photo 2](#) and [Photo 3](#) in below appendix for a view of the limited available space in location.

Refer [Photo 2](#) and [Photo 3](#) in below appendix for a view of the limited available space in location which resulted in the decision to place the heater where it is currently located.

**Issue #9** – There is a retaining wall planned along the edge of the new driveway on the southern boundary line that is going to be placed on top of an existing sandstone wall. The existing sandstone wall is approximately 600mm high and 120mm thick. This sandstone wall is constructed on top of the sandstone bedrock and is currently retaining the soil to support the tree above it. The structural integrity of the sandstone wall is not sufficient enough to support the weight of the retaining wall that is proposed to be placed on the edge of this sandstone wall and poses a risk of collapsing onto the driveway for number no. 26. This has the potential to happen under the weight of the new wall, and also as it is being used as a driveway, there is the possibility that impact from a vehicle could cause the wall to collapse down onto the driveway of no. 26.

Refer [Photo 2](#) in below appendix for detail of the existing sandstone wall

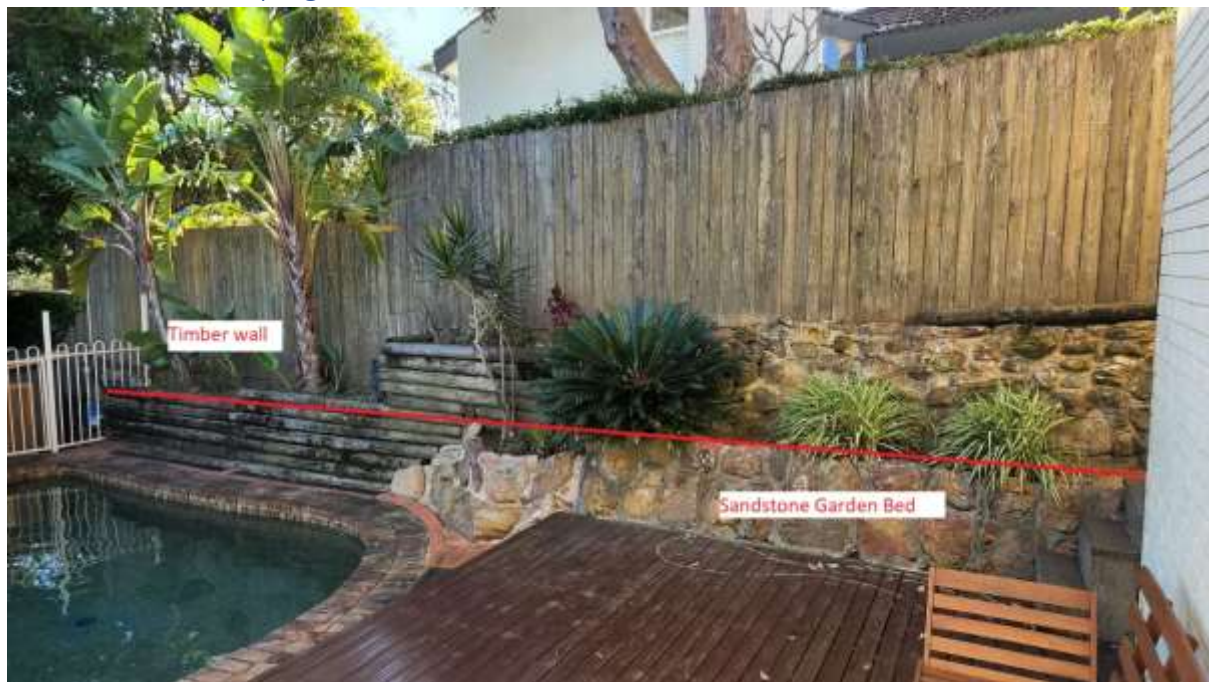
Photo 4 – Landscaping

**Issue #4** – There is substantial landscaping along the boundary line that has been omitted from the plans that would need to be demolished and removed. Slide 6 in the *Plans - Master Set.pdf* refers to a 'Timber Wall', but in actuality there is also stormwater guttering and a sandstone garden bed. The excavation and construction of retaining walls as planned in the DA would result in removal and loss of these entities.

Refer [Photo 4](#) and [Photo 5](#) in below appendix for detail of the entities that will be lost.

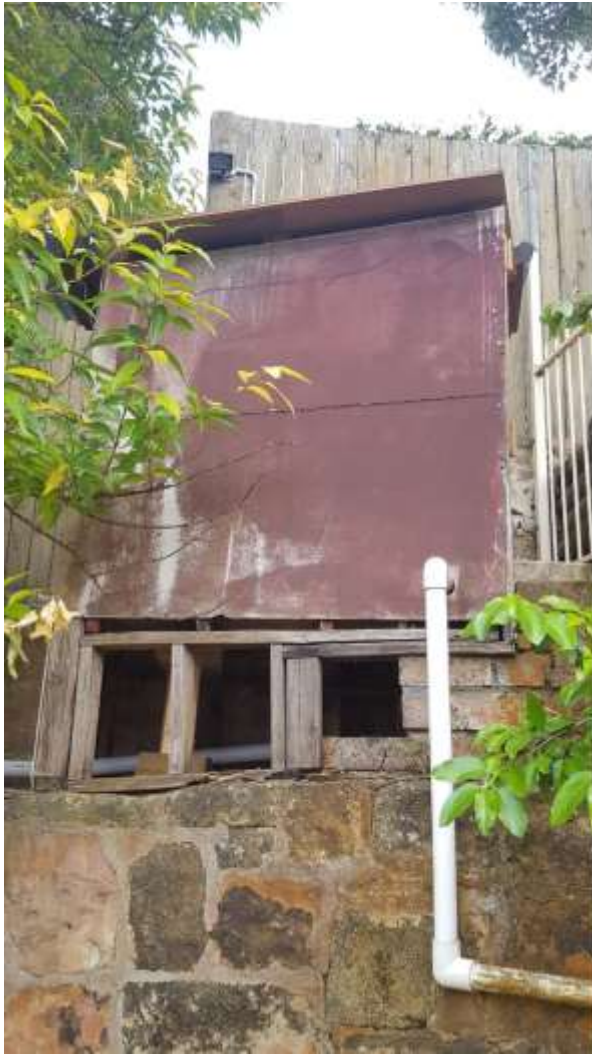
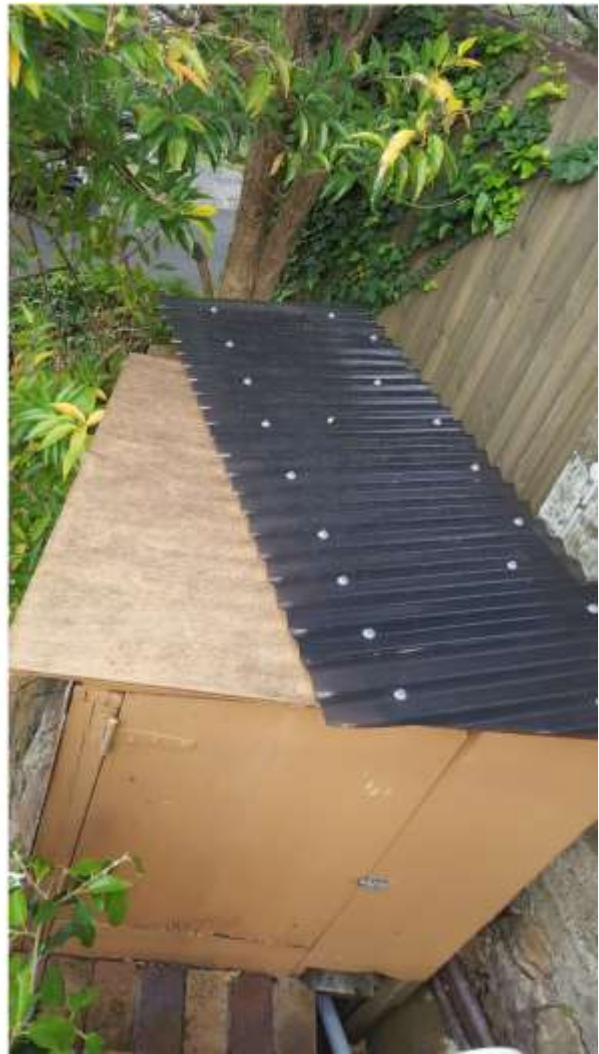
Photo 6 – Old Pool Filter Equipment Shed

Refer [Photo 6](#) in below appendix for photos of the old pool equipment structure present on the site from pre-2013 (when we purchased no. 26 Goondari Rd) until 2016 when it was rebuilt to the current standing structure. The new structure takes up the same footprint as the previous structure, but placed on a concrete slab and elevated to protect from water damaging the wooden structure – as was the fate of the previous structure.

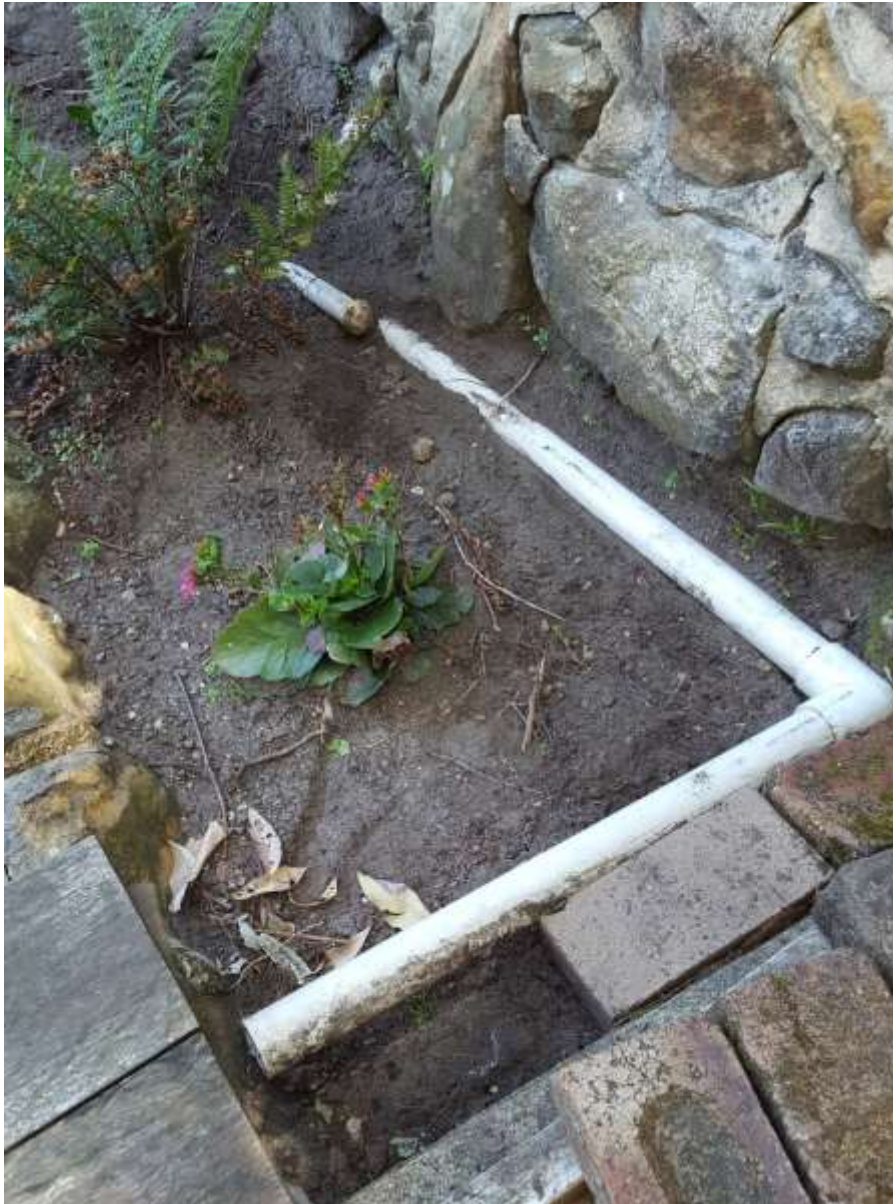
Photo 7 – Additional Pool Plumbing along Boundary Line for Provision of Solar Heating

Refer [Photo 7](#) in below appendix for pool pipe location in the garden bed for solar heating.

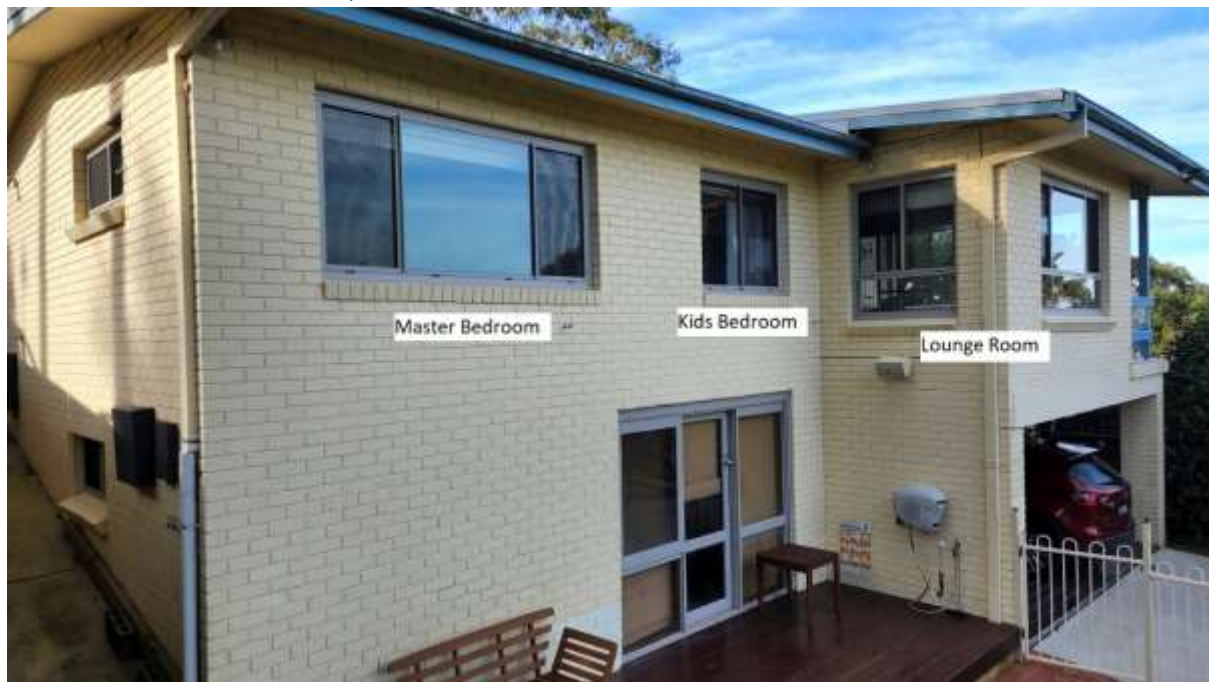
Photo 8 – View from Proposed Patio towards the House at no. 26

**Issue #8** – The main outdoor entertaining area proposed in the DA is located in an elevated position directly along the southern boundary line. With the construction being directly on the boundary line there is no available space on either side for any natural landscaping to be added to provide a level of privacy between this patio and the front premises of no. 26. With this elevated and un-obstructed viewing angle, the occupants of no. 28 will have direct views over the pool, alfresco dining area, and more concerning, directly into the 2 front bedrooms and lounge room of no. 26.

Refer [Photo 8](#) for a photo taken on the boundary line and at the elevation of the top of the balustrade (1.2m above patio floor) for the proposed patio – towards the house. Actual view of an adult (~1.8m tall) standing along the balustrade would be from a higher angle than shown.

- The proposed development at no. 28 providing increased levels of privacy between no. 26 and no. 28 relating to the entertaining area (patio) on the southwest corner. Amendments to the proposal should be made to relocate the entertaining areas or restrict the direct and unobstructed views this area would provide over the swimming pool area, alfresco dining area, and into bedrooms and lounge room of no. 26.

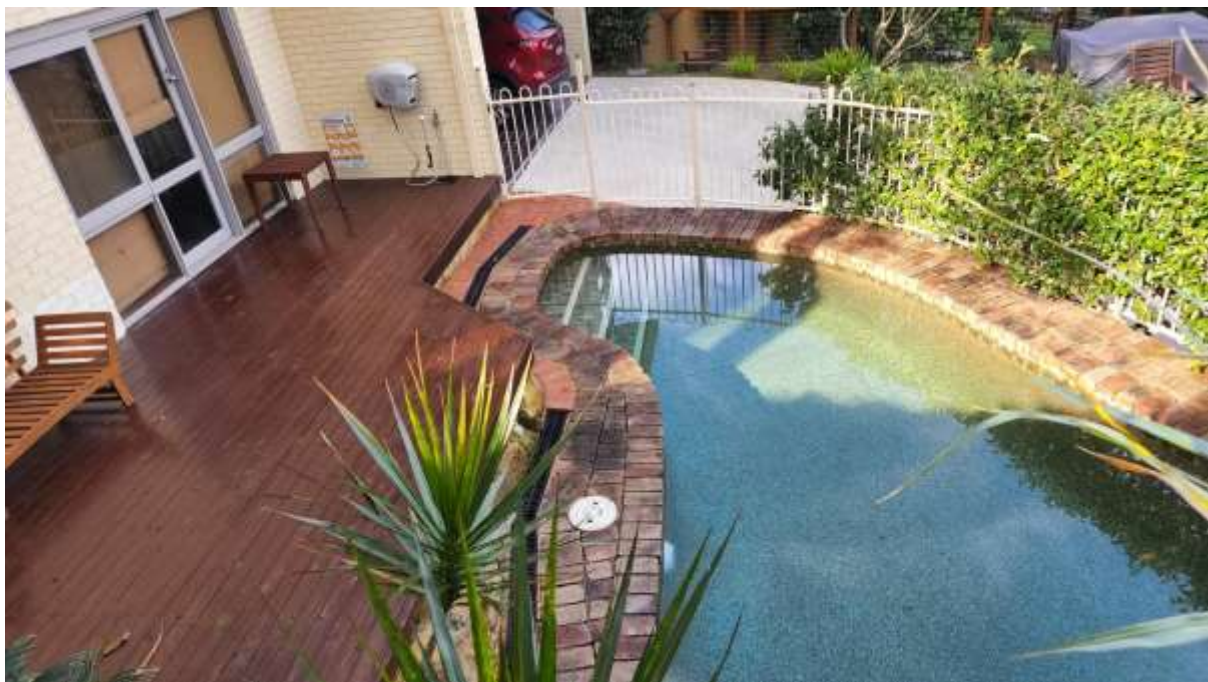
Photo 9 – View from Proposed Patio towards the pool at no. 26

Refer [Photo 9](#) for a photo taken on the boundary line and at the elevation of the top of the balustrade (1.2m above patio floor) for the proposed patio – towards the swimming pool. Actual view of an adult (~1.8m tall) standing along the balustrade would be from a higher angle than shown.

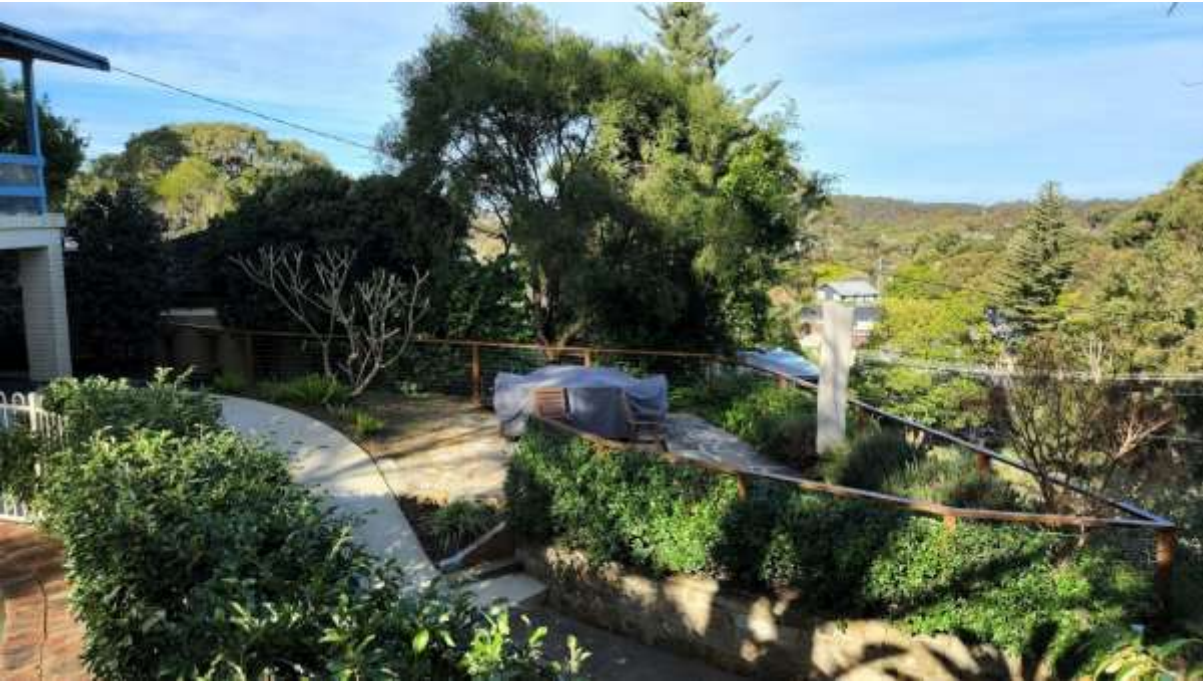
Photo 10 – View from the Proposed Patio towards the Alfresco Dining area at no. 26

Refer [Photo 10](#) for a photo taken on the boundary line and at an elevation approx. 0.4m lower than the top of the balustrade for the proposed patio – towards the alfresco dining area. Actual view of an adult (~1.8m tall) standing along the balustrade would be from a significantly higher angle than shown.

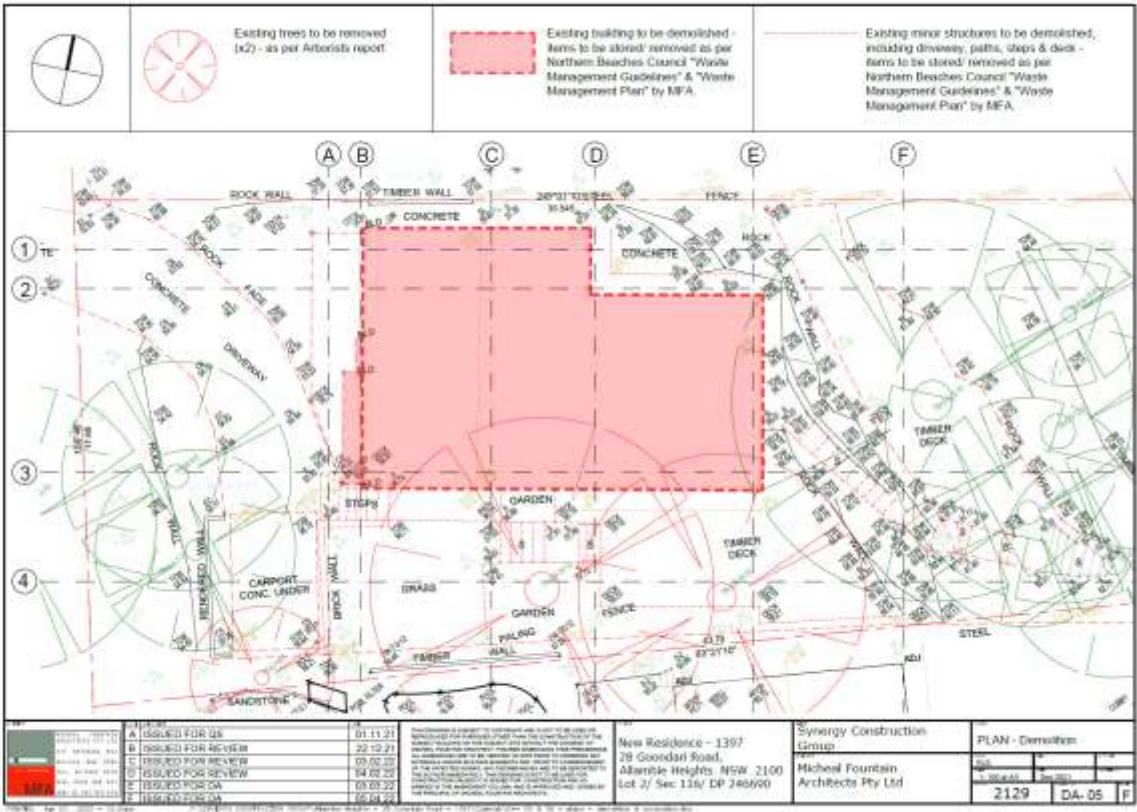
Slide 6 from Plans\_-\_Master\_Set.pdf

[Slide 6](#) – shows the encroachment area at the front of the blocks.

The DA submission shows a minor encroachment from no. 26 over the boundary of a 'pool filter' and a 'timber wall', but the encroachment is more severe than what has been shown (refer slide 6 of *Plans\_-Master\_Set.pdf*).

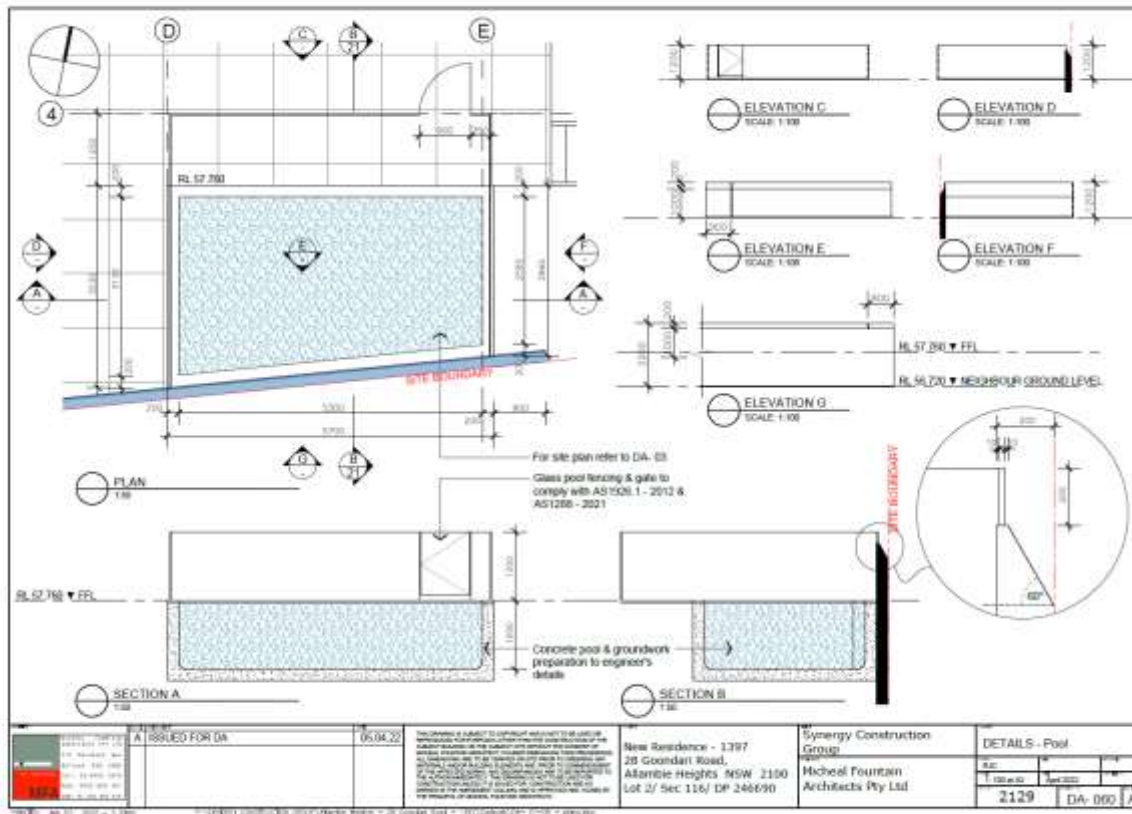
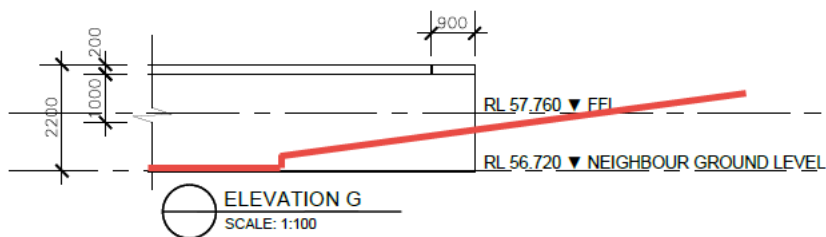
Enlarged view of Elevation G showing estimated slope of neighbouring footpath

**Issue #6** – Slide 19 in the *Plans\_-\_Master\_Set.pdf* show misleading elevations in relation to the boundary between no. 26 and no. 28. Elevation G shows a flat neighbouring ground line at elevation 56.720, but we actually have a sloping footpath on this side of our house. The elevation of 56.720 is only applicable to western half of the proposed swimming pool and from the halfway point the ground slopes upwards towards the east. It is estimated that at the eastern edge of the swimming pool water (not including the 900mm outcrop of retaining wall), the height of the retaining wall and the 200mm glass topper will only be 1700mm, resulting in an un-obstructed view line between the swimming pool and persons on the footpath which would be a privacy concern for both parties I imagine.

Refer [Slide 19](#) in below appendix for detail of Pool elevations, and an illustration of the estimated elevation of the sloping footpath.

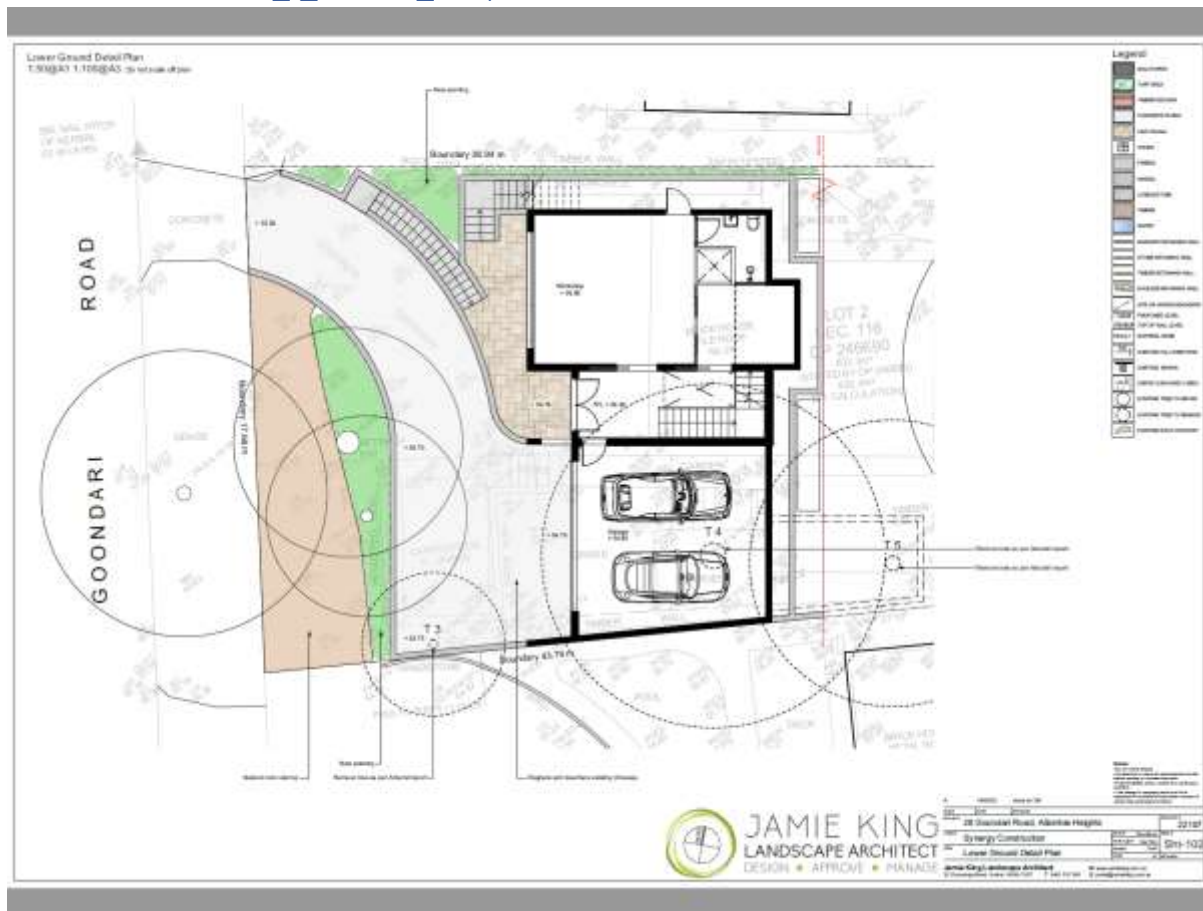
Slide 21 from Plans\_-\_Master\_Set.pdf

In addition to the concerns relating to the stability of this retaining wall, we have concerns over the unbroken height of the resulting structure. The current height of the wall along the driveway at no. 26 where the new retaining wall is to be placed is at 2.6m. This height is measured at the midpoint of the wall, where the new retaining wall will be placed closest to the edge. There is no clear

indication of the height of the new retaining wall, but assuming it will be around 2.2m, this gives a total height of 4.8 meters of unbroken wall surface. This will have a negative impact on the street scape, as well as pose a series risk of injury should anyone or anything fall from this height.

Refer [Slide 21](#) in below appendix for detail of proposed retaining wall location

- The proposed development at no. 28 is amended to eliminate the safety concerns we've outlined relating to the building of several high walls and balustrades directly on the boundary line, both during and after construction.

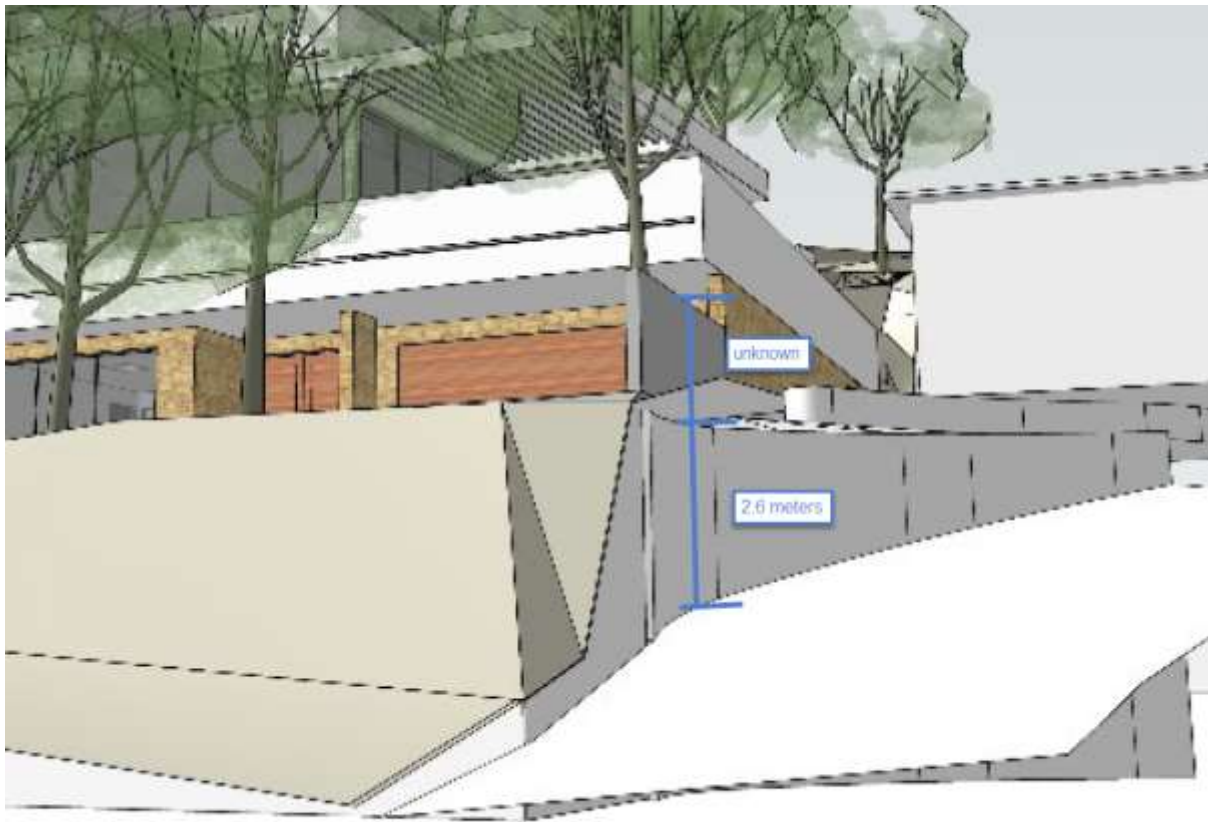
Illustration 1 – Artists impression from Report\_  
\_Statement\_of\_Environmental\_Effects.pdf showing the drop height of the retaining  
wall above the driveway at no. 26.

Refer [Illustration 1](#) in below appendix showing the artists impression of the new driveway retaining wall and the resulting drop onto the driveway at no. 26.

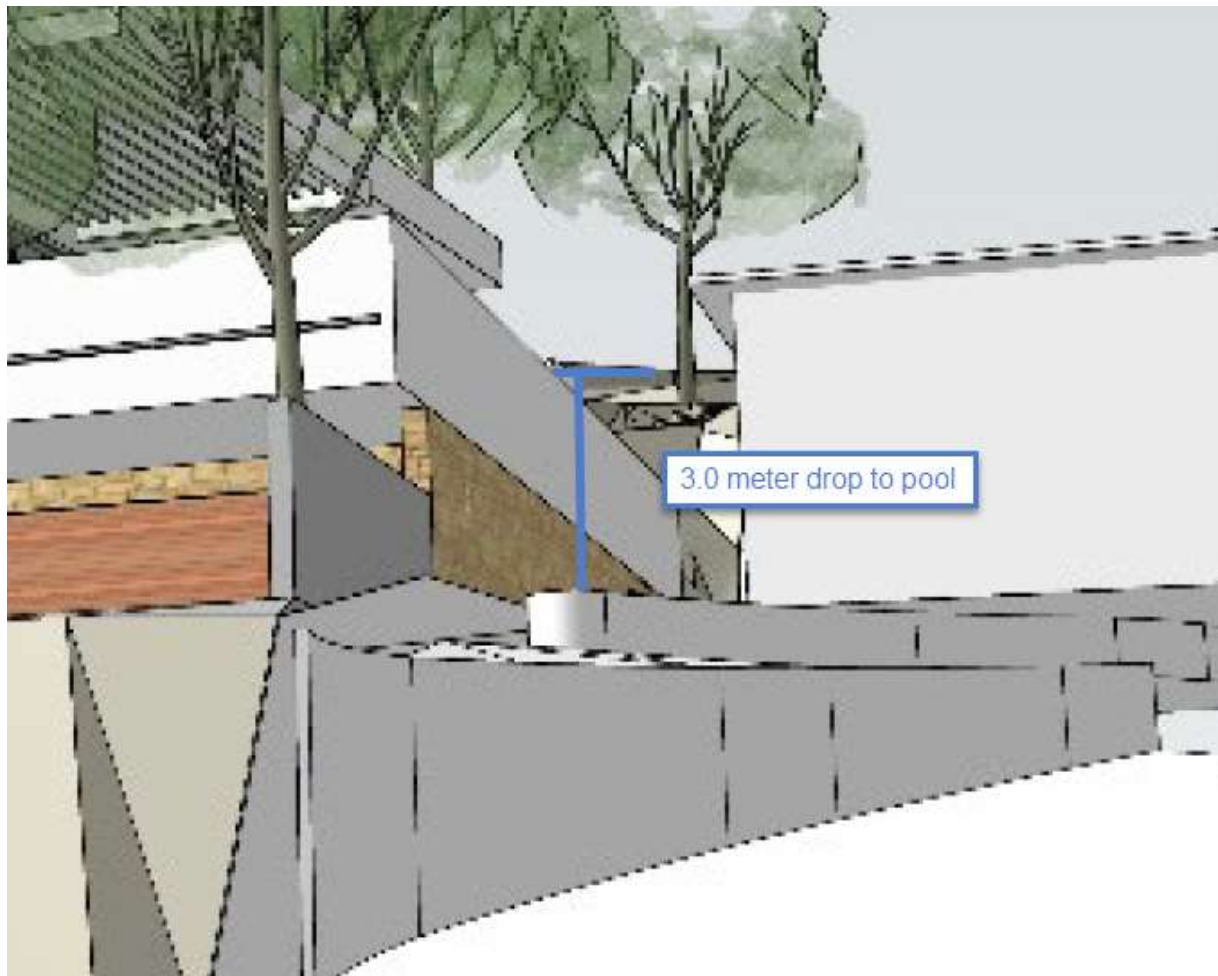
Illustration 2 – Artists impression of Garage and Patio Balustrade directly above swimming pool at no. 26.

**Issue #11** – The development is calling for the new garage wall and the balustrade for the ground floor patio area to be constructed right on the boundary line. With the elevation of the swimming pool at 55.80 and the top of the patio balustrade at 58.80, this will result in a 3m high wall face along the edge of the swimming pool. This poses a serious risk of someone or something falling directly into the swimming pool from a height, and would be a safety concern for the swimmers using the pool at no. 26.

Refer [Illustration 2](#) in below appending show artists impression of the new wall being placed on the boundary.

Several of these concerns could be addressed by moving the new structures (garage, pool, elevated patio) back from the boundary line to allow for the existing landscaping and fencing to remain, as well as give opportunity for landscaping to be included at no. 28. Relocation of the main outdoor entertaining areas from the southern boundary to either the front or rear of the block is also an option.
