REPORT ON GEOTECHNICAL SITE INVESTIGATION

**50 LAWRENCE STREET,
FRESHWATER
NSW**

Project No.: 2020-050

**GEOTECHNICAL REPORT FOR CONSTRUCTION OF A NEW THREE STOREY BUILDING
WITH UNDERGROUND BASEMENT CARPARK
50 LAWRENCE STREET, FRESHWATER, NSW**

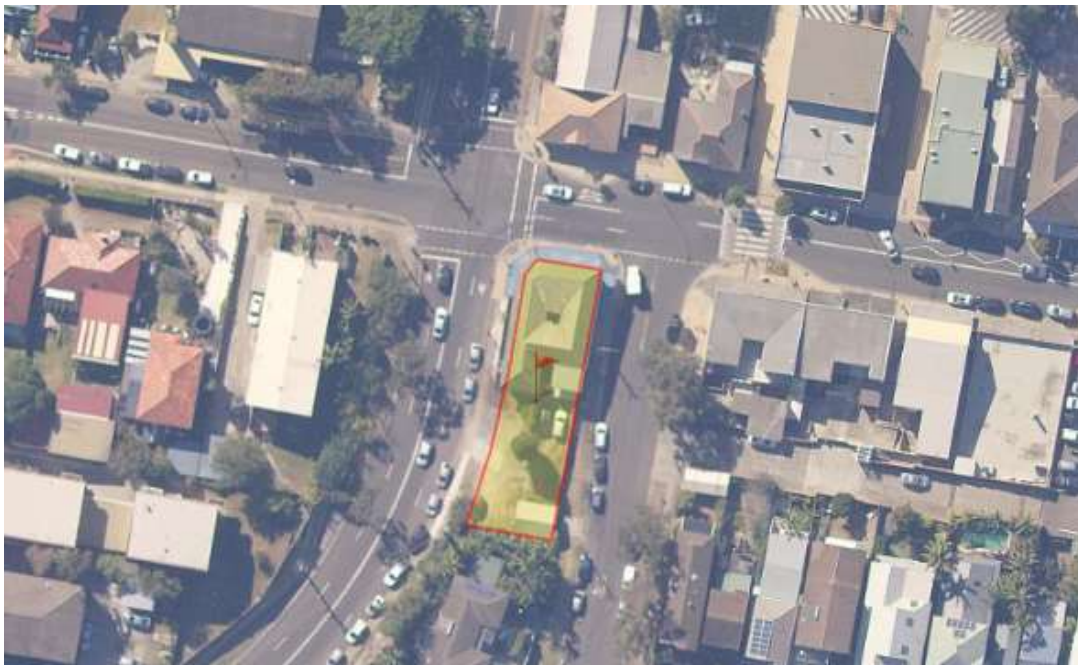
Photograph: 1 – Aerial photo of site and surrounds.

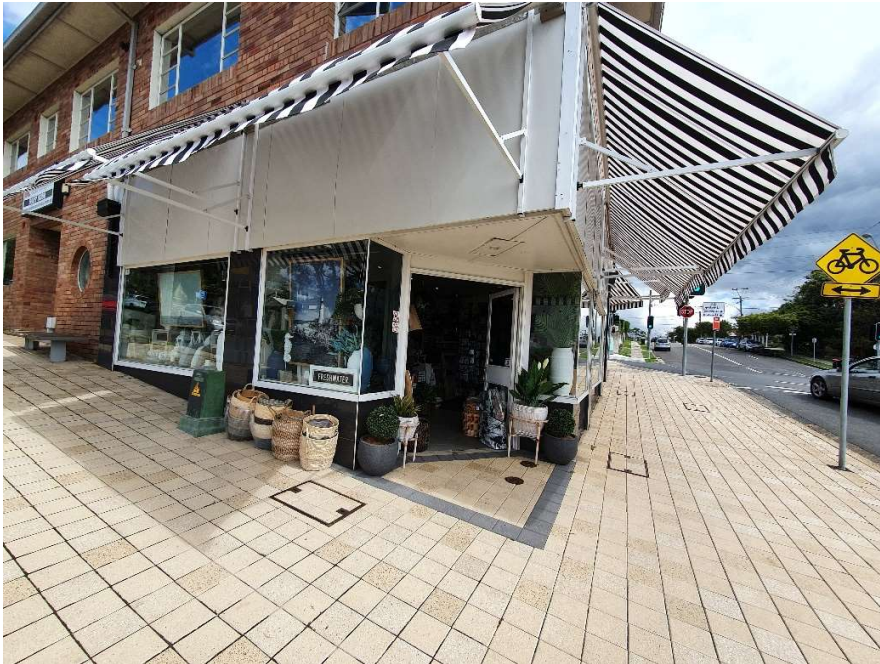
Photograph-2: Front view of the site within the road reserve adjacent to Lawrence Street and Dowling Street intersection. View looking west.

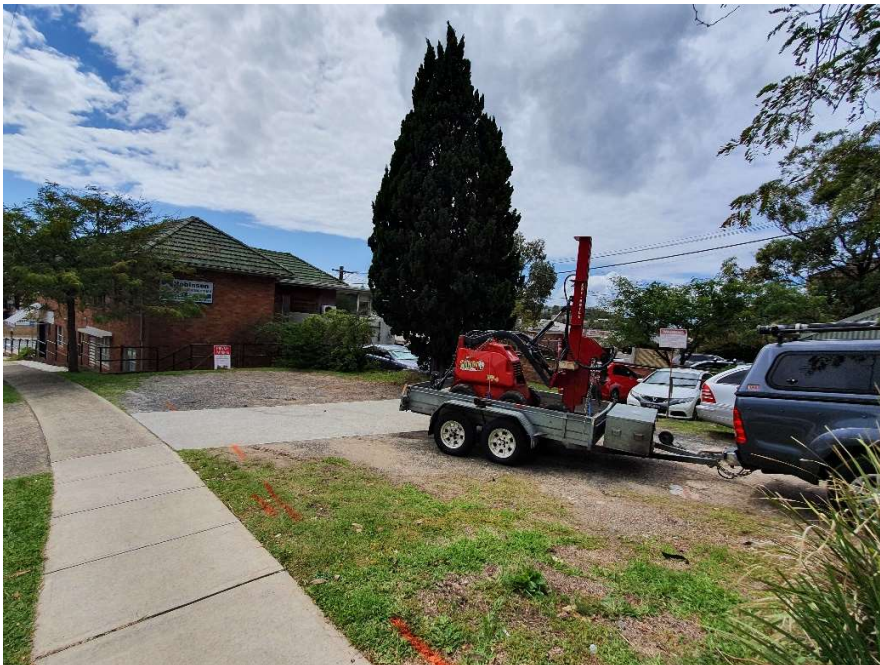
Photograph-3: Rear of the site from the south west corner of the site. View looking north.

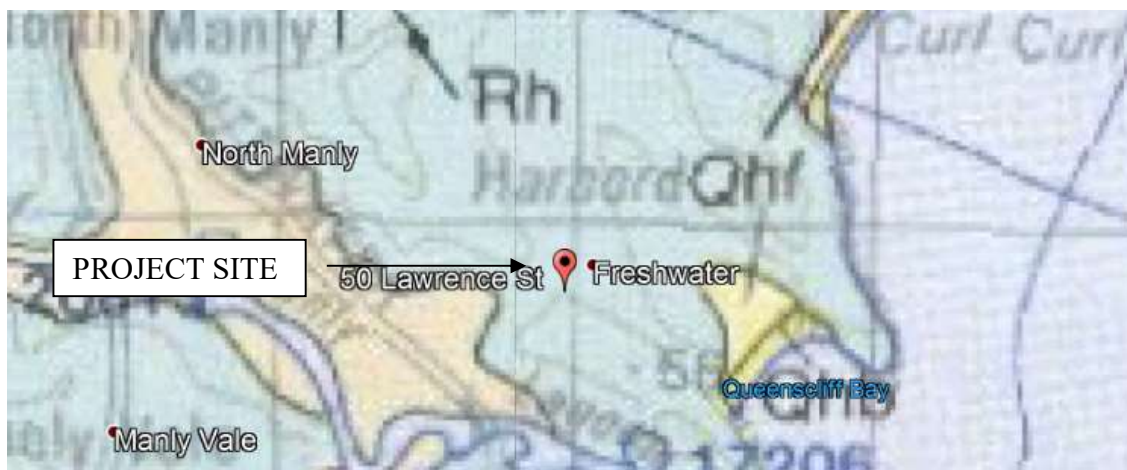
Reference to the Sydney 1: 100,000 Geological Series sheet (9130) indicates that the site is underlain by Hawkesbury Sandstone (Rh) which is of Triassic Age. The rock unit typically comprises medium to coarse grained quartz sandstone with minor lenses of shale and laminite.

Extract of Sydney: 1:100 000 – Geology underlying the site

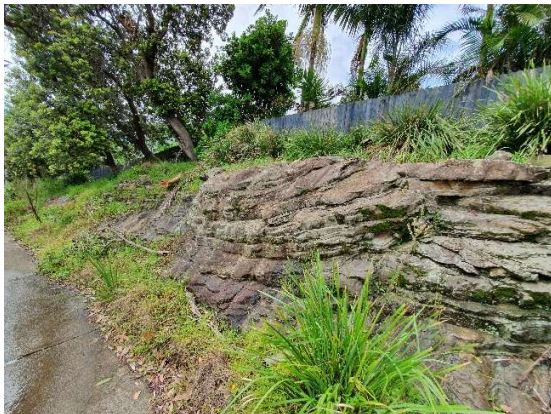
Oliver Street is on the high west side of the site, it is formed with a gently ($\leq 5^\circ$) north dipping bitumen pavement, with low concrete gutter and kerbs adjacent to strip garden beds, power poles, a concrete pathway and significant bedrock outcrop. The bedrock outcrop comprises sandstone with embedded rounded and sub rounded clasts. The sandstone was classified as slightly to moderately weathered and comprised gently west dipping, cross bedding defects (Photograph-5). Significant cracking and undulations were not observed within the road pavement and concrete footpath and they appear in good condition. More sandstone bedrock outcrop comprising similar competency and at slightly higher ground level was observed to the west of Oliver Street (Photograph-6).

Photograph-5: Sandstone bedrock to the east of Oliver Street. View looking north.

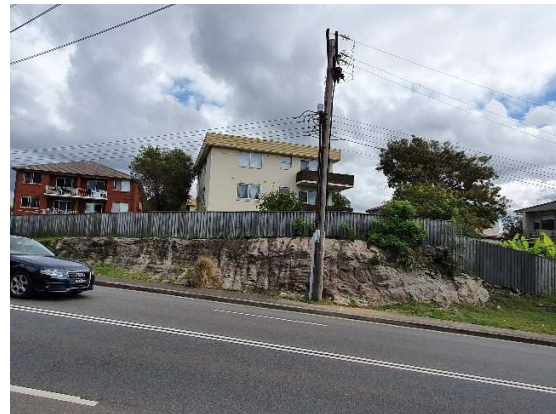
Photograph-6: Sandstone bedrock to the west of Oliver Street. View looking west.

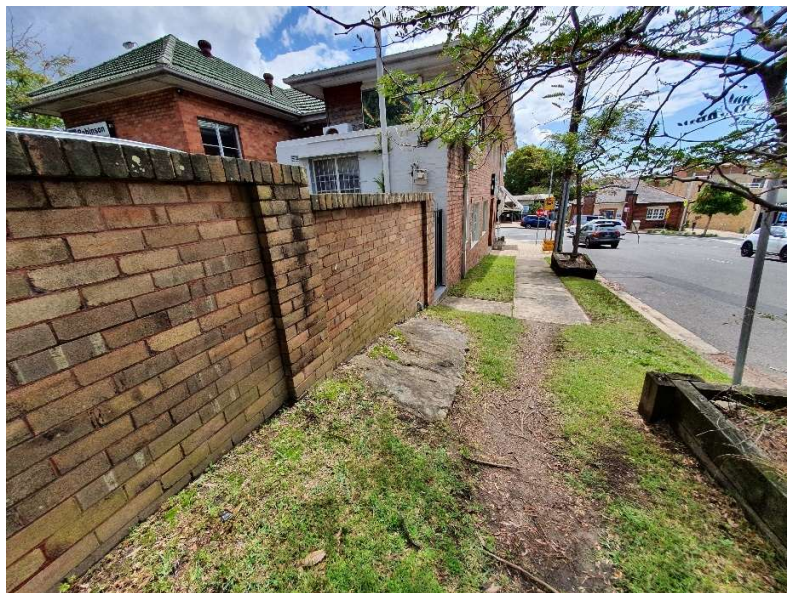
Dowling Street is on the low east side of the site, it is formed with a gently ($\leq 5^\circ$) north dipping bitumen pavement. It's road reserve contains the continued tiled footpath, a concrete footpath adjacent to strip garden beds, continued south by a wide garden bed, raised planter beds and bedrock outcrop at the base of the site's eastern boundary/retaining wall (Photograph-7). The sandstone outcrop comprises similar consistency as the previously detailed bedrock outcrop. The road reserve also comprises a concrete driveway to the south, which grants vehicular access from Dowling Street to an old rendered brick garage located at the south east corner of the site (Photograph-8 and Photograph-9). Significant cracking and undulations were not observed within the road pavements and road reserves in Lawrence and Dowling Street, similarly the site's boundary/retaining wall and concrete driveway within the Dowling Street road reserve appear in good condition. However moderate cracking was observed within the lower portion of the garage façade (Photograph-9), from experience, it appears to be construction/durability related.

Photograph-7: Dowling Street road reserve. View looking north.

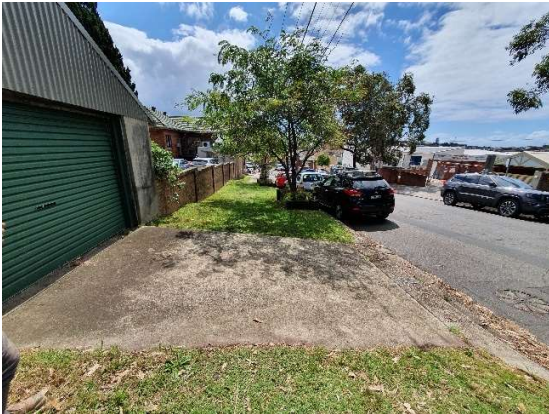
Photograph-8: Dowling Street road reserve, concrete driveway. View looking north.

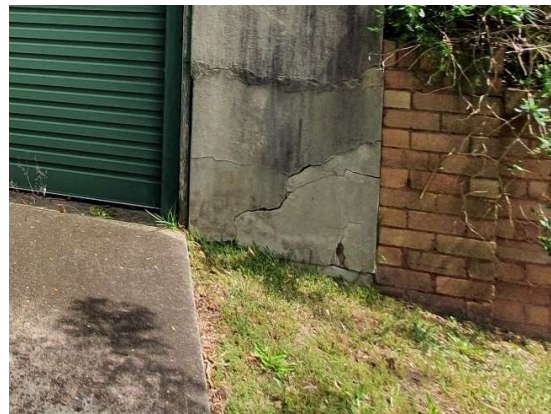
Photograph-9: Rendered brick garage defect. View looking west.

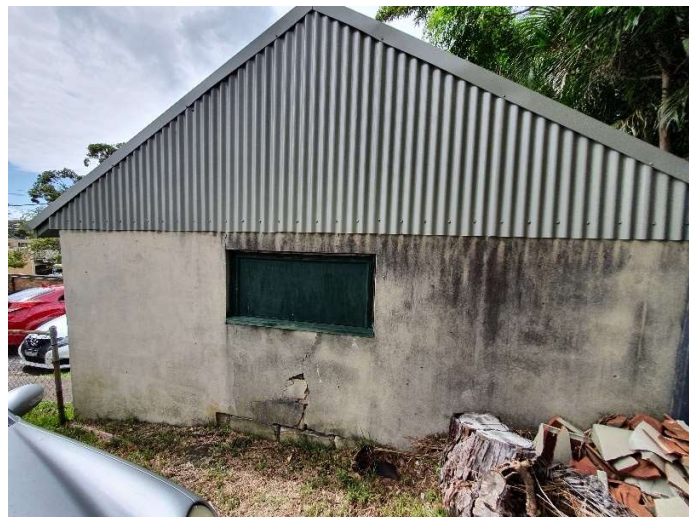
Access to the site was gained from the south west portion of the site, the entrance contains a concrete driveway (that extends east approximately 10.0m) which grants vehicular access from Oliver Street to the southern portion of the site. The southern portion of the site comprises a gravel carpark within the west, a slightly lower ($\leq 0.5\text{m}$) grassed lawn within the east (currently used as a carpark extension and is retained by a 0.60m high brick retaining wall to the north and bounded/supported by the brick boundary/retaining wall along the east) and the rendered brick garage at the south east corner of the site. Significant undulations or geotechnical related issues were not observed within the southern portion of the site. The rendered brick garage contains moderate cracking within its external walls and a tree stump adjacent to the base of its west facing wall (Photograph-10). However, these appear to be construction/durability related.

Photograph-10: Rendered brick garage. View looking east

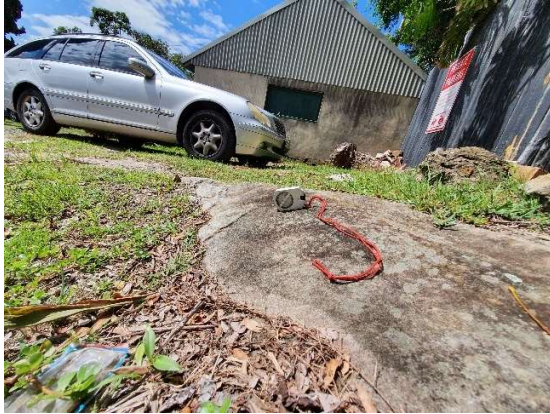
Bedrock outcrop was observed within the southern end of the site (Photograph-11). Similarly, the low ($\leq 1.50\text{m}$) bedrock cutting cliff face (Photograph-12) observed to the north (within the centre east portion of the site) is characterised as fine to medium grained, low to medium strength and contains gently north dipping cross bedding defects within the crest along with minor seepage between the soil and bedrock interface. Trace of river-based pebbles were also observed embedded within the sandstone matrix.

Photograph-11: Bedrock outcrop within the southern portion of the site. View looking east.

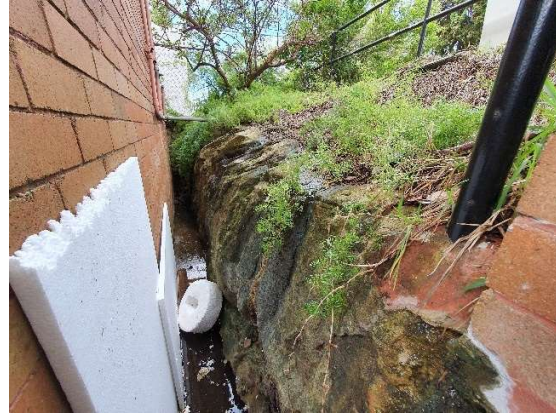
Photograph-12: Low bedrock cutting cliff face. View looking east.

The exposed low cliff-face within the centre of the site contained gently north dipping bedding defects within the crest along with massive sandstone within the lower portion. It appeared vertically stable, slightly to moderately weathered with no unfavourable defects or indications of previous failures/instability, at least since the construction of the development. However moderate seepage is expected within the soil rock interface and on rock defects.

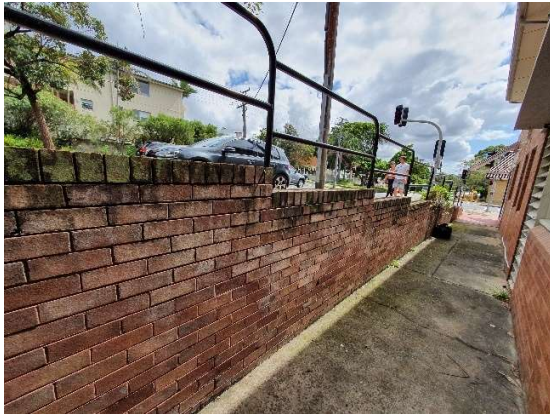
The northern portion of the site comprises a two-storey brick building of residential and commercial use formed at a lower ground level than the south of the site (approximately 2.0m). The ground floor contains a retail shop with a front tiled façade facing onto Lawrence Street. A concrete pathway surrounds the building along the south and west side. Adjacent to the pathway, along the west, is a brick retaining wall of up to 1.7m height that supports the Oliver Street road reserve above the site (Photograph-13). The outer walls of the building, pathways and retaining wall appear in good condition and did not show any obvious signs of cracks or settlement or underlying any geotechnical issues.

Photograph-13: Brick retaining wall to the west of concrete pathway. View looking north.

It is understood that part of the works is to match the existing retaining wall to the west, to the proposed structure. Therefore, to ensure a good service lifetime, as well as protecting the wall from collapse/damage and subsequently impacting the supported road reserve and people. This wall should be assessed by a structural engineer. Similarly, a geotechnical consultant professional should be contacted to inspect the founding strata and footing. This inspection can be done via test pits, to ensure competent founding material. This works should be undertaken prior commencing any excavation works in the northern portion of the site.

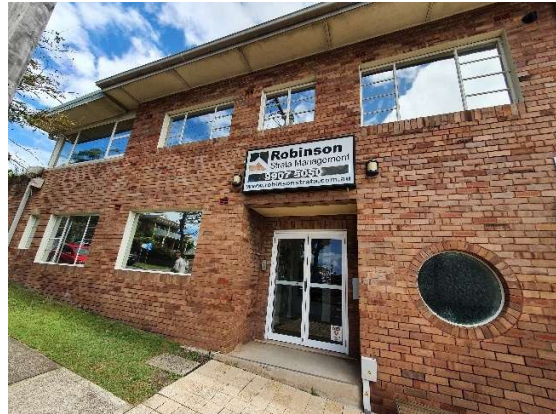
Photograph-14: Building outer wall, facing onto Dowling Street. View looking west.

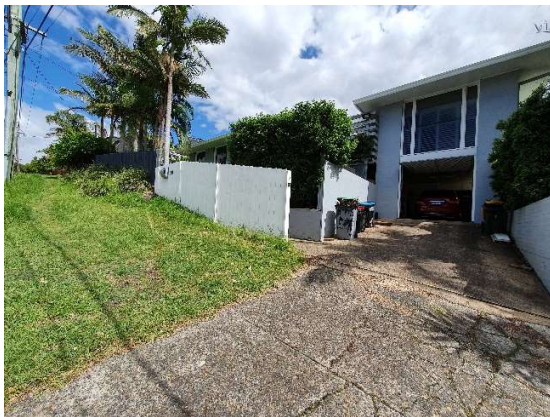
The property to the south (No. 30 Dowling Street), contains a two-storey brick residence with a lawn in the northern portion of the property, a garage below the front east side of the building and a concrete driveway that allows vehicular access from Dowling Street to the property. The house extends north to within 9.50m of the common boundary and it is formed at a higher ground level to the southern portion of the site. A limited inspection of the neighbouring property did not identify any obvious signs of cracks or settlement in the structure, only minor cracks were observed within the concrete driveway (Photograph-15). Bedrock outcrop of similar competency was observed at the base of the boundary wall within the road reserve (Photograph-16).

Photograph-15: Cracks within the concrete driveway. View looking west.

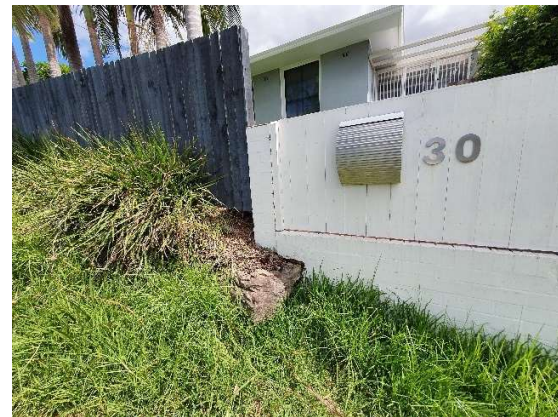
Photograph-16: Bedrock outcrop at the base of the boundary wall. View looking west.
