REPORT ON GEOTECHNICAL SITE INVESTIGATION

PROPOSED NEW STRUCTURES AND ALTERATIONS TO THE EXISTING

70 SOUTH CREEK ROAD, COLLAROY, NSW

Project No.: 2019-120

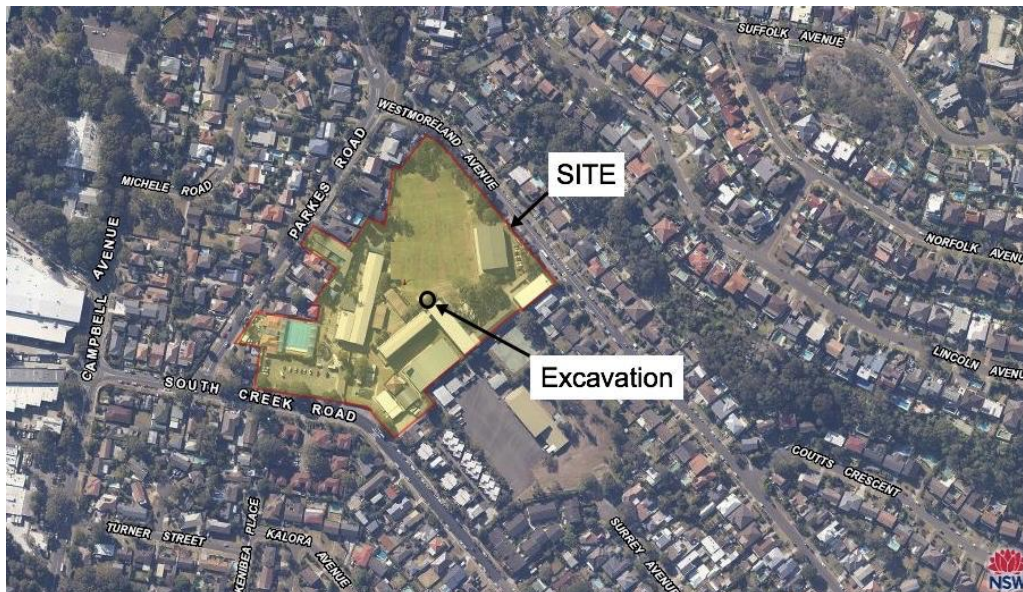
An aerial image of the site, immediate surrounds and the broad location of the proposed lift/access excavation are shown in Photograph 1, obtained from the NSW Government Six Maps website.

Photograph 1: Aerial view of the site, immediate surrounds and vicinity of the proposed lift excavation.

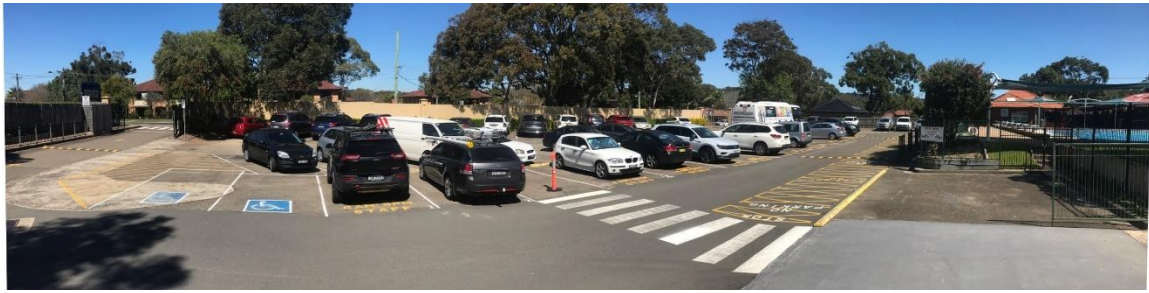
Photograph 2: View of the car park looking south to west from the eastern side of the existing staff car park.

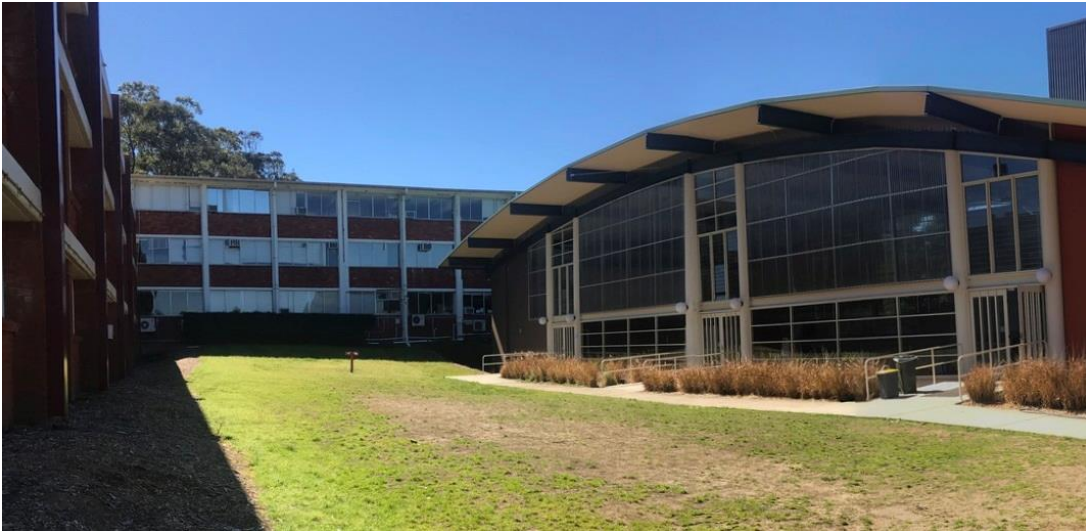
Within the location of the proposed new road an area of green space which dips gently from the north to the south is present and is shown in Photograph 3.

Photograph 3: View of the proposed new road location looking broadly north.

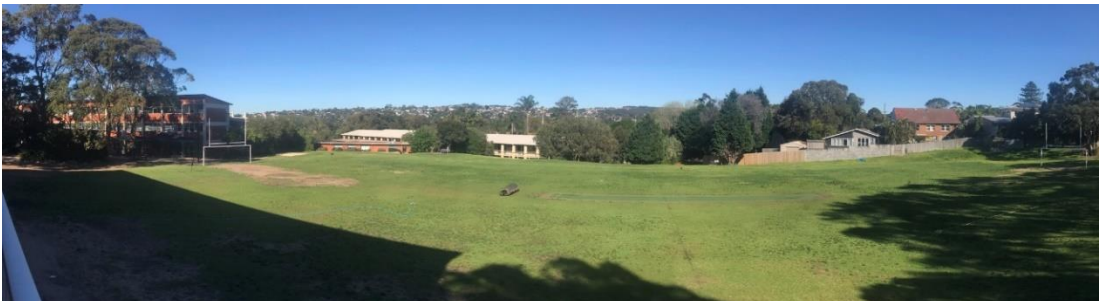
Photograph 4: View of the school playing field facing broadly east from the Great Hall.

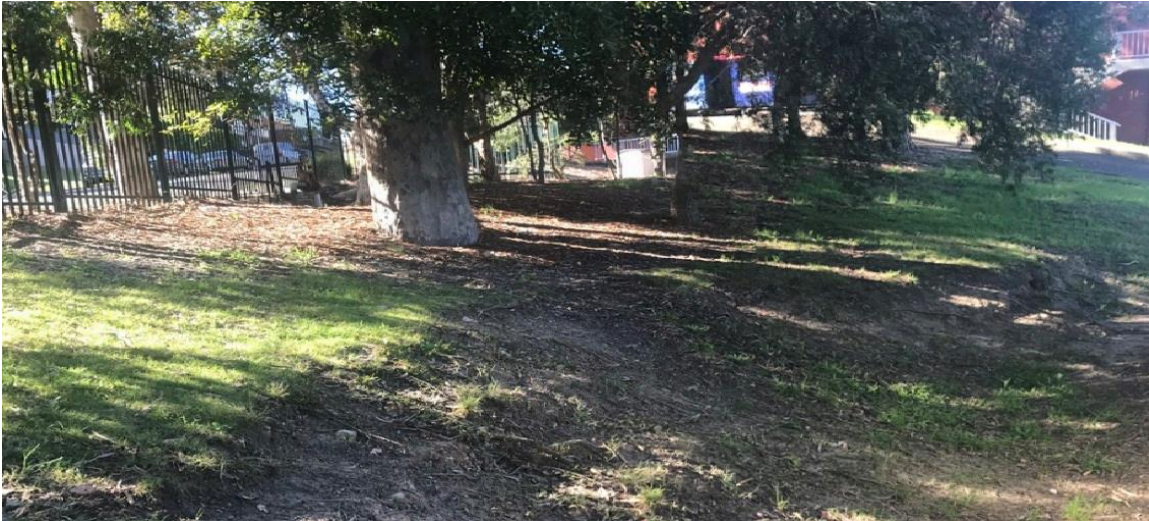
Within the north of the site and in the vicinity of BH12, a treed embankment was present adjacent to Westmoreland Avenue. Closer inspection of the embankment revealed that the external surface comprised fill. The embankment sloped gently from the north site boundary and did not display any signs of movement (tension cracks, rotating trees etc.). A view of the embankment looking broadly south is shown in Photograph 5.

Photograph 5: View of the embankment adjacent to Westmoreland Avenue looking broadly south.
