GEOTECHNICAL ASSESSMENT REPORT

No. 8 Battle Boulevard Seaforth, NSW

Reference No. ESWN-PR-2019-423

15th August 2019

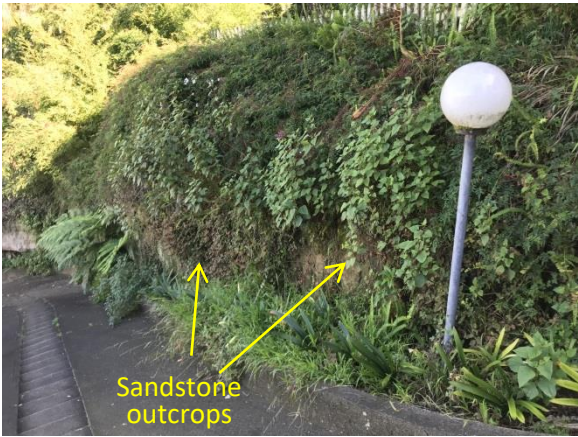
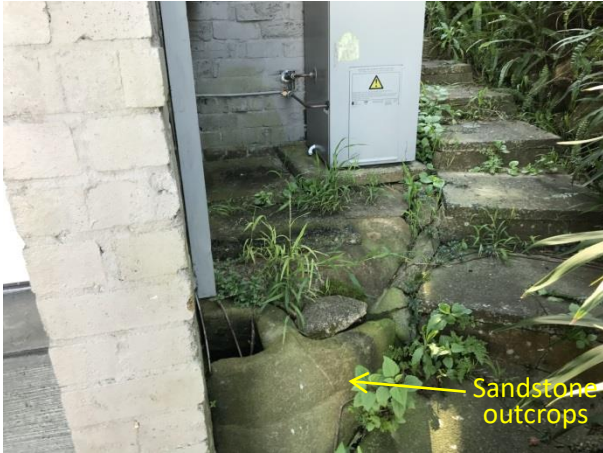
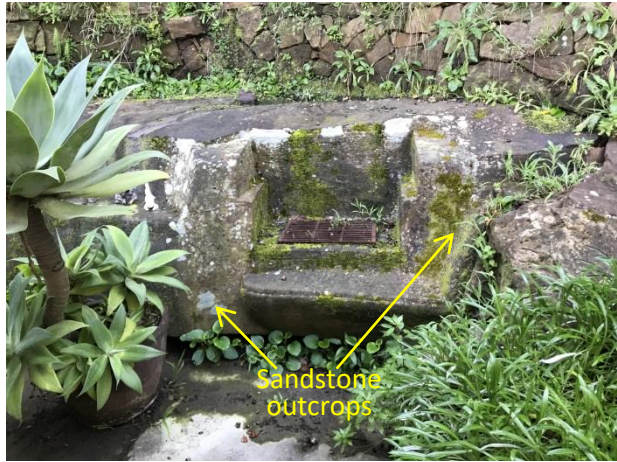
<p>Photograph 1 Sandstone outcrop along concrete path within front portion</p>	<p>Photograph 2 Sandstone exposed at front corner of existing building</p>	<p>Photograph 3 Sandstone outcrops in vicinity of north-eastern corner of existing building</p>

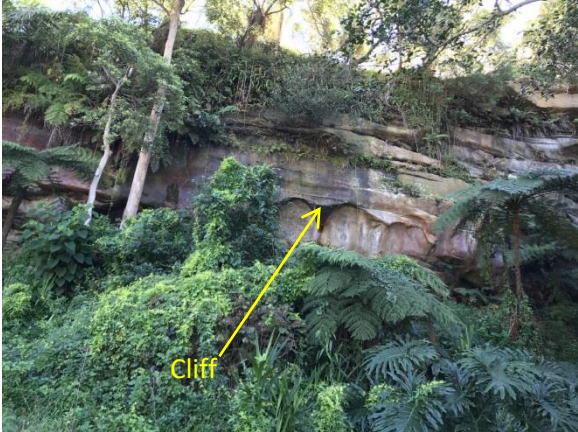
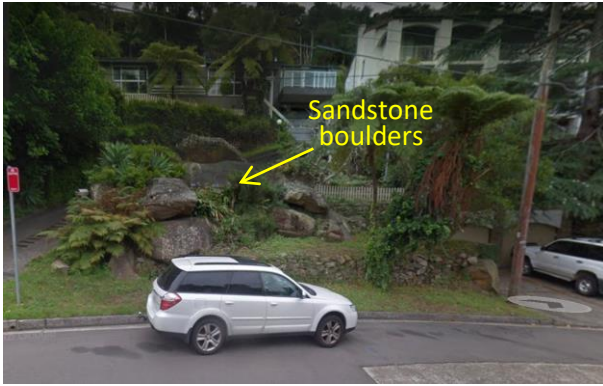
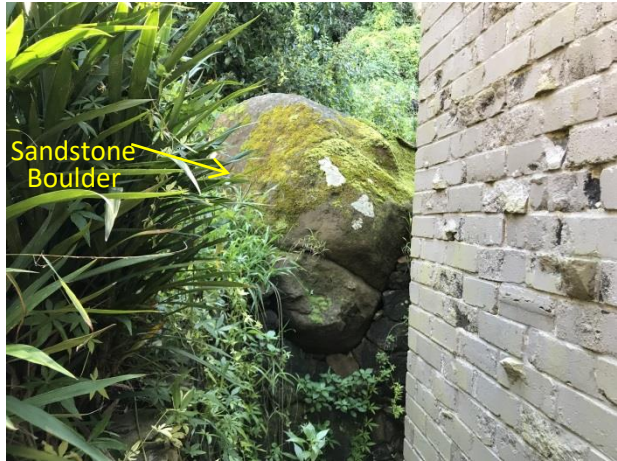
<p>Photograph 4 Sandstone cliff in vicinity of site rear boundary facing north</p>	<p>Photograph 5 Sandstone boulders present within front yard</p>	<p>Photograph 6 Sandstone boulder adjacent to the rear of north-western corner of existing building</p>

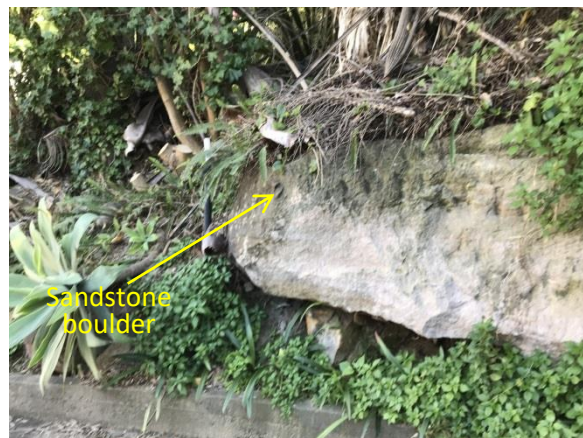
Photograph 7

Sandstone boulder at northern side of existing concrete path within front portion

- The unstable rock and boulders on ground surface should be either stabilised or removed after an assessment by Project Geotechnical Engineer.
- All cut/fill during construction should be shored or retained in accordance with our recommendations provided in Sections 6.4 and 6.5.

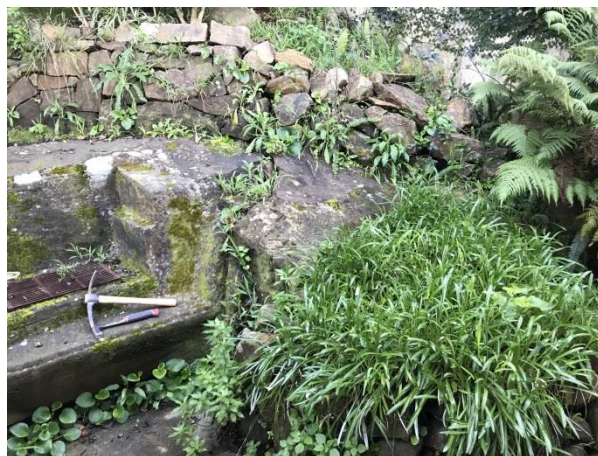
Photograph 8

Sandstone block wall at rear of the site

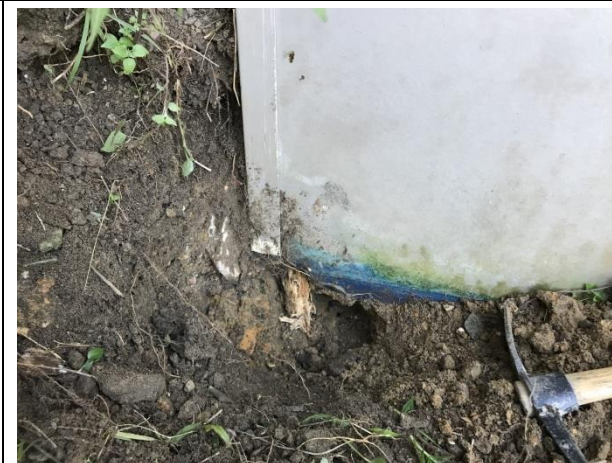
Photograph 9

A test pit was excavated at south-western corner of existing building, where thick fill and/or deep rock within founding area was expected based on our site walkover and observations. The test pit dug shown on Photo 9 in Appendix B, information in borehole BH1 and results of DCP1 confirmed our prediction.

Test pit excavated at location of BH1 adjacent to south-western corner of existing building

We recommend the existing building footings in vicinity of south-western corner along western and southern(front) external walls should be further checked for underpinning requirement.

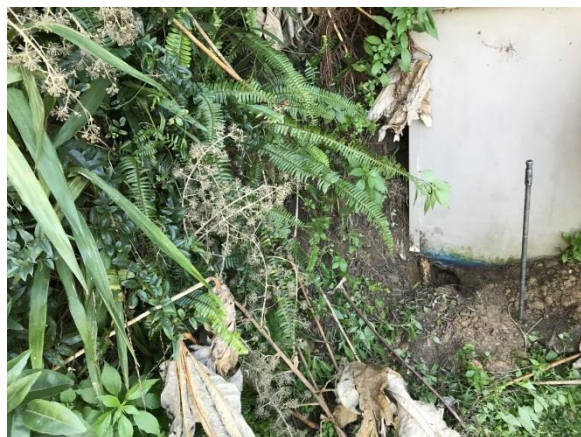
Photograph 10

Dynamic Cone Penetrometer(DCP) Test at location of BH1/DCP1

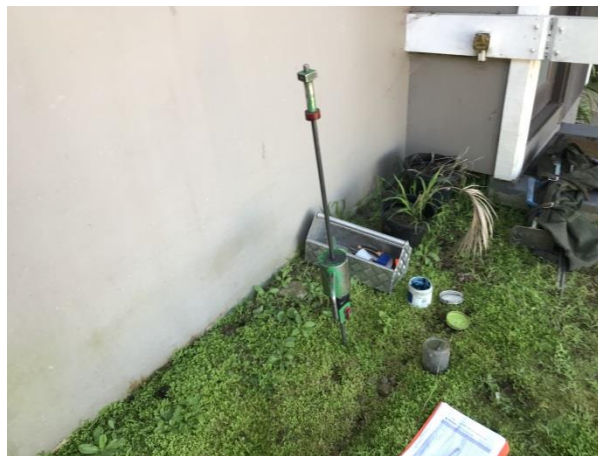
Photograph 11

DCP test at location of DCP2 in front of existing building

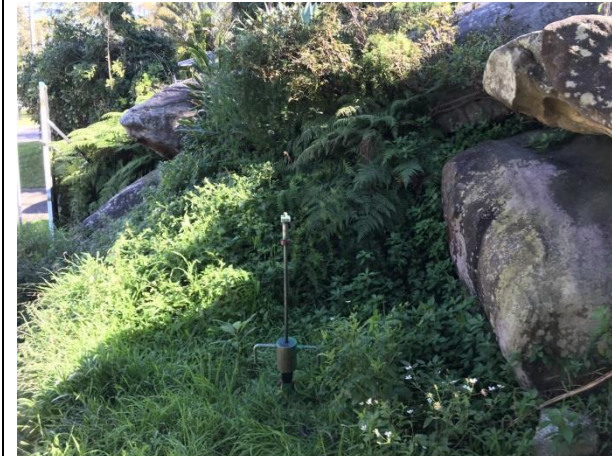
Photograph 12

DCP test at location of DCP4 within front yard
