PRELIMINARY (STAGE 1) SITE INVESTIGATION

PRELIMINARY SITE INVESTIGATION REPORT
PRELIMINARY CONTAMINATED LAND REPORT
PRELIMINARY GEOTECHNICAL ADVICE

**Proposed Residential Sub-Division
45/49 Warriewood Road, Warriewood, NSW**

28 February 2020

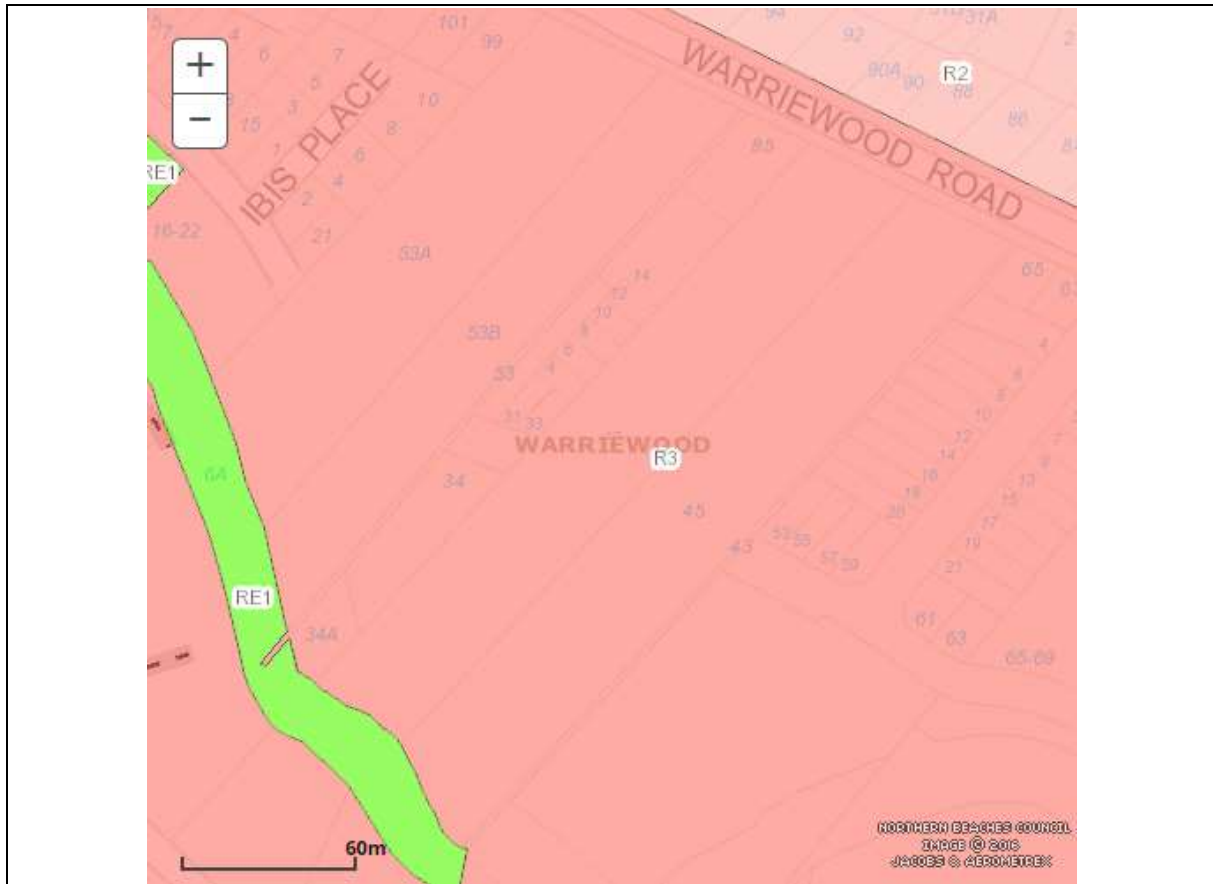
Figure 1.5 – Land Zoning Diagram

The diagram provided in Figure 1.4 is sourced from the current Northern Beaches Local Environment Plan. The site is shown at the approximate centre of Figure 1.4 and is zoned R3 Medium Density Residential.

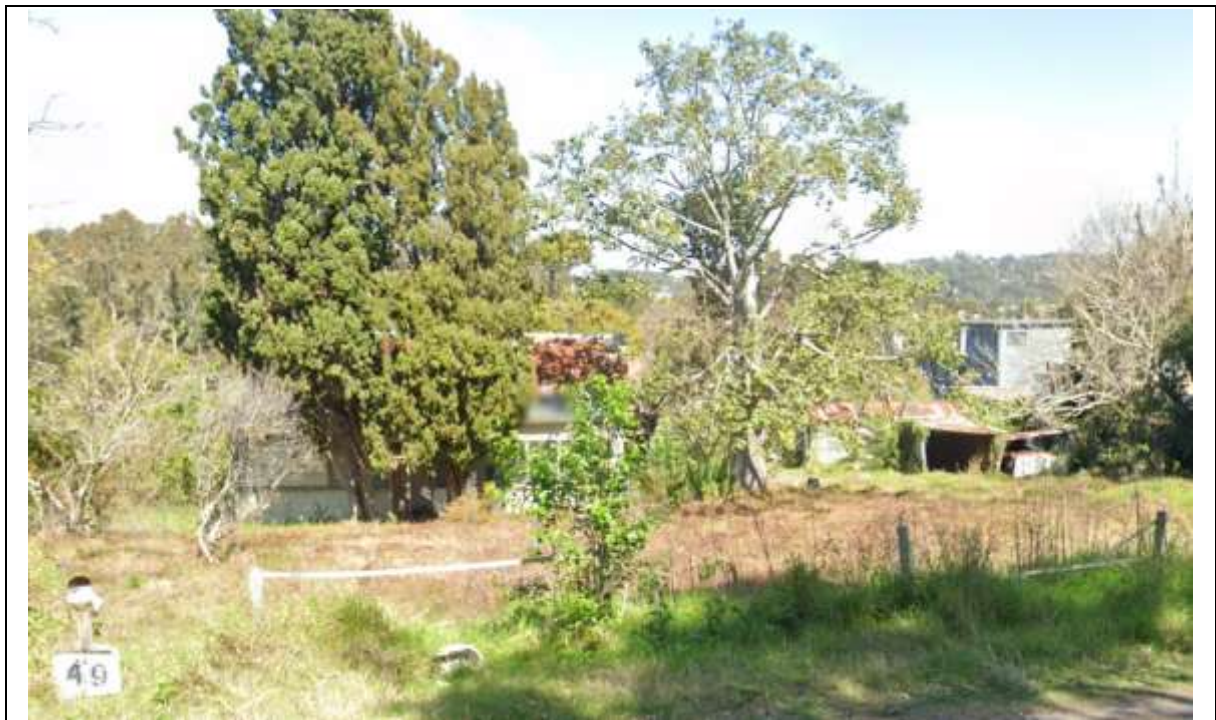
Figure 6.1 – Existing Buildings and Structures on 49 Warriewood Road

Given the apparent vintage and nature of the structures, and their -physical appearance, it is considered that potentially hazardous materials (including in particular asbestos cement sheeting in the form of “fibro”) are present, and comment re procedures to be followed during any future demolition operations have been provided for completeness in Section 8 and Appendix A.

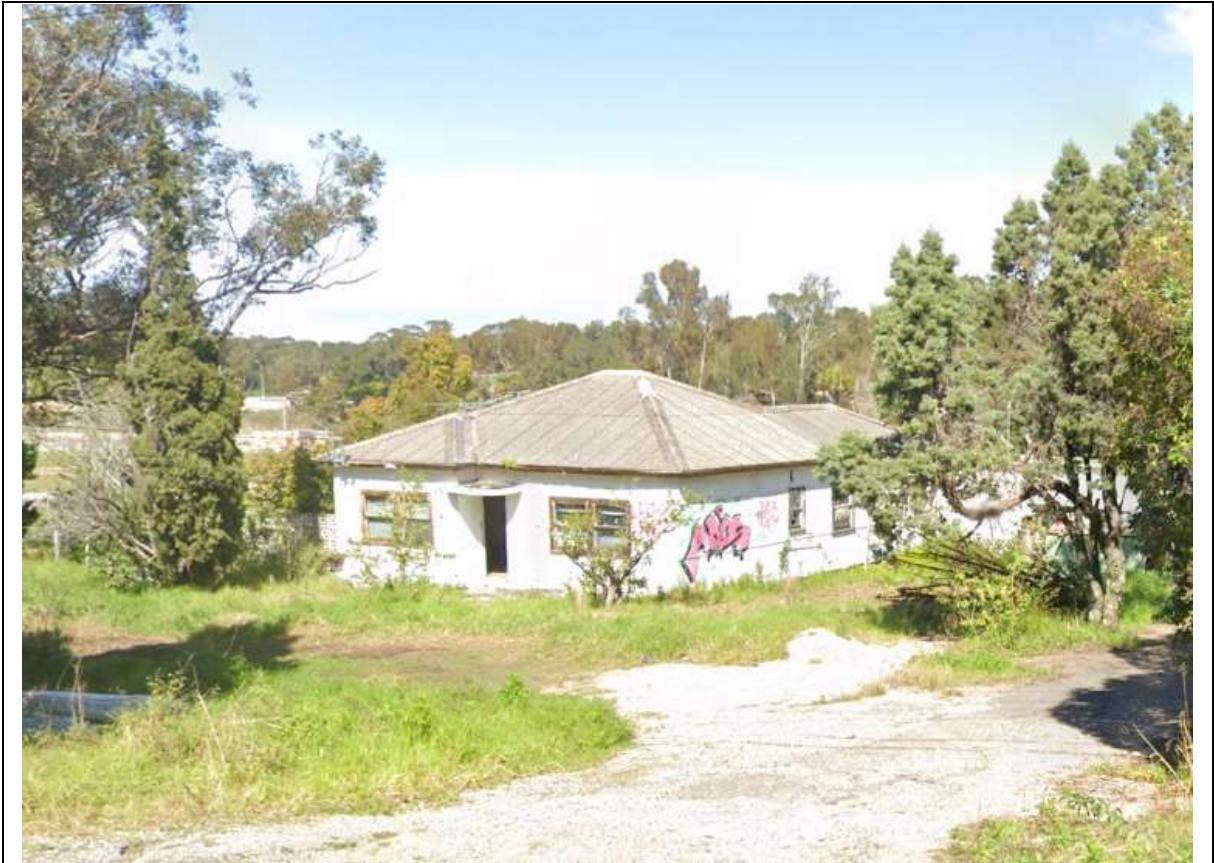
Figure 6.2 – Existing Buildings and Structures on 45/49 Warriewood Road

Some outbuildings and structures associated with the dwellings also appear to include potentially hazardous materials, including asbestos.

1. That appropriate handling and disposal practices, in accordance with relevant asbestos handling and disposal guidelines as detailed in this report are observed during any future demolition and site clearing operations undertaken at the site;
2. That appropriate care is taken in respect of the possible identification of any other potentially hazardous or dangerous materials that may unexpectedly be identified during future demolition and site clearing operations; and
3. That an appropriate Unexpected Finds Protocol is developed and implemented during future works at the site.

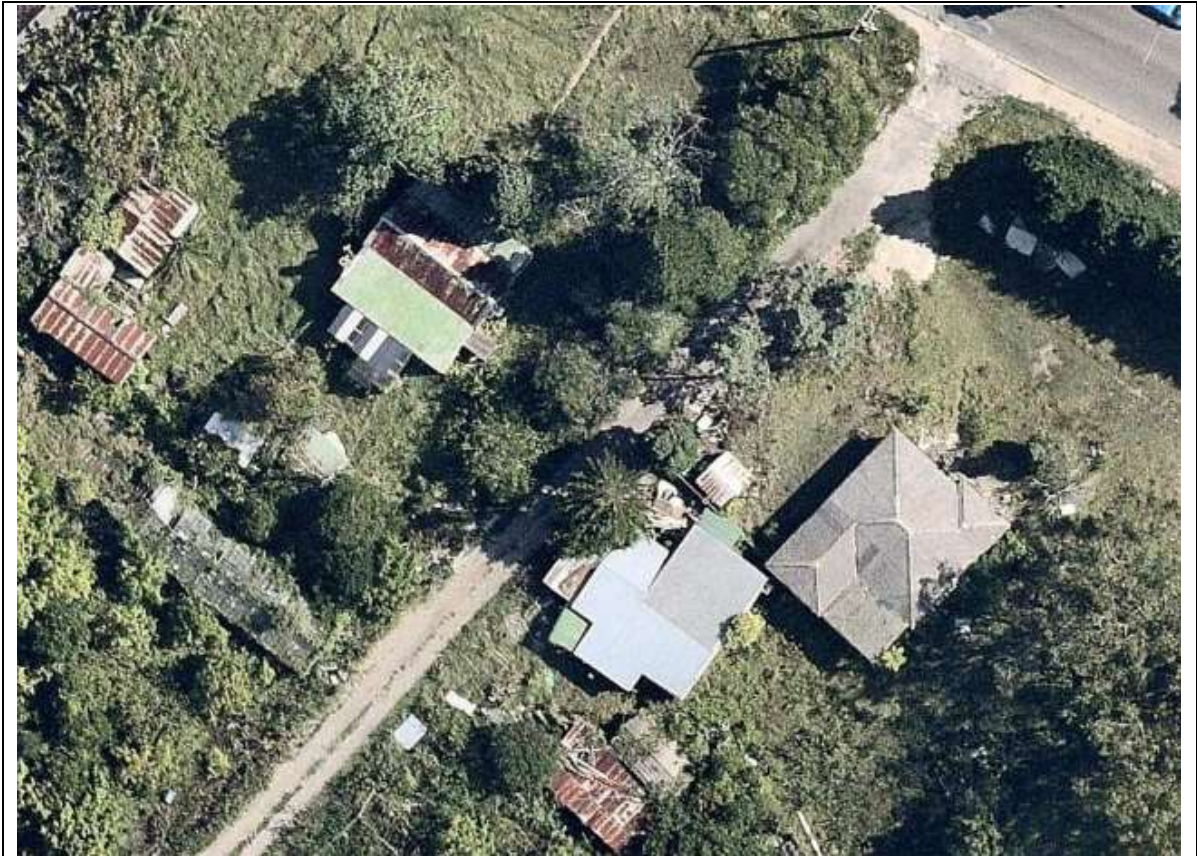
Figure 6.3 – Aerial View of Dwellings and Outbuildings

The site and associated improvements were found to be in a reasonably sound condition, although some outbuildings and structures were noted to be in a poorly maintained state.

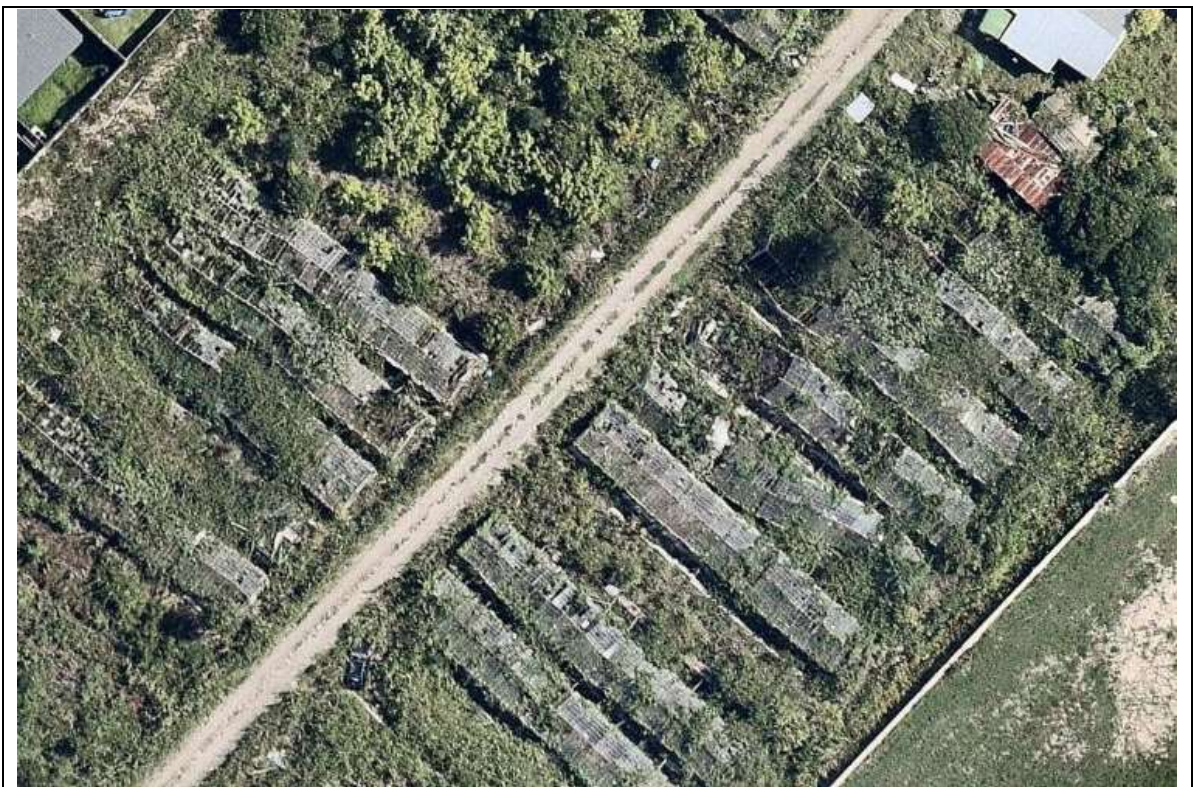
Figure 6.4 – Disused Glasshouse Structures in Northeastern Portion of Site

The very slight elevations noted in arsenic concentration, particularly in soil samples from the north eastern or glasshouse area of the site, are attributed to past chemical use, but it is noted that these concentrations remain very significantly lower than the applicable residential soil quality criterion.

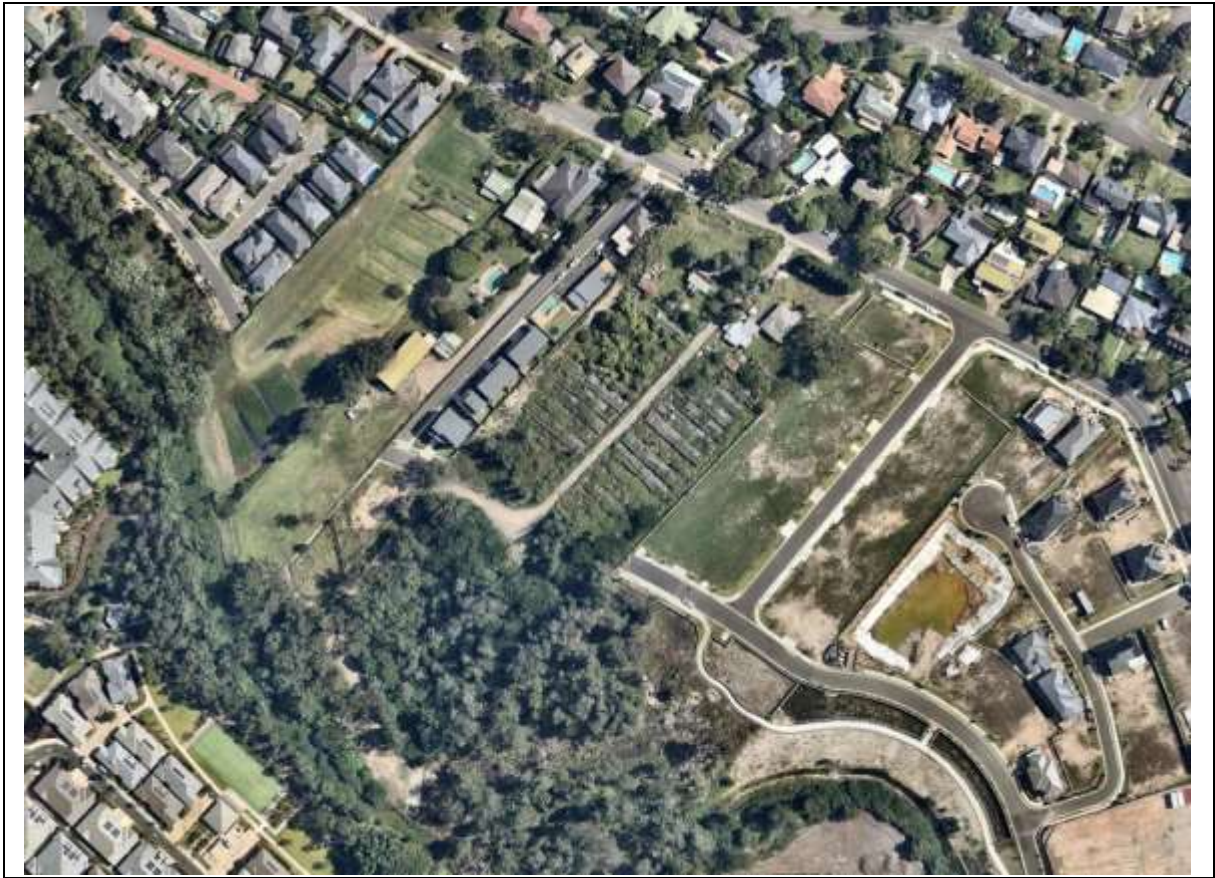
Figure 6.6 – Site Area in Relation to Surrounding Land Uses and Activities

An aerial view of the site in relation to nearby land uses and activities is provided in Figure 6.6, below.

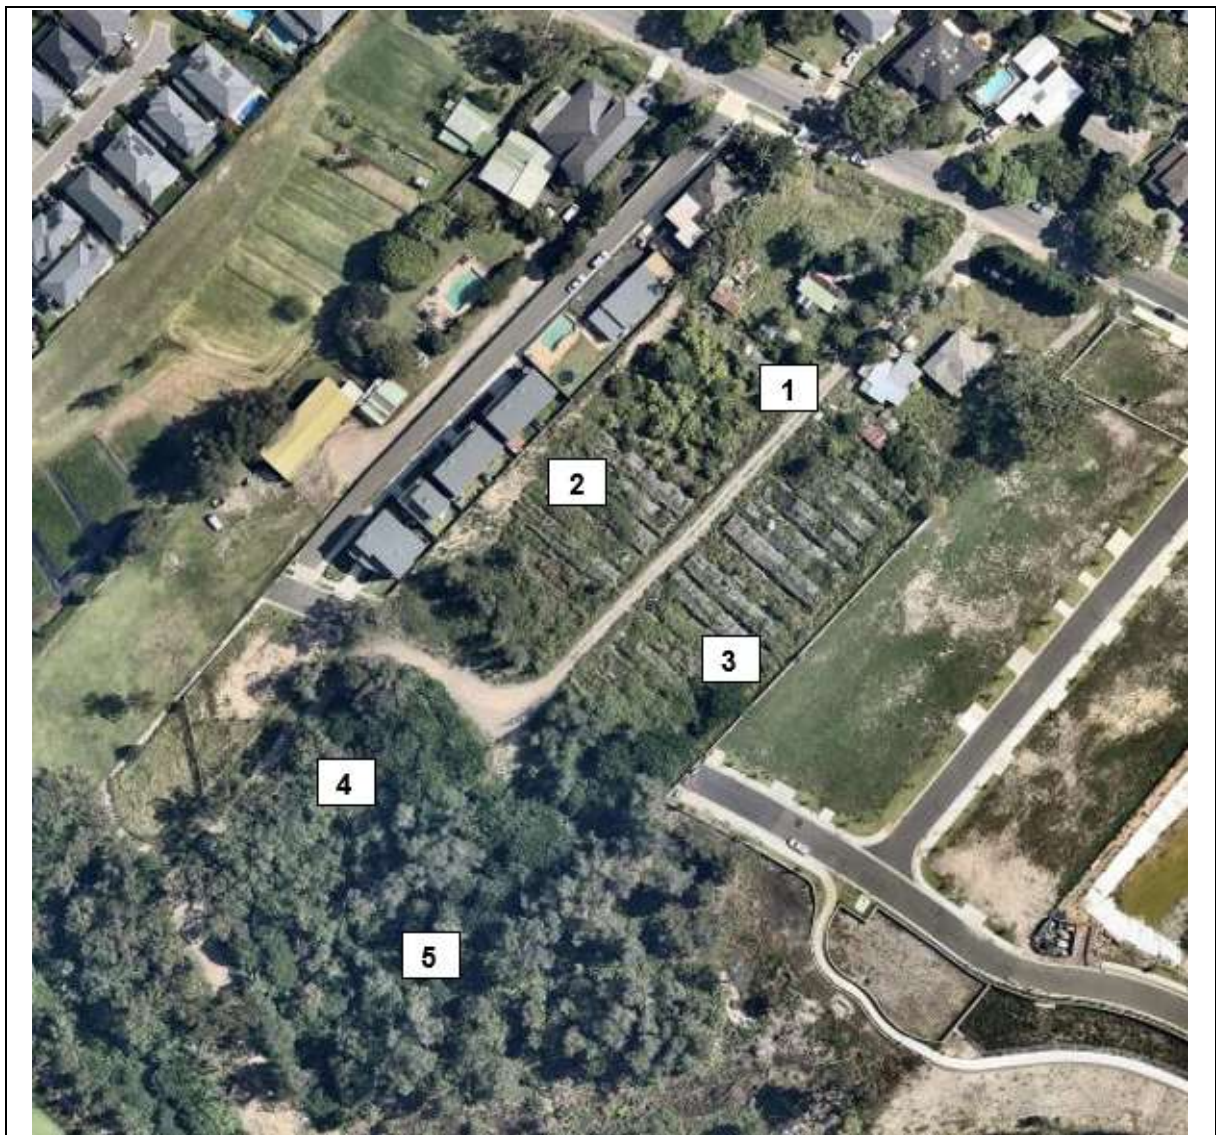
Figure 7.1 – Soil Sampling Locations

The five soil sampling locations are identified in Figure 7.1, on the following page.

The soil bores were hand drilled to the limit imposed by soil conditions. 200 gram soil samples were collected and inspected from the surface, and at 500 mm depth increments tot termination of the soil bores.
