REPORT on GEOTECHNICAL INVESTIGATION

**PROPOSED DEVELOPMENT
1112 - 1118 BARRENJOEY ROAD
PALM BEACH**

**Prepared for
LESIUK ARCHITECTS**

**Project 36684 02
October 2009**

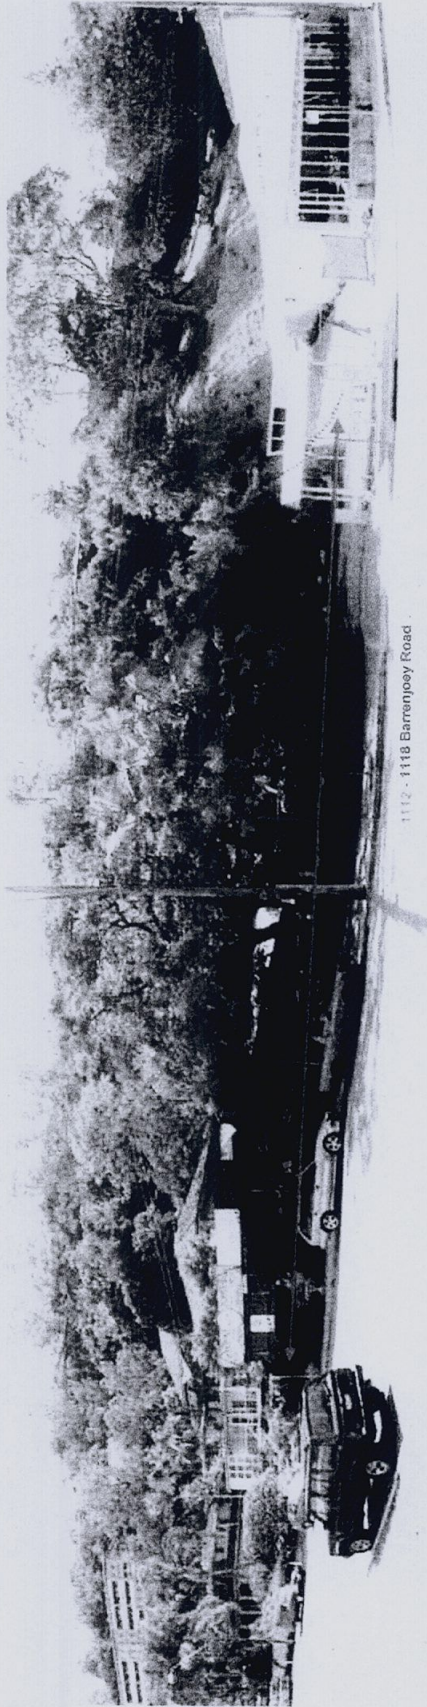
Photo 1 The site viewed towards the east

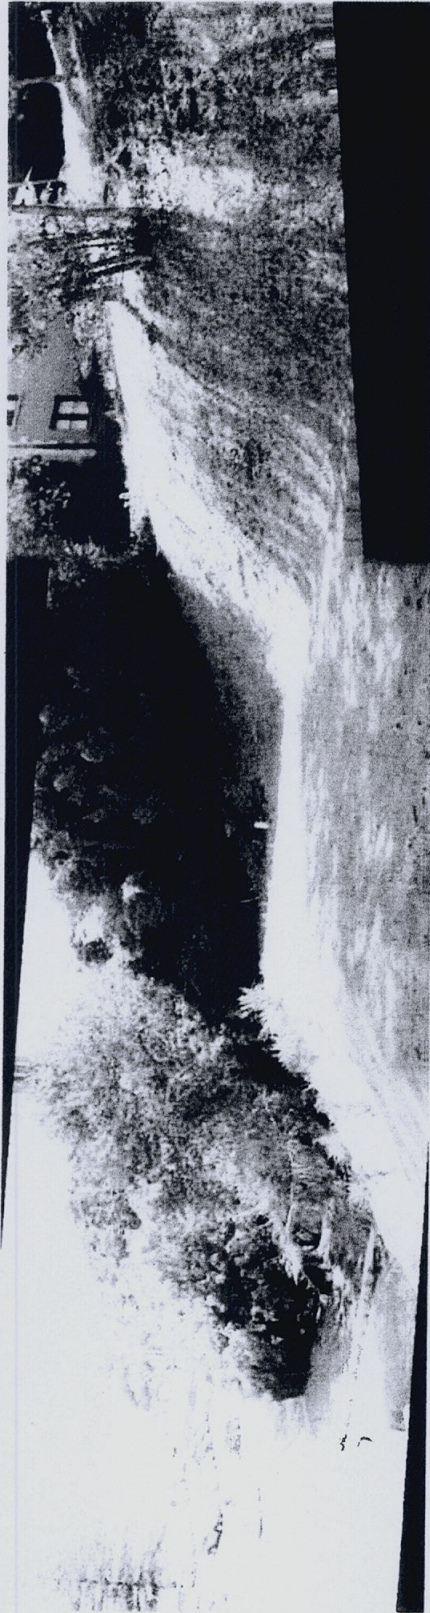
- on the adjoining southern property there is a very steep grass-covered batter at about 45° (refer Photo 2) which includes a surficial slump about 5 m wide and about 0.5 m to 1 m deep

Photo 2 The site viewed towards the north from the adjoining southern property. Grassed benching located on adjoining property Upslope residence visible in upper right hand section of photo.

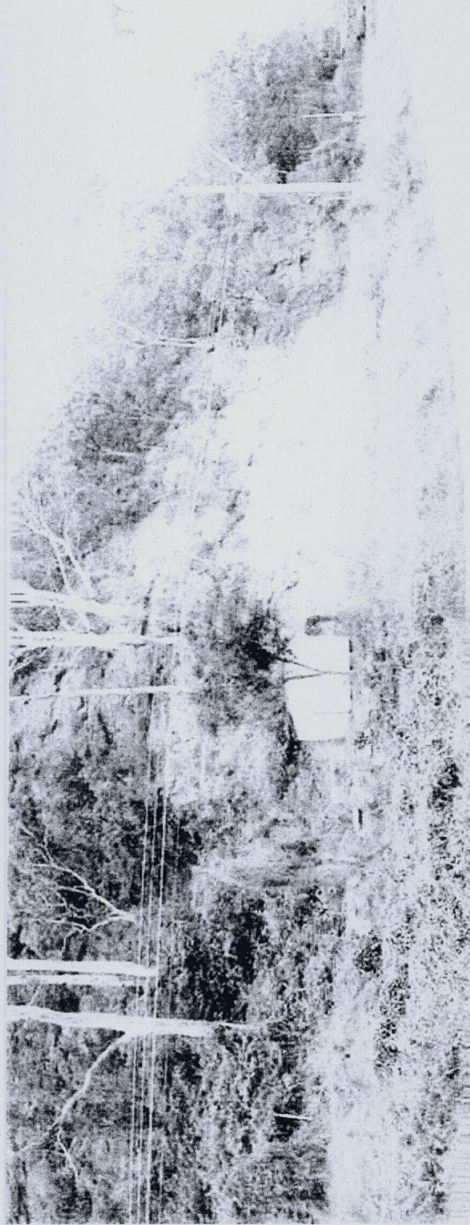
- behind the residences at 1096 and 1098 Barrenjoey Road (refer Photo 6) low to medium strength, shaly sandstone/sandy siltstone is exposed to a height of approximately 6 m above road level Above this level, the rock comprises medium to thickly bedded sandstone as exposed beneath 1094 Barrenjoey Road and in the sites opposite the Iluka Road shops (refer Photos 4 and 7)

- to the south along Barrenjoey Road (about 1080 Barrenjoey Road), siltstone is exposed in the batter/slope at the rear of the properties to about 6 m above ground level and was in turn overlain by sandstone with some shaly beds (refer Photos 4 and 8)

Photo 4 Shaly sandstone /sandy siltstone outcrop and overlying sandstone with minor shaly beds opposite Jula Road shops

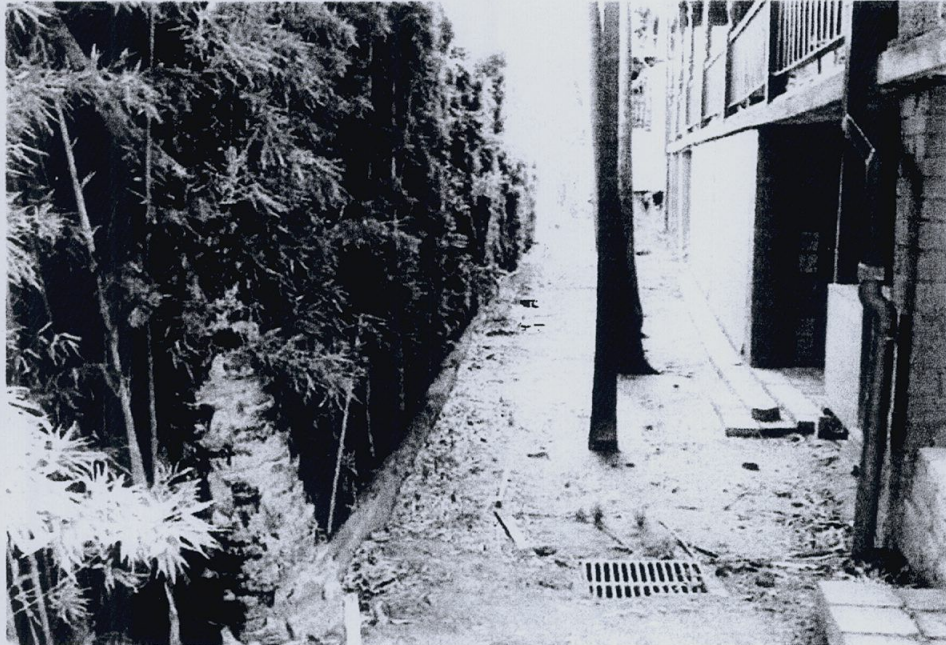
runoff onto the subject site (refer Photo 5) A grated pit is evident, however the discharge pipe alignment was not apparent At least one additional PVC pipe is noted at the crest of the bamboo-covered slope

Photo 5. Upslope property above right-of-way Note grated drain, discharge location alignment not evident.

It is recommended that the proposed development include stormwater and subsoil drainage control measures. Such measures are very important to the maintenance and improvement of

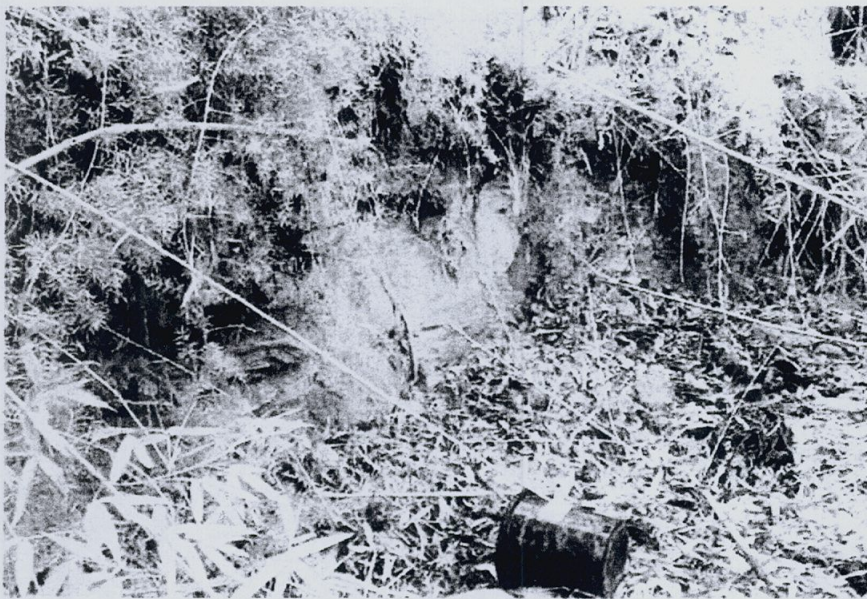
Photo 6. Colluvium overlying highly weathered outcrop of low strength shaly sandstone on southern side of timber residence.

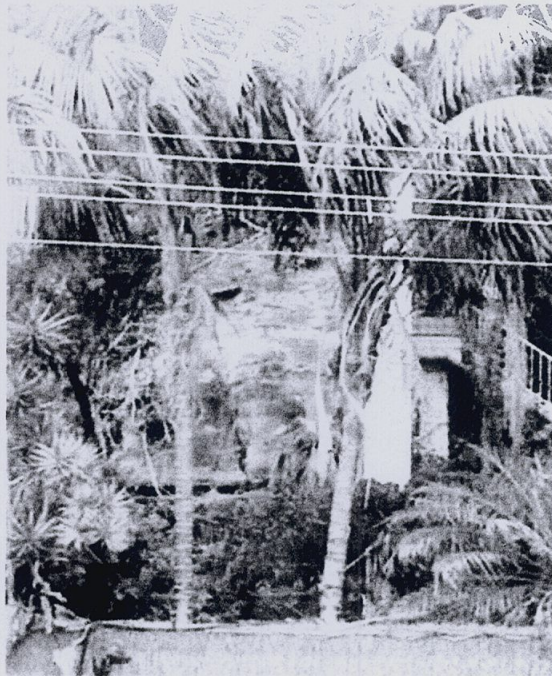
Photo 7. Outcrop behind 1094 Barrenjoey Road showing sandstone above shaly sandstone/sandy siltstone
