RISK ANALYSIS & MANAGEMENT FOR THE PROPOSED ADDITIONS AT 143 PRINCE ALFRED PARADE, NEWPORT

Development Application for <u>MR & MRS WILLS</u>	Name of Applicant
Address of site <u>143 PRINCE ALFRED PARADE, NEWPORT</u>

**RISK ANALYSIS & MANAGEMENT
FOR
PROPOSED ADDITIONS
AT
143 PRINCE ALFRED PARADE, NEWPORT**

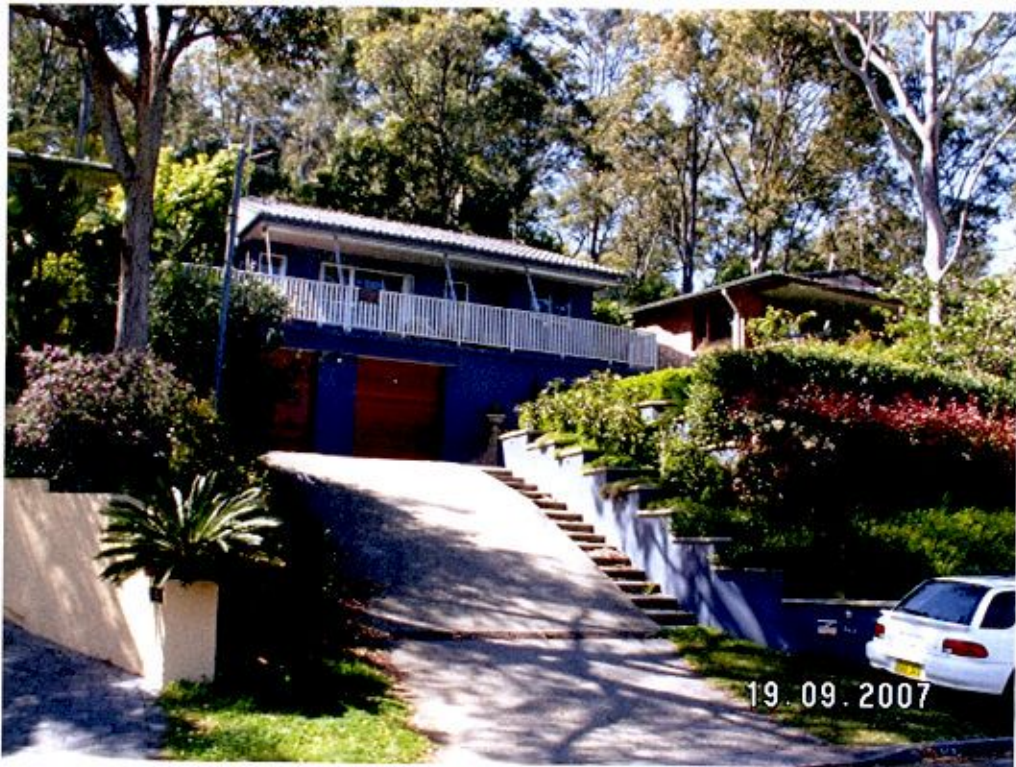
Photo 1

3.2 The property is on the high side of the road and has an easterly aspect (Photo 1). The original land surface sloped up from the road at angles of some 20 to 25 degrees. The surface has since been modified. At the road frontage a garage runs up the northern boundary to a garage under the house. To the south of the driveway a series of retaining walls provide a level fill that forms a lawn (Photo 2). The supporting concrete block retaining walls are in excellent condition. A path cuts across the front of the house and runs up the southern side providing access to the back yard. A concrete block wall that rises beyond the lawn marking the edge of the path is cracked (Photo 3). The wall is stable in its present state. A platform has been excavated in the slope to form a level patio area that runs along the uphill side of the house (Photo 4). The toe of the cut batter for this excavation is supported by a low concrete block wall in good condition. The upper area of the cut is battered back at an angle of some 45 degrees and is supported by a stack rock wall in stable configurations. Beyond the cut the surface of the block has been terraced in a series of low stack rock walls (Photo 5). The surface is grass covered.

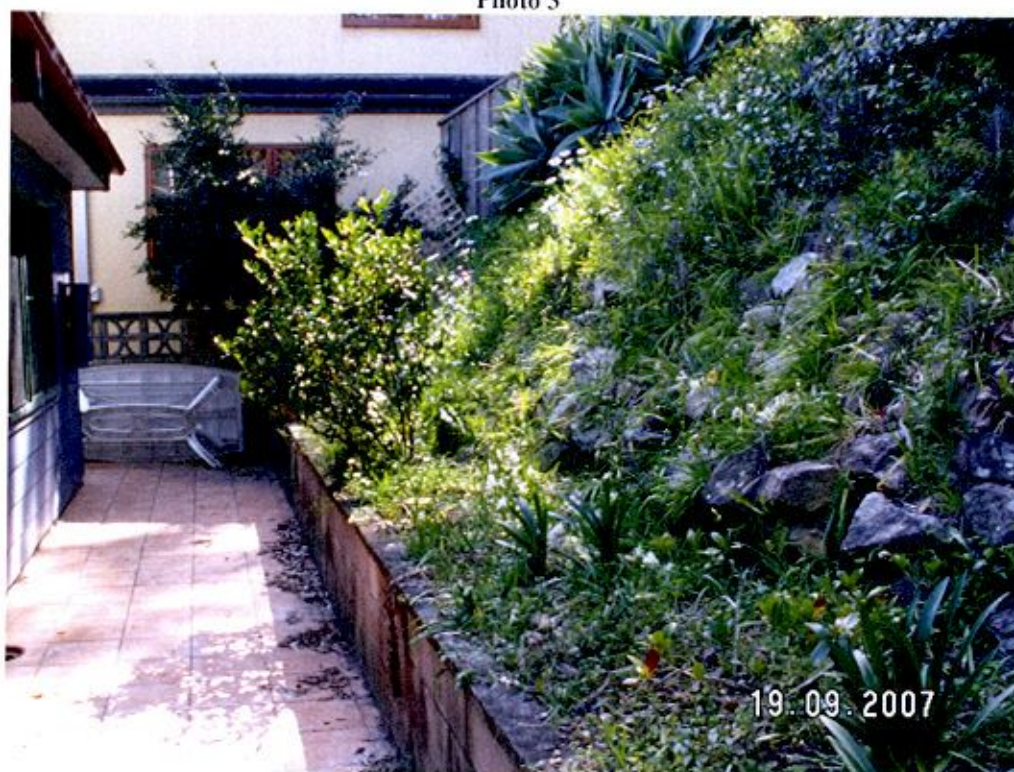
Photo 4

7.2.1 The cut batter at the rear of the house is a potential hazard (Photo 4, HAZARD ONE).

8.2.1 HAZARD ONE The cut batter is supported at the toe by a low stable concrete block wall. The batter is angled back at some 45 degrees and is supported by a stack rock wall in stable configurations. The likelihood of the batter failing is assessed as 'Unlikely' ($>10^{-4}$). The consequences to property of such a failure are assessed as 'Medium' ($>1\%$). The consequences to life of such a failure are assessed as 'Medium' ($>10^{-3}$). The risk to property is 'Low' (10^{-6}). The risk to life is 'Low' (10^{-6}).

All retaining walls are to have adequate drainage such as those fitted with standpipes to permit flushing of the system.
