Arboricultural Impact Assessment

Proposed Double Garage and Deck at
28 Woodbine Street, North Balgowlah

Client: Corona Projects

Date: August 2019

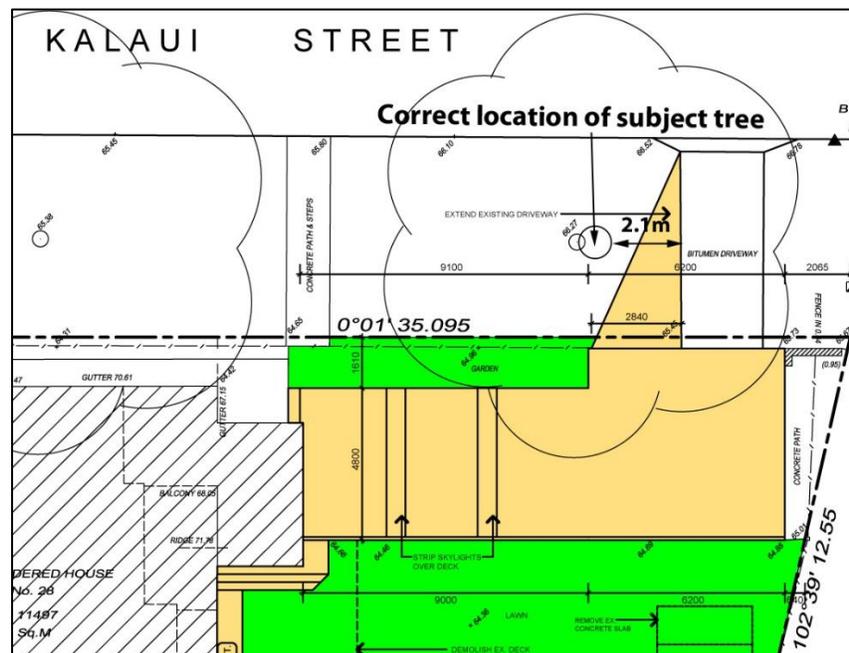
Refer to Figure A on for location of the subject tree. The location of the subject tree is incorrectly plotted on the Site Survey and Architectural Plans. The location shown in Figure A is based on measurements taken from the existing driveway taken during the tree assessment.

Figure A: Excerpt from the Site Analysis Plan showing tree location.

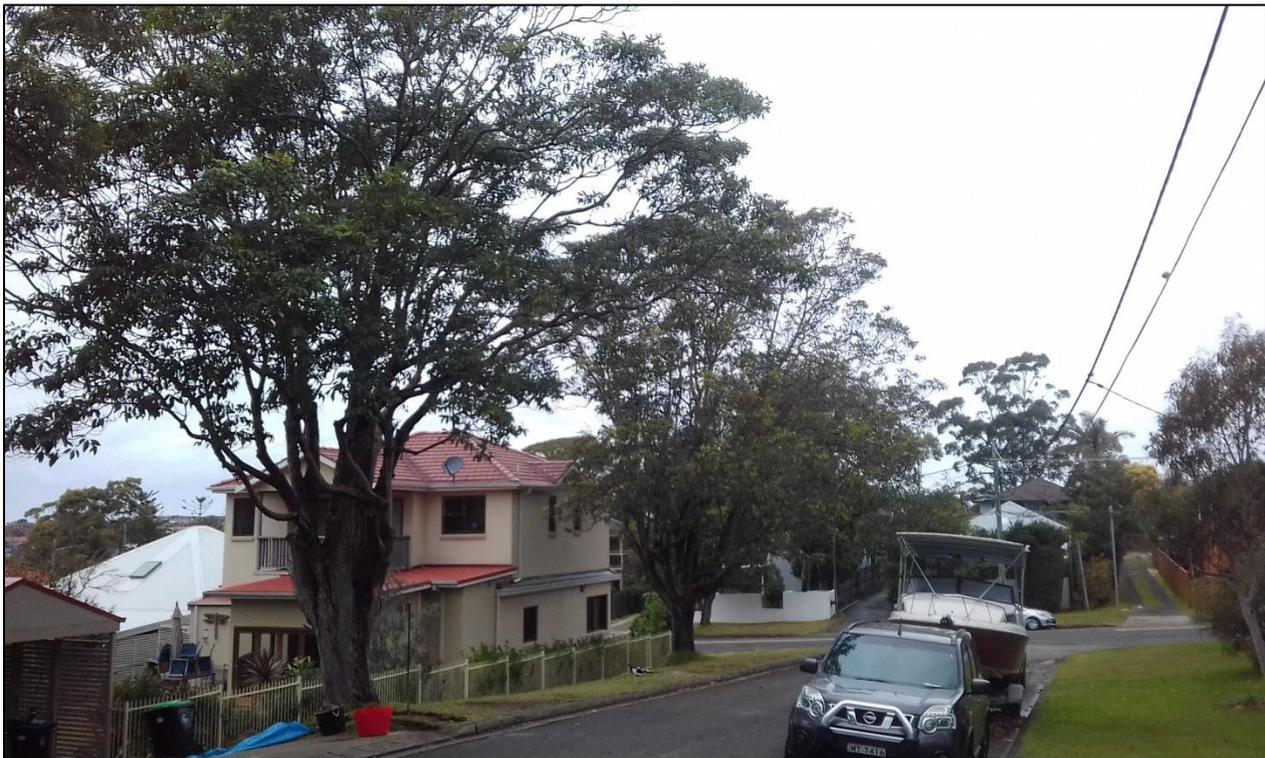
Subject Tree –Brushbox, <i>Lophostemon confertus</i>	
Trunk Diameter (above root flare)	820mm.
Height (estimated)	17 metres
Canopy Spread Radius	7 metres
Age-Class	Mature
Health/Vitality	Good.
Structural Condition	Good.
Estimated Life Expectancy (remaining)	Long (30+ years)
Landscape and Environmental Significance	2. The subject tree provides amenity to the site, surrounding properties and provides a significant contribution to the streetscape amenity. This is a commonly planted Australian native. No specific wildlife nesting sites were observed.
Retention Value	High. This tree is worthy of retention and protection during construction.
Comments	The north eastern side of the canopy has been pruned in the past to reduce property overhang.

Photo A: Subject tree taken from Kalau Street facing south east.

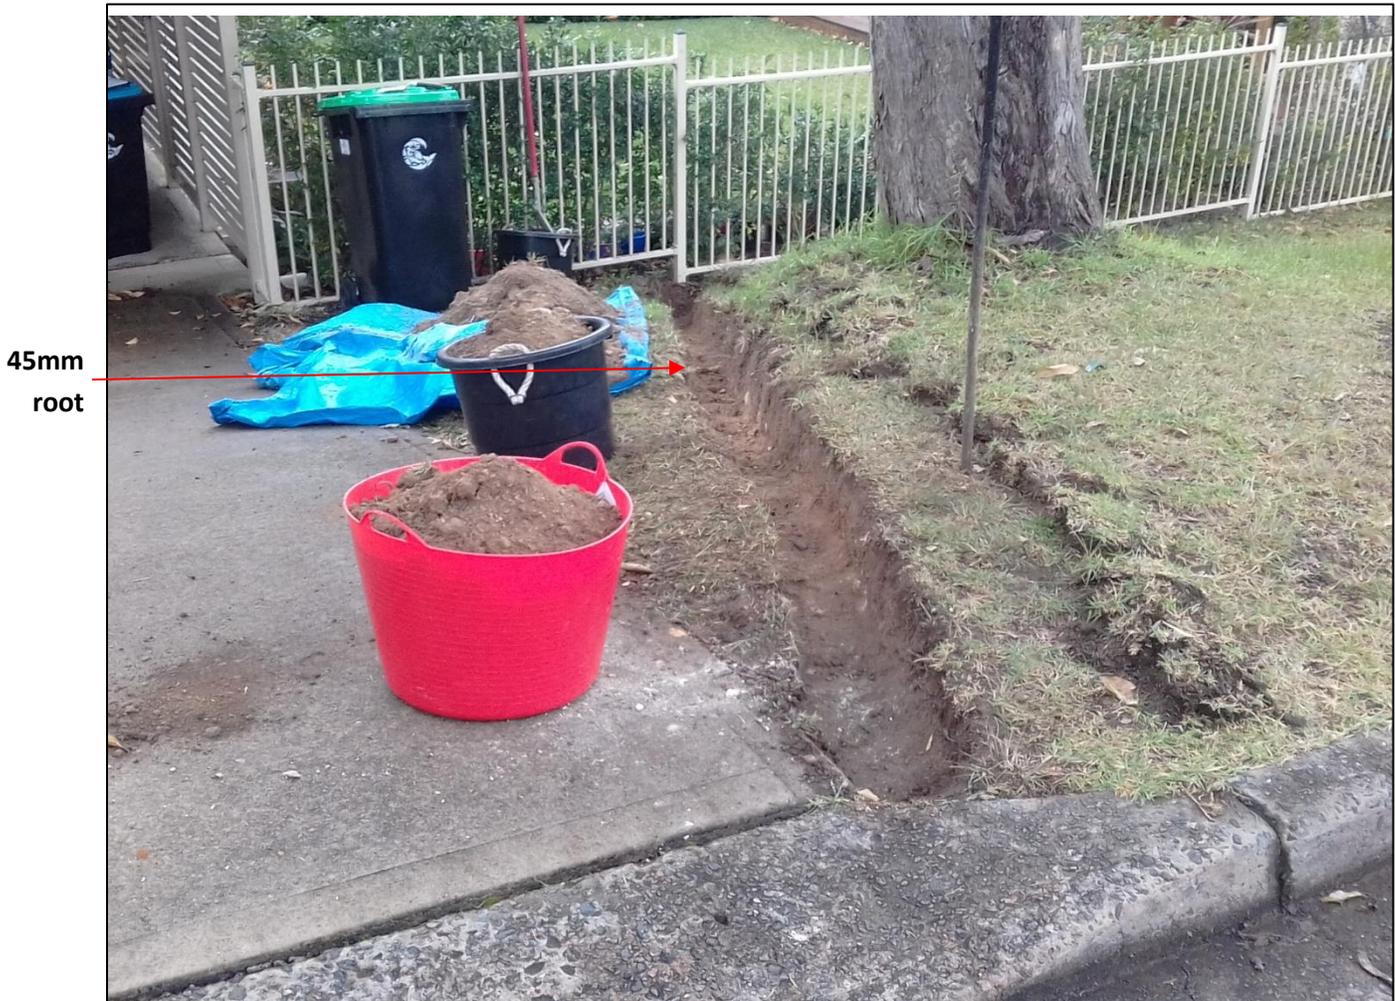
Exploratory excavation and root mapping was undertaken along the southern edge of the proposed new driveway in the area of the grassed verge (Photos A and B). The purpose of this was to determine the extent of root growth in the area of the proposed driveway to guide the driveway design and layout. Exploratory excavation was undertaken with care, using hand tools, to depths ranging between 200-350mm. These depths were sufficient to expose any roots that may be damaged as part of excavation for driveway widening.

Exploratory excavation was undertaken along the southern edge of the proposed driveway layout. The soil in this location consisted of compacted stoney fill. A single 45mm diameter root was encountered within the trench. This root branches into two smaller roots at the trench location. The root was located 4.1m from the existing kerb layback at a depth of 250mm. It is likely that this root will be pruned as part of driveway excavation. Based on the size of the root relative to its proximity to the trunk, it is not considered to be a critical structural root. It is likely that large structural roots critical for tree stability are located beneath the depth of the proposed driveway.

Photo B: Exploratory excavation trench.

The stability of the subject tree is unlikely to be compromised by the pruning of the 45mm diameter root.

The root is likely to form less than 5% of the entire root mass of the tree. The impact on the health, vitality and longevity is likely to be negligible.

Driveway Construction: All excavation for the new driveway must be undertaken under guidance of the Project Arborist. If the 45mm diameter roots requires pruning, it must be cleanly cut using a sharp hand saw by the Project Arborist. The purpose of this is to minimise the surface area of the pruning wound and to avoid additional root damage (splintering/tearing) that typically occurs when roots are pruned using an excavator.

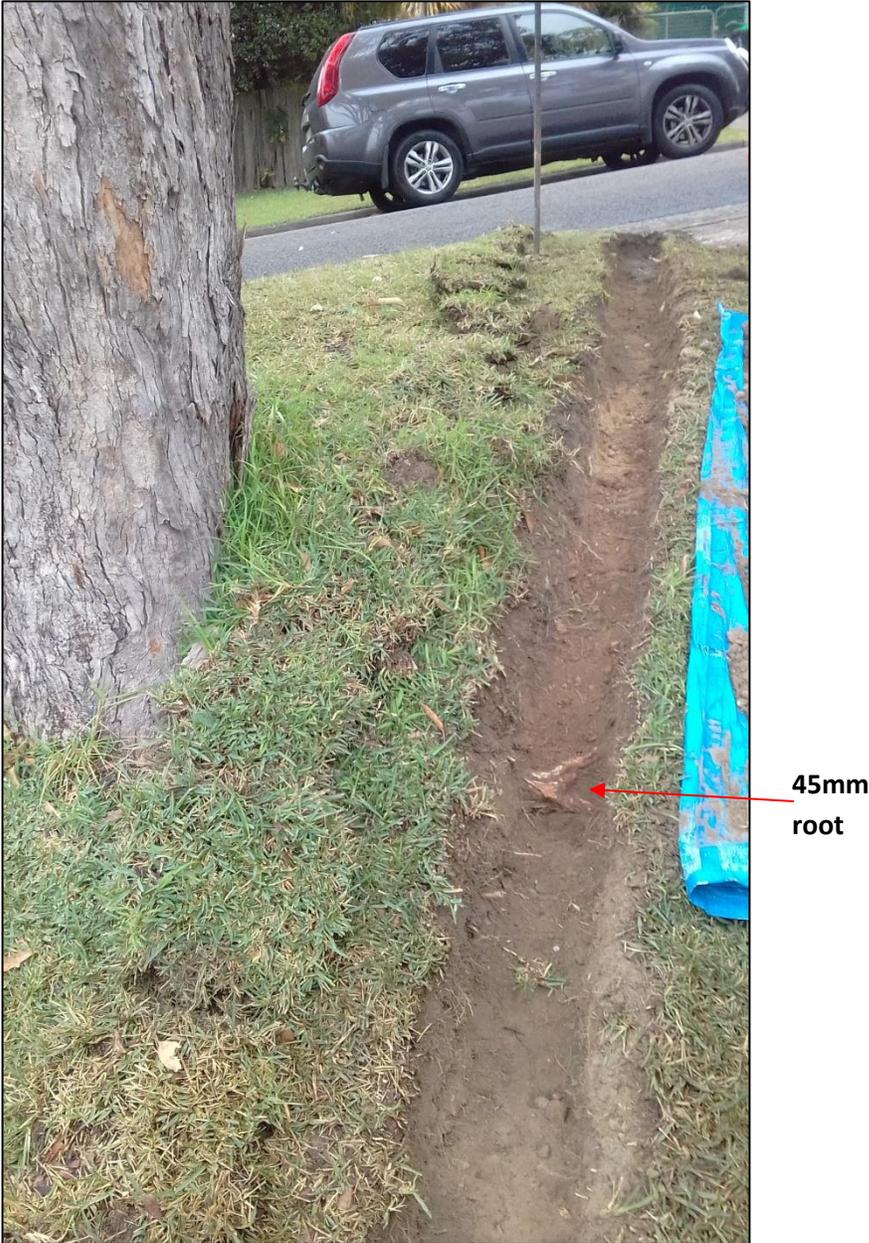
Photo C: Exploratory excavation findings and proposed driveway alignment near Tree 1

Driveway Levels: The driveway levels must be no deeper than the existing driveway. It may be possible to gently ramp the new southern section of driveway to be slightly above the level of the existing driveway to minimise the depth of excavation required for installation. This will increase the distance between large underlying structural roots and the driveway underside and minimise the likelihood of future cracking.

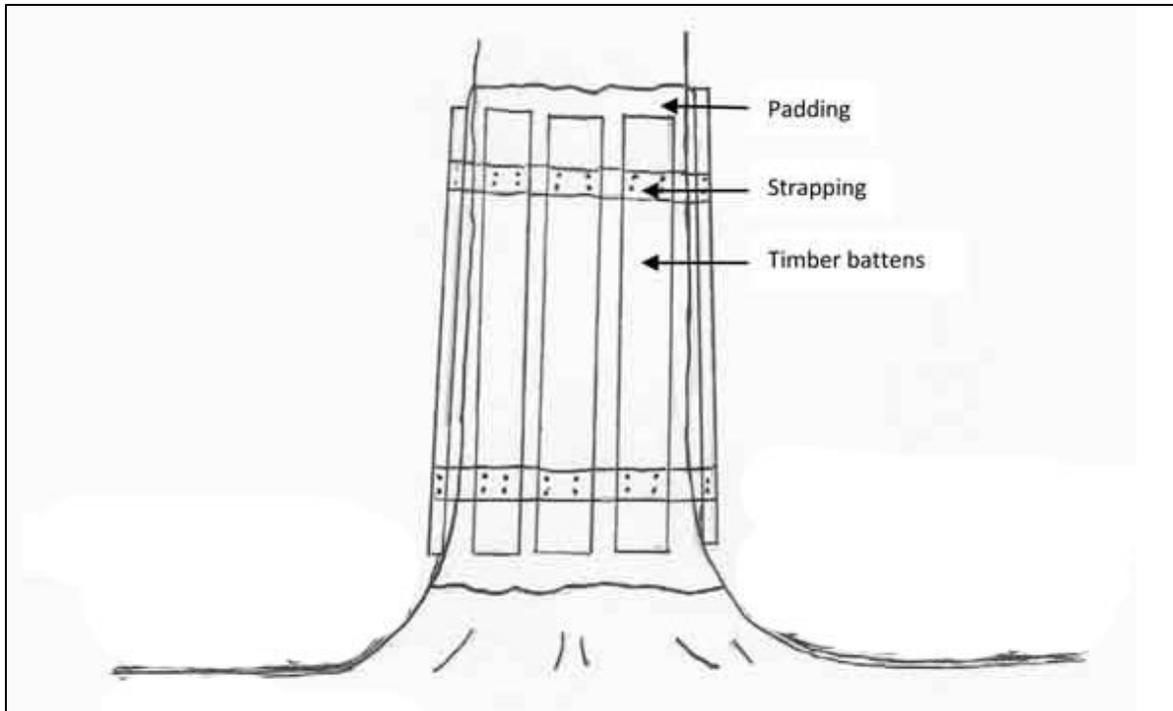
Figure B: Example of adequate trunk protection.

Trunk Battening: Trunk protection is recommended for the subject tree. The purpose of this is to prevent accidental trunk injury during construction.
