Zoe and Martin Jenkins
C/- Council Approval Experts Pty Ltd
11 Jersey Ave
Leura NSW 2780

Project 99688.00
27 May 2020
R.001.Rev1
HDS

Preliminary Geotechnical Investigation
Alterations and Additions
16 Marshall Crescent, Beacon Hill

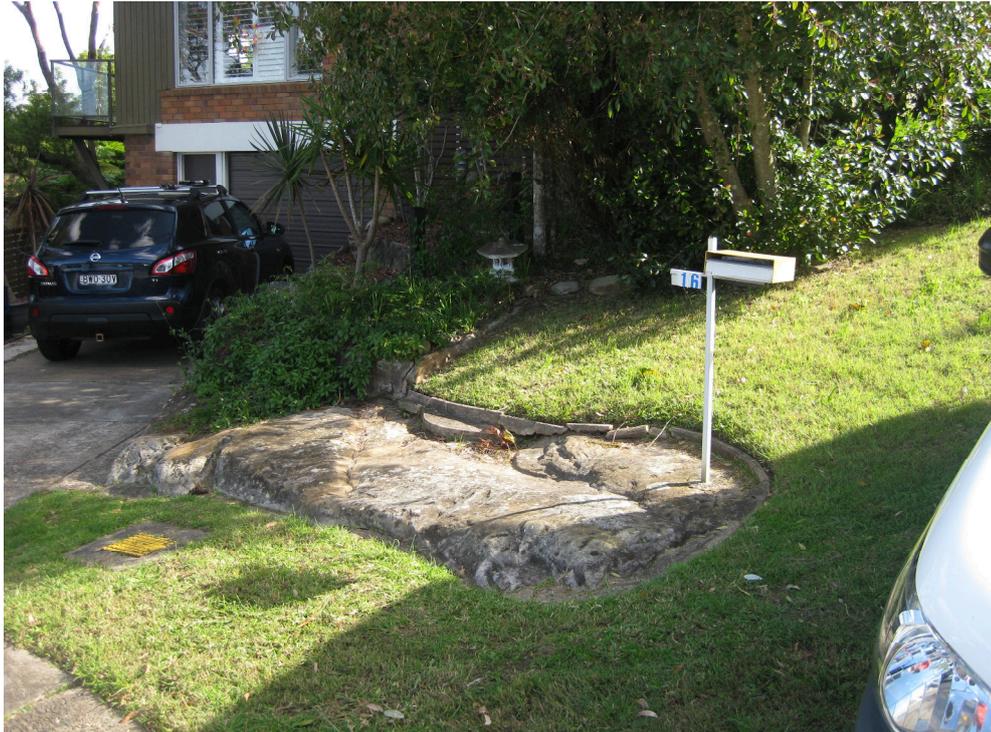
Inferred outcrops of medium to high strength sandstone were exposed on the southern, sloping part of the site near the street frontage (refer attached Photographs 1 and 2, Plate 1), and also within and to either side of the 3-level residence (refer Photograph 10 on Plate 5). The residence on the site appears to have been constructed over a 'step' in the rock outcrop (~2.5 m high). The surrounding properties are also occupied by residential dwellings.

Photograph 1 – View to the west from the street frontage and property boundary. Sandstone outcrop was present at this boundary.

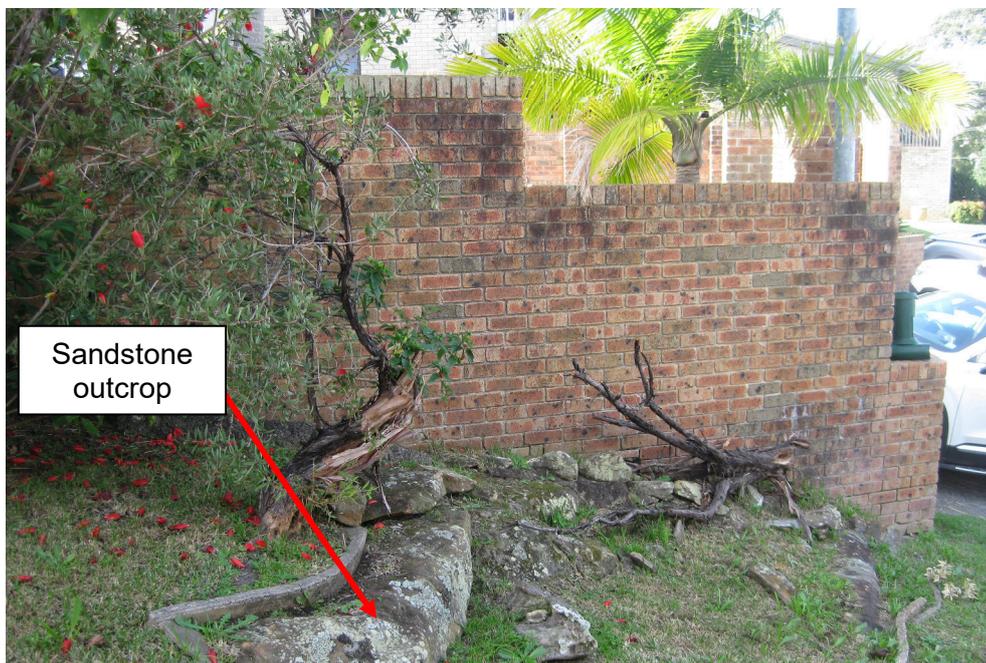
Photograph 4 – View north-east towards the north-eastern property boundary with 17 Marshall Crescent. Sandstone outcrop is present in this area of the site.

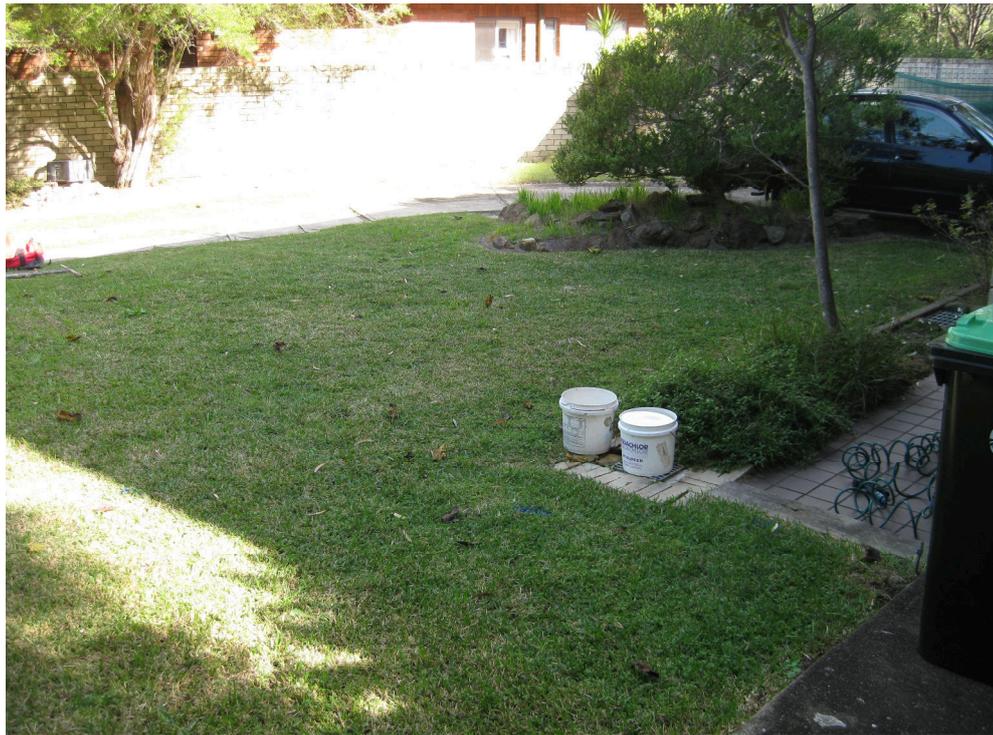
Photograph 9 – View to the south towards the southern property boundary.

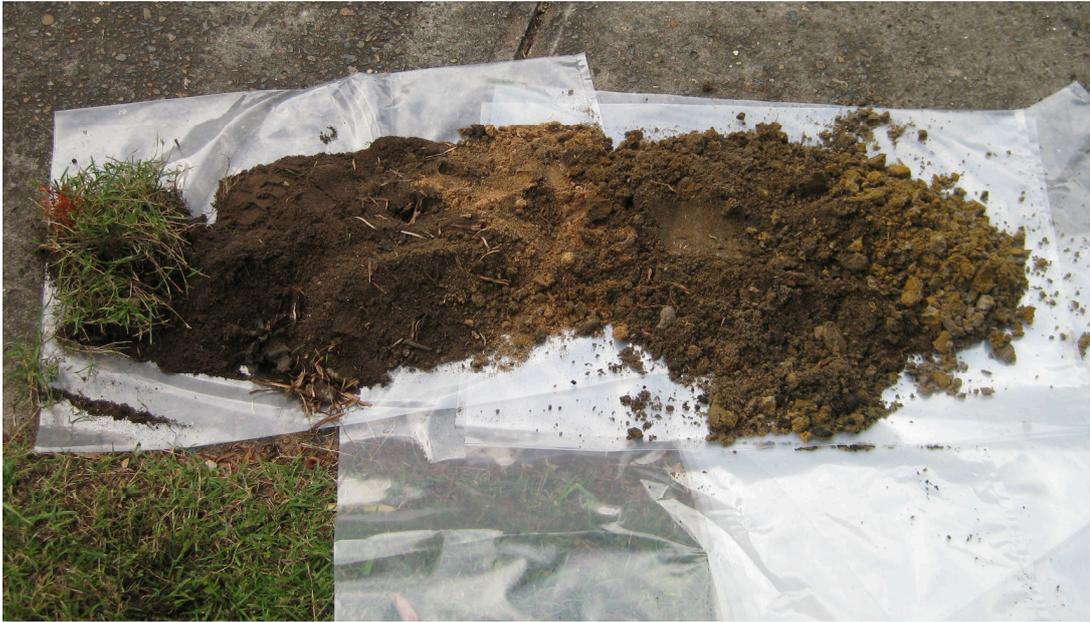
RL	Depth (m)	Description of Strata	Graphic Log	Sampling & In Situ Testing				Water	Dynamic Penetrometer Test (blows per 150mm)					
				Type	Depth	Sample	Results & Comments		5	10	15	20		
82	0.05	FILL/Silty SAND: fine and medium, dark brown, trace fine roots, moist, generally in a loose condition			0.05									
		FILL/SAND: fine and medium, dark brown, moist, generally in a loose to medium dense condition		D										
		At 0.2m: with plastic, concrete and igneous gravel				0.2								
		Below 0.3m: grading to fine to coarse, brown, trace clay and gravel, generally in a medium dense condition		D		0.3

0.37	Silty SAND SM: fine and medium, dark brown with black mottle, trace roots, organic matter, and fine quartz and sandstone gravel, moist to wet, medium dense, possible colluvium		D		0.37								
81	0.57	Clayey SAND SC: fine and medium, mottled grey and orange-brown, medium plasticity fines, trace fine roots, moist, medium dense, residual			0.57

0.62	Clayey SAND SC: fine and medium, mottled grey and orange-brown, medium plasticity fines, trace fine roots, moist, medium dense, residual Bore discontinued at 0.62m - Refusal on inferred sandstone bedrock		D	0.62									
80	1

Photograph C1 – View of soils excavated from Borehole BH1, with the top of the soil profile commencing from the left of the field of view.

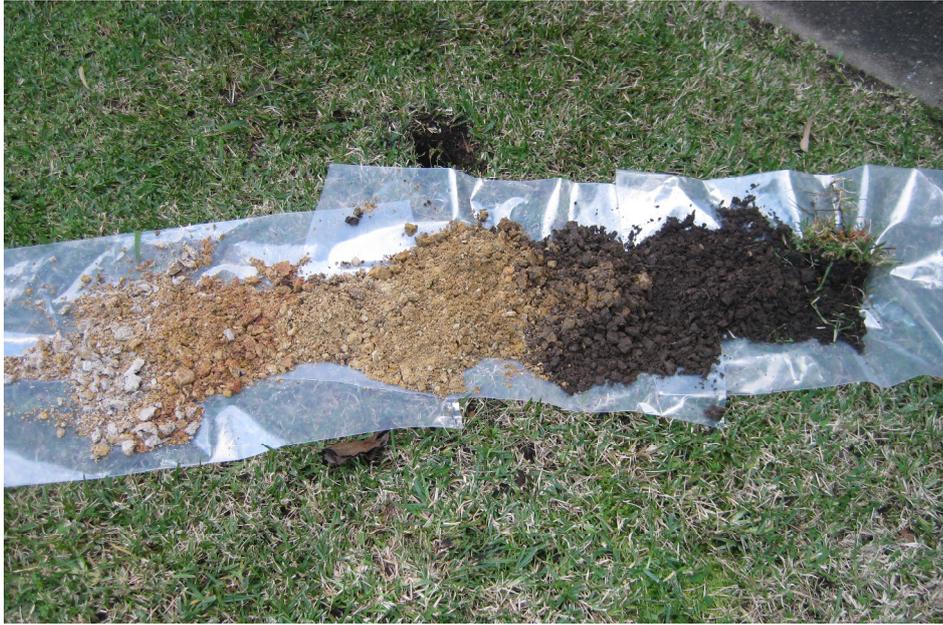
Photograph C2 – View of soils excavated from Borehole BH102, with the top of the soil profile commencing from the right of the field of view.
